Eastern Infrastructure, Salisbury Plain Training Area, Wiltshire

Archaeological Field Evaluation

WA Ref: 63213.02

## April 2007

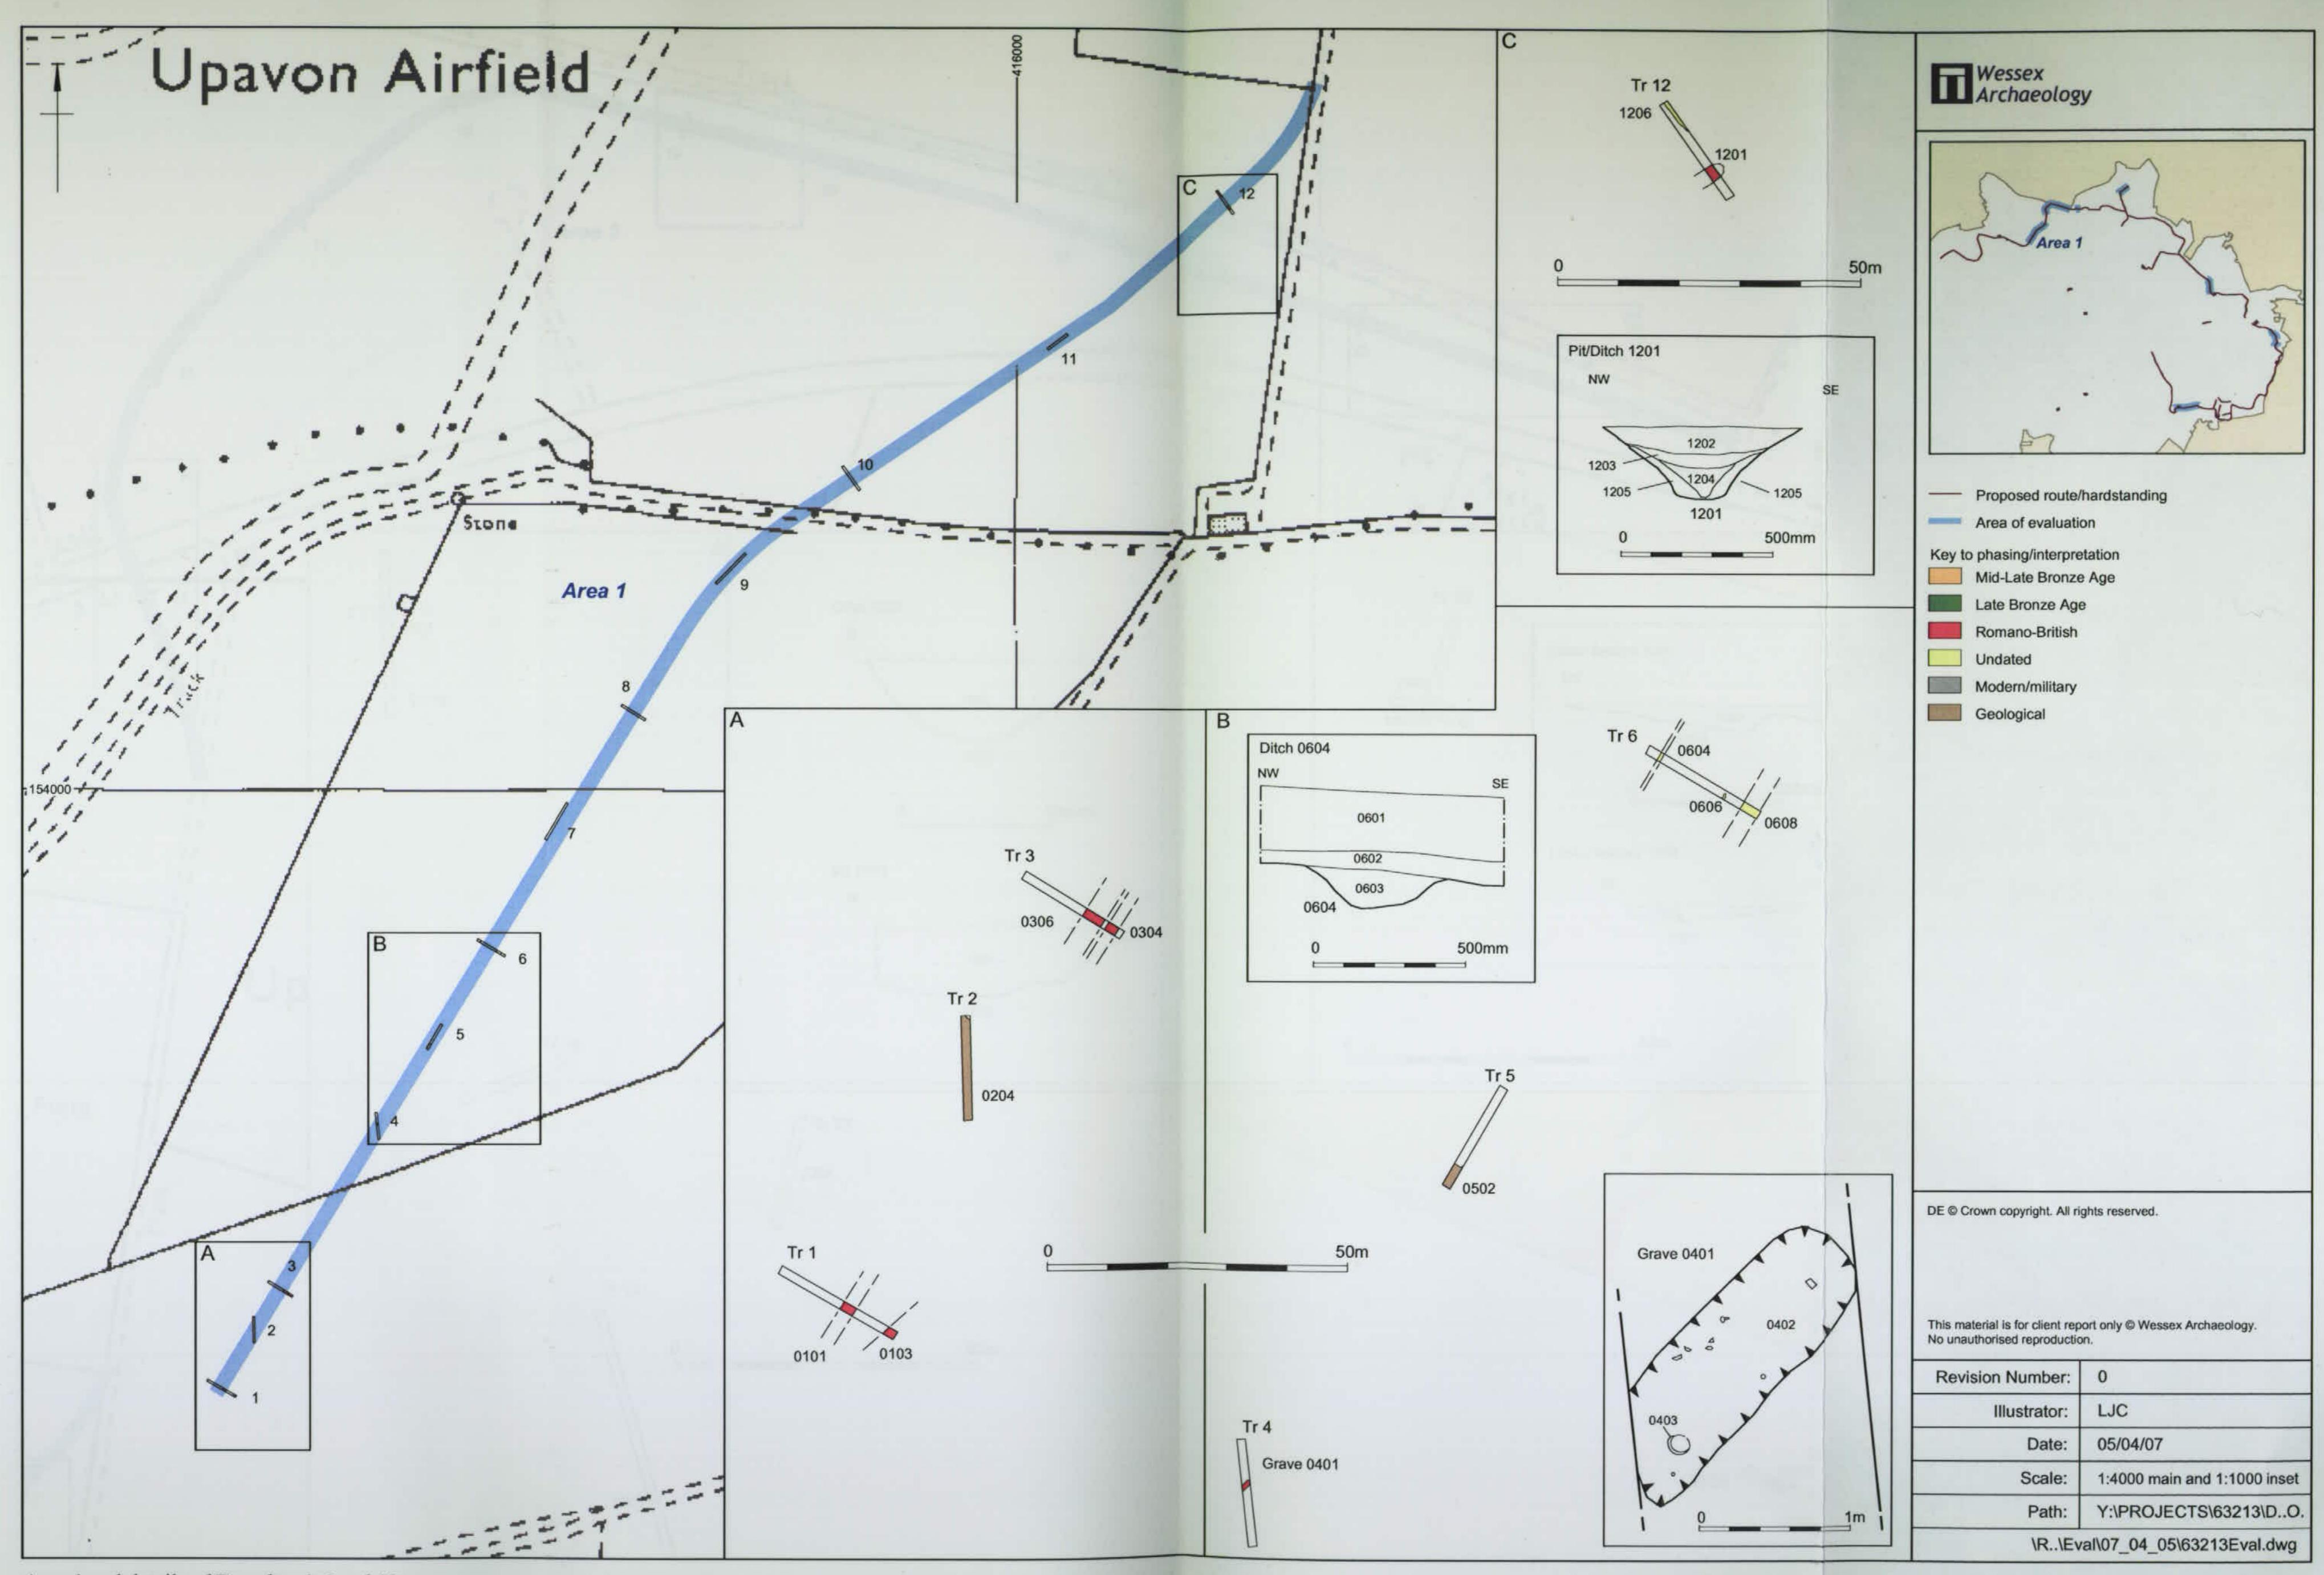
Area 1 and details of Trenches 1-6 and 12

5.2.1 The thick deposits of clay and flint and redeposited chalk recorded in Trenches 2 and 5 (Figure 7) appear to be filling wide gullies in the western side of the large coomb or dry valley in the southern end of Area 1. The very irregular form of these gullies, their alignment down the prevailing slope and the very mixed and contorted fills suggest a geological origin, possibly periglacial. It is, however, possible that these deposits represent fluvial erosion caused by woodland clearance and/or tillage, similar to deposits recorded at Strawberry Hill, Wiltshire (Allen 1992). The only datable material recovered from these deposits comprised two small sherds of Romano-British pottery from the upper clay and flint fill from Trench 5 (0504), which could indicate that such erosion may be the result of agricultural intensification and excessive ploughing in the area during this period.

- 5.4.2 The most significant feature was a single rectangular grave (0401 Figure 7) found in Trench 4 (Area 1), this was aligned approximately south-west to north-east and was over 2m long, 0.75m wide and over 0.1m deep with vertical sides. Excavation was curtailed when the skull of skeleton 0403 (Figure 7) and possible coffin nails and fittings were recognised within fill 0402 (Figure 7). Two small sherds of Romano-British pottery were recovered from the backfill of the grave before excavation was halted. Only a part of the skull of skeleton 0403 was exposed, however, from the position of this and the arrangement of coffin nails recognised within the fill, it is assumed to have been in a supine, extended position, with the head to the south-west. Although the whole of Trench 4 was carefully hand cleaned, no further graves were recognised. Whilst this may be an isolated burial it is also possible that it represents part of a larger cemetery that has not been identified by the evaluation.

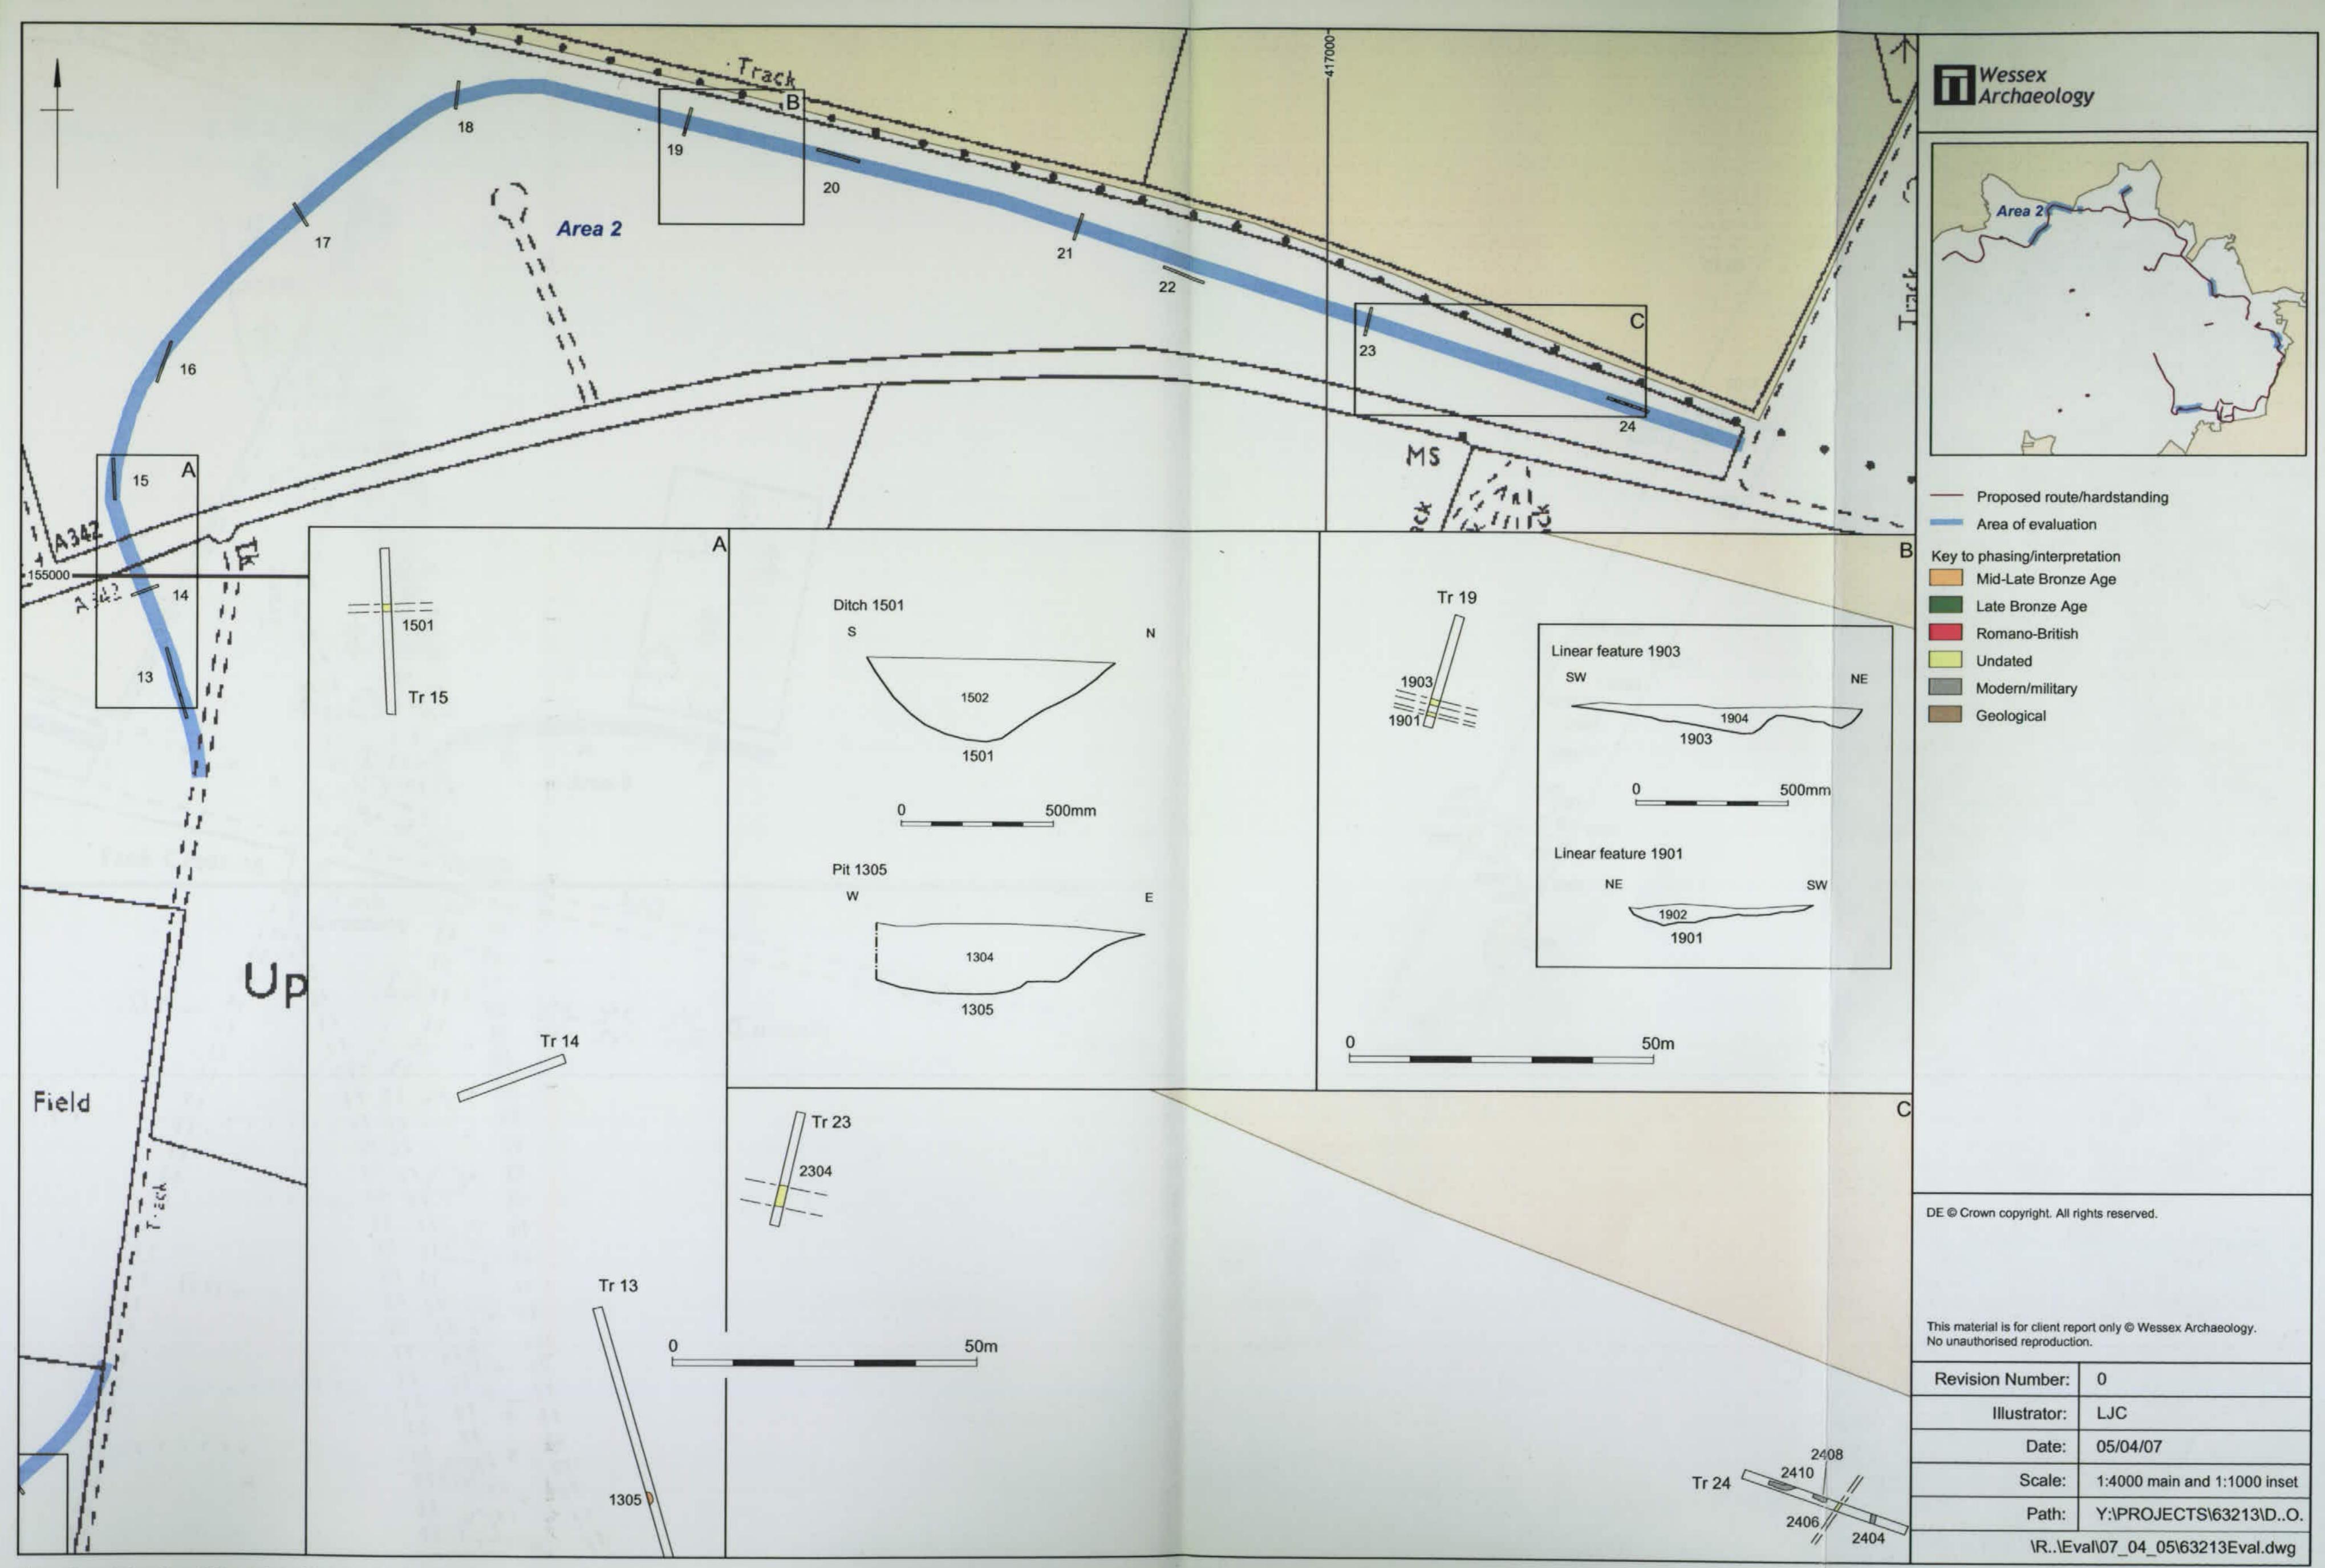
Area 2 and details of Trenches 13-15, 19, 23 and 24

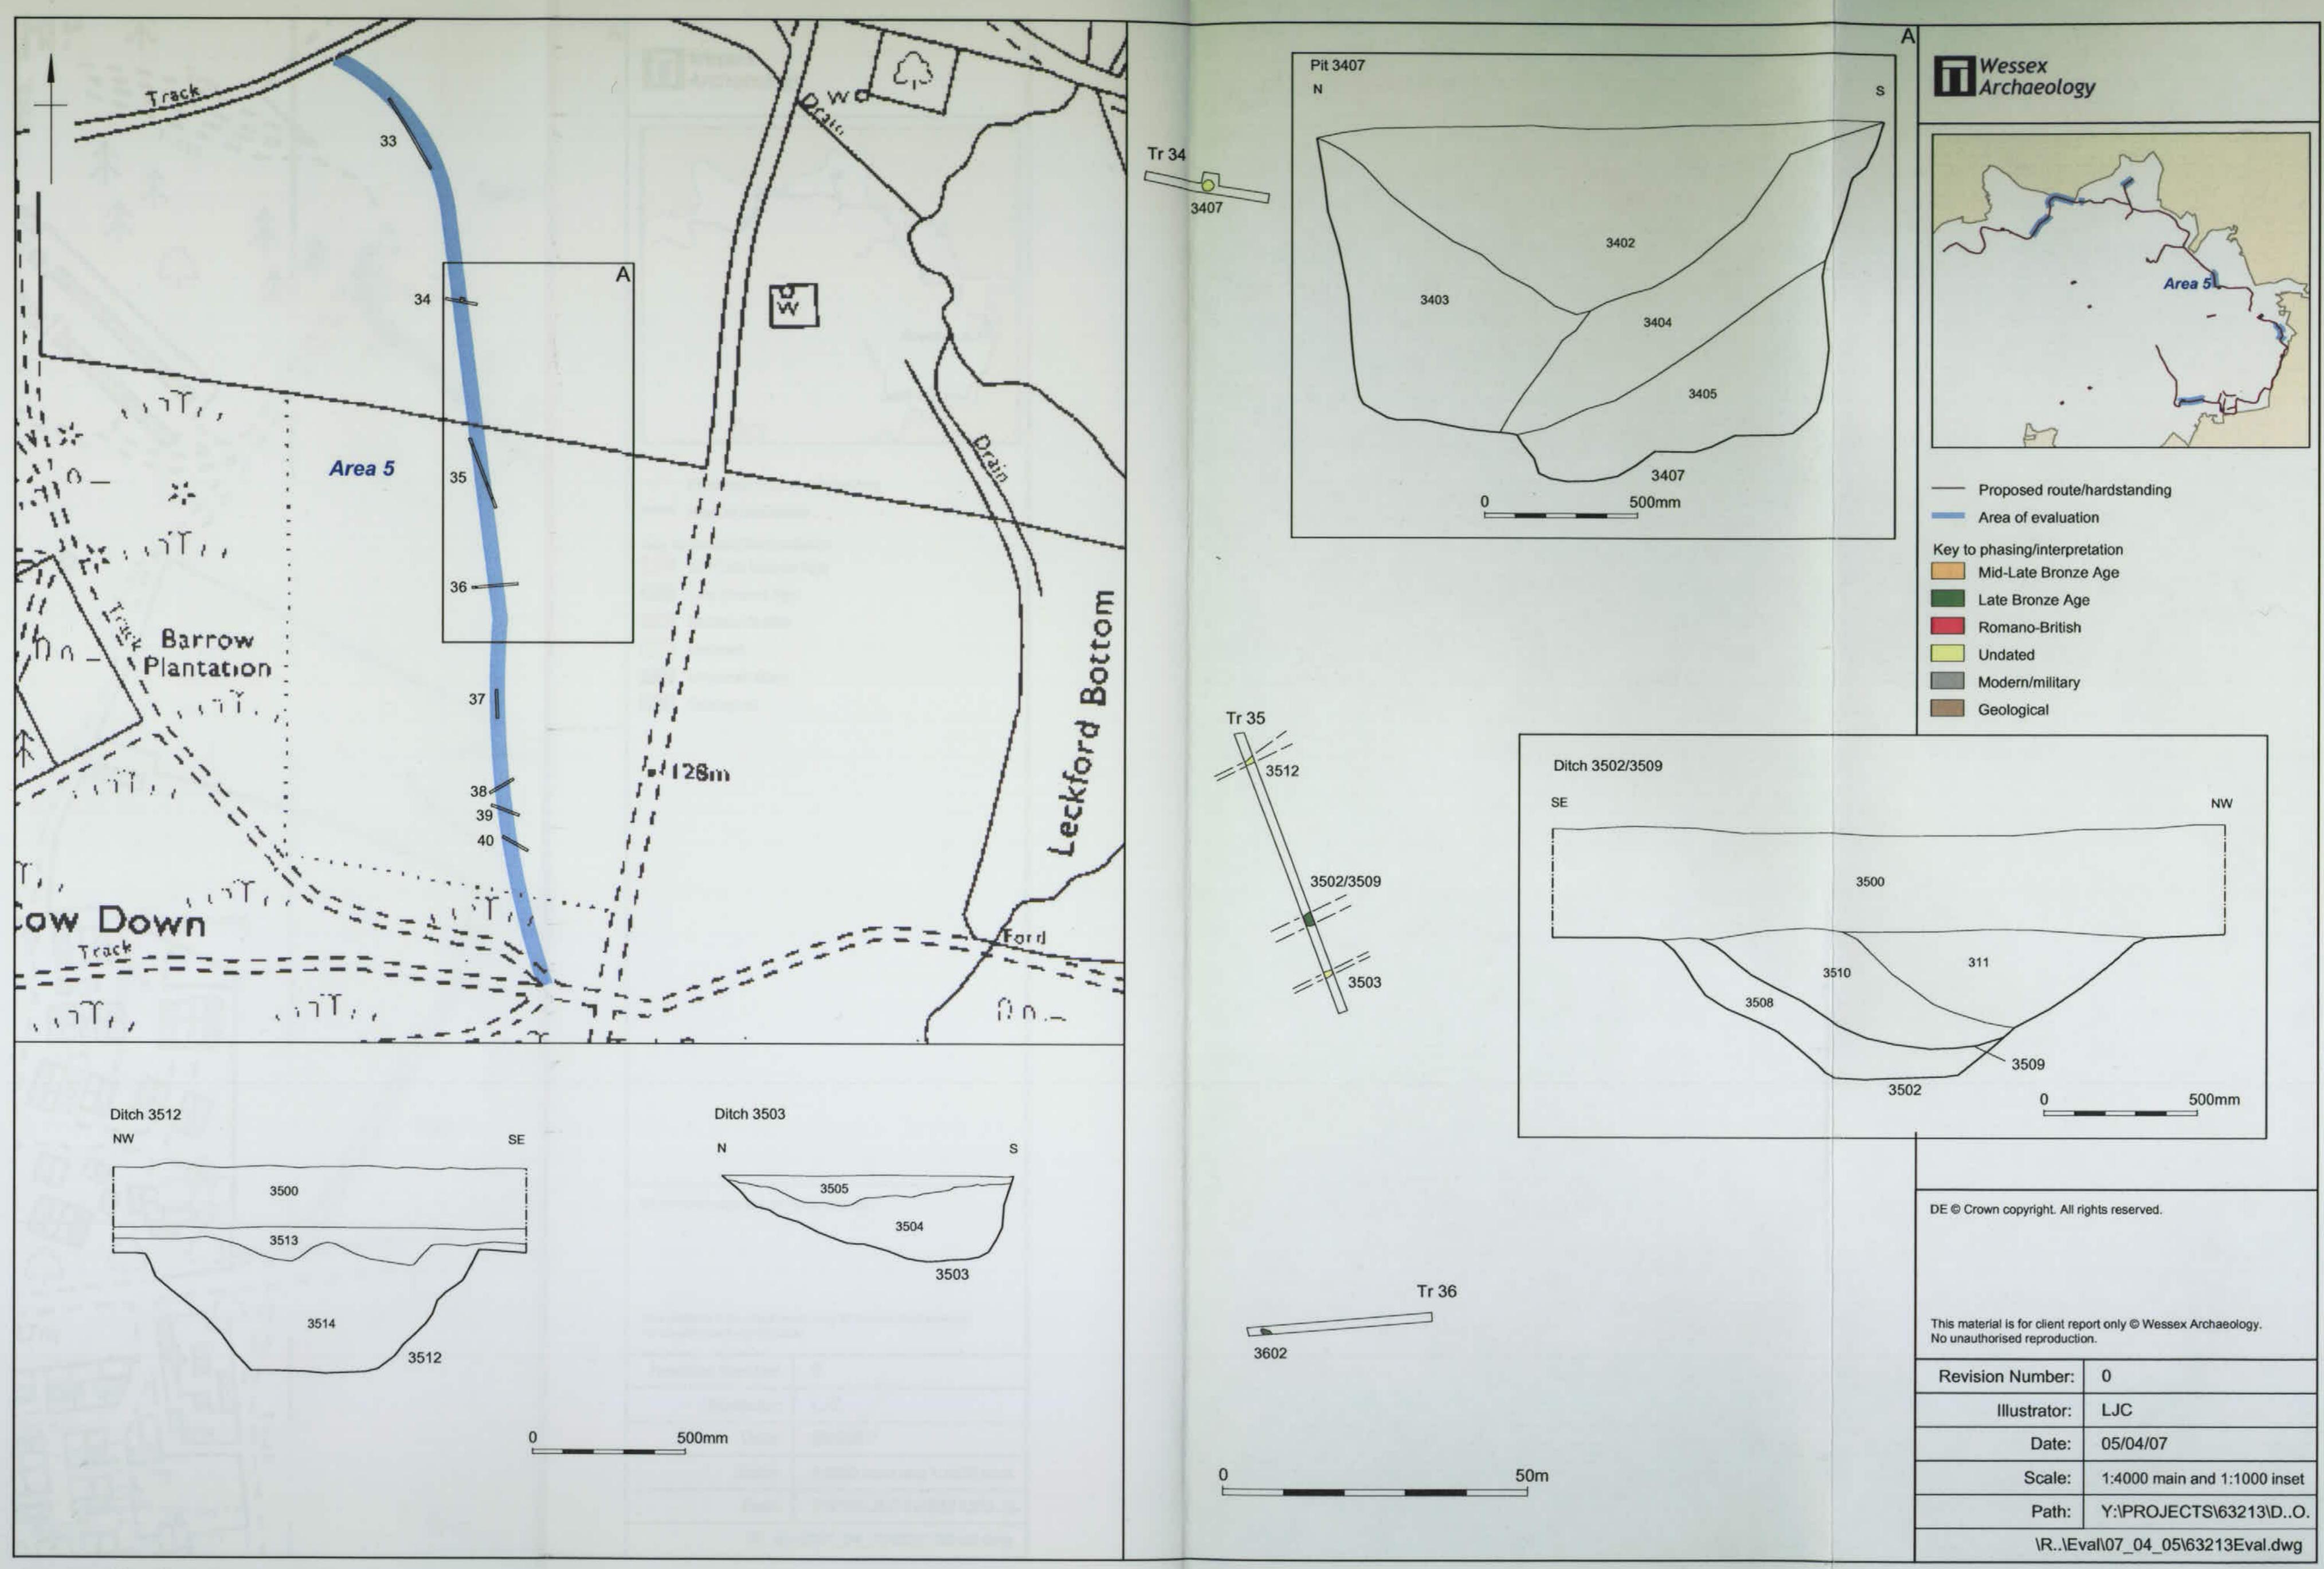
Area 5 and details of Trenches 34-36

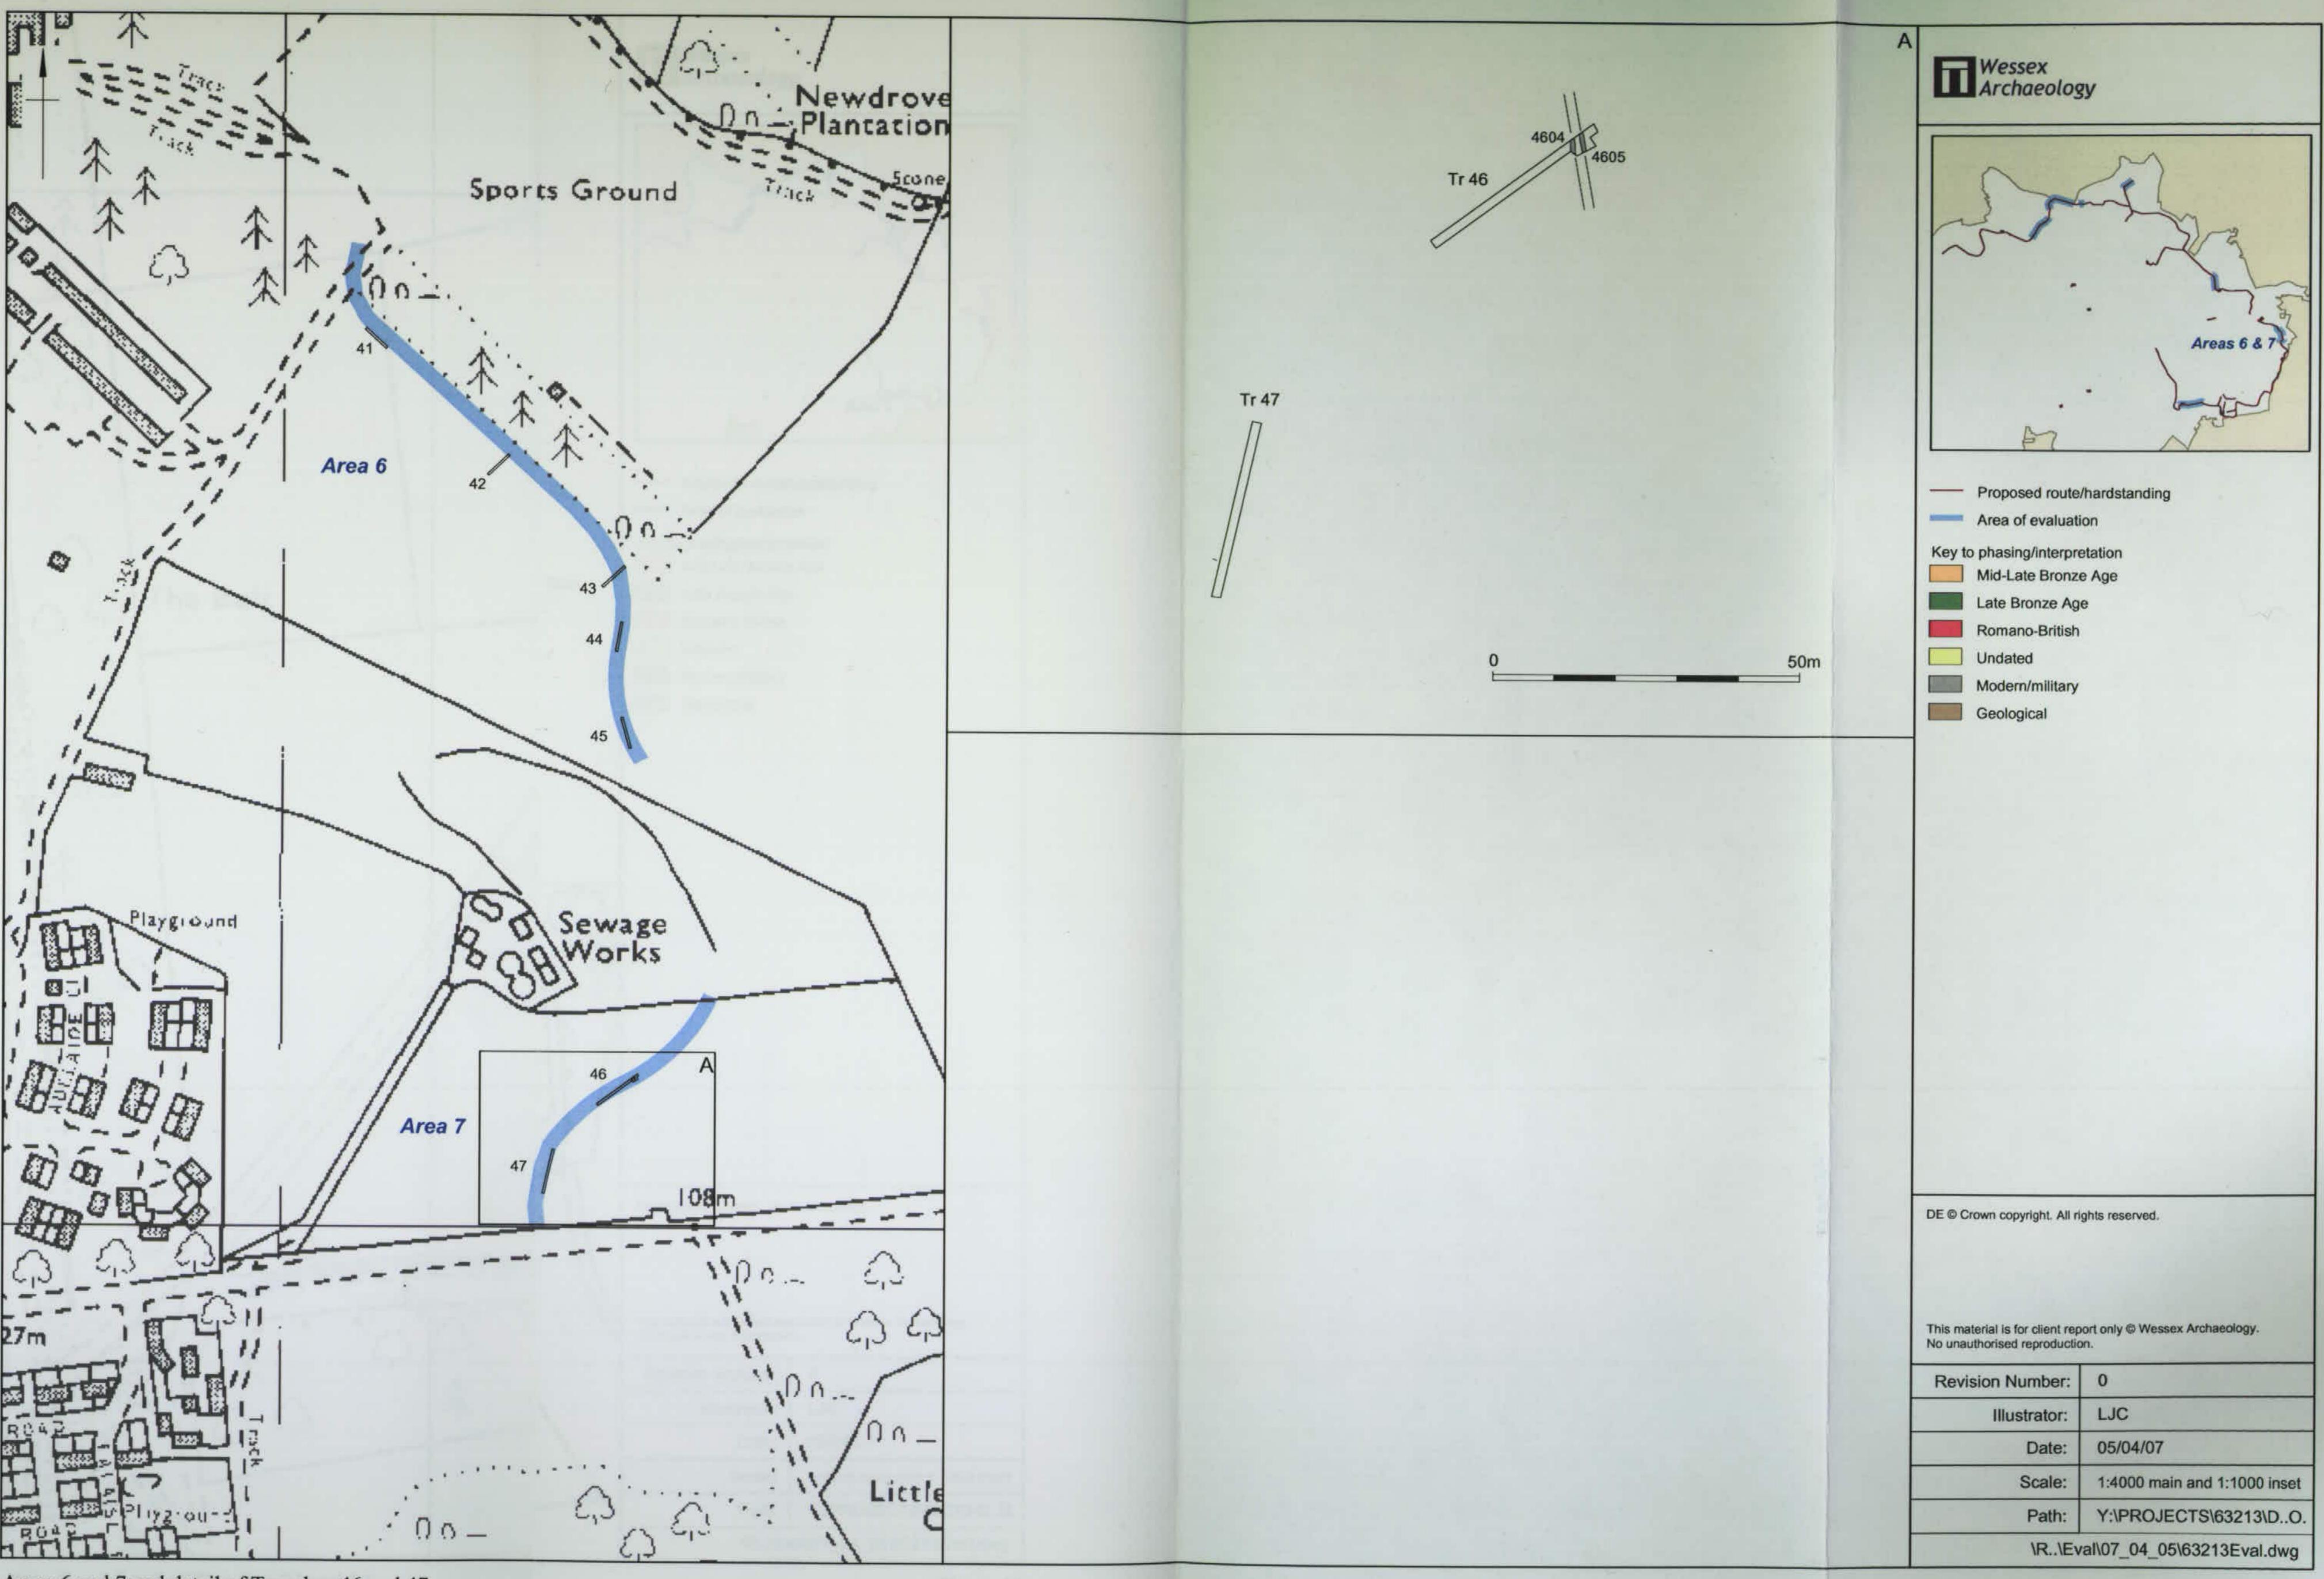
Areas 6 and 7 and detail of Trenches 46 and 47

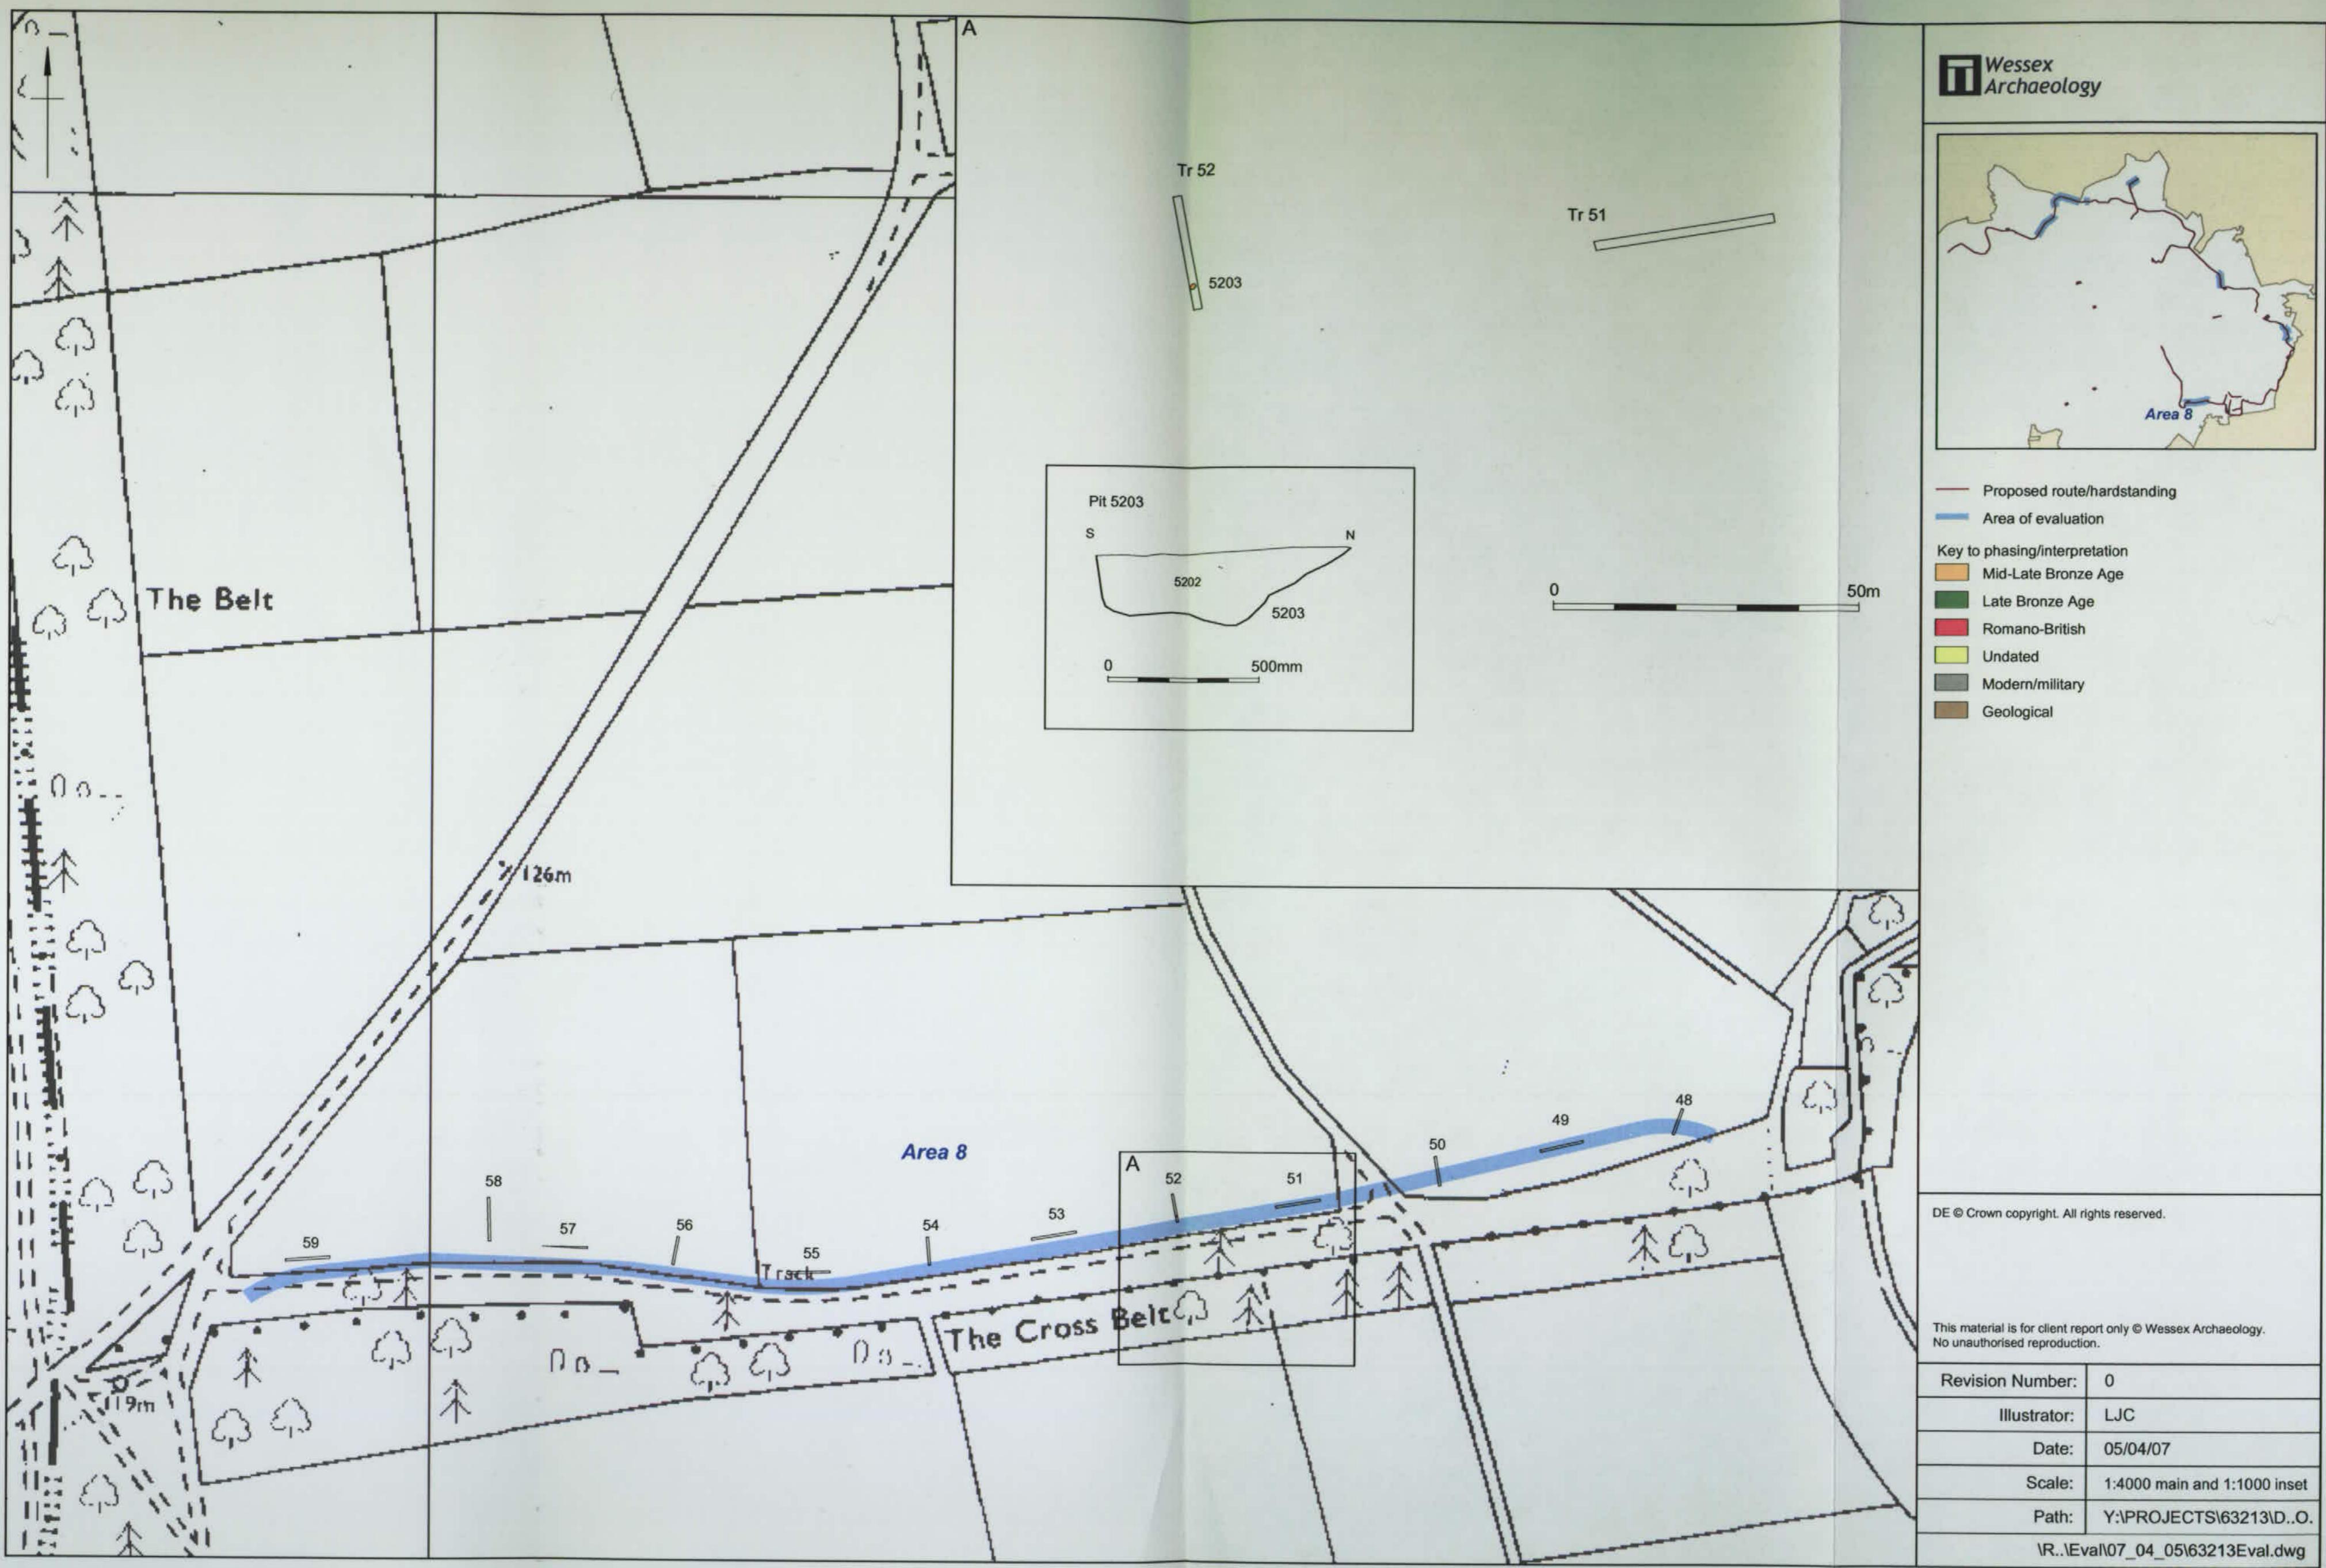
Area 8 and detail of Trenches 51 and 52
