GLA/SITE/3/24

I.M. Rendell

Glastonbury 1964

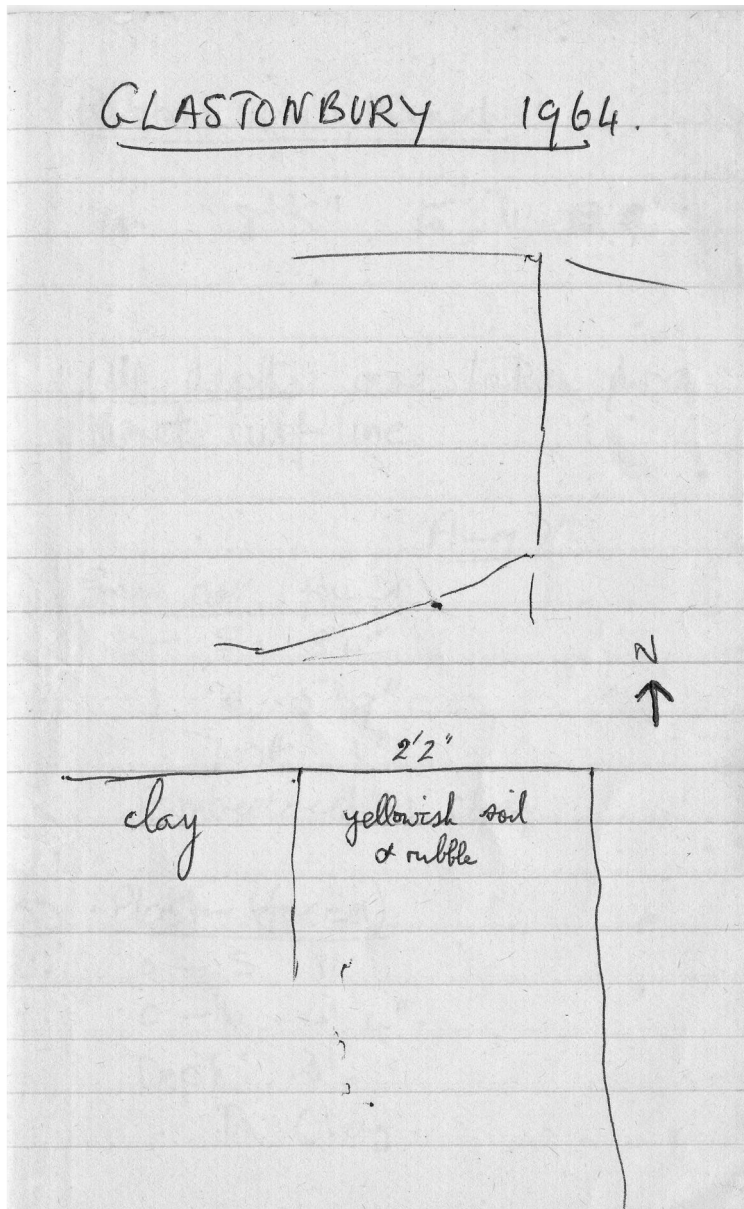
Sketch plan within trench.

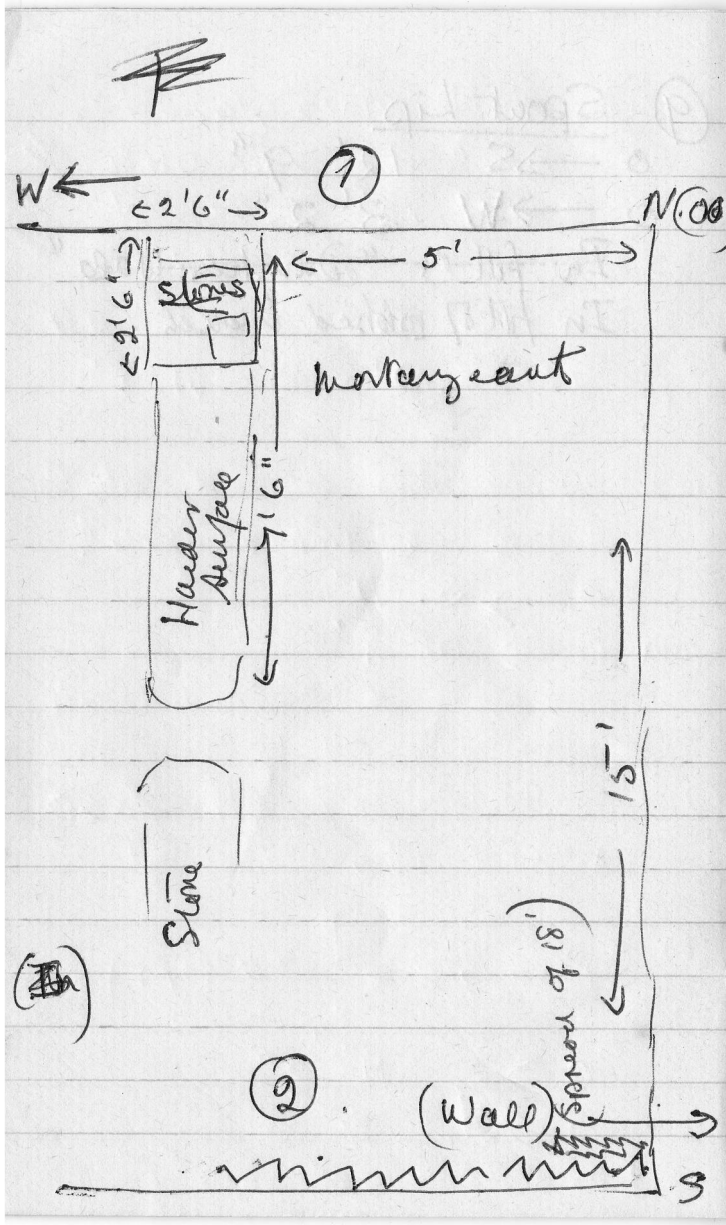
Sketch plan of NE area of trench.

NE corner of excavation

1) At a depth of 3'3" (measured from N turf of trench) there is a spread of mortary earth (yellowish).

O-W. 5', a harder surface with some large flat stones covering an area 2'6 x 2'6.

The harder surface, without stone, runs to 7'6" from N to S.
