DB 19/2/8

Cow Tag	255	Function Code	<del>5A</del> 521.3
---------	-----	---------------	---------------------

Brief Description: [timber element, p/s, condition, fragments]

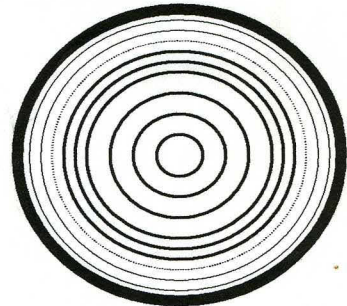
Att Scarf: Clean nail hole with no head marks. Situated within diameter of Clinke Nail head. Wooden spike cut flush with outboard. - Sequence of manufacture?

Radial not curved - partial plank

Photo. - see Att Scarf in 'Notable Features'
