DB 19/2/8

261 S22_2 Yardeni Vorst 7 August 2006

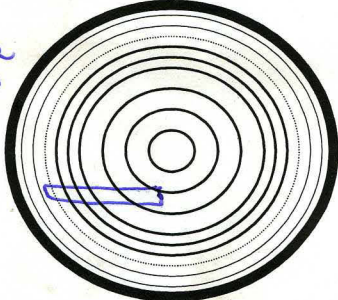
Cow Tag 261		Function Code 522,2
Brief Description: [timber element, p/s, condition, fragments]		
Notable Features: [tool marks, scribed lines, decoration, repairs] POINTS TO LOOK OUT FOR WHEN RECORDING ufos FORWARD EDGE CUT OFF IN ANTIQUITY WHEN STEP CUT OUT. LB: INSCRIBED LINES: VAGUE NEAR COW TAG AUGER HOLE THAT THE NAIL'S MISSED. - overall: small nail holes - inboard: sapwood? (or just softwood.) - inboard: forward end, big dip next to first row (3rd time I've seen this) - inboard: aft end: limit next to last tree nail = animal bore hole - inboard: aft end: near bevel: rectangular hole <input type="checkbox"/> - outboard: sharp type 1 line on scarf		
Wood Science: [rings, ARW, knots, sapwood, conversion] <u>Tangential</u> Pith beyond lower edge (checked by computer microscope!) see plot c80H. No ARW - too angled.

Recommended action: [samples, additional photos, moulding, queries and problems] Dado?

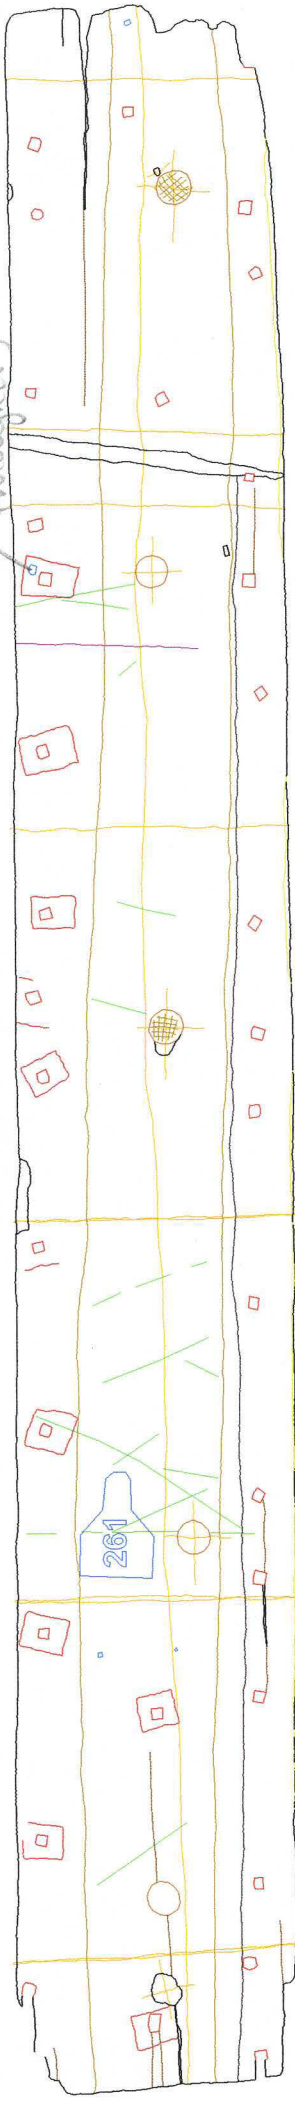
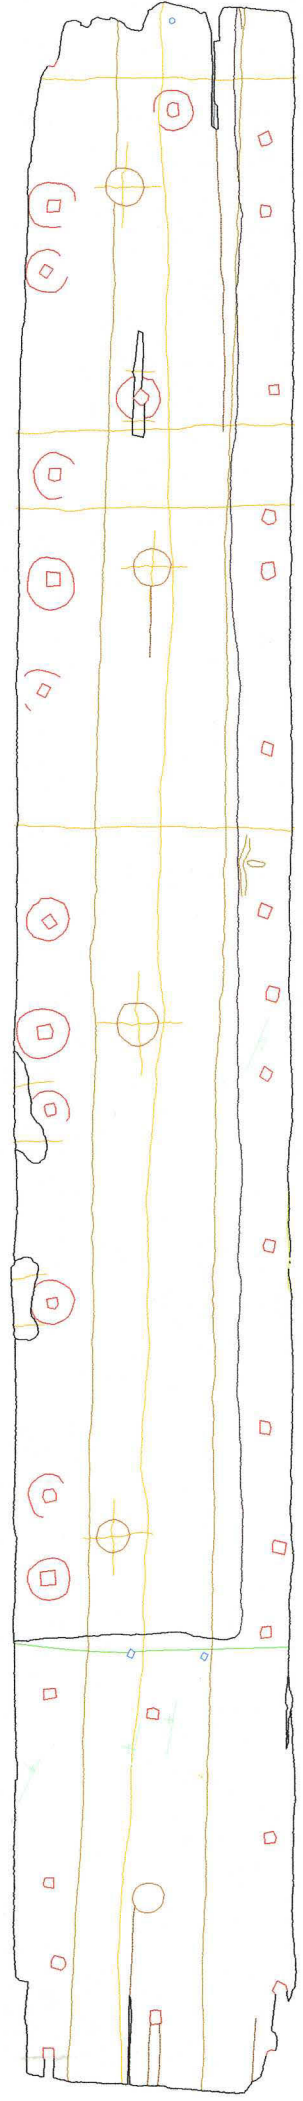
✓ ends up in the other nail hole
 on outboard (I've put an angle
 through it)
