Cow Tag	27	Type	PART OF PLANK / hinge
---------	----	------	-----------------------

ORIG NUMBER 257

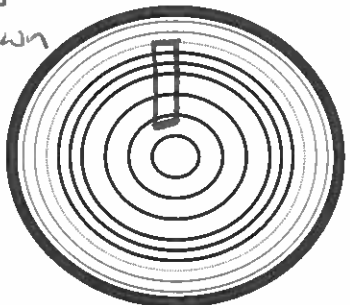
Description radially split, approx 100 rings. Possibly part of a plank. 40cm in length, 13cm in width. Four fastenings with varying shaft sizes - .4x.4cm to .8x.8. The largest fasten although damaged measures approx 1cm x .8cm. No evidence of clench plates. One possible head impression remains with diameter of 2.2cm. No nailing pattern is visible. Timber is dry, outboard is in poor, brittle state, inboard surface is very good. One possible axe mark. some evidence of animal hair on inboard. Piece is quite uniform in thickness measuring 1.5cm. It appears two original edges remain. (see drawing)

Bark	Yes	<input checked="" type="radio"/> No	APPROX 100 Rings Relatively slow grown radially split curved.

Sapwood	Yes	<input checked="" type="radio"/> No		
Knotty	Yes	<input checked="" type="radio"/> No		
Straight grained	<input checked="" type="radio"/> Yes	<input type="radio"/> No

sample taken # 3012 for dendro
Rest discarded.
