DB 20/2/8

304 S19_7A Matthew Simmonds 5 September 2006

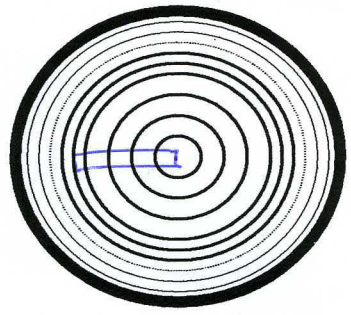
Cow Tag	Function Code
304	519.7A
<p>Brief Description: [timber element, p/s, condition, fragments] DAMAGED PLANK ^{small} LAND MISSING FULL LENGTH, MOST OF AFT SKAFF MISSING Connections V.V.V. had a scratch on - V. HORRIBLE PLANK</p> <p>Notable Features: [tool marks, scribed lines, decoration, repairs] POINTS TO LOOK OUT FOR WHEN RECORDING ufos</p> <p>✓ INJECTED - LOTS OF <u>T.I.</u> lines all over plank, O.B. - wedge on dead T.N from aft end. 3 oversized holes - why?</p>	
<p>Wood Science: [rings, ARW, knots, sapwood, conversion]</p> <p>Wavy (slightly) grain Radial c/10 HD. Pith beyond lower upper edge?</p>

oversized hole.

<p>Recommended action: [samples, additional photos, moulding, queries and problems]</p>	
<p>Cleaned:</p> <p>17/08/06 SS VT</p>	<p>Recorded:</p> <p>MS 6/9/6</p>
<p>Checked: [corrections needed]</p> <p>✓</p>	<p>Photos:</p> <p>Initials & Date:</p> <p>NN 11/9/6</p>
<p>Corrections Done [desktop, Faro Arm?]:</p>	<p>Initials & Date:</p>
