Cow Tag 310		Function Code SIL3C
Brief Description: [timber element, p/s, condition, fragments] Was attached to 309 + 1703 Damaged on fore side		
Notable Features: [tool marks, scribed lines, decoration, repairs] POINTS TO LOOK OUT FOR WHEN RECORDING ufos No useful notable features One more core probably end of strip		
Wood Science: [rings, ARW, knots, sapwood, conversion] Radial at aft scart. c120H Pit beyond lower edge? ARW = 230/120

310 S11_3 C Ben R. Jennings 02 June 2006

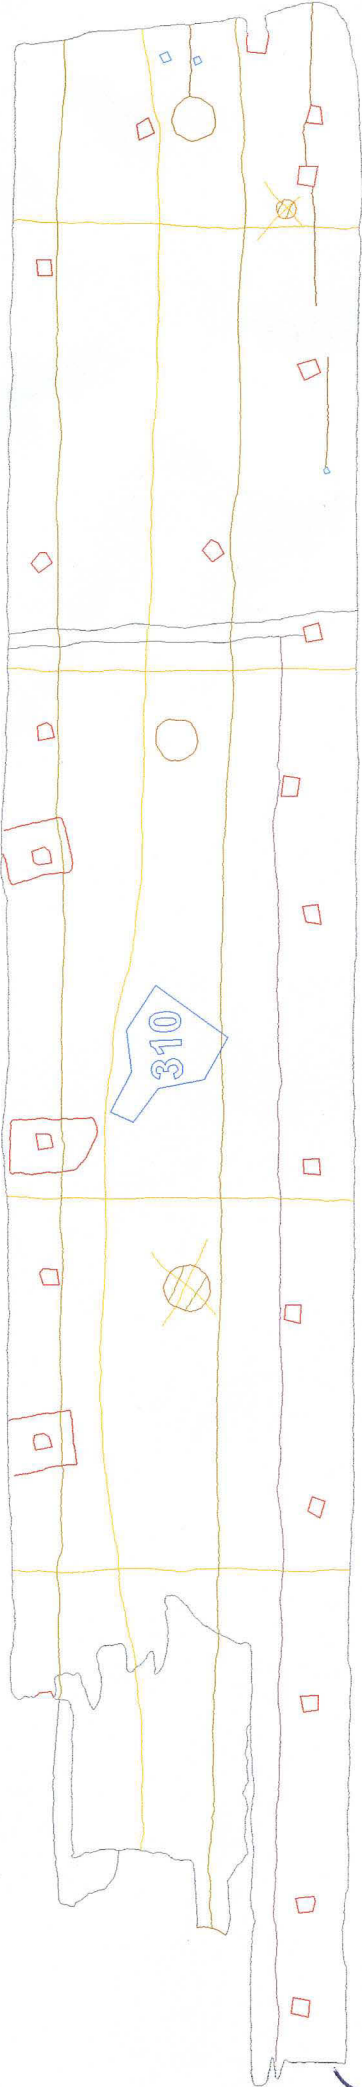
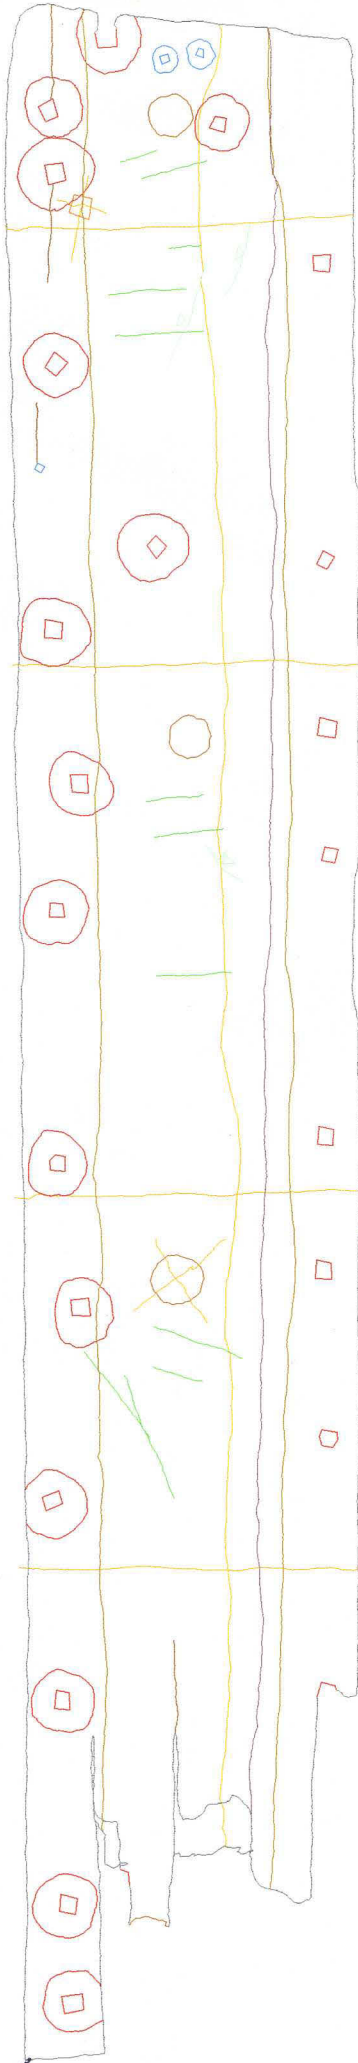
Ed
strip

Wider cut

Recommended action: [samples, additional photos, moulding, queries and problems]		
Cleaned: VT 25/03/06	Recorded: 02/06/06 BS	Photos:
Checked: [corrections needed] ✓		Initials & Date: NN 16/6/6
Corrections Done [desktop, Faro Arm?]:		Initials & Date:
