Cow Tag 373		Function Code P10-06
Brief Description: [timber element, p/s, condition, fragments]		
Notable Features: [tool marks, scribed lines, decoration, repairs] POINTS TO LOOK OUT FOR WHEN RECORDING ufos		
<p><i>Hal Outboard Tingle</i></p> <p><i>Numerous additional nails and wooden spikes</i></p> <p><i>Diamond (Type 3) end of crack near forward end.</i></p>		
Wood Science: [rings, ARW, knots, sapwood, conversion]

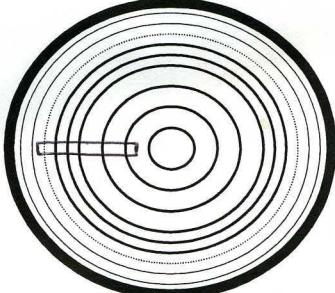
<p><i>Radial. Pitt beyond upper edge.</i></p> <p><i>115 H + 55. ARW = 212/120</i></p>		
Recommended action: [samples, additional photos, moulding, queries and problems]		
<p><i>Take photos of tingles + repairs + wooden nails</i></p> <p><i>DOND</i></p> <p><i>ReRecorded TNJ 17/11/2006</i></p>		
Cleaned:	Recorded: MMR 04.04.05	Photos: VT 24/1/7
Checked: [corrections needed]		Initials & Date: NN 23/1/7
Corrections Done [desktop, Faro Arm?]:		Initials & Date:
