DB 11/3/8

Cow Tag <b>378</b>		Function Code <b>P10-07</b>
Brief Description: [timber element, p/s, condition, fragments]		
Notable Features: [tool marks, scribed lines, decoration, repairs] POINTS TO LOOK OUT FOR WHEN RECORDING ufos  Additional Nails on scarf-forward Att Scarf damaged   Type 1 and 2 Lines		
Wood Science: [rings, ARW, knots, sapwood, conversion]

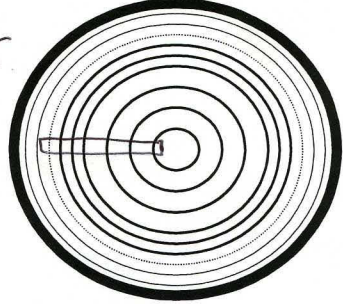
Radial c10 DH + 5 S. ARW = 208/105 Pith beyond lower edge.		
Recommended action: [samples, additional photos, moulding, queries and problems]		
DEAD   Re Recorded TNJ 20/11/06		
Cleaned:	Recorded: <b>TNJ 08.03.05</b>	Photos: 10/3/05
Checked: [corrections needed]		Initials & Date: NN 23/1/7
Corrections Done [desktop, Faro Arm?]:		Initials & Date:
