DB 11/3/8

| Cow Tag 389 | Function Code P 3.8 | |
| Brief Description: [timber element, p/s, condition, fragments] VERY WELL PRESERVED PLANK | | |

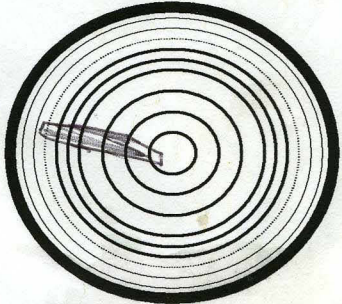
| Notable Features: [tool marks, scribed lines, decoration, repairs] POINTS TO LOOK OUT FOR WHEN RECORDING ufos 1 ADDITIONAL NAIL AT EDGE OF PLANK, AFT END 2 PLUGGED HOLES ON EITHER SIDE OF TREEMAIL PLUGGED ^{OR PLUGGED HOLE} AT AFT END, HOLES TOWARDS UPPER + LOWER EDGE 2 ADDITIONAL NAILS ON OUTB. LAND, APPR. 85cm ^{aft} away _{from} FORW. END 3 INSCRIBED LINES ON OUTB. FACE, APPR. 1.75m ^{aft of} away from FORW. END * Roundwood (non oak?) plug | | |
| Wood Science: [rings, ARW, knots, sapwood, conversion] c 90H+SS (at aft scft.) Radial to grain inboard face. Pith beyond lower edge ARW = 200/90 | | |

| Recommended action: [samples, additional photos, moulding, queries and problems] <u>Man symbol on wrong side/layer</u> Photos of Type 1 outboard → roundwood plug + area note. Wood ID of plug. | | |
