Cow Tag 393		Function Code P 3.5	
Brief Description: [timber element, p/s, condition, fragments] VERY WELL PRESERVED PLANK			
Notable Features: [tool marks, scribed lines, decoration, repairs] POINTS TO LOOK OUT FOR WHEN RECORDING ufos - RHOMBUS-SHAPED INSCRIBED LINE ON INBD FACE FORW. END - Borer damage TRD + OUTBD. (LABEL)? ↳ Little holes filled with white stuff - 3 INSCRIBED LINES OUTBD. (LABEL) - 1 ADDITIONAL NAIL ATTEND INBD. SCARF - 1 PLUGGED HOLE LAND FORW. END INBD.			
Wood Science: [rings, ARW, knots, sapwood, conversion] 95H ARW = 205/95 Unclear but near radial?

383 P3.5 Toby N. Jones 21 October 2005

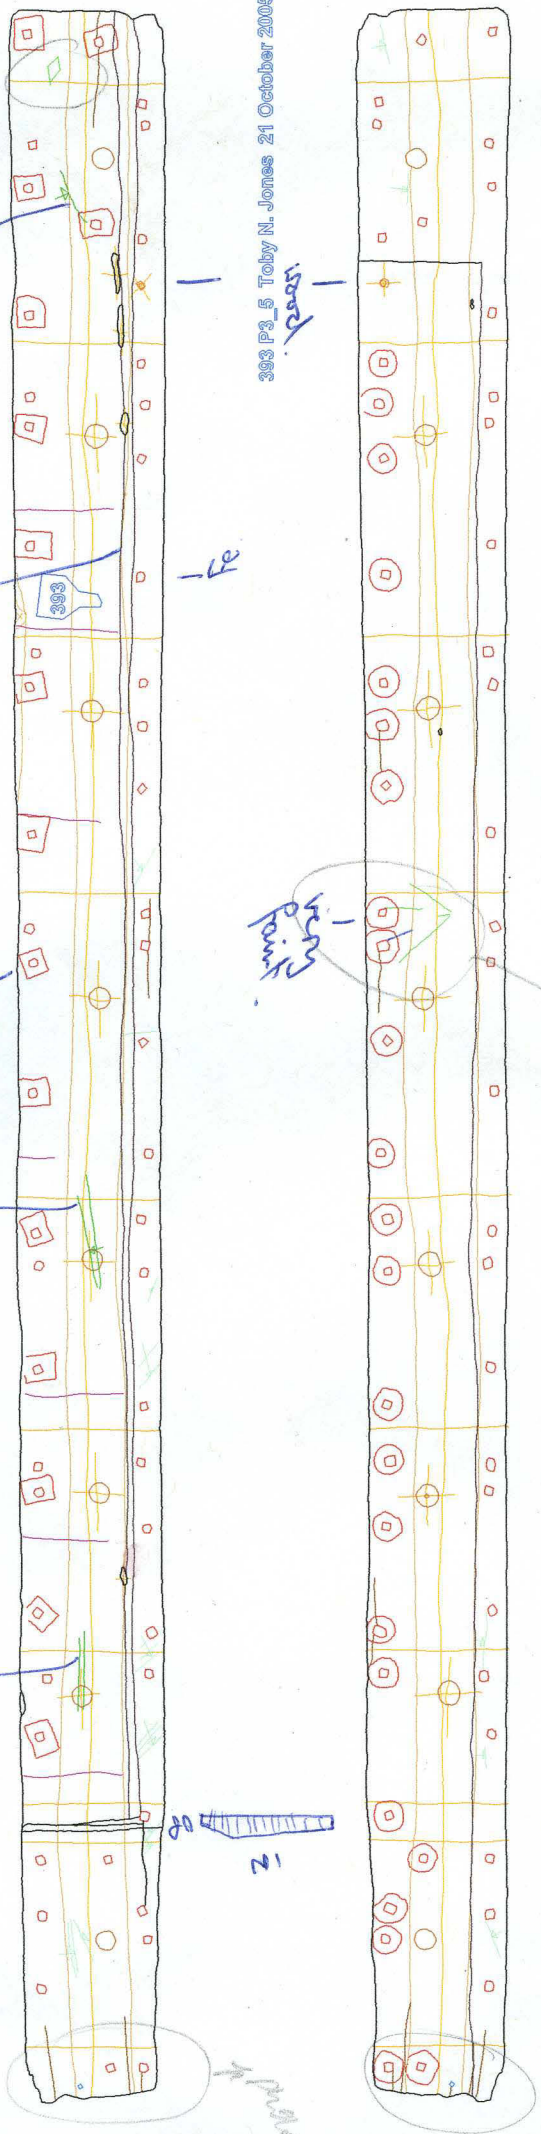
level extending beyond modern.

small core 38 x 37

modern

Recommended action: [samples, additional photos, moulding, queries and problems] Photos of inscribed rhombus			
Cleaned: 20.10.05 MH, HPM, AK	Recorded: TNT 21.10.05	Photos: MPR 2/03/06 IN: INSC. LINES <input checked="" type="checkbox"/> Rhombus OUT: — — — + ADD NAIL	ADD NAIL (SCARF) 310
Checked: [corrections needed]		Initials & Date: N N 28/10/5
