DB 11/3/8

394 P3_3 Toby N. Jones 6 March 2006

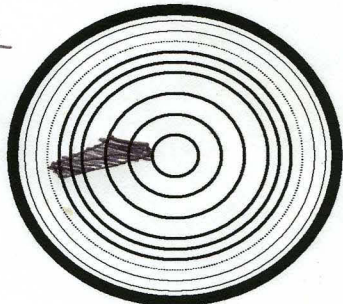
Cow Tag 394		Function Code P 3.3
Brief Description: [timber element, p/s, condition, fragments] VERY WELL PRESERVED PLANK		
Notable Features: [tool marks, scribed lines, decoration, repairs] POINTS TO LOOK OUT FOR WHEN RECORDING ufos 2 ADDITIONAL NAILS EDGE OF SCARF, AFT END 2 INSCRIBED LINES, APPR. 1,10m away from FORW. END - Type 1x2 OUT: • FORWARD ^{FORWARD} END - PLUGGED HOLE (WITH WOODEN) • ± MIDDLE OF PLANK - LAND → WOODEN SPEA SPIKE		
Wood Science: [rings, ARW, knots, sapwood, conversion] <i>Wide spaced - slightly wavy grain</i> <i>Slightly off axial at aft scarf (ray parallel with bevelled end)</i> <i>c 60A ARW = 230/60 . Pith beyond bevel edge?</i>

deep - damage rather than intentional?

Recommended action: [samples, additional photos, moulding, queries and problems]		
Cleaned: 27/02/2006 AK, MMR	Recorded: TNJ 05.03.06	Photos:
Checked: [corrections needed] ✓		Initials & Date: NN 25/4/6.
Corrections Done [desktop, Faro Arm?]:		Initials & Date:
