DB 11/3/8

| Cow Tag 396 | Function Code P & P A | |
| Brief Description: [timber element, p/s, condition, fragments] TRUNCATION ON AFT SCARF (INBOARD) OTHERWISE GOOD CONDITION | | |

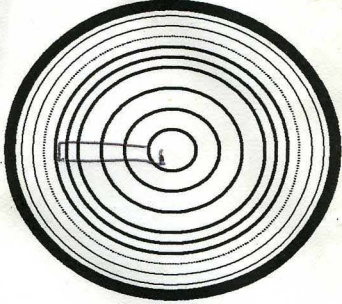
| Notable Features: [tool marks, scribed lines, decoration, repairs] POINTS TO LOOK OUT FOR WHEN RECORDING ufos INBOARD: - 'V' SHAPE MARKING, ON UPPER EDGE OF FOX END OF PLANK BETWEEN CENTRAL & UPPER TRUNNEL HOLES. INSCRIBED 'X' ADJACENT TO AFT END OF PLANK TO TRUNCATED TREE RING AT OUTBOARD: TOOLMARKS ON AFT SCARF 5 Double tree rings | | |
| Wood Science: [rings, ARW, knots, sapwood, conversion] 65 H. Radial at damaged aft scarf. ARW = 195 / 65 P.H. beyond lower edge on aft scarf. | | |

| Recommended action: [samples, additional photos, moulding, queries and problems] photo: toolmarks on aft scarf OUTBOARD | | |
