Cow Tag 418

Function Code Tangle from S13.4/S.13.5

Brief Description: [timber element, p/s, condition, fragments]
Bulky tangle, covered in tar

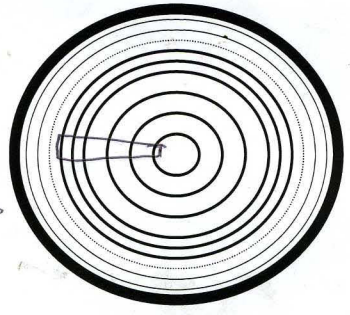
Large side branch at one end
c 40 H Radial. Slightly wedge-shaped. Pith beyond upper edge.
Fast growth with band of narrower rings.
ARW = 205/40

Photo side branch piece

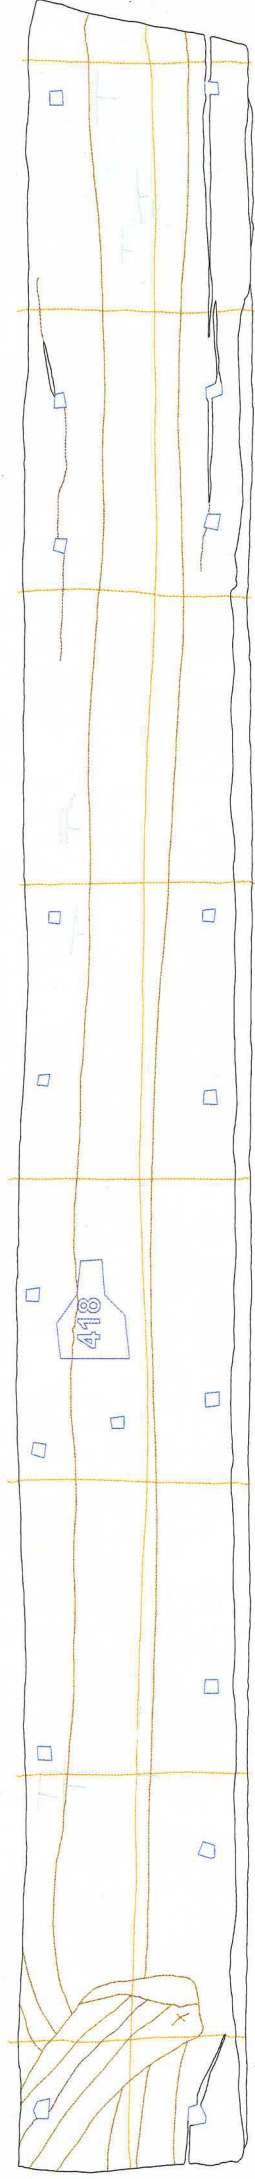
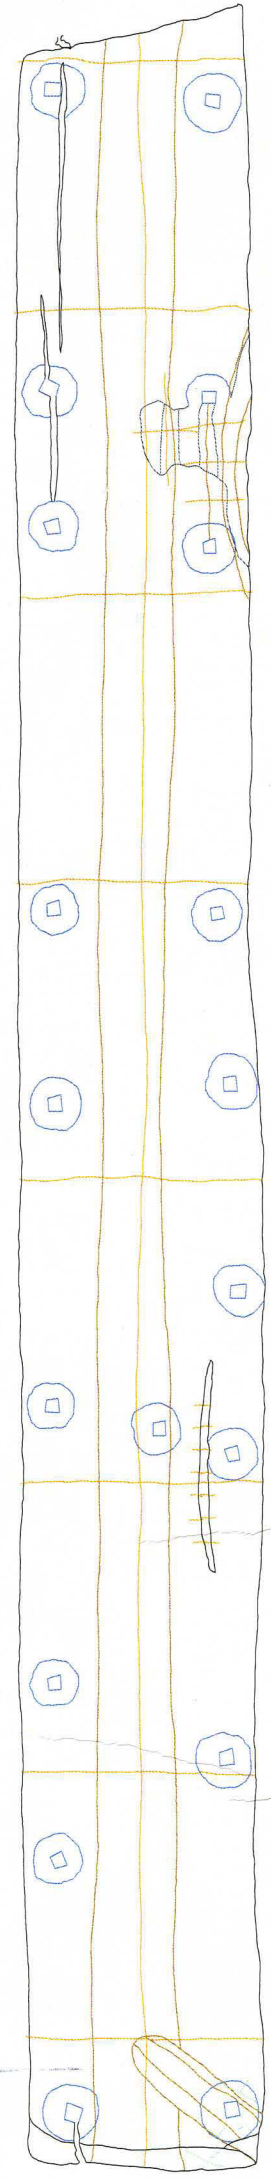
418 Tingle Outboard S13_4 to 5 Toby N. Jones 15 September 2006

both sides photos of branch
