Cow Tag 540 Function Code SS-3

Brief Description: [timber element, p/s, condition, fragments]
Good CONDITION - LOW PLANK

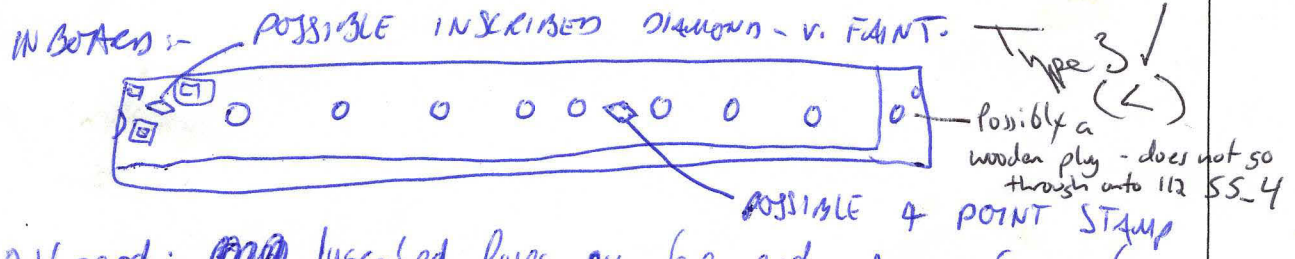
Outboard: ~~scribbled~~ Inscribed lines on fore end. A number of wooden pegs present. Evident crack on power side of the plank on the outboard side.

Numerous wood nails along lower edge. Depressions / tool mark x 2. Repaired crack along lower edge.

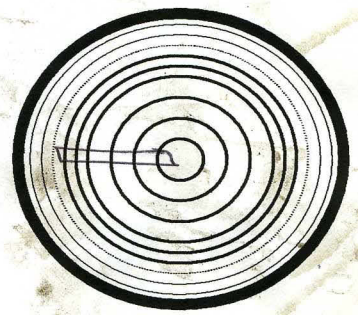
Just off radial c100W at a ft scant
Pith beyond lower edge on growth trend
ARW = 2.03mm.
