Cow Tag 554 Function Code ~~57.4~~ 57.4

Brief Description: [timber element, p/s, condition, fragments]
Good condition

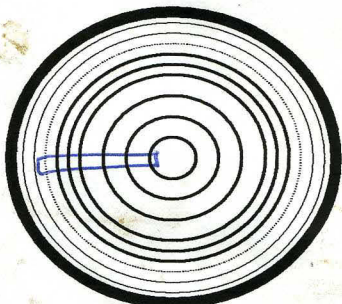
Notable Features: [tool marks, scribed lines, decoration, repairs] POINTS TO LOOK OUT FOR WHEN RECORDING ufos
Inboard: 2 wooden pegs on fore side. 1 peg in splinter hole next to cow tag.
Outboard: Inscribed lines aft end.
Wear on inboard upper edge.

Wood Science: [rings, ARW, knots, sapwood, conversion]
75 HT 3 S Radial Pith beyond upper edge. ARW = 225/78

Recommended action: [samples, additional photos, moulding, queries and problems] wide rings
photos: -aft end outboard additional rails with railhead impression
-little star on railhead, aft end, outboard
