DB 13/3/8

| Cow Tag 568 568 | Function Code P2.1A | |

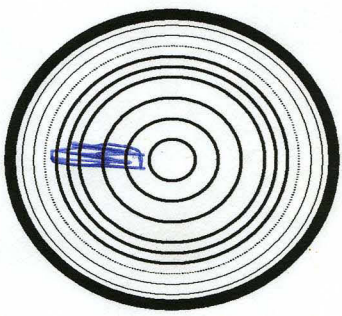
| Brief Description: [timber element, p/s, condition, fragments] ACTUALLY WELL PRESERVED PLANK BUT BOTH ENDS ARE DAMAGED TINGLE (cow 569) ^{was} attached to outbd. | | |
| Notable Features: [tool marks, scribed lines, decoration, repairs] POINTS TO LOOK OUT FOR WHEN RECORDING ufos - SEVERAL SMALL CRACKS — knife across one of these - LOADS OF ADDITIONAL NAILS ALSO ON LAND - 2 "NOTCHES" ON OUTBD. LAND - 1 LINE GOTTING UNDER NAIL HEAD - 1 PLUGGED HOLE ⇒ more (3) Damaged wood end with rebate for P3. ↳ Fragment low 2595 | | |
| Wood Science: [rings, ARW, knots, sapwood, conversion] C75A ARW = 185 / 75 Near radial. Pith beyond lower edge. | | |

| Recommended action: [samples, additional photos, moulding, queries and problems] Detached frag at forward end not recorded - needs adding as this is part of wood end with outboard rebate for P3 - done Need photos of wood end + knife. RE RECD 05/09/07 SJ | | |

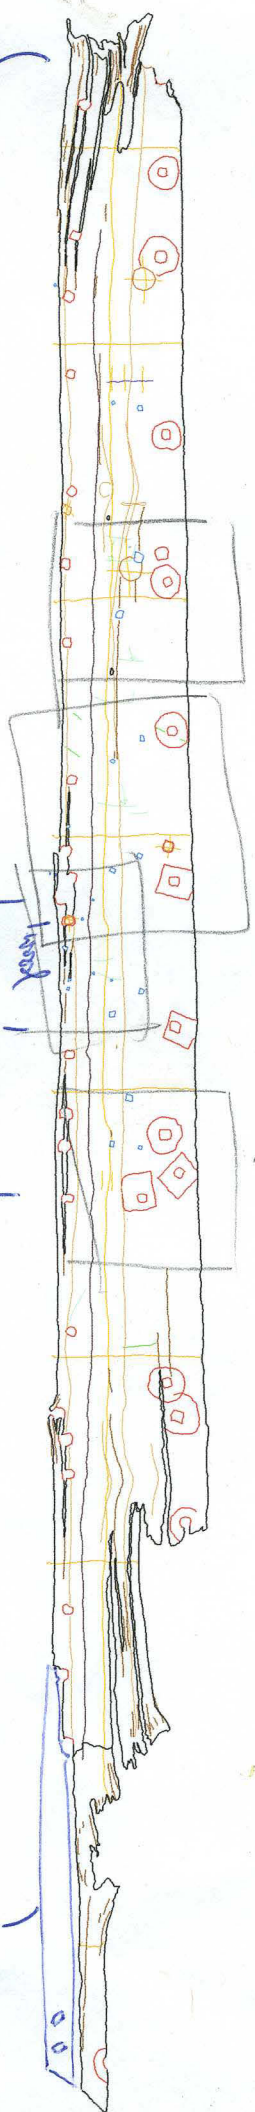
588 P2_1A Angela Karsten 14.10.05

photo damage.

NB shows on original plan
