DB 13/3/8

Cow Tag <u>569</u>		Function Code <u>Tingle OB</u>
Brief Description: [timber element, p/s, condition, fragments] <u>Small outboard tingle (P2.1A)</u>		
Notable Features: [tool marks, scribed lines, decoration, repairs] POINTS TO LOOK OUT FOR WHEN RECORDING <u>ufos</u> <u>Numerous facets with tool signatures</u> <u>heavily worked on all faces.</u>		
Wood Science: [rings, ARW, knots, sapwood, conversion] <u>Near radial, slow growth -</u> <u>50% ARW = 80/50 -</u>

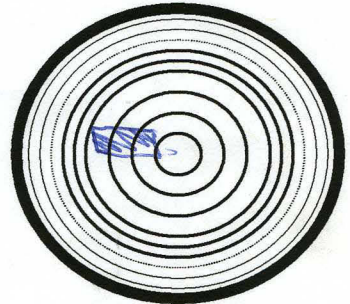
Recommended action: [samples, additional photos, moulding, queries and problems] <u>cf tool signatures with those on 568 P2.1A.</u> <u>DEND? - borderline on ring count BUT...</u> <u>Photos of tool signatures</u>		
Cleaned:	Recorded:	Photos: <u>12/10/05 MMR</u> <u>GENERAL PHOTO. BEFORE CLEANING.</u> <u>22/03/05 - AFTER CLEANING</u>
Checked: [corrections needed]		Initials & Date: <u>MM 28/10/05</u>
Corrections Done [desktop, Faro Arm?]:		Initials & Date:

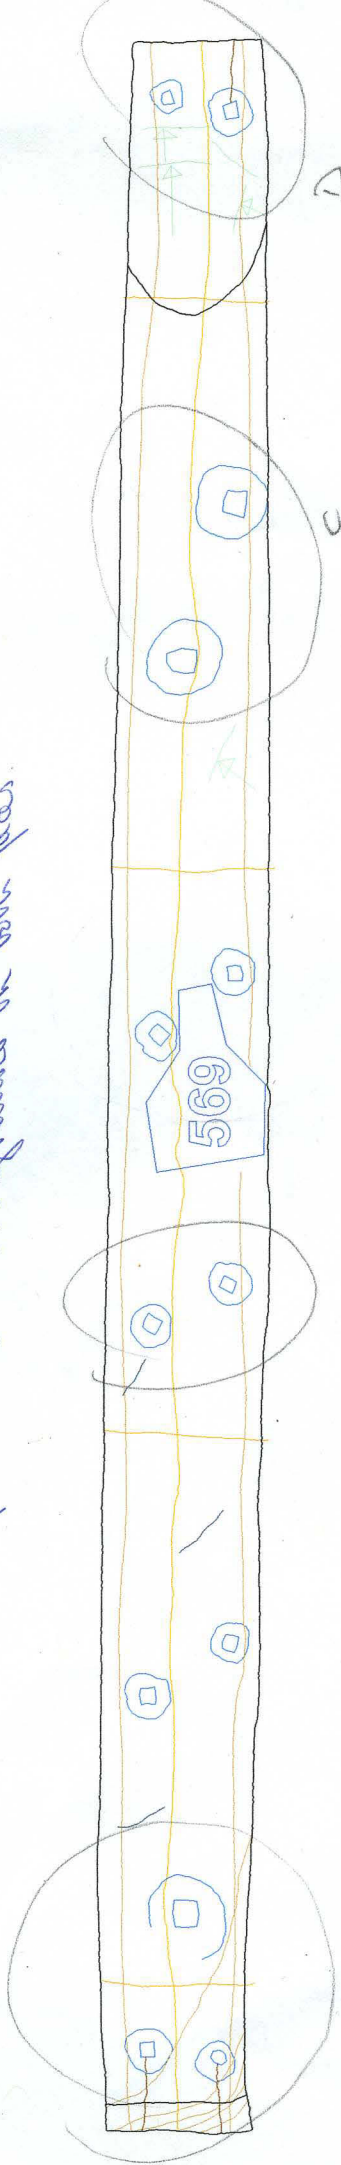
569 Tingle P2_1A Toby N. Jones 13.10.05

Number facts the top signatures on both faces.
