DB 13/3/8

584 P2_2 Toby N. Jones 17.09.05

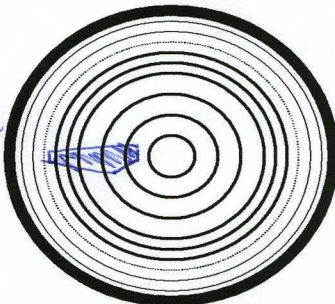
Cow Tag 584	Function Code P 2.2.	
Brief Description: [timber element, p/s, condition, fragments]		
Notable Features: [tool marks, scribed lines, decoration, repairs] POINTS TO LOOK OUT FOR WHEN RECORDING ufos Large scribed lines (x2) on outboard upper edge band. Some nice axe marks on scarfs.		
Wood Science: [rings, ARW, knots, sapwood, conversion] c 80 H ARW = 162/80. Radial at forward scarf becoming intermediate at aft scarf Centre beyond lower upper edge?

Fe corrosion product
in filling void holes

Note core split on scarf

Recommended action: [samples, additional photos, moulding, queries and problems]		
Cleaned: 7	Recorded: 7	Photos: 7
Checked: [corrections needed] NA		Initials & Date: 11/10/5
Corrections Done [desktop, Faro Arm?]:		Initials & Date:
