Cow Tag 616	Function Code 0 6.1	
Brief Description: [timber element, p/s, condition, fragments] FRAGMENT (LARGE) OF P 6.1, TRUNCATED AT STEM END, BY UNKNOWN DAMAGE (PROBABLY PILE)		
Notable Features: [tool marks, scribed lines, decoration, repairs] POINTS TO LOOK OUT FOR WHEN RECORDING ufos INBOARD: ② INSCRIBED 'V' ADJACENT TO SECOND TREE NAIL HOLE FROM FORE END. ① POSSIBLE INSCRIBED 'V' ADJACENT TO SECOND TREE NAIL FROM AFT END.

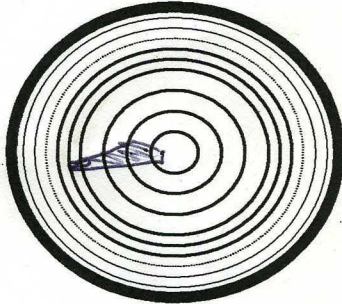
OUTBOARD: - POSSIBLE WEDGES IN HEADS OF TREENAILS (2 at most) Type 1 inboard. FORWARD END: VERY DAMAGED AND FLEXIBLE NO VISIBLE 143/70		
Wood Science: [rings, ARW, knots, sapwood, conversion] c 70 H at aft scarf. Just off radial pith beyond lower edge.

Recommended action: [samples, additional photos, moulding, queries and problems]		
Cleaned: 21/04/06 BJ NT	Recorded: 24/04/06 MMR	Photos:
Checked: [corrections needed] ✓	Initials & Date: NN 18/5/06	
Corrections Done [desktop, Faro Arm?]:	Initials & Date:
