Cow Tag 635	Function Code F49-0
--------------------	----------------------------

Floor Striker - Sapwood

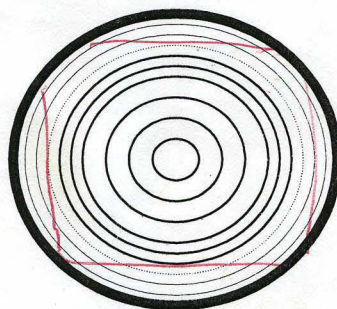
For - axe marks
 - aft face - Tu
 - outboard: 5 nail holes on one joggle!

Main stem = part aim, branch =
 starboard At timber hole.
 C + 60H + 12S + Be.
 (asymmetric pitch?)
 ARW = 110/72.

Photo as on point out - multiple nail holes, axe marks
 in chambered timber hole
