Cow Tag 64 Type CARVEL Ship's plank

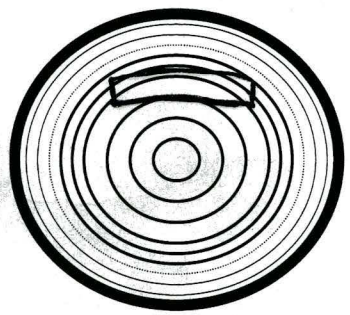
Description 98cm in length, 21cm wide, 3cm thick. One partial treenail hole - hexagonal in shape. Treenail no longer in situ. Second treenail, also hexagonal, treenail remains in situ. No iron nails. The outboard has a covering of paint, under the paint appears to be charred. Inboard surface is in poor condition. Some iron staining on outboard.

Elm tangential

Recommended action: [samples, additional photos, moulding, queries and problems] Discarded
