Cow Tag <u>099</u>		Function Code <u>S9.4</u>	
Brief Description: [timber element, p/s, condition, fragments] <u>COMPLETE PLANK.</u>			
Notable Features: [tool marks, scribed lines, decoration, repairs] POINTS TO LOOK OUT FOR WHEN RECORDING <u>ufos</u> <u>POSSIBLE INTENTIONAL MARKS VISIBLE ON OUTBOARD.</u> <u>7 ADDITIONAL NAILS AT STERN END OF PLANK. - NAILING END OF SCARF BACK INTO PLACE.</u> <u>2 TYPE 5 inboard</u> <u>Additional nails after scarf</u> <u>2 wooden nail/spikes</u>			
Wood Science: [rings, ARW, knots, sapwood, conversion] <u>✓ near true radial - 73H+5S.</u> <u>ARW = 205/78 ✓</u>

COWING
099

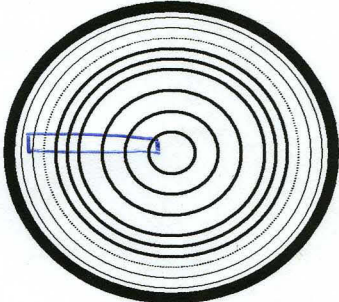
Wb sign forms made here.

Recommended action: [samples, additional photos, moulding, queries and problems]			
Cleaned: ✓	Recorded: ✓ <u>TNT-10.04.0541/03/05</u> <u>Re-recorded 17/01/07</u>	Photos: <u>x ADDITIONAL NAILS ON SCARF</u> <u>AK</u>	
Checked: [corrections needed]		Initials & Date:	
Corrections Done [desktop, Faro Arm?]:		Initials & Date:

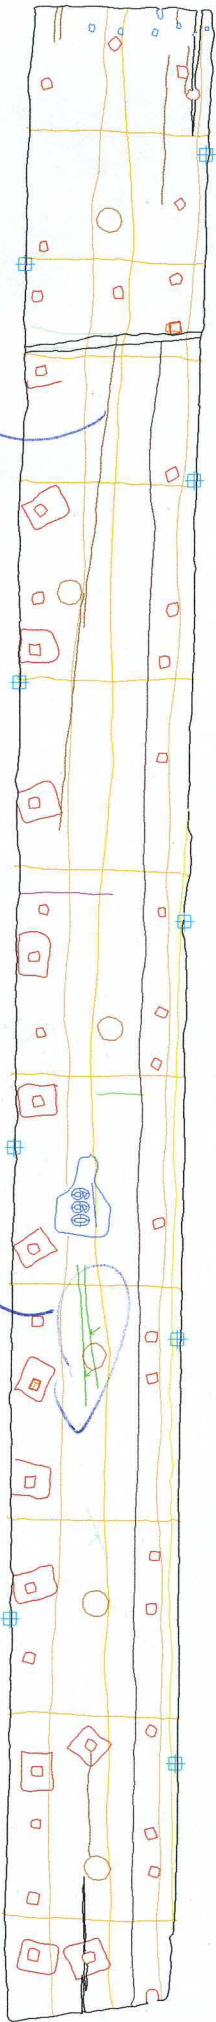
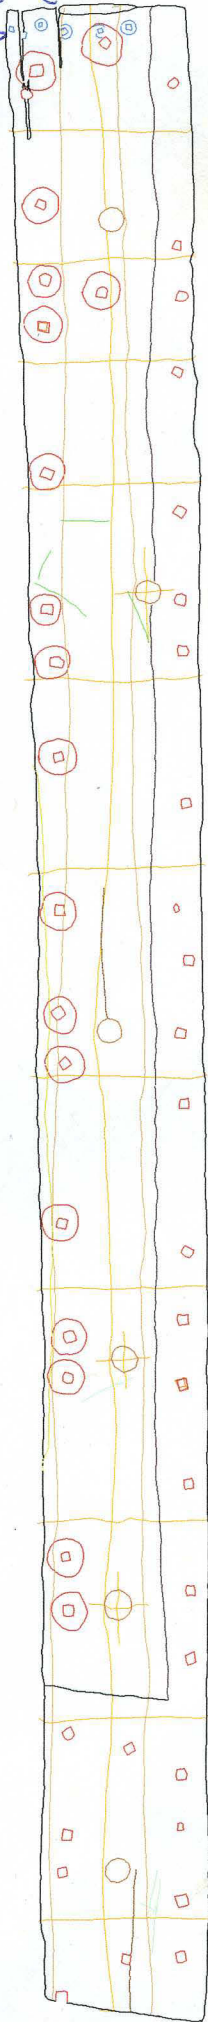
modern.

but's add mail 7
not really visible
