ARCHAEOLOGICAL RECORDING at the FORMER REGENT BINGO HALL, 3, MARKET PLACE, THIRSK, NORTH YORKSHIRE

A report to Blackett, Hart and Pratt

14th September 2006

In connection with planning consents 05/02349/FUL and 06/00685/FUL

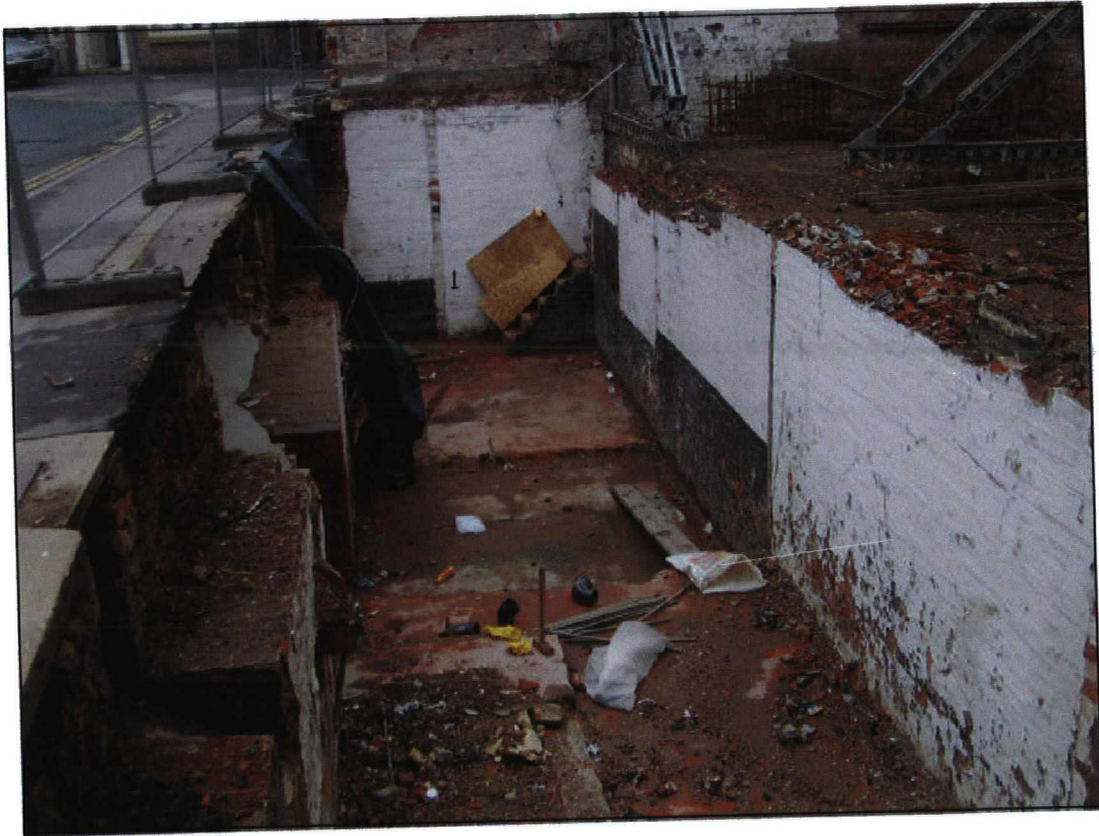
Fig. 3

5. Initial work by the developer involved stripping-out the interior of the building: an initial visit at this stage revealed the presence of a basement, almost 2.5 metres deep, running along the entire frontage of the former cinema building (Figs 3 and 5). It was immediately clear that remaining archaeological potential of this cellared frontage must be accounted as very low; although in the rearward part of the building, still at this stage under a concrete slab, there appeared to be the possibility of surviving deposits.

Cellar on street frontage

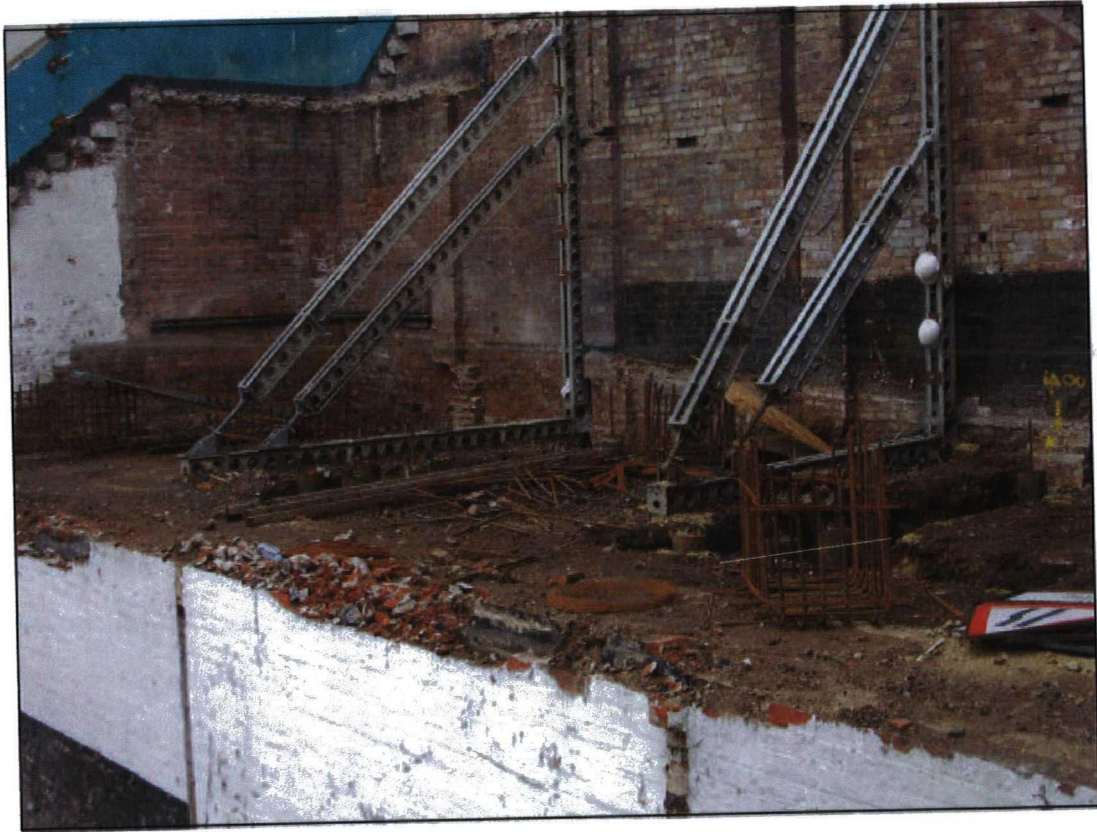
Fig. 4

6. The decision having been made by the developer to retain the rear (northern) wall of the building while demolishing the rest, it now became necessary to dig trenches which could be filled with concrete to hold the supporting struts for the wall which are visible in Fig. 4: their positions are shown in blue in Fig. 5.

Locations of concrete supports
