Figure 2. Watching Brief Area

Land adjacent to Beckside Cottage, Kirby Grindalythe 01.04.06

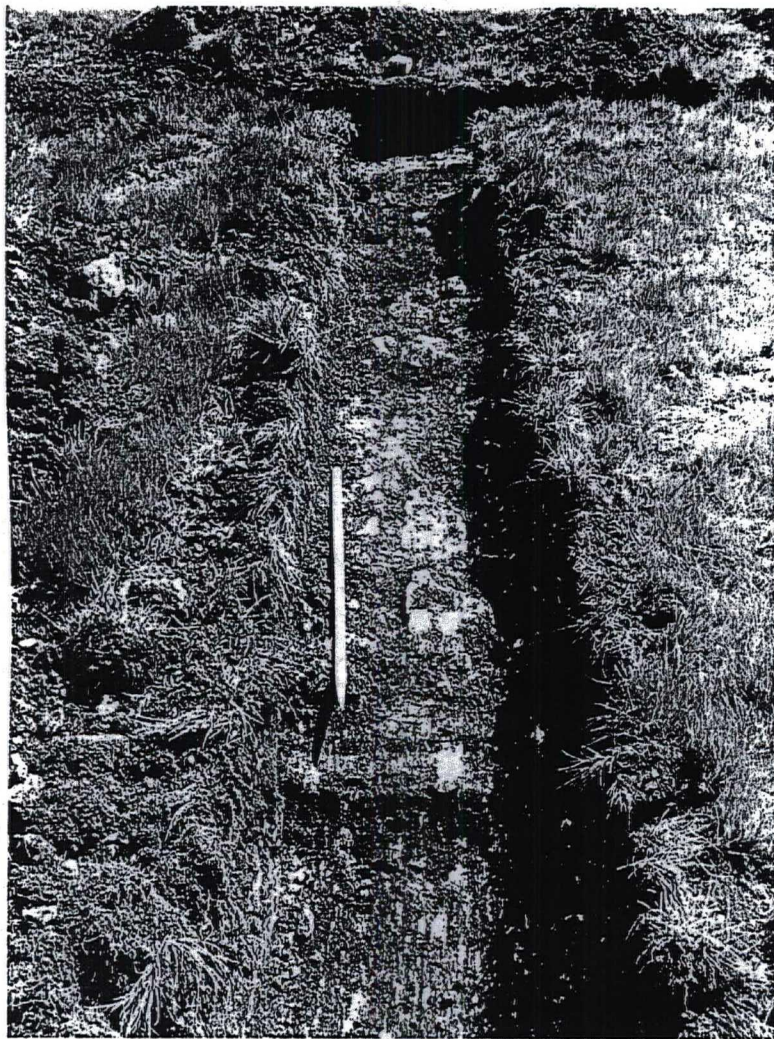
Plate 1. Trench 1. Wall 1003. Facing South

Context	Description
1001	Deposit 10YR 4/2, silty, Topsoil
1002	Deposit 10YR 4/3; silt, Subsoil
1003	Structure Chalk wall foundation

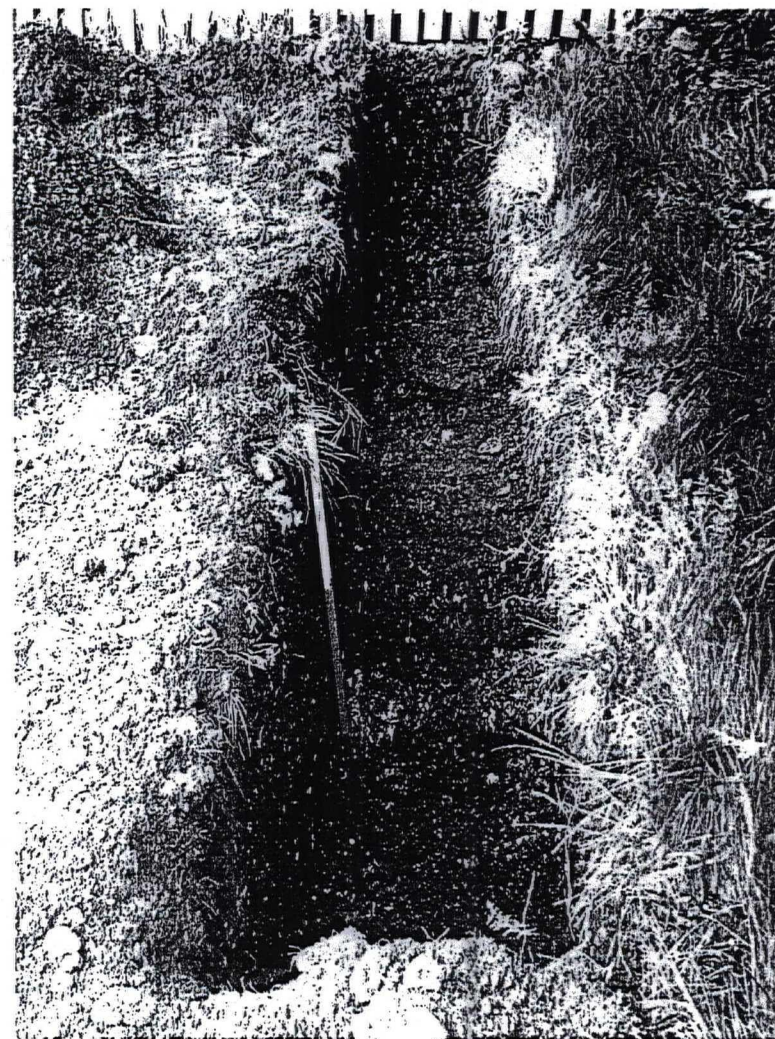
Plate 2. Trench 2. Drain Cut 2004. Facing West

Context	Description
2001	Deposit 10YR 4/2, silty, Topsoil
2002	Deposit 10YR 4/3; silt, Subsoil
2003	Deposit 10YR 4/3; silt; fill of Cut 2004
2004	Cut; drain filled by 2003

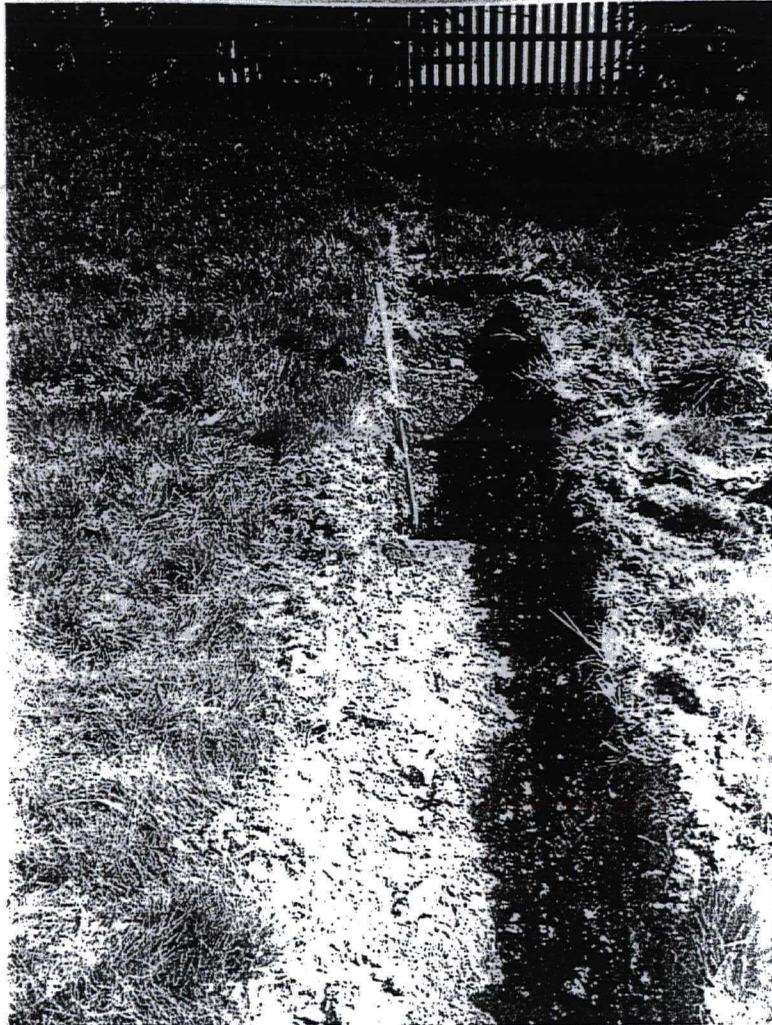
Plate 3. Trench 3. Overall View. Facing East

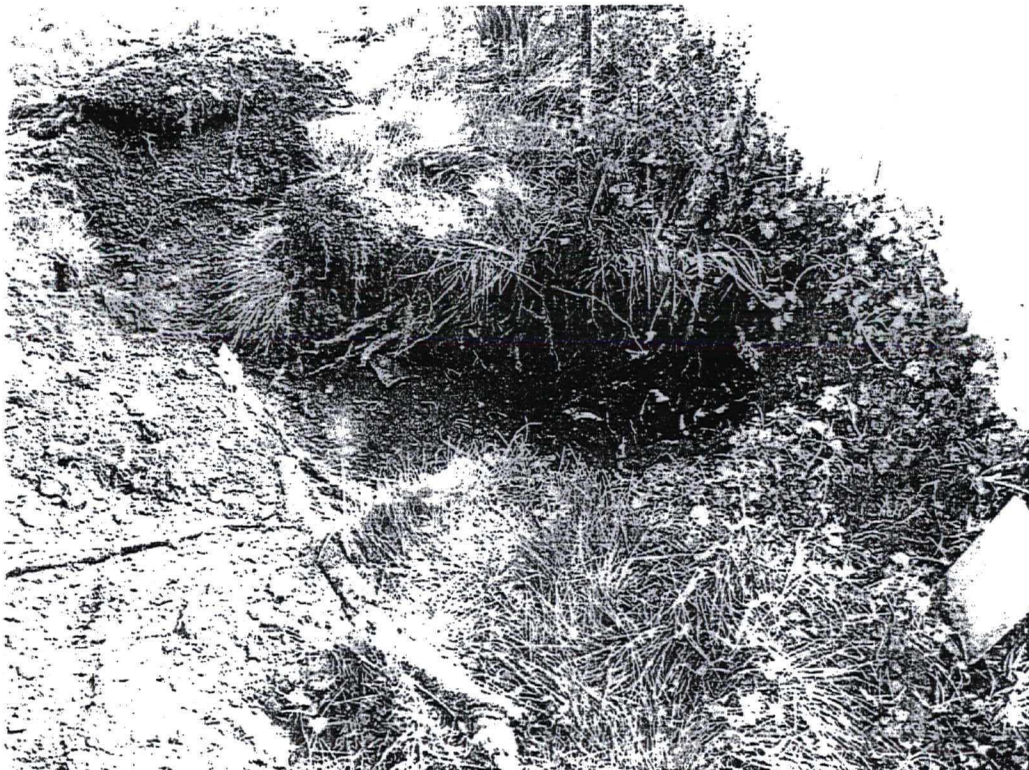
Plate 4. Trench 4. Drain. Facing South West
