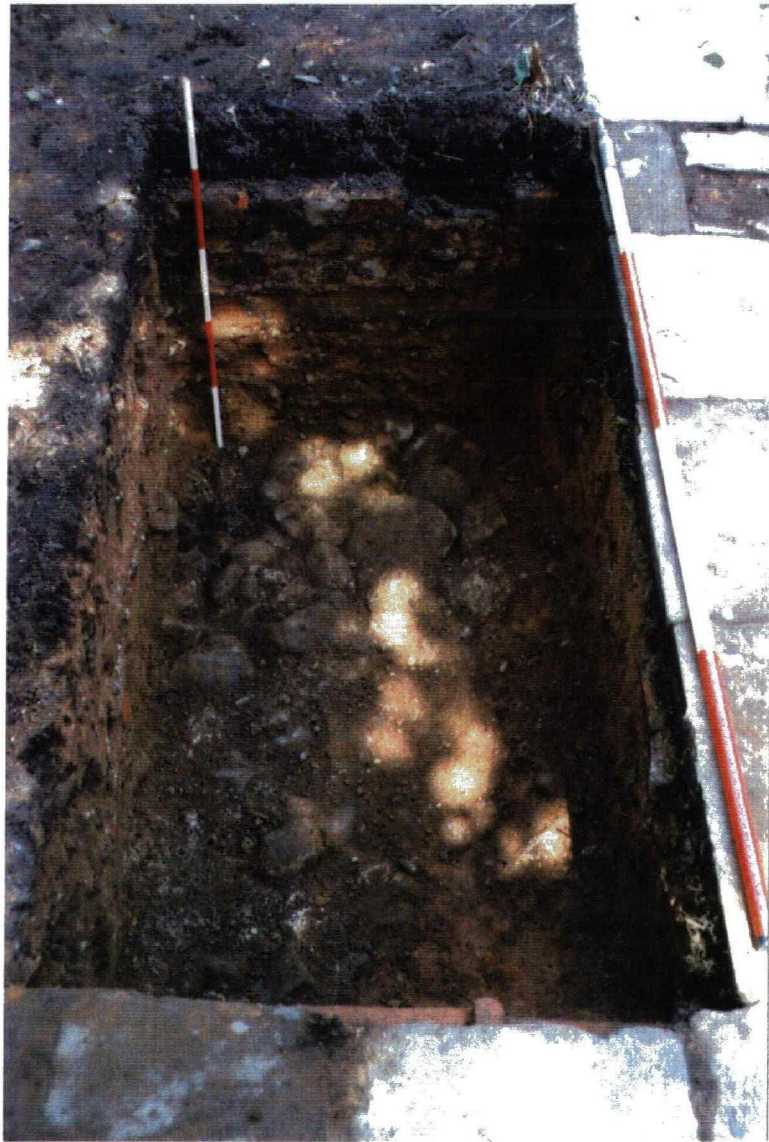
PLATE 8

Trial Hole No.3, a late medieval cobbled yard surface.

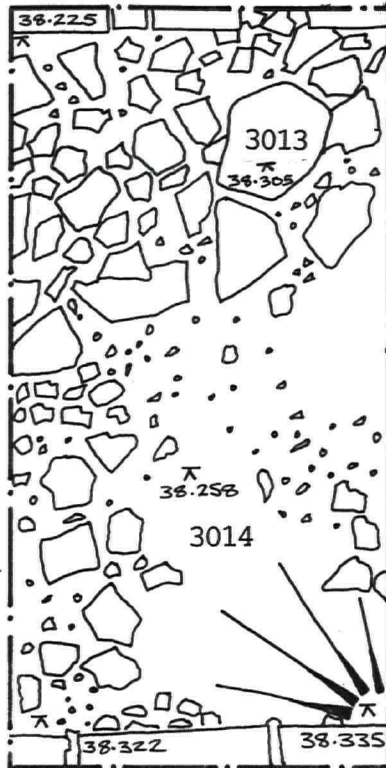
FIGURE 19

TRIAL HOLE NO.3: PLAN

DESCRIPTION A THIN LAYER OF SAND WITH A LOW QUANTITY OF
INCLUSIONS. THE LAYER SLOPES GENTLY FROM THE SSE TO
THE NORTH, BENEATH THE ROUGH COBBLE YARD SURFACE
3013.

CLASS/INTERPRETATION A LAYER OF ORANGE PINK BEDDING SAND FOR
THE ROUGH COBBLE FLOOR 3013.

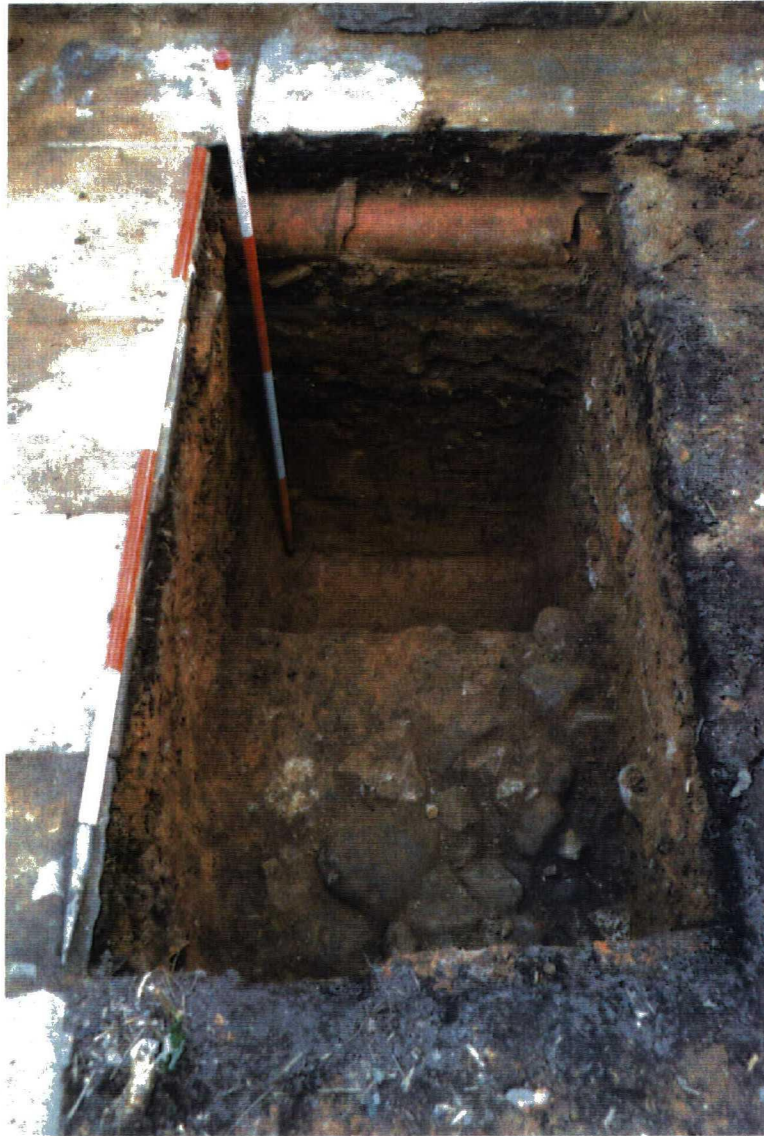
PLATE 9

Trial Hole No.3, as excavated, revealing the depth of the natural sand deposits.
