***JERVAULX ABBEY CAR PARK:***

***PROPOSED DEVELOPMENT***

***ARCHAEOLOGICAL WATCHING BRIEF***

**JUNE 1993**

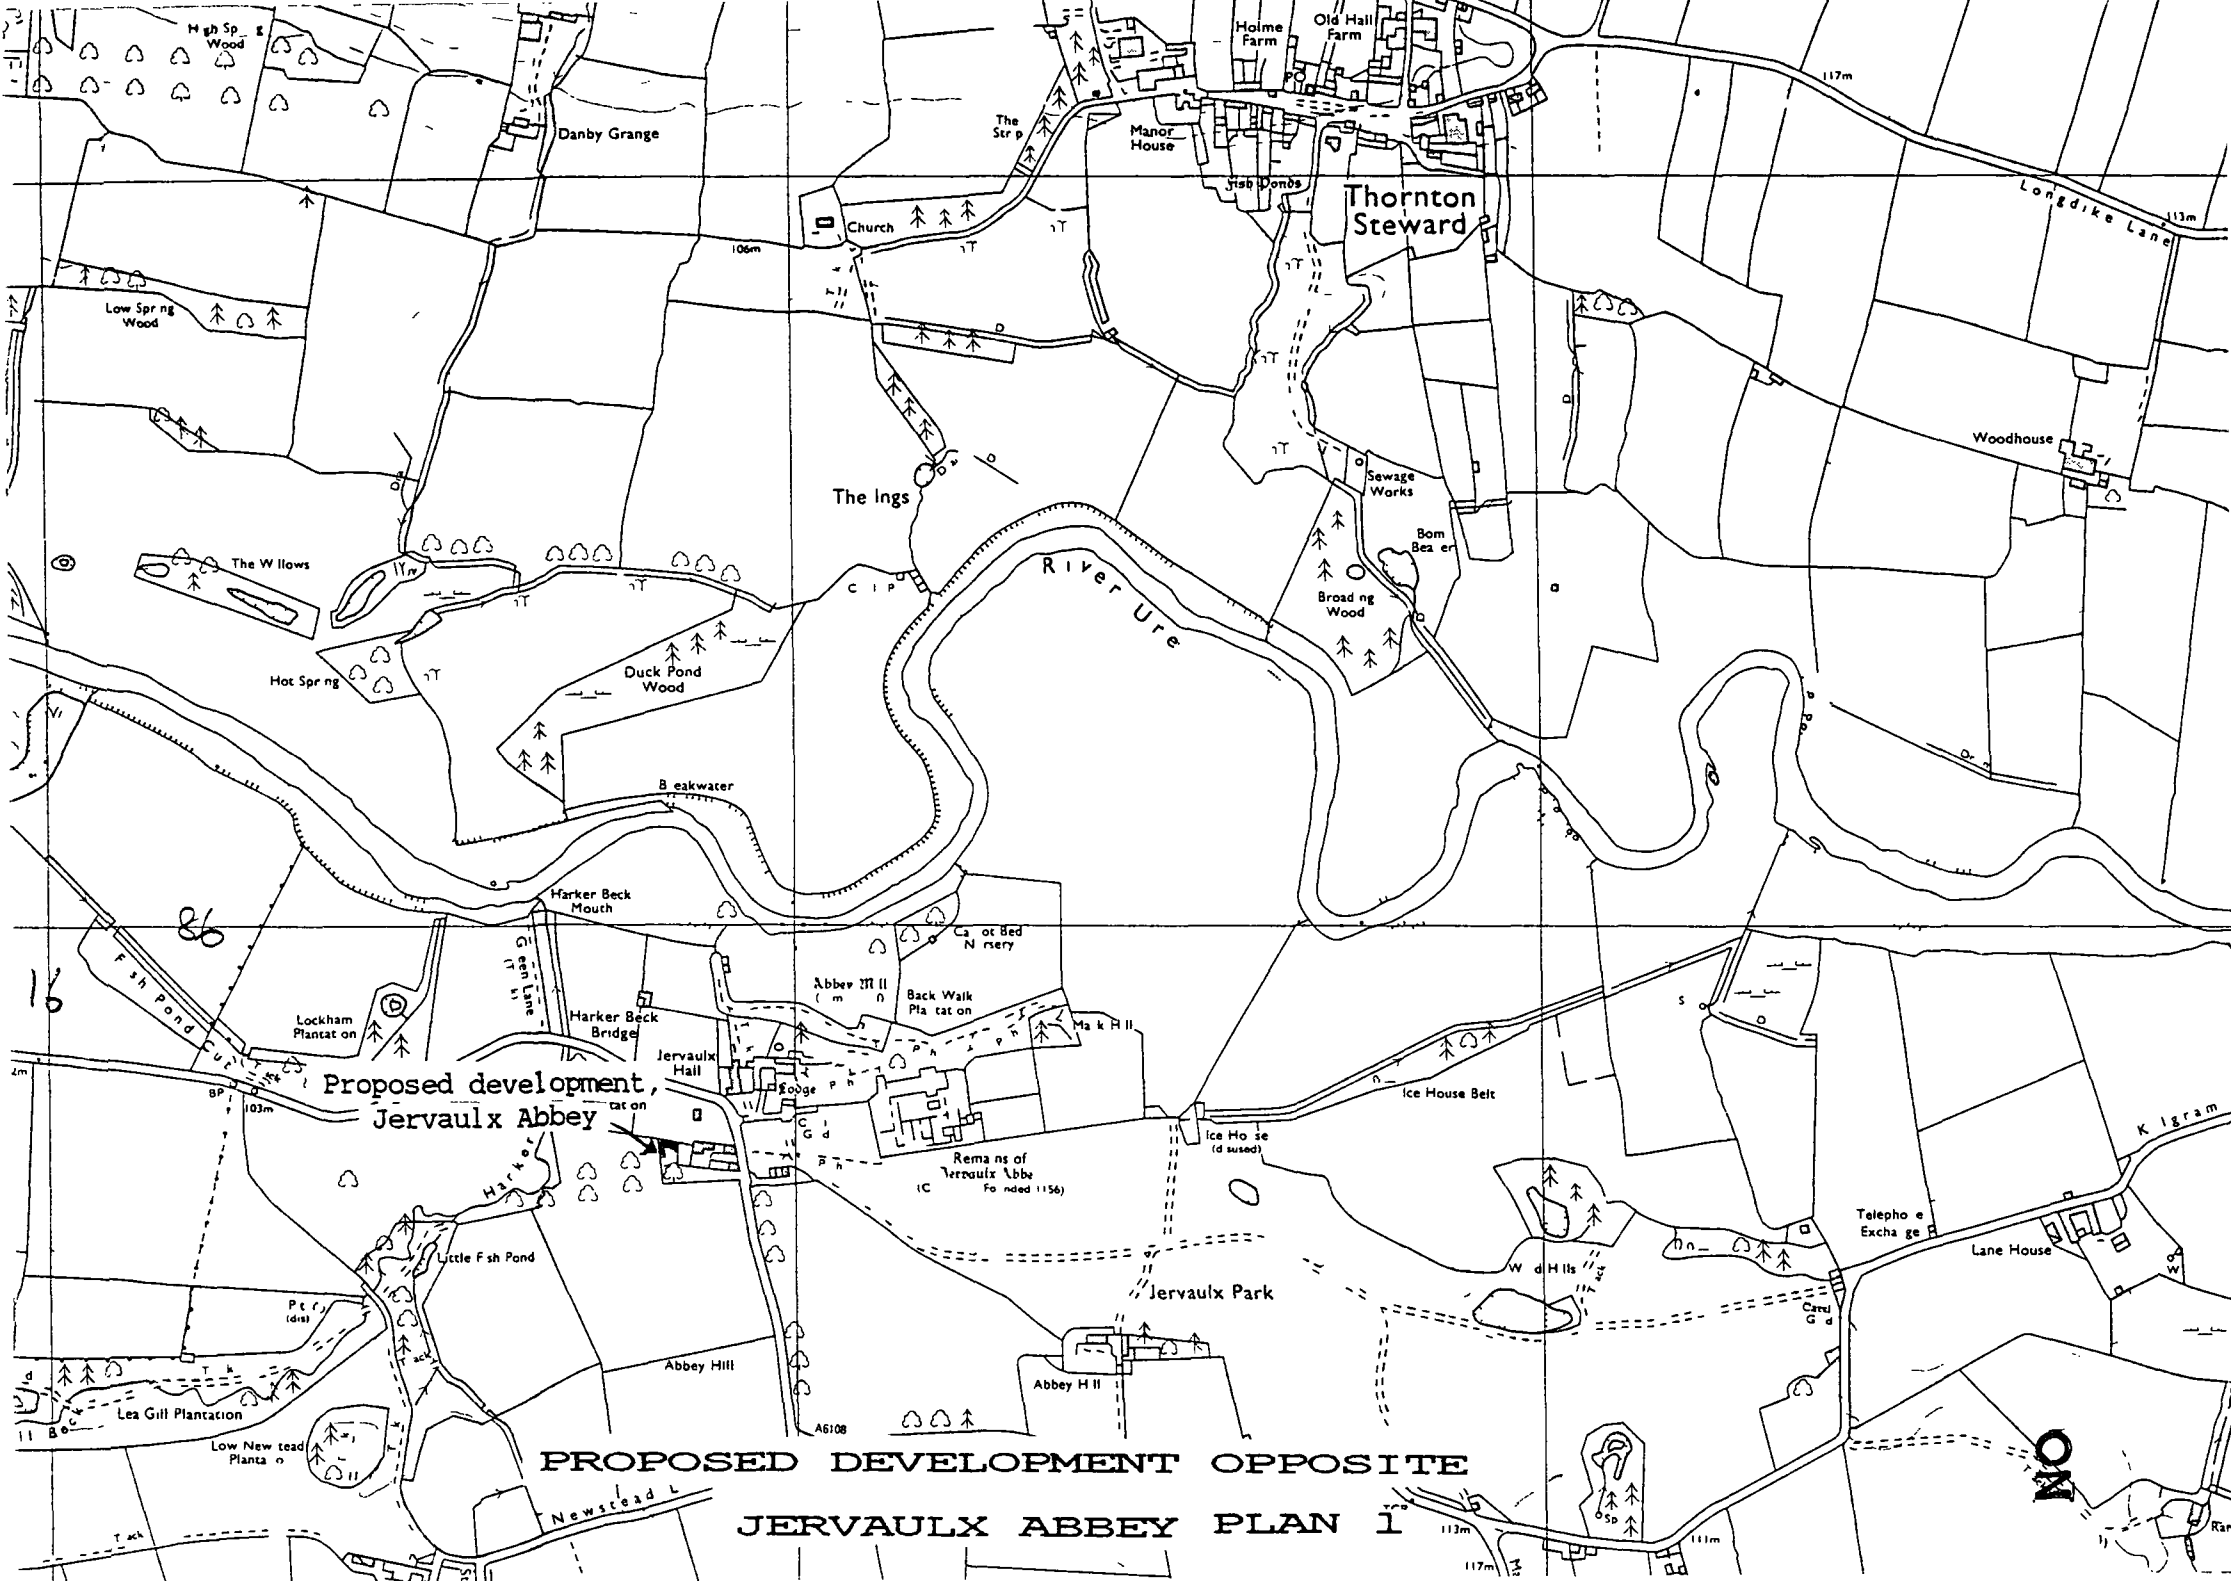
**PROPOSED DEVELOPMENT OPPOSITE  
JERVAULX ABBEY PLAN I**

The existing buildings, themselves not more than 40 years old, lie to the west of the abbey, at the western edge of the abbey carpark which fronts onto the A6108, at NGR SE 1682 8570 (see plan 1). They are at present unused, and consist of single storey stone buildings in an L-shape (see plan 2). The proposed extension consists of a south facing conservatory style building in the corner of the L shape.

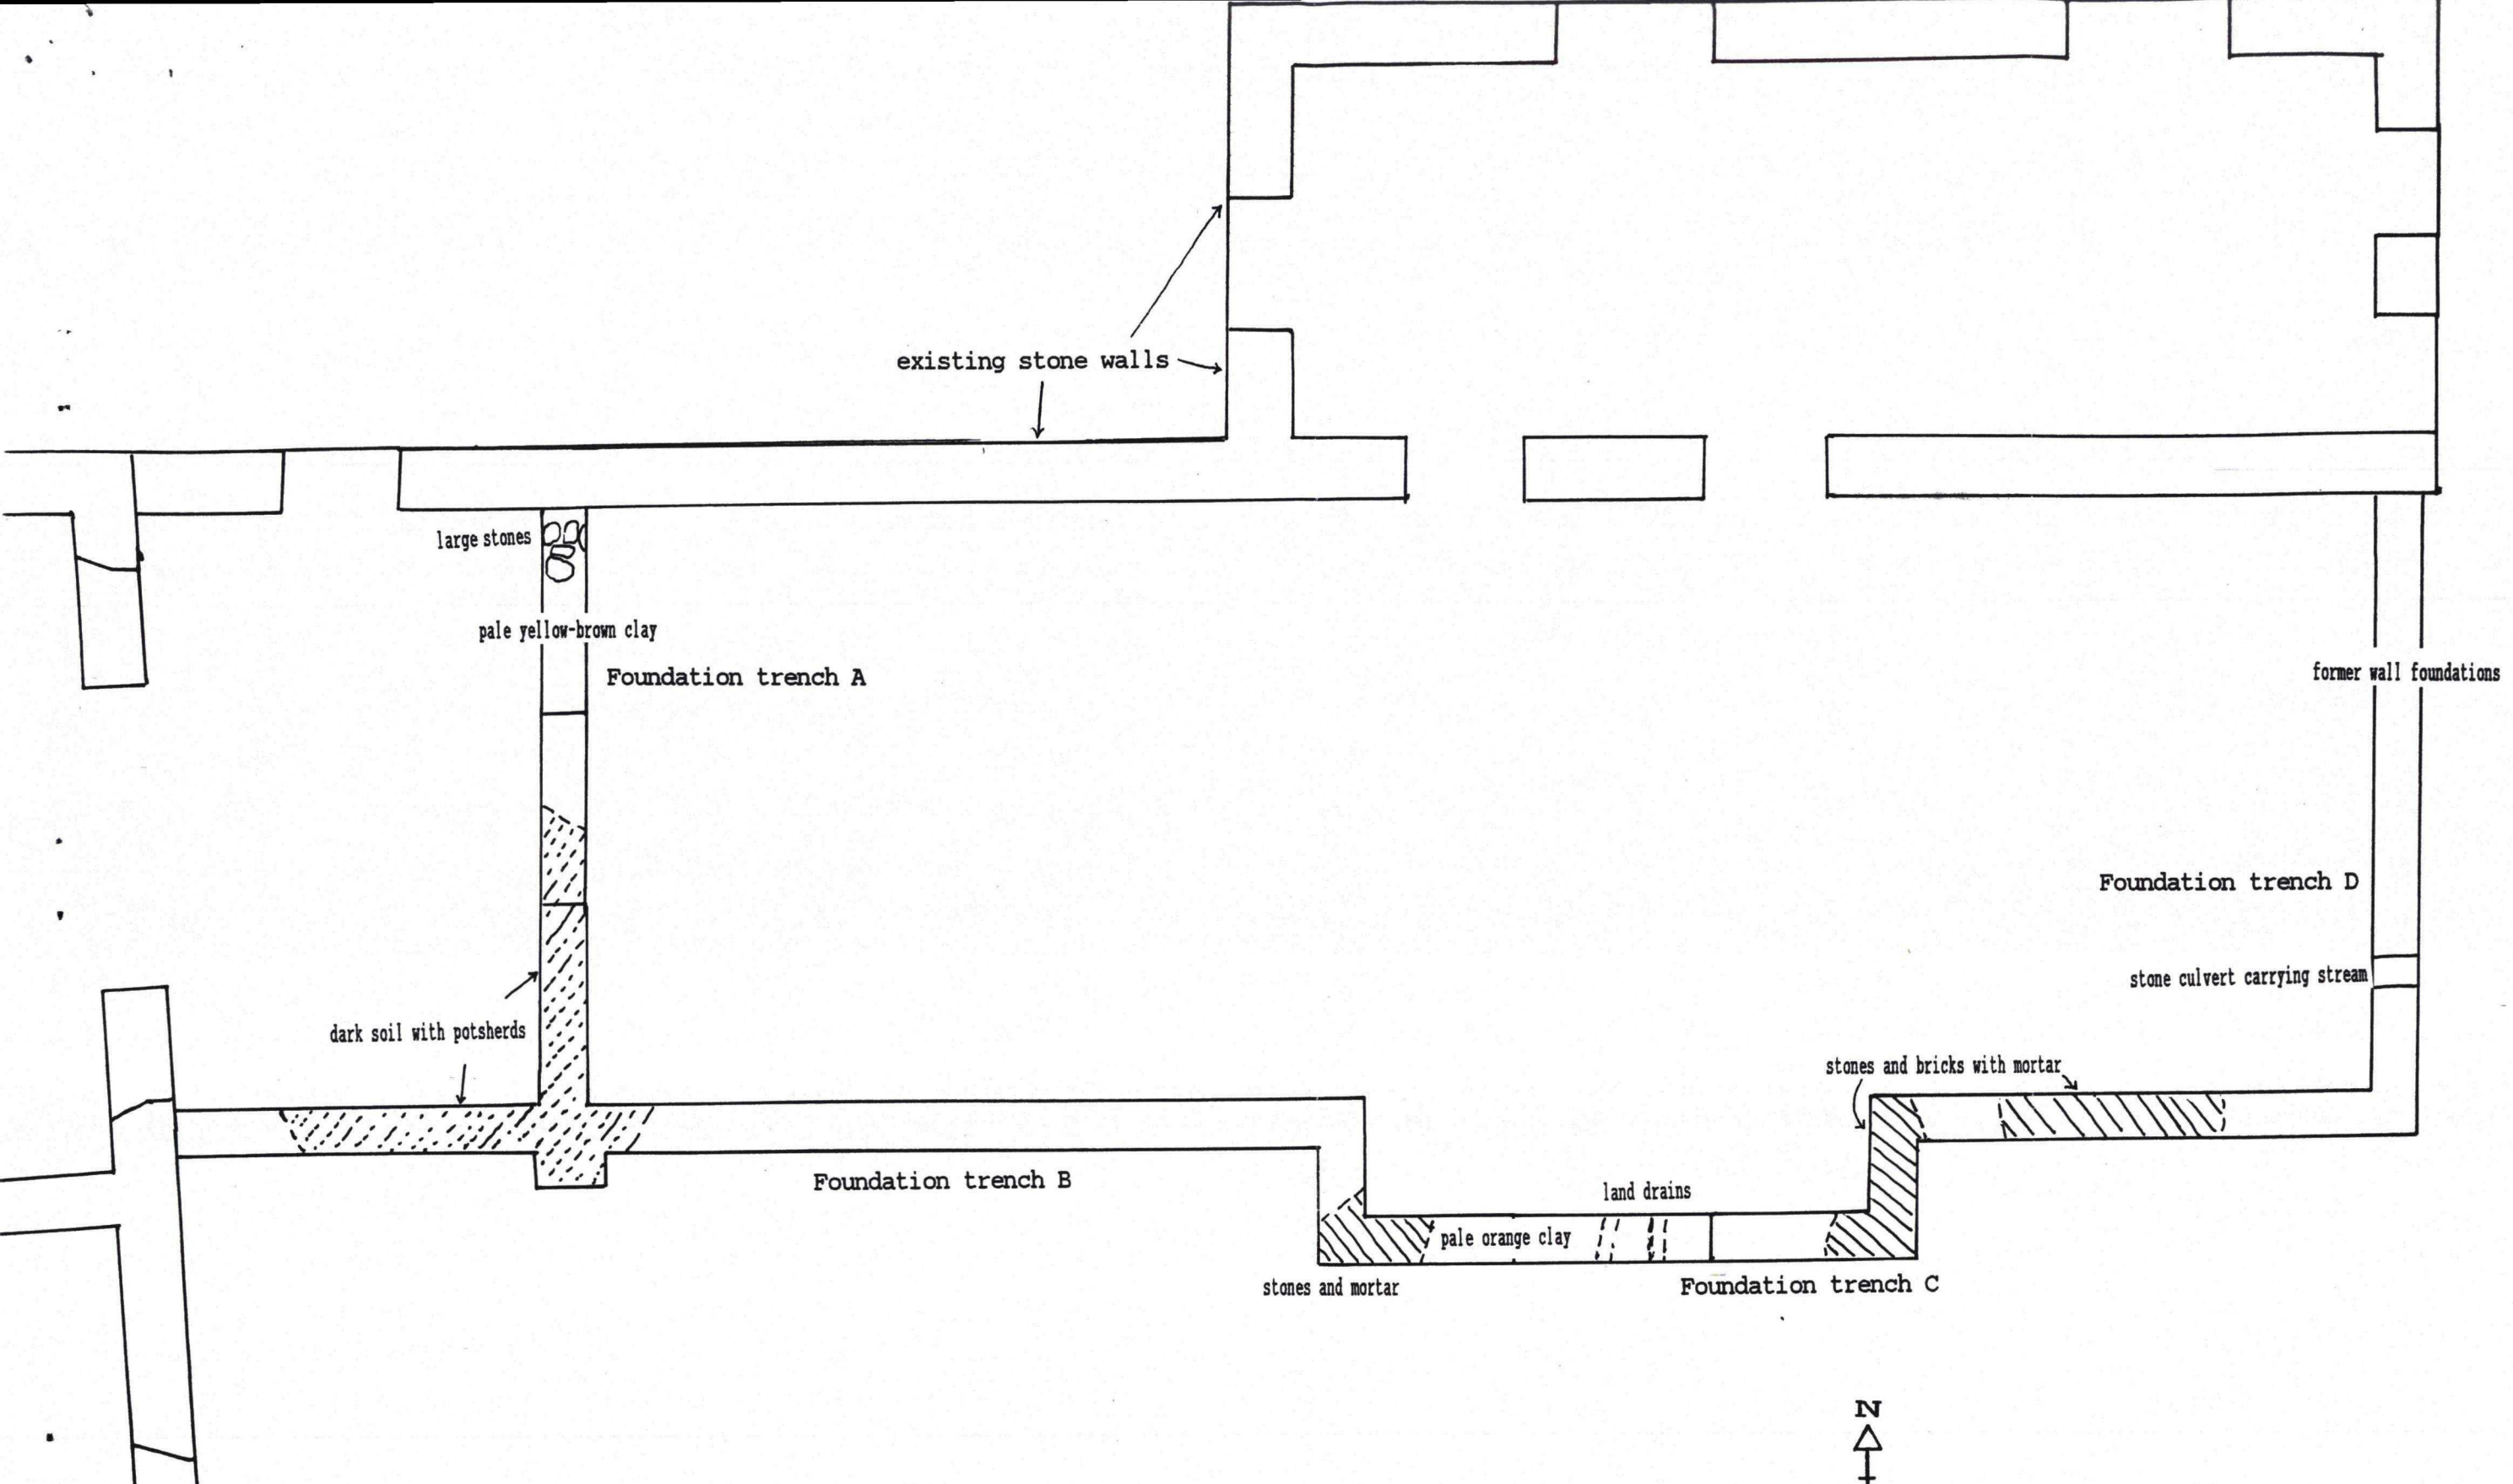
PROPOSED DEVELOPMENT OPPOSITE  
JERVAULX ABBEY PLAN 2

A small machine was used to excavate foundation trenches approximately 50 cm wide and up to 75 cm in depth (see plan 2).

Foundation trench A (see plan 2), running north-south, contained large stones, fairly tightly packed but not coursed, next to the existing wall to the north, at a depth of c 50 cm. The rest of the trench was composed of dark soil containing many flower pot fragments overlying pale orange clay. The dark soil with flower pot fragments continued into Foundation trench B, running east-west.

At both ends of Foundation trench C (see plan 2) were concentrations of stones and mortar with some brick fragments. Land drains also crossed C in several places. The underlying clay here was a pale yellow brown.

Foundation trench D ran along the line of a former stone wall, the foundation stones of which were removed by the machine. The stones were large dressed stone lying from c 20 cm below the surface, which ran right up to and abutted the existing wall to the north. Approximately 3.5 m from the existing wall, a stone lined culvert carrying a stream ran east-west across Foundation trench D at a depth of c 75 cm. This ran below the foundations of the former wall, apparently from west to east. It was previously unknown and did not connect in to any of the known water supplies in the vicinity.

existing stone walls

large stones

pale yellow-brown clay

Foundation trench A

dark soil with potsherds

Foundation trench B

stones and mortar

pale orange clay

land drains

Foundation trench C

stones and bricks with mortar

Foundation trench D

stone culvert carrying stream

former wall foundations

No pottery other than modern plant pots was recovered, and the whole area seems to have been thoroughly disturbed in modern times. Part of it was certainly in use as a garden area. The pre-existing wall at Foundation trench D was undated, but was similar in style to the walls of the existing buildings to the north. It was probably contemporary or later. The area of the development was part of a small garth prior to the existence of the car park, and was probably part of the kitchen garden area associated with Jervaulx Hall which still survives in an overgrown state to the north of the existing buildings.
