# Archaeological investigations at 60-62 Quay Street Scarborough

## Preliminary report

**NGR** TA 0509 8882

**SAHS SITE CODE** 60QS11 and 60QS12

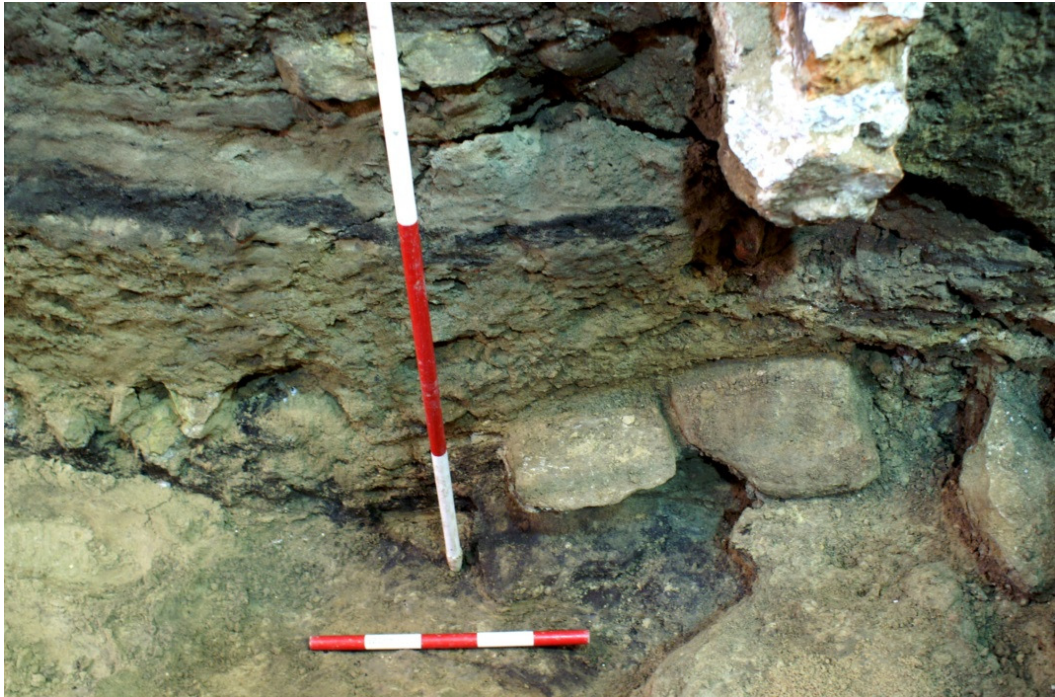
**Figure 2. The barrel feature in Trench 1**

At the north end of the trench below the sand was a brick lined saucer shaped feature shown in the photograph above, containing a thin layer of organic material. This was interpreted as being associated with a spring or well in the cliff face and the brick layer may be a 'hard-standing' to aid the filling of barrels to supply ships with water

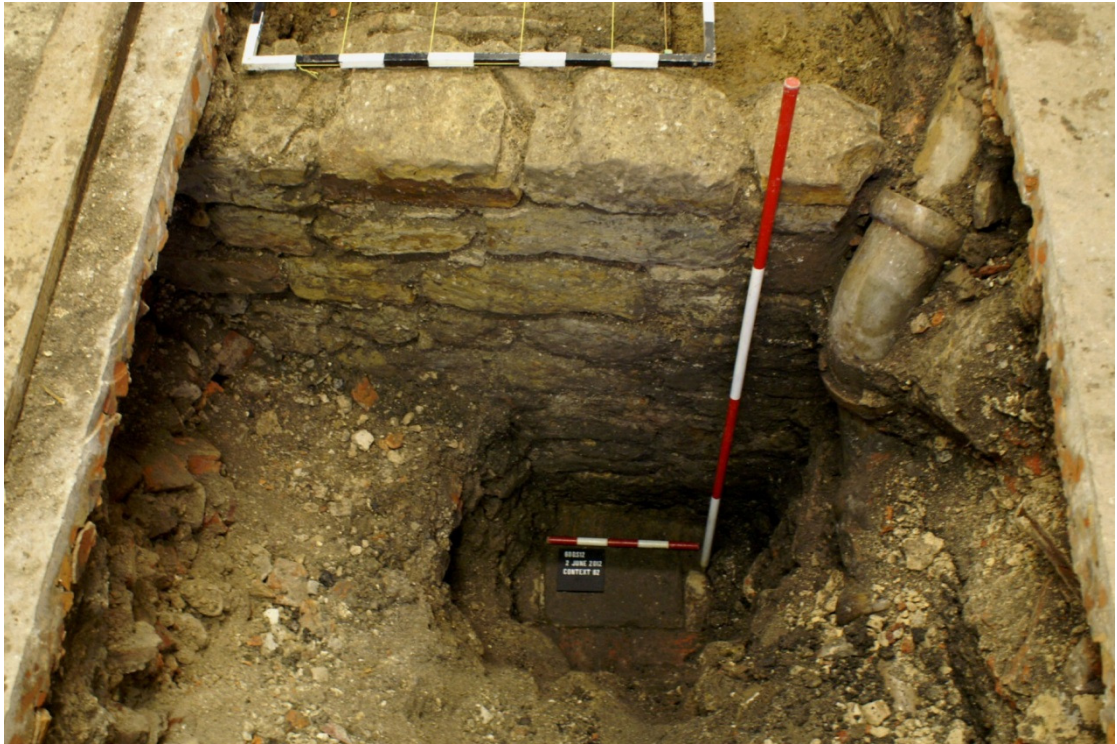
Trench 2 was carried out in June 2012 in 60A Quay Street. This trench measured 1.6 by 4.5 metres. As with Trench 1 the northernmost 1.3 metres consisted of levelled off natural clay. In this case however the clay was retained by a large stone wall. No such feature had been found in trench 1 nearby. The south end of Trench 2 revealed a cellar which had been in-filled by pushing the previous cottage into it. The bricks recovered from this cellar confirm an early 18th century date for the cottages. The infilled cellar was 2.2 metres deep, with a floor of stone slabs built off naturally deposited beach sand. Thus trench 2 revealed a completely different response to land reclamation in this area from that in both Trench 1 and investigations some years earlier at 58 Quay Street.\*

**Figure 3. The stone retaining wall in Trench 2 showing the excavation down to the tiled floor in front of it**
