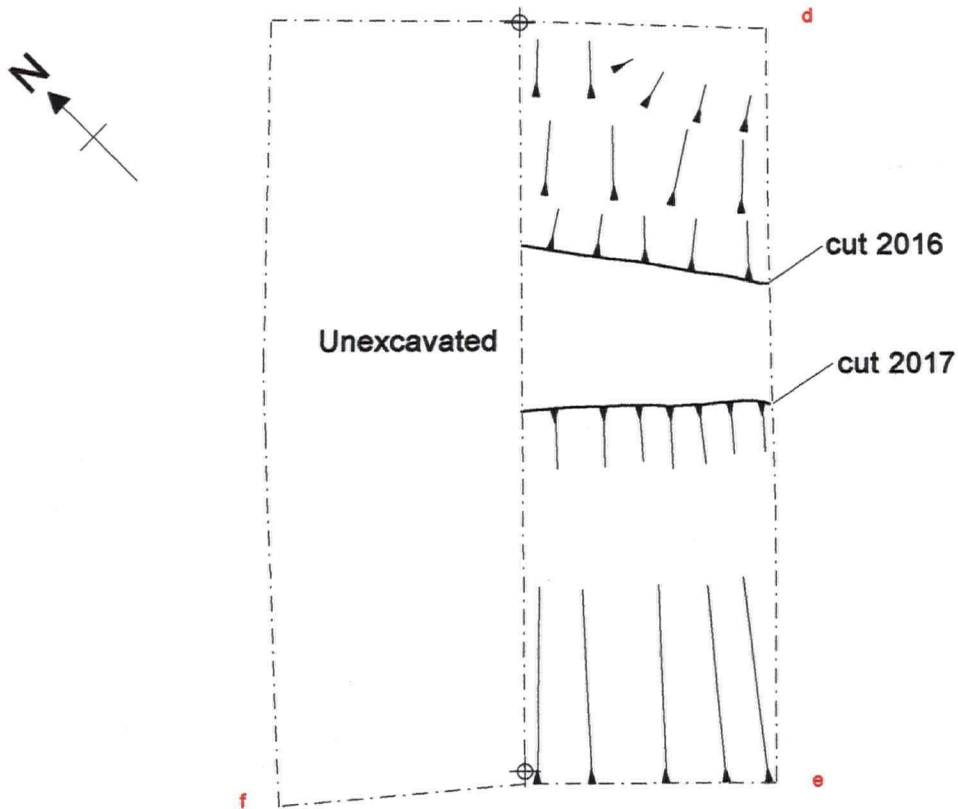
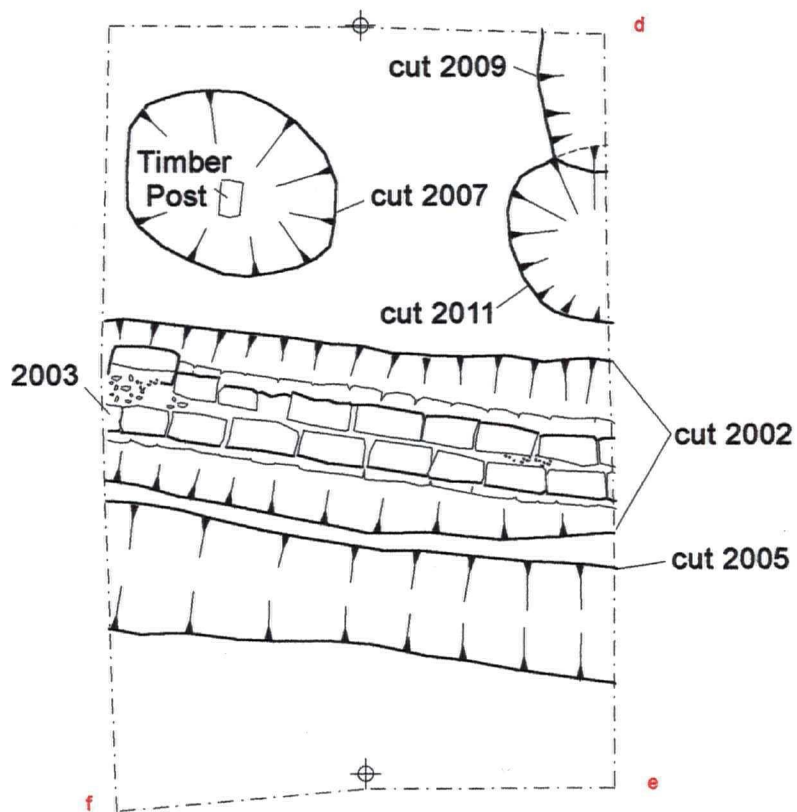
Figure 4: Trench 2 Cut Features

Trench 2 Phase 1 Cut Features

Trench 2 Phase 2 Cut Features

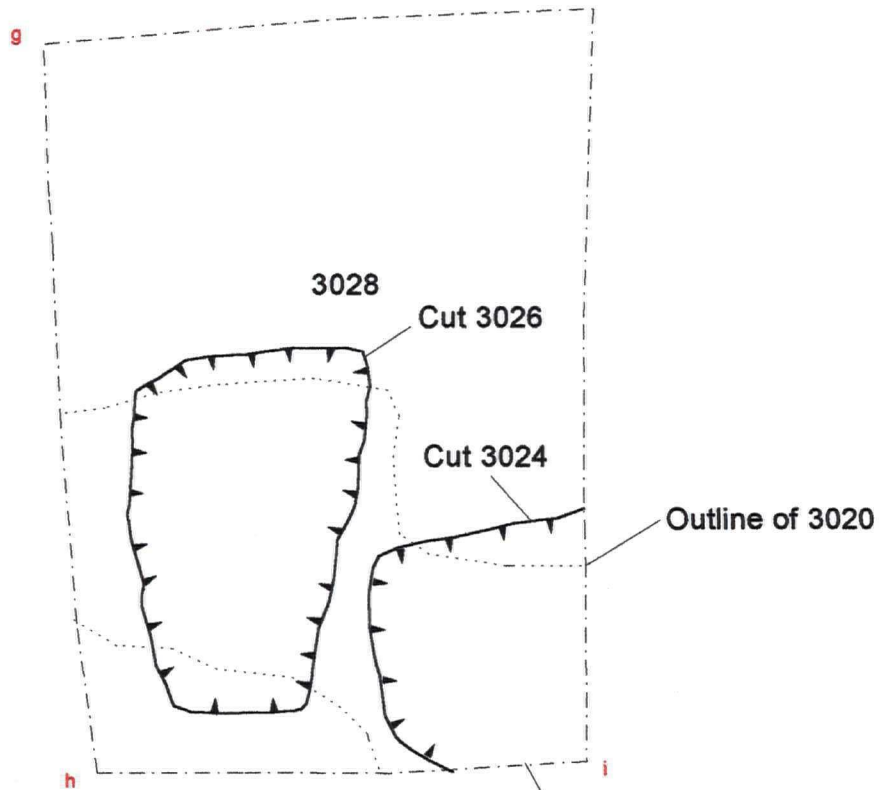
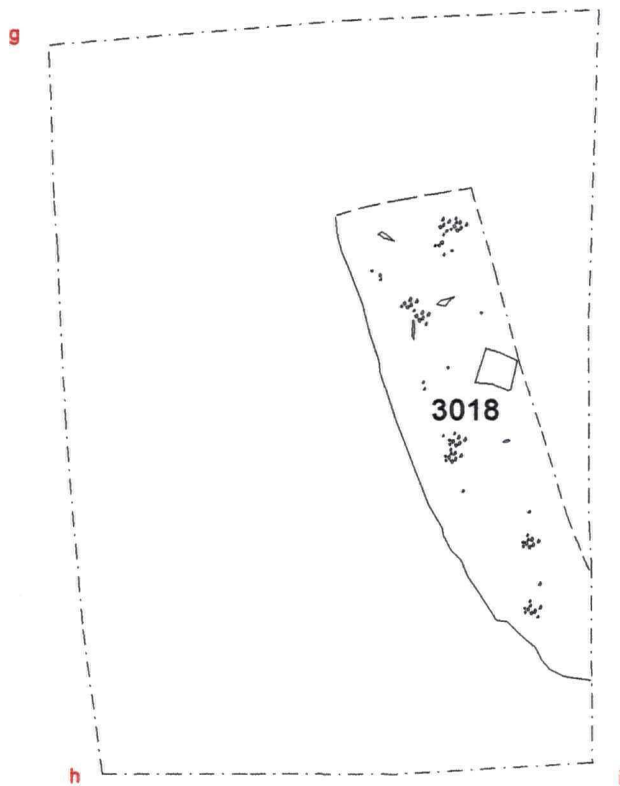
Figure 5: Trench 3 Phase Plans

Phase 1 Pits

N.B. 3028 does not show in this section

Mortar Surface

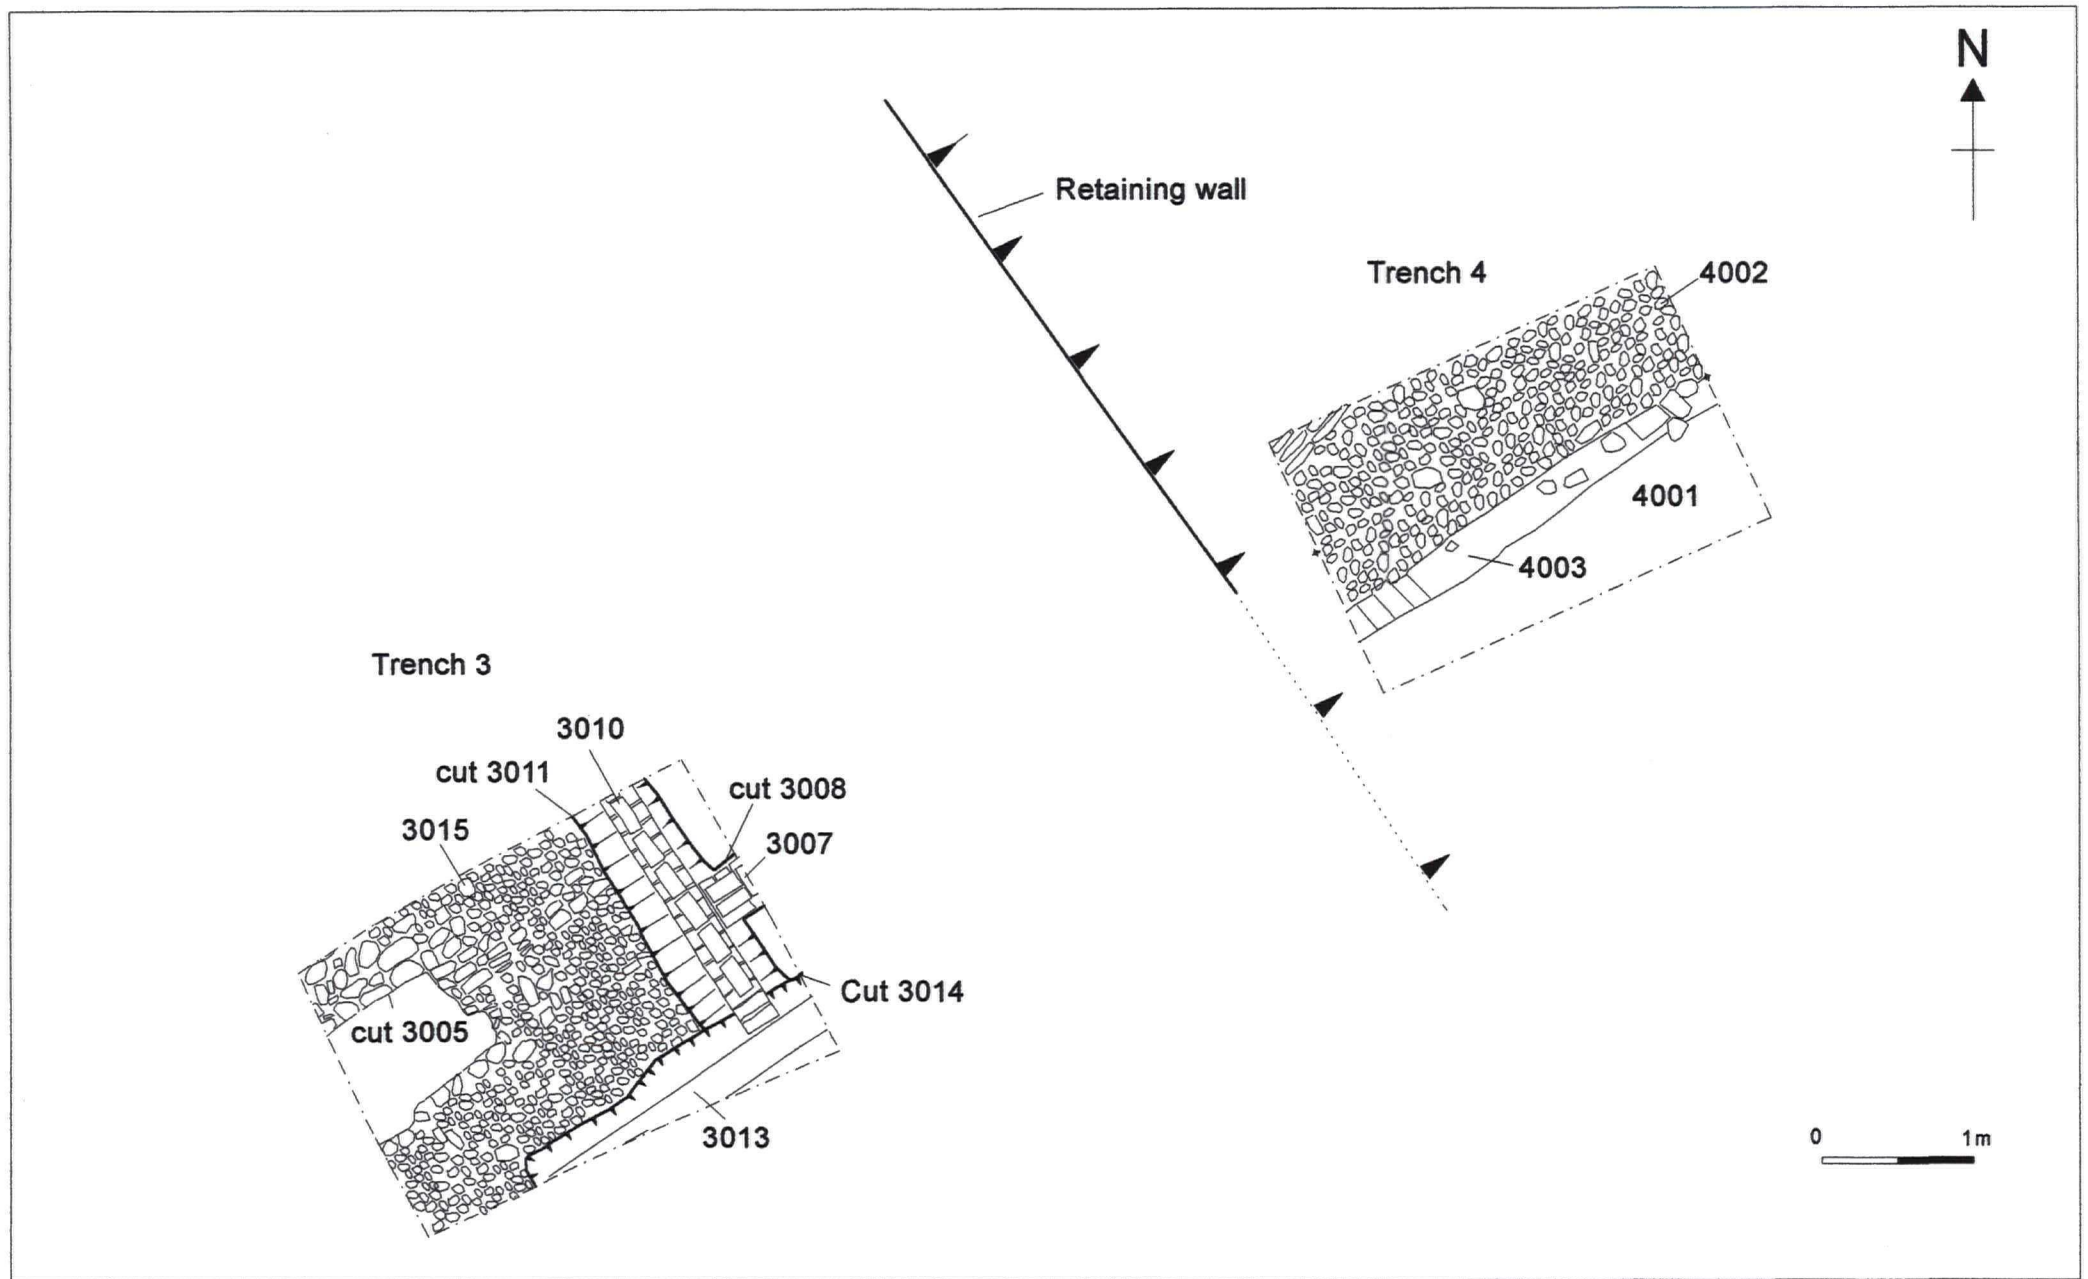
Figure 6: Post Medieval Structures in Trench 3 and 4

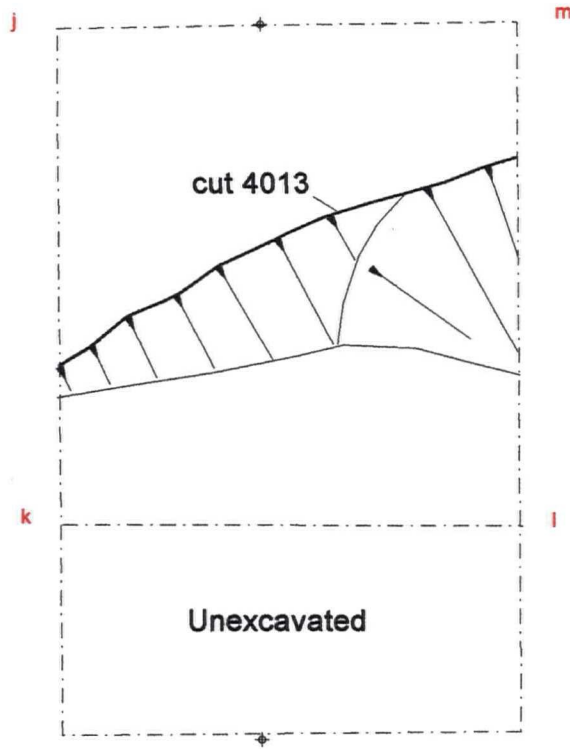
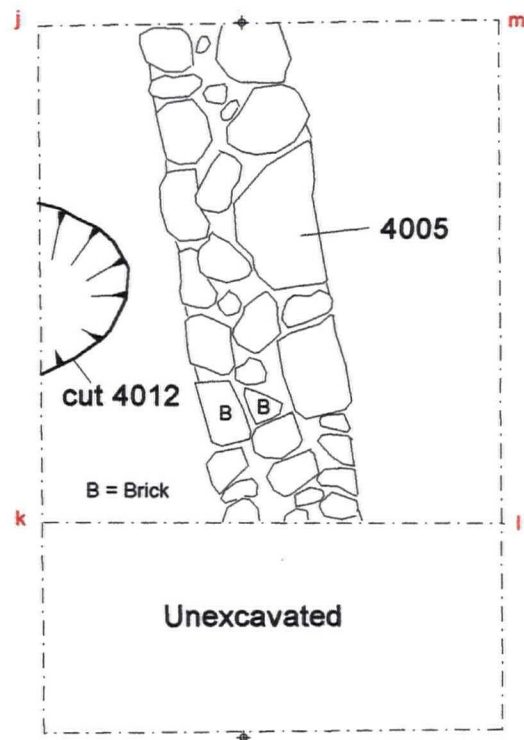
Figure 7: Trench 4 Phase Plans

Pit or Ditch Cut 4013

Medieval Wall and Post Hole

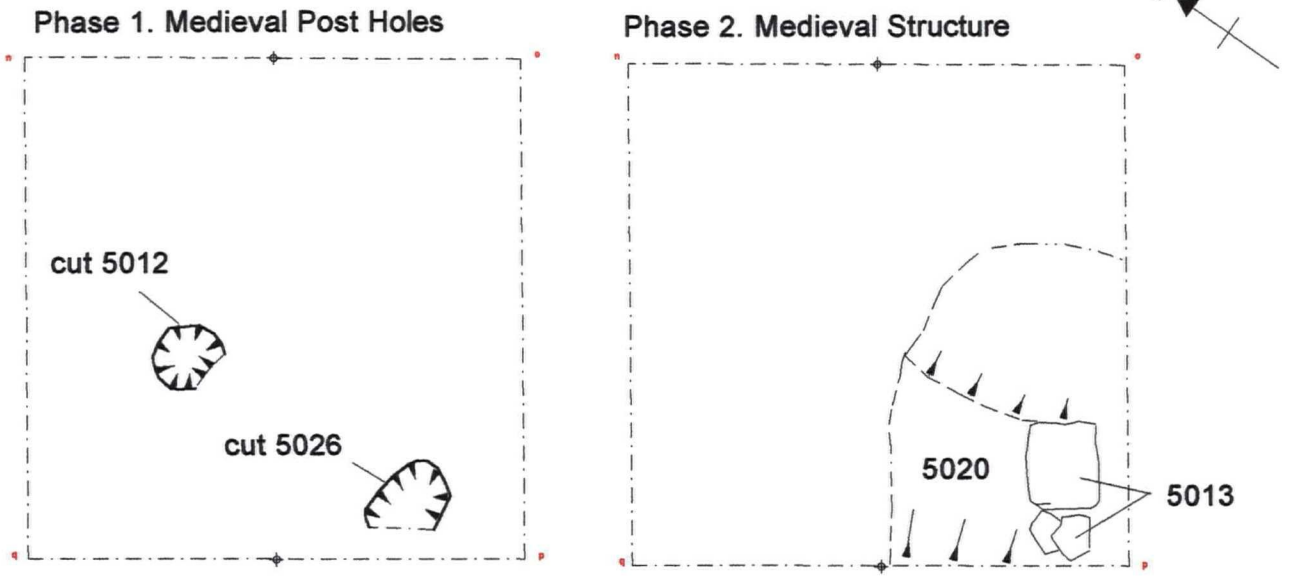
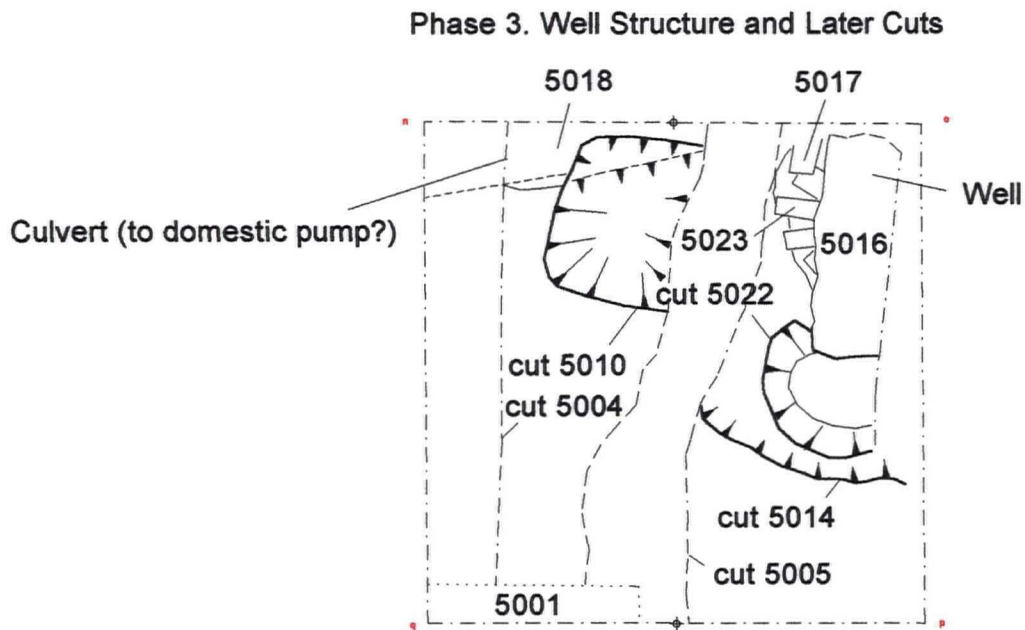
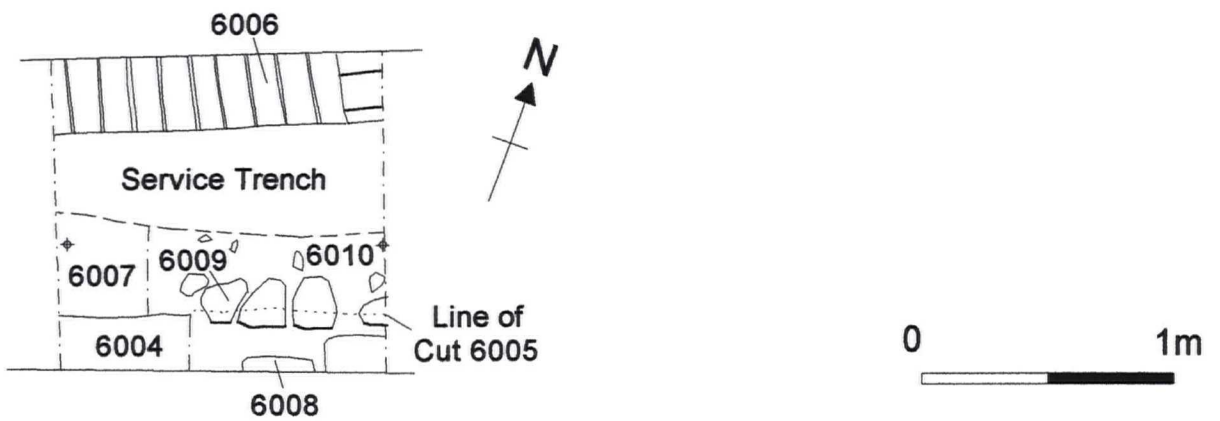
Figure 8: Trench 5 Phase Plans; Trench 6 Plan

Trench 5 Phase Plans

Trench 6 Excavated Features

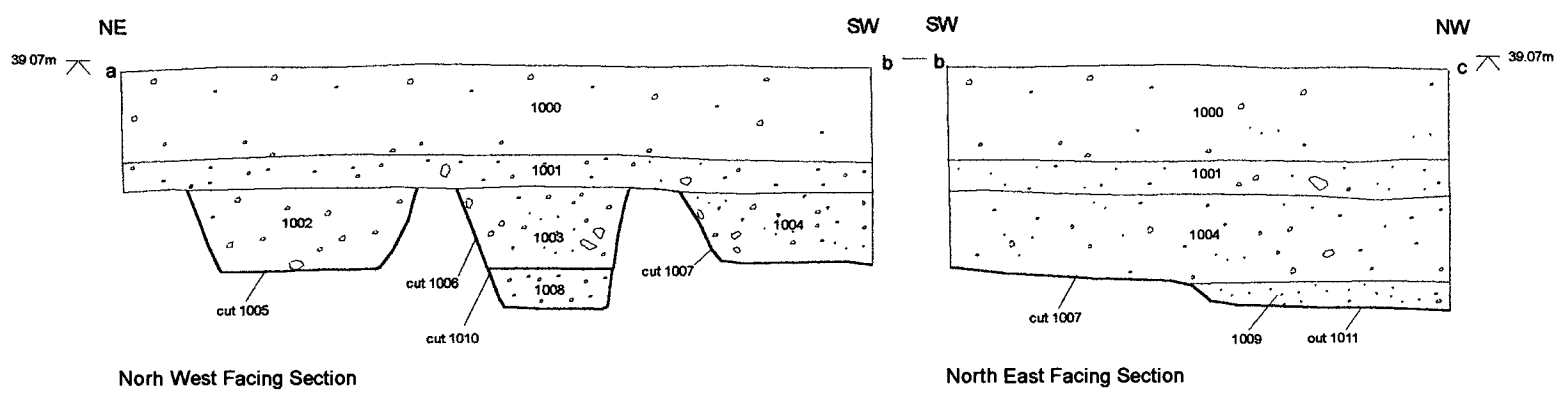
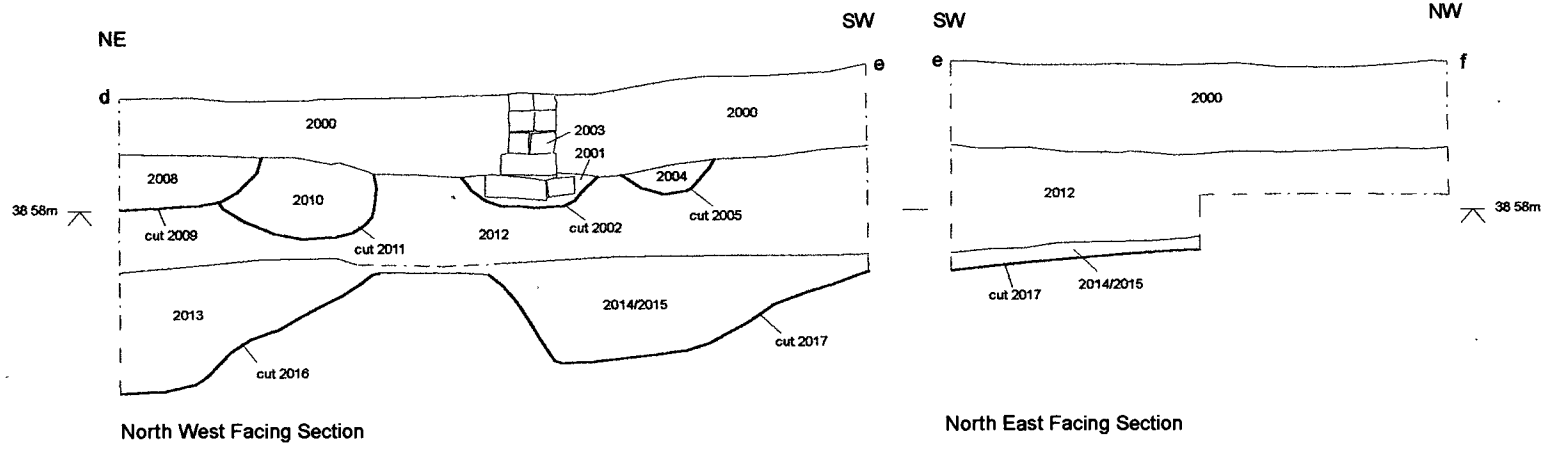
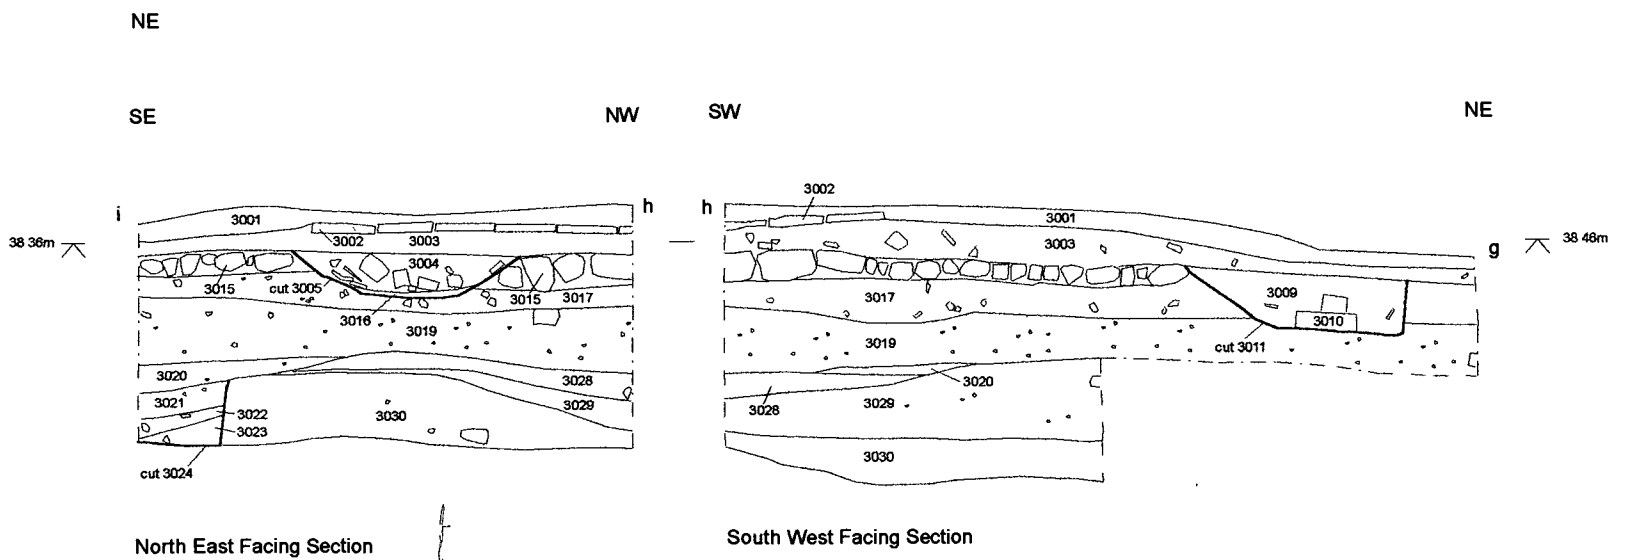
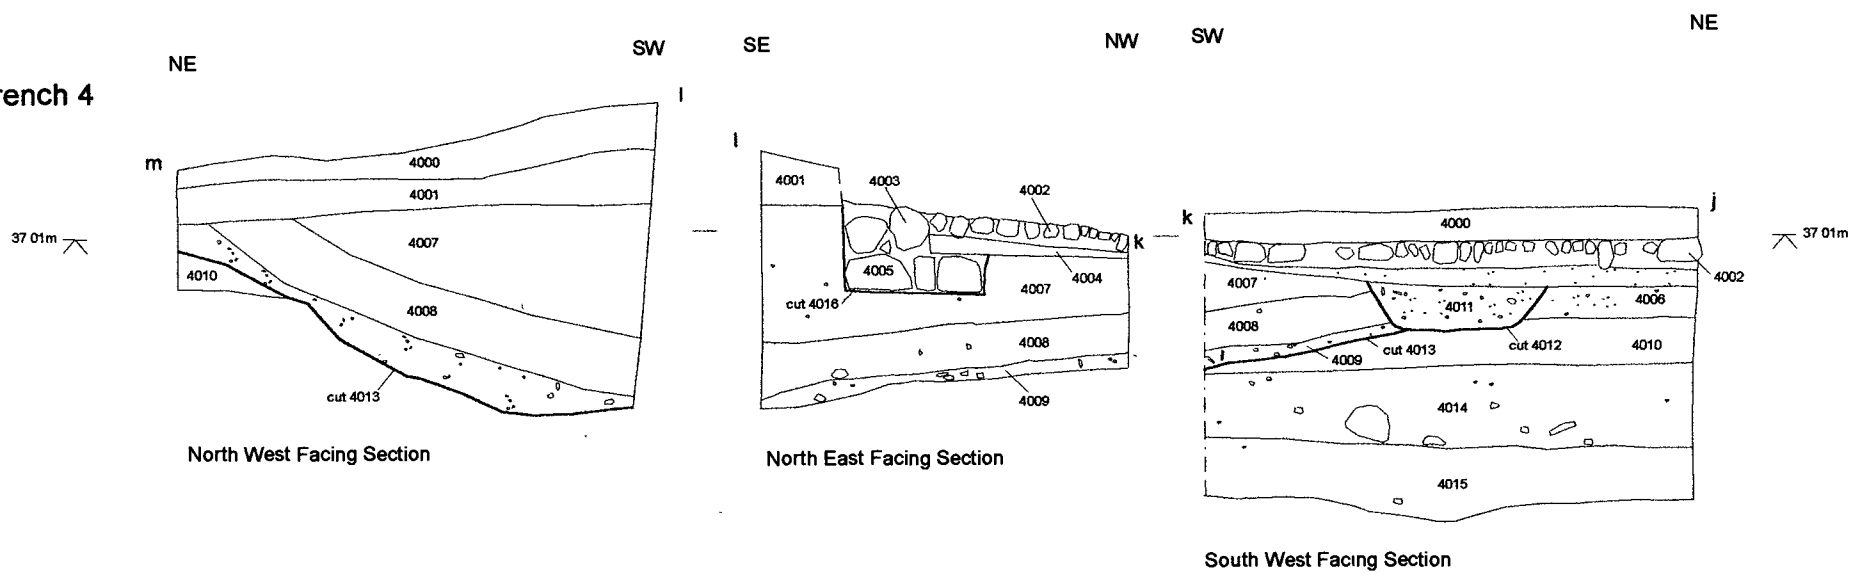
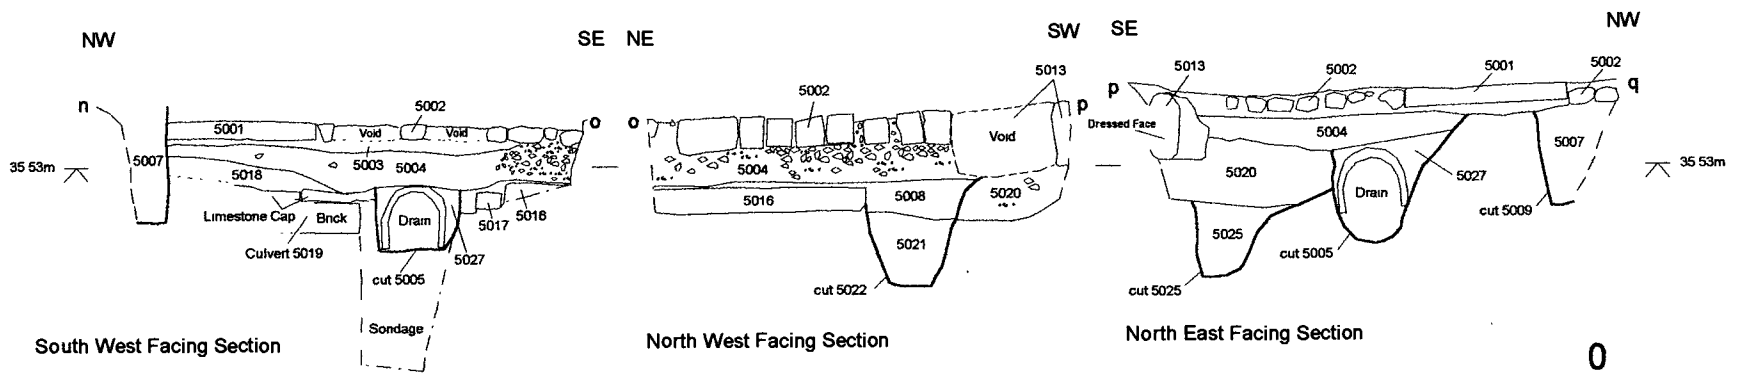
Figure 9: Trench Sections

Trench 1

Trench 2

Trench 3

Trench 4

Trench 5

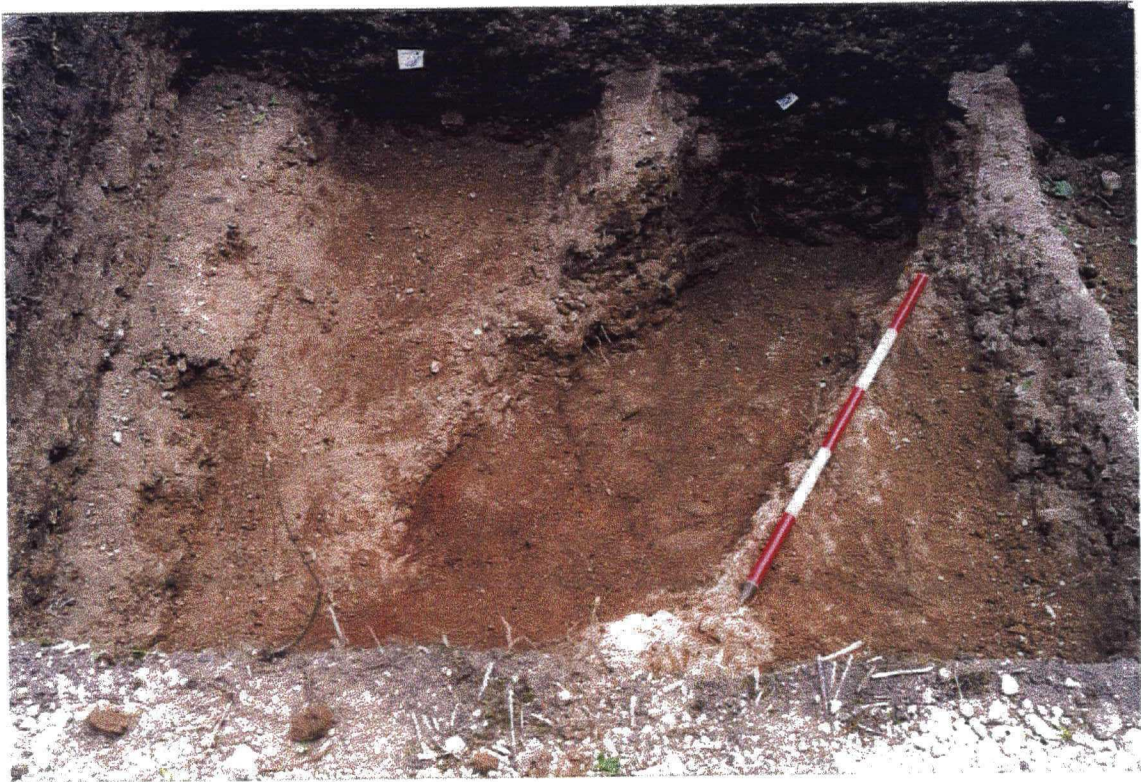
Plate 1. Trench 1. Phase 1 Cut Features. Facing South.

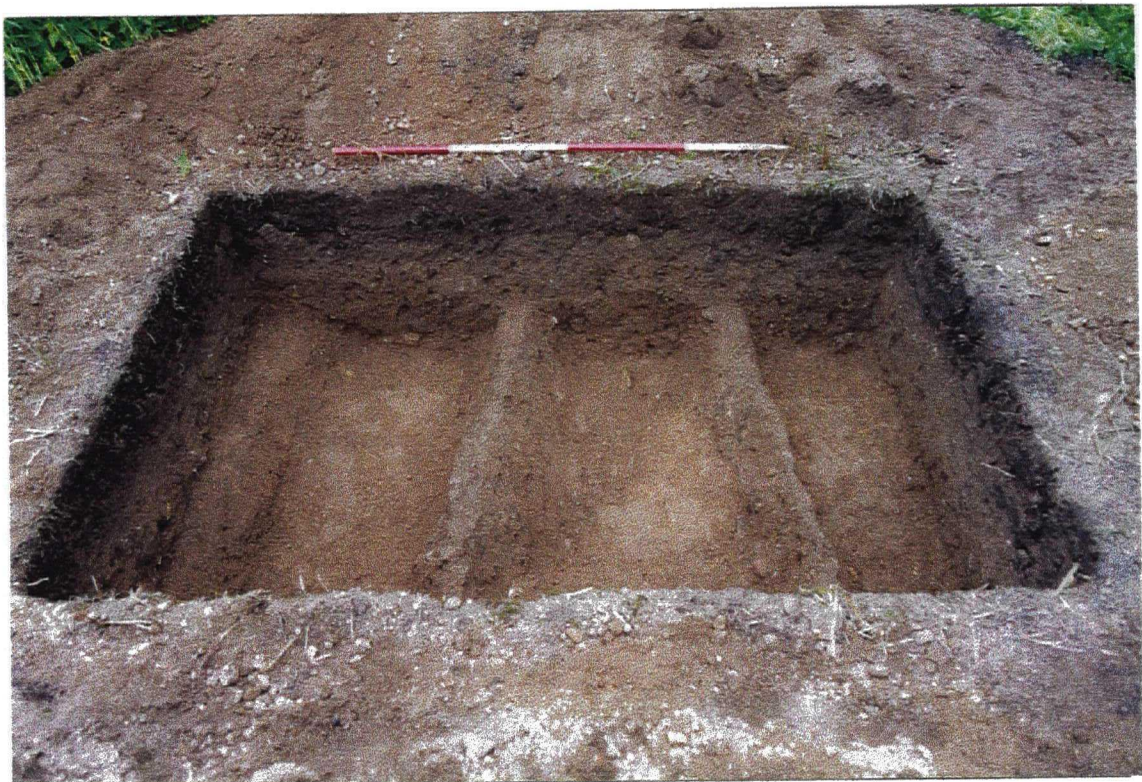
Plate 2. Trench 1. Phase 2 Cut Features. Facing South-east.

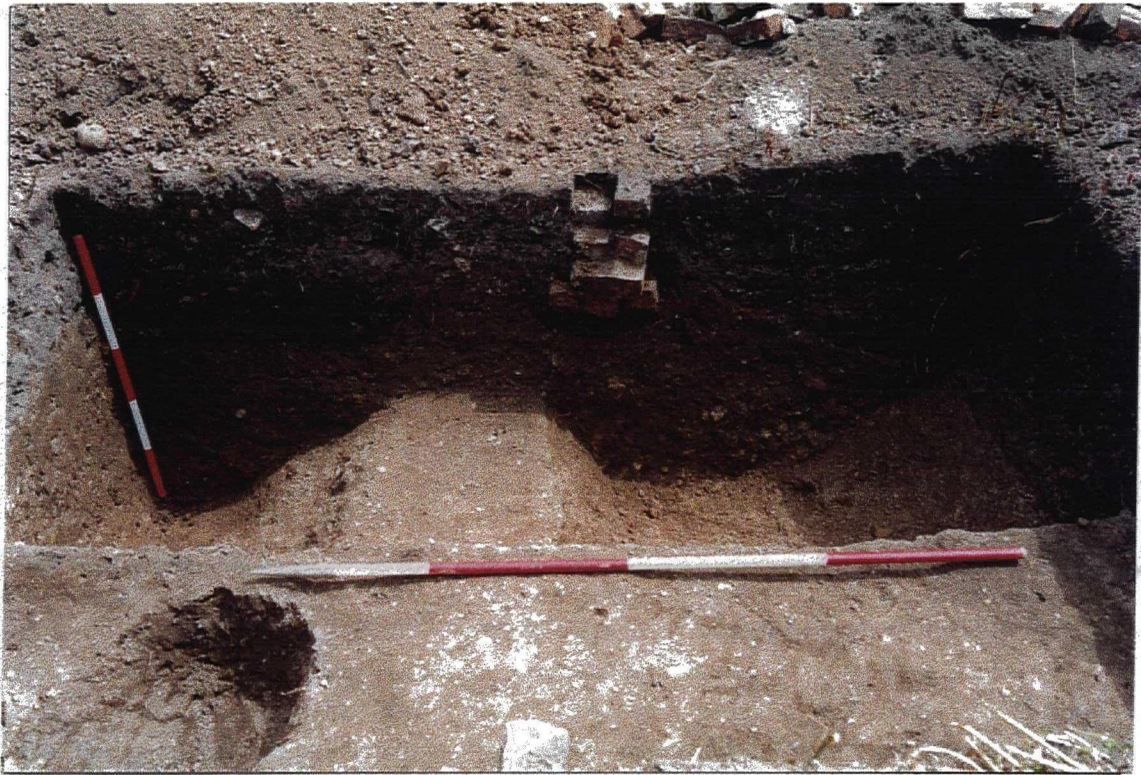
Plate 3. Trench 2. Phase 1 Cut Features. Facing west.

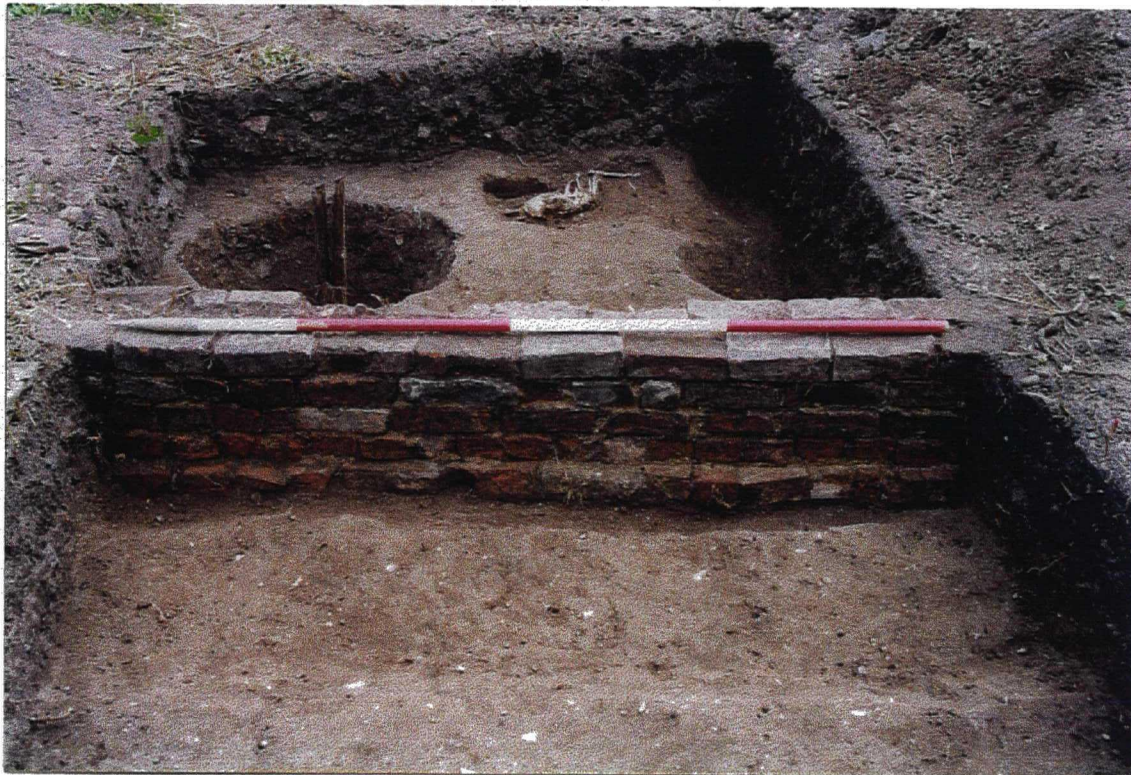
Plate 4. Trench 2. Phase 2 Cut Features and Wall 2003. Facing north.

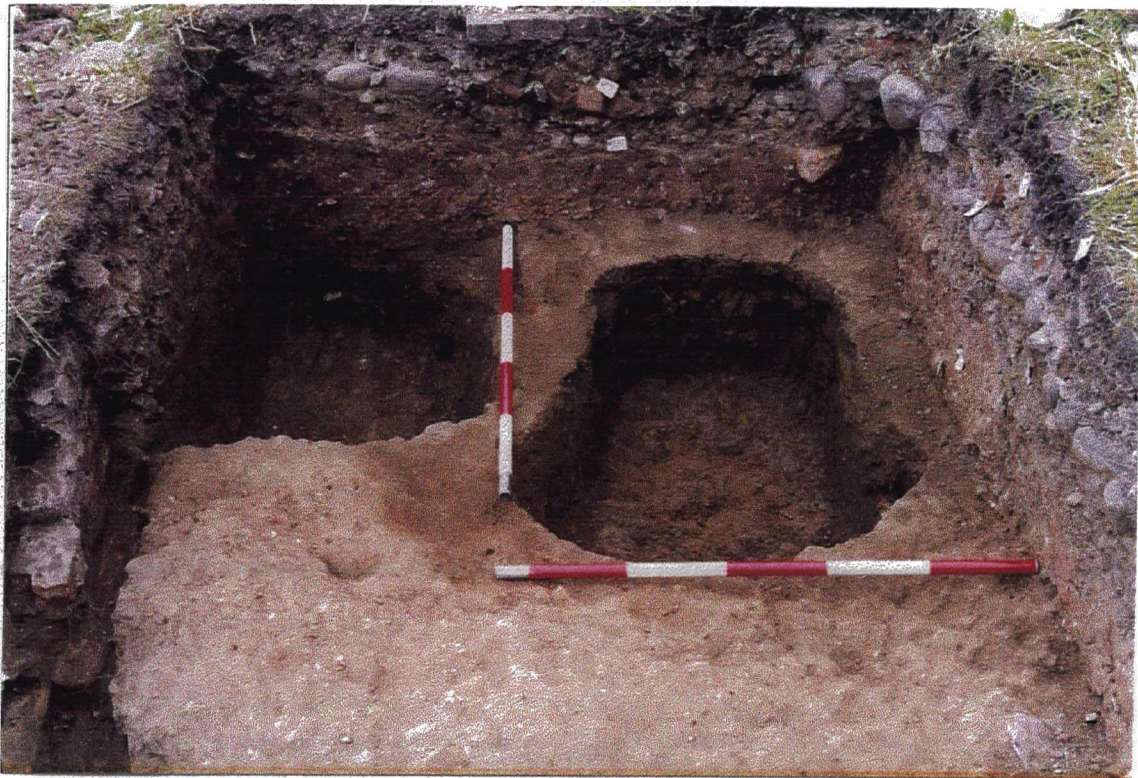
Plate 5. Trench 3. Pit Cuts 3024, 3026. Facing west.

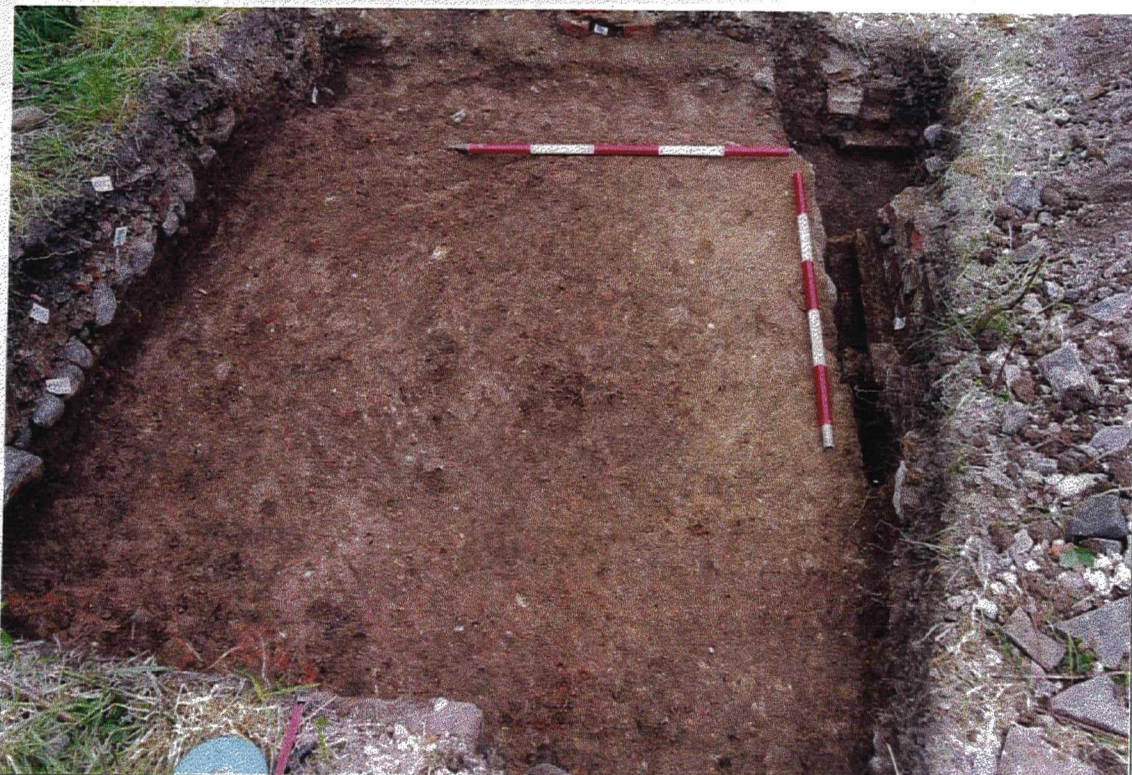
Plate 6. Trench 3. Mortar Floor Surface 3018. Facing east.

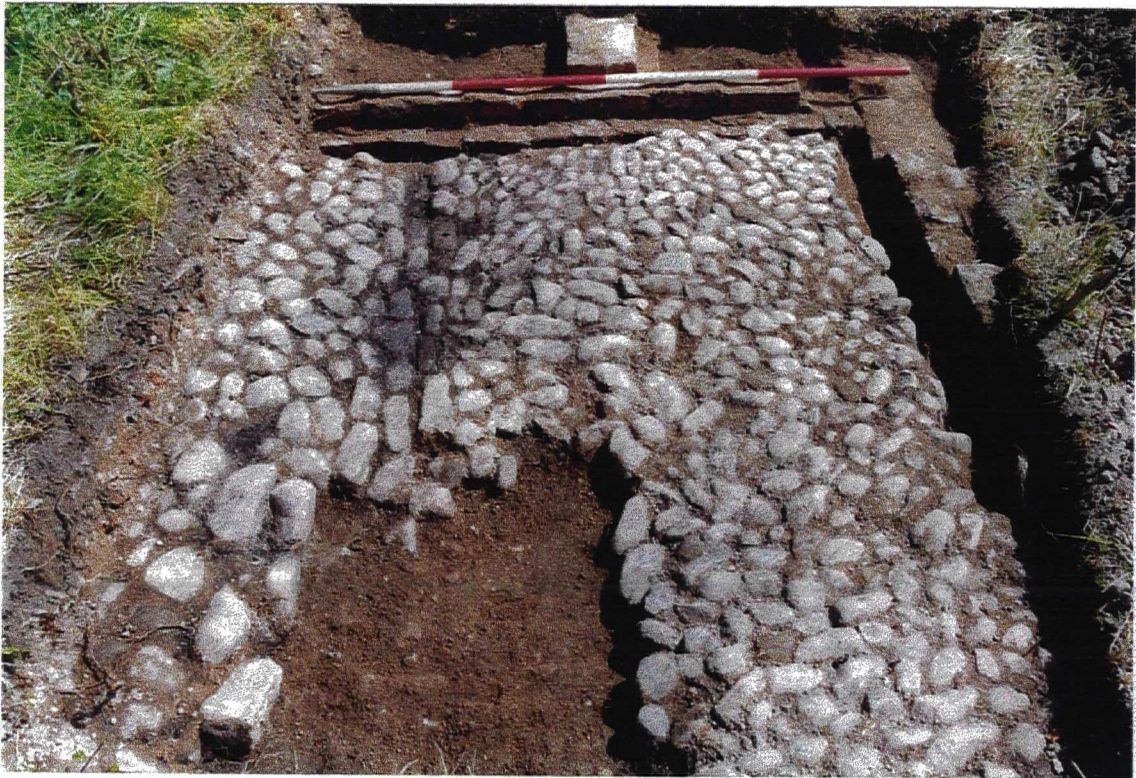
Plate 7. Trench 3. Cobble Surface 3015. Facing north.

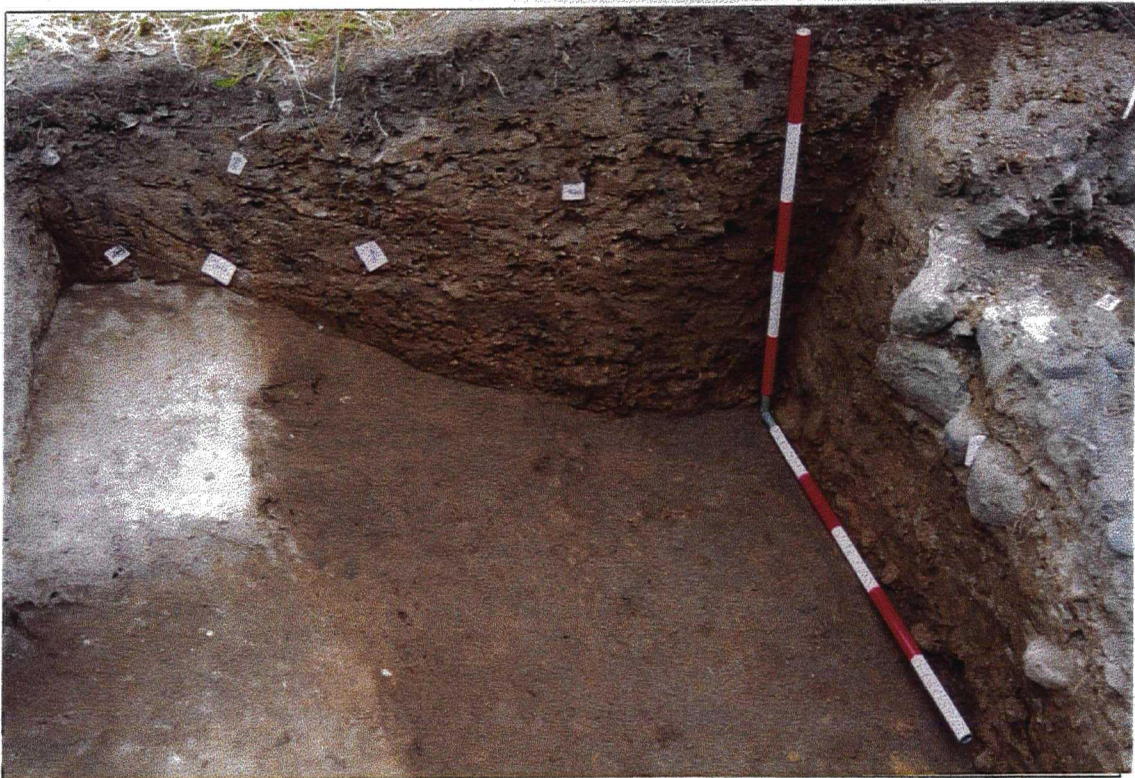
Plate 8. Trench 4. North-west Facing Profile of Cut 4013. Facing South-east.

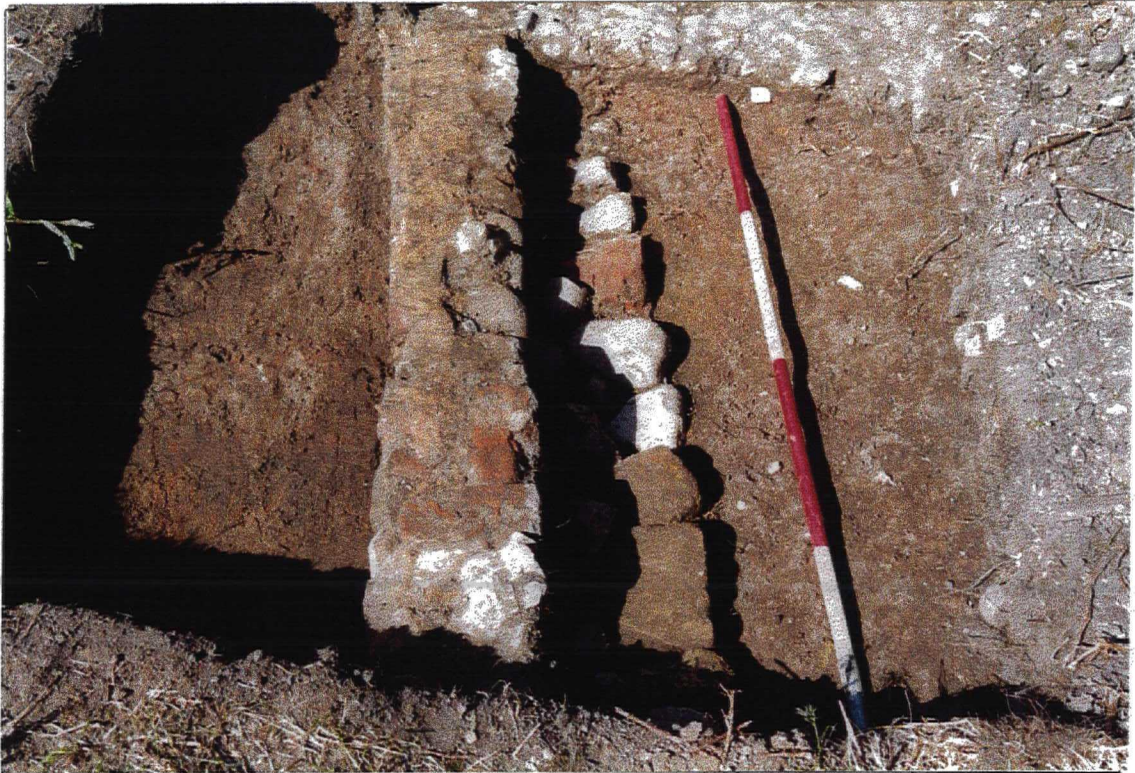
Plate 9. Trench 4. Walls 4003 and 4005. Facing south.

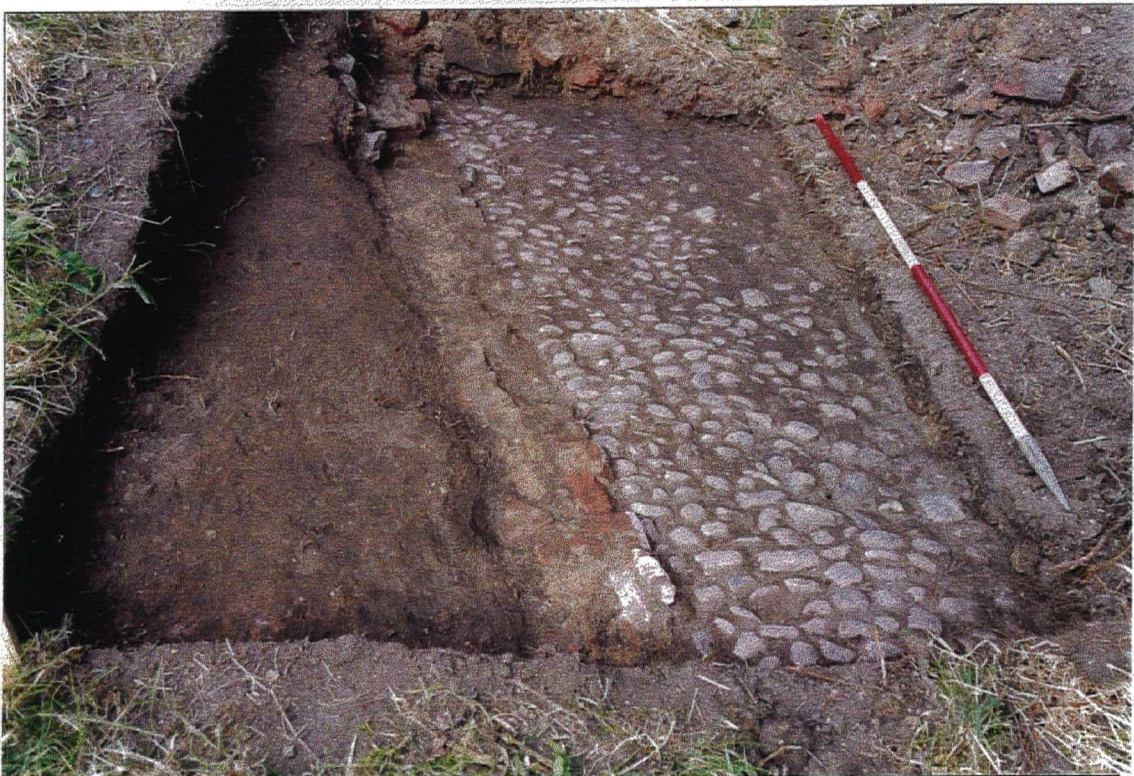
Plate 10. Trench 4. Cobble Surface 4002. Facing south.

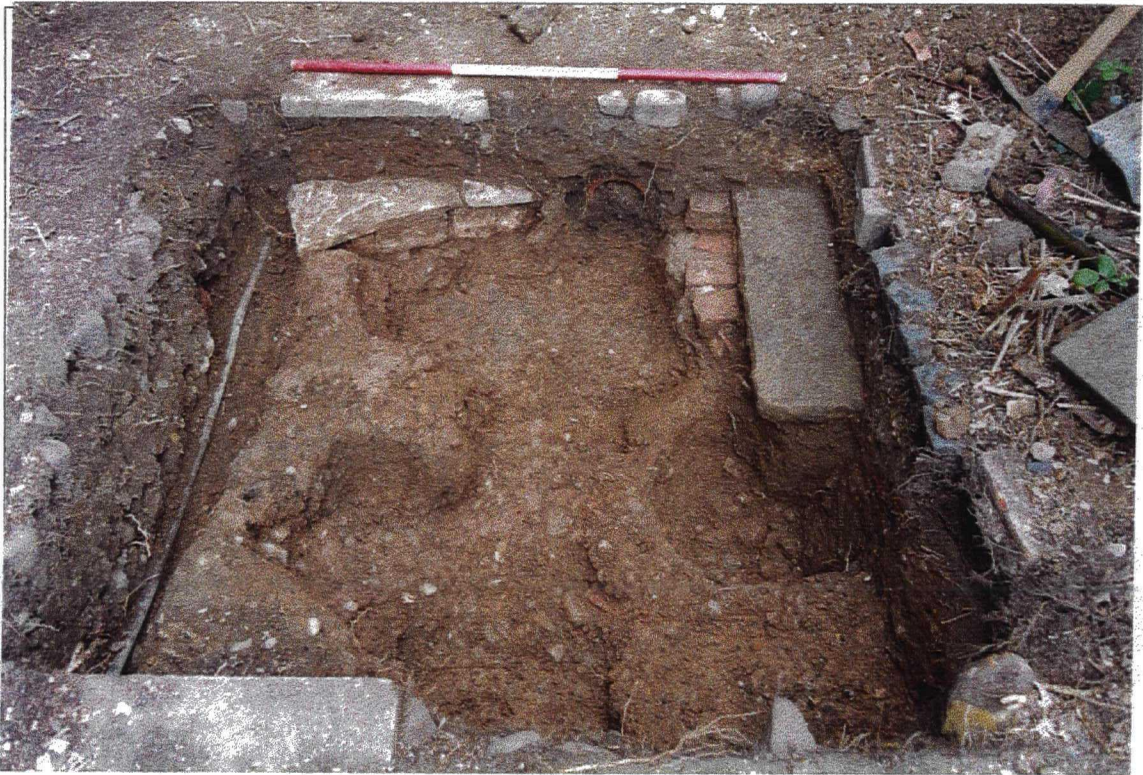
Plate 11. Trench 5. Post Excavation Showing Cut Features and Modern Structures. Facing North-east.

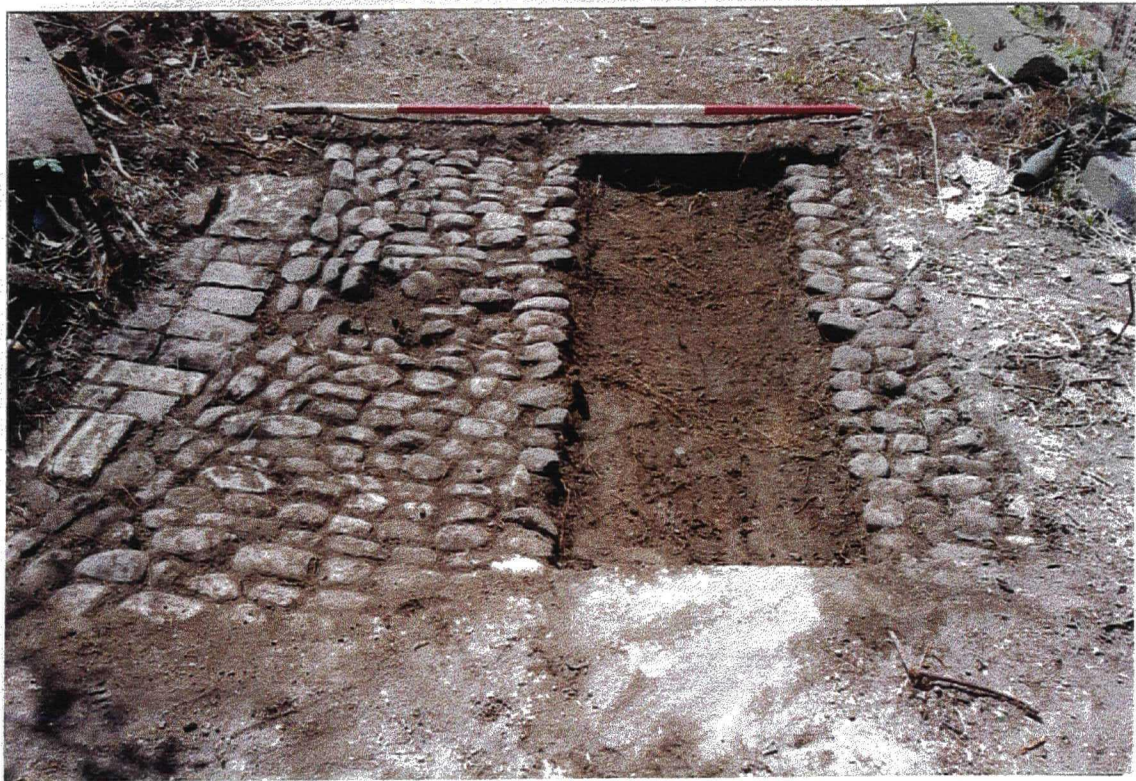
Plate 12. Trench 5. Cobble Surface 5002. Facing South-west.
