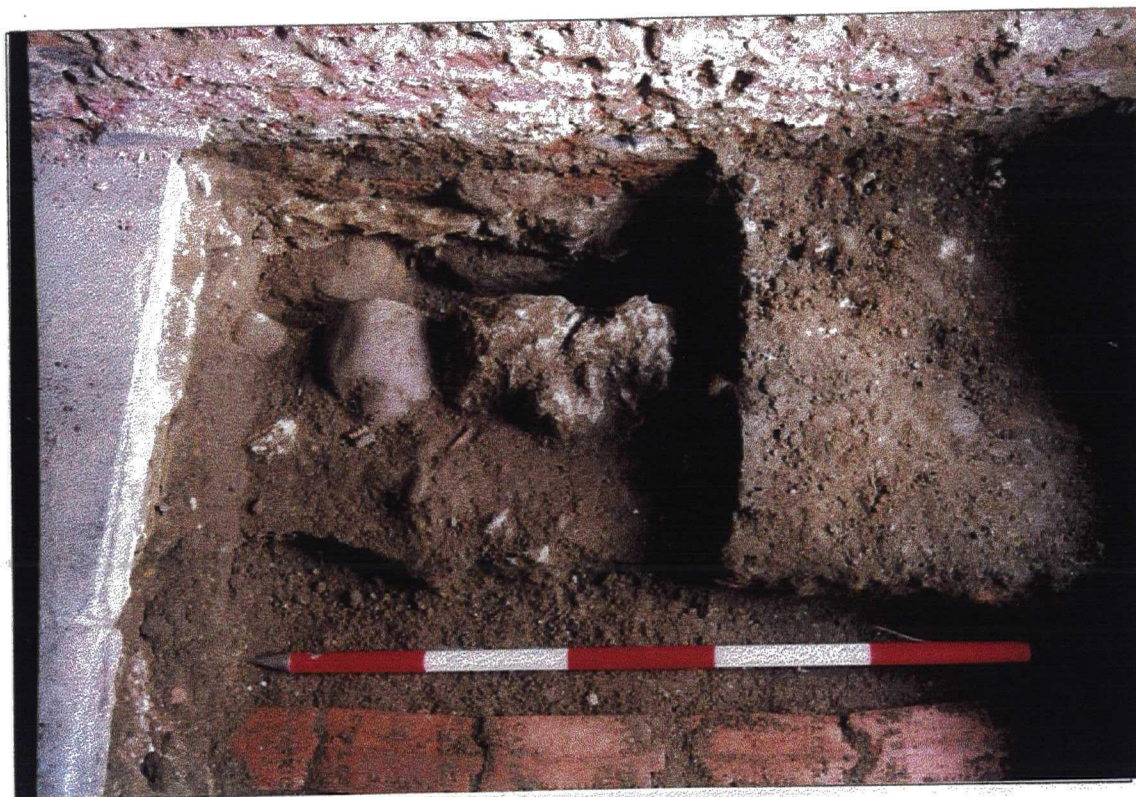
Plate 13. Trench 6. Post Excavation Showing all Cut Features and Structures.
Facing North-east.
