**No. 2 Magdalene Lane,  
Taunton, Somerset  
Heritage Statement**

Client: GGFF Limited

AB Heritage Project No:60258

Date:29/03/2018

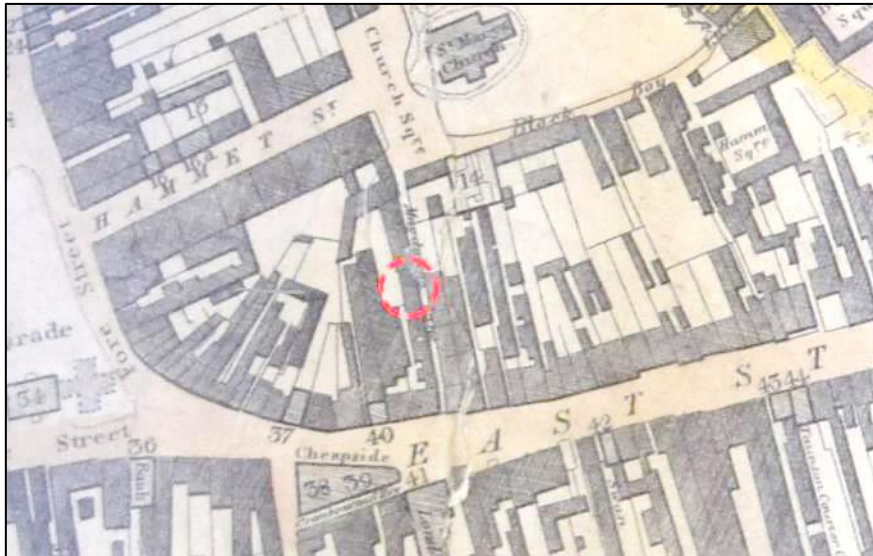
**Plate 1: Plan of Taunton, 1840. Approx. location of site outlined in red (SWHT Ref. DD/SAS/C212)**

- 3.2.1 The proposed development site was formerly occupied by an earlier row of almshouses known as the Osborne Almshouses. A translation of a charter from 1435 describes how several patrons, including the vicar of the Church of St Mary Magdalene, conveyed two messuages in Taunton, seven cottages called Osborne Almshouses, with adjoining gardens enclosed by hedges, to Thomas Osborne. These are described as located on the west side of Church Lane (now Magdalene Lane), extending for a length of 112 feet along the lane (South West Heritage Trust (SWHT) Ref.A/DIF/91/1).
- 3.2.2 Late 18<sup>th</sup> and early 19<sup>th</sup> century maps of the area show that the site was occupied by a row of buildings during this period, likely to be the original Osborne Almshouses, with yards or garden space at the rear (Plate 1).

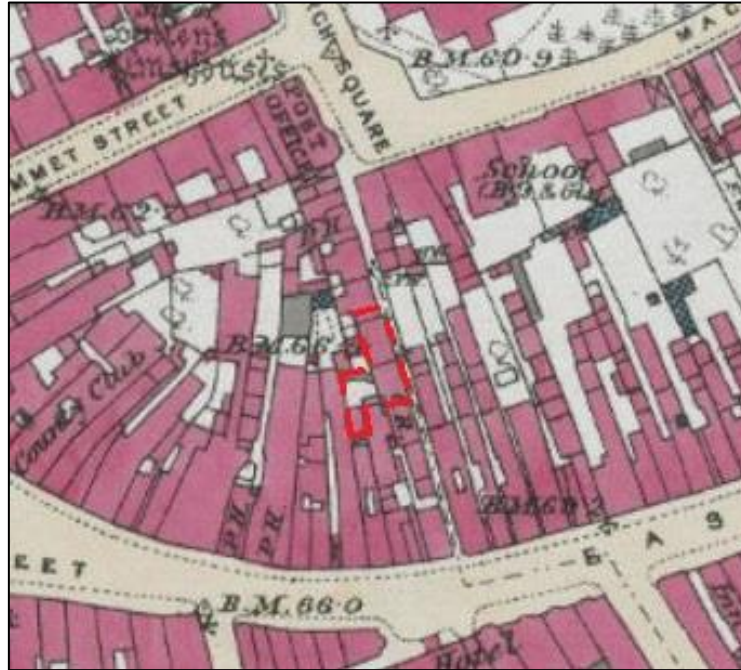
**Plate 2: 1<sup>st</sup> edition 25" OS map, c. 1888. Approx. location of site outlined in red (Know Your Place, 2018)**

- 3.2.8 The earliest available historic map to depict the site is the 1<sup>st</sup> edition of the 25" OS map, dated c. 1888 (Plate 2). This shows the site as part of a row of separate buildings occupying the west side of Magdalene Lane, with a rear yard containing several outbuildings, including a feature or structure of wood or iron.

- 3.2.9 This map shows that the wider setting at this date comprised densely packed, narrow plots with buildings facing onto Fore Street and East Street, with yards, outbuildings and linear

gardens at the rear running northwards towards Church Square. Here, the landscape opened out to a degree with the churchyard and the gardens beyond to the north. Buildings lined most of the east side of Magdalene Lane, although a gap was present opposite the site at this date.

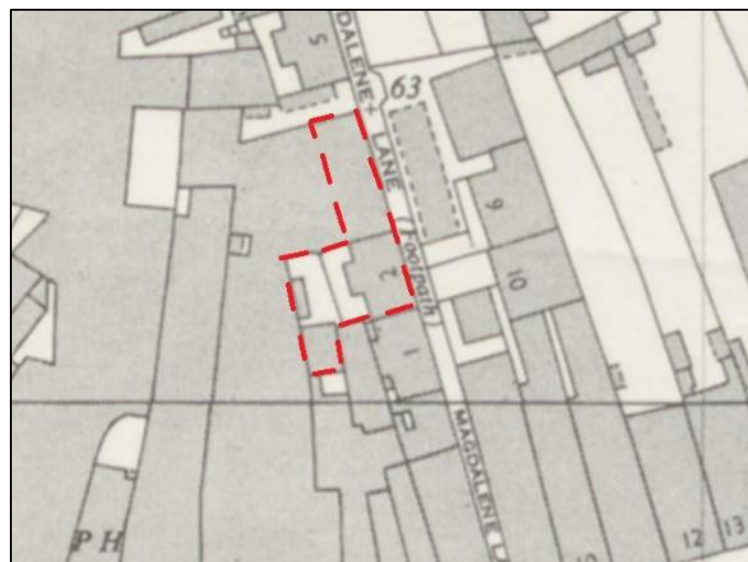
**Plate 10: OS Map, c. 1960 (Know Your Place, 2018)**

3.2.19 The next available map dates to c. 1960 (Plate 10). This demonstrates that several of the almshouses at the northern end of the row had been demolished since 1932 and replaced with a new linear building on the same footprint (extant Fine Fabrics shop). The existing extension from the 1932 redevelopment is shown and the rear yard appears to be divided between several properties and to contain several outbuildings. The gap on the eastern side of Magdalene Lane had been largely infilled with new buildings and the wider setting remained largely unchanged.

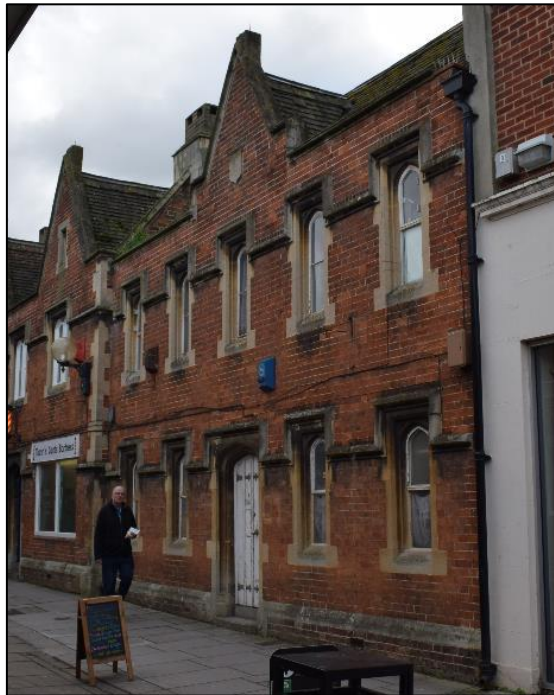
- 3.3.2 The ground floor windows flank a central entrance. The elevation has the original red brick parapet and moulded Bath Stone dressings including window detailing, a moulded shield on the gable and coping. The original Bath Stone chimneys survive but a moulded ornamental finial is missing from the apex of the gable. The pitched roof appears to be original, with glazed ridge tiles (Photo 1).

- 3.3.3 The front eastern elevation has the original wrought iron framed casement windows although the original leaded diamond glass has been replaced in all of them. The original battened folding double entrance doors also survive (Photo 1).

**Photo 1: The east elevation from the north-east, taken from Magdalene Lane**

- 4.1.2 Therefore, the current proposal to replace them with large rectangular windows is perceived to have a Direct High Adverse magnitude of impact upon the importance of the building. This is because this alteration is considered to make a considerable change to a large part of the key surviving heritage baseline elements of the building, which would likely result in a dramatic visual alteration to the eastern elevation and appreciation of the building overall.

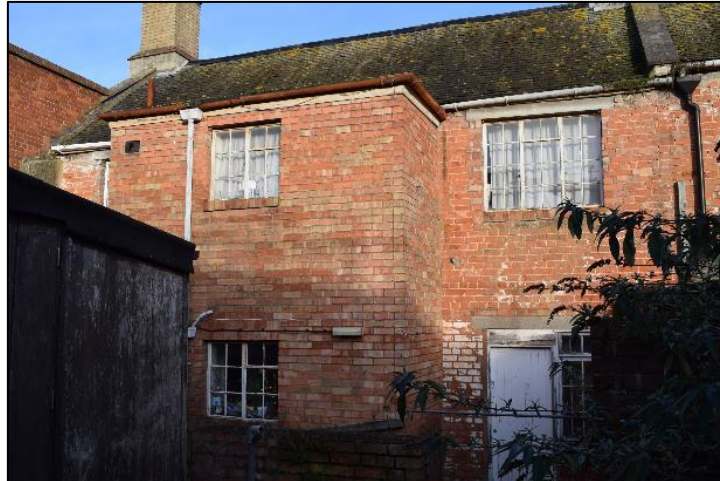
- 3.3.4 The rear, west facing elevation has been substantially altered from its original form (Photo 2), which would also have had windows with stone detailing. As a result of the alterations, no architectural features of historic interest are thought to survive on this elevation. A two-storey brick extension is present in the centre of the rear elevation, with square steel framed windows. Further windows of the same construction have been inserted into the positions of the original ground and first-floor windows. Their enlargement is evident from the alterations to the brickwork around the windows. A door has also been inserted into the southern ground floor aperture.

**Photo 2: The rear (west facing) elevation from the rear yard**

- 4.1.10 The 1930s replacement windows are considered to be poor quality and unsympathetic alterations and are thought to be of no historic value as architectural features. The proposed designs indicate that the position of the former windows would be distinguishable, maintaining a reference to the historical position of the original windows.

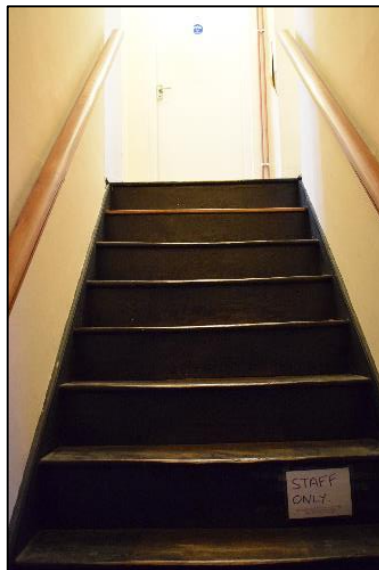
- 3.3.5 On the interior, the original layout, room hierarchy and circulation of the building has been substantially altered, due to the removal of original partitions to open up the spaces (See Figure 3). The only elements of the original circulation to remain are the ground floor access to the building from the main front entrance and into the two front principal rooms from the entrance lobby. The original rear entrance survives on the north side of the building as an existing aperture. The original stairs to the first-floor remain in place, with most of the original timber treads and risers (Photo 3).

**Photo 3: The original stairs from the entrance lobby**

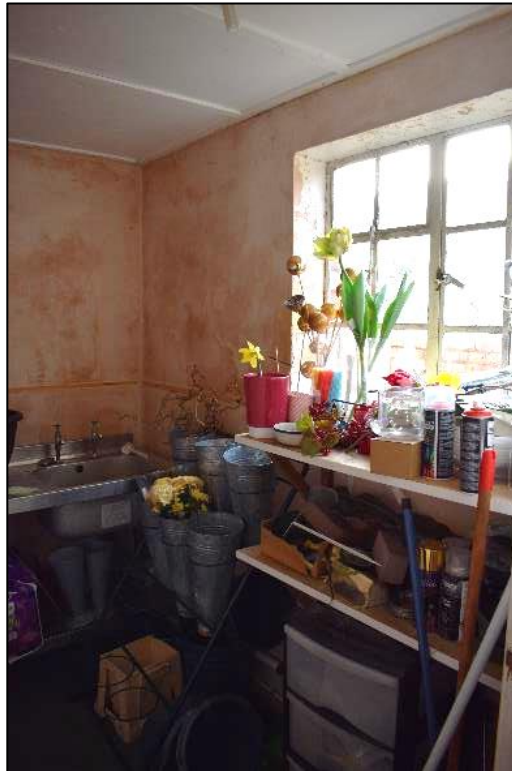
- 3.3.8 At first-floor level, the rooms have once again been opened out, removing the original layout, room hierarchy and most of the original circulation of this part of the building (See Figure 3). The original closets survive adjacent to the eastern elevation, although they have been knocked into one. Secondary aluminium glazing has been inserted over some of the first-floor windows.
- 3.3.9 The 1930s rear extension is completely devoid of architectural features of historic interest at both ground and first-floor level (Photo 4).

**Photo 4: Ground floor of the rear extension**

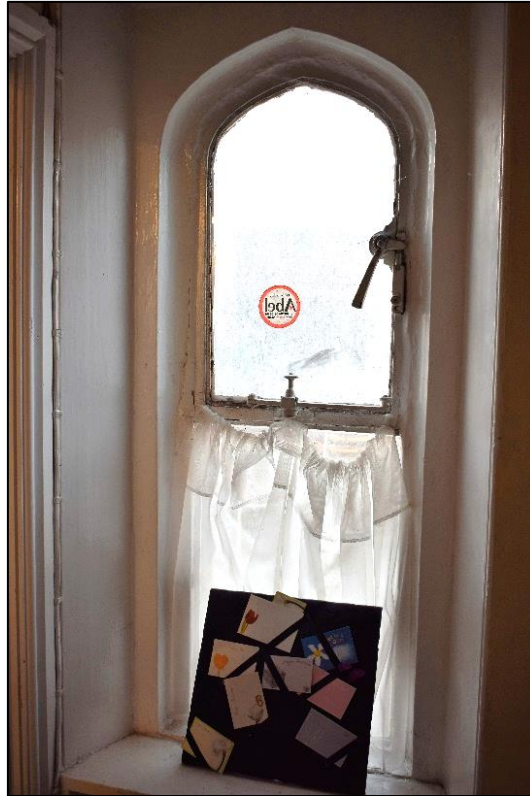
- 3.3.10 Apart from the stairs and original front doors (Photo 6), few historical architectural features survive on the interior of the building. A small amount of original door architrave survives in the ground floor entrance lobby and hallway and most of the original window furniture survives on the front elevation windows (Photo 5).

Photo 5: Original window furniture on the ground floor

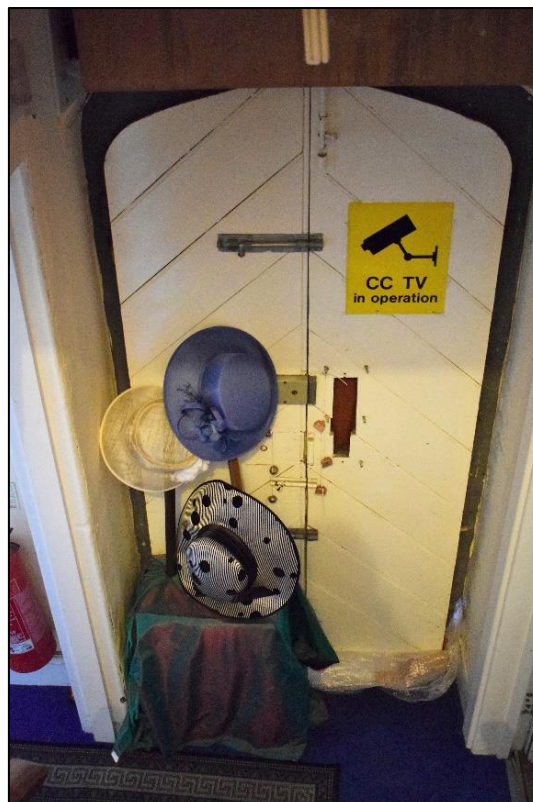
Photo 6: Interior of the original front doors

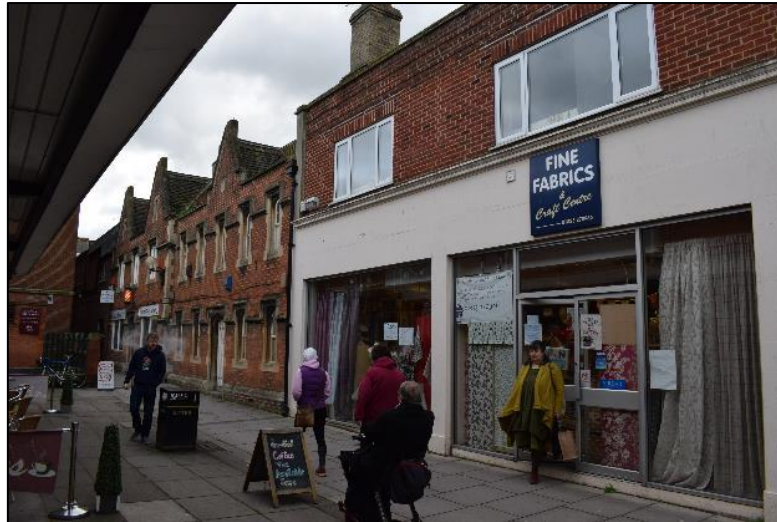
**Photo 7: The site from the north-east, taken from Magdalene Lane**

- 3.4.1 Magdalene Lane is a pedestrianised footpath which leads from the main thoroughfare of East Street in the south to the quieter open region of Church Square, dominated by the Church of St Mary Magdalene and its open churchyard, in the north. The site occupies part of a row of buildings on the west side of the Lane, with the mid-late 20<sup>th</sup> century brick Fine Fabrics shop to the north and the only other surviving element of the former almshouses, No. 1 Magdalene Lane, adjoins the site to the south (Photo 7).

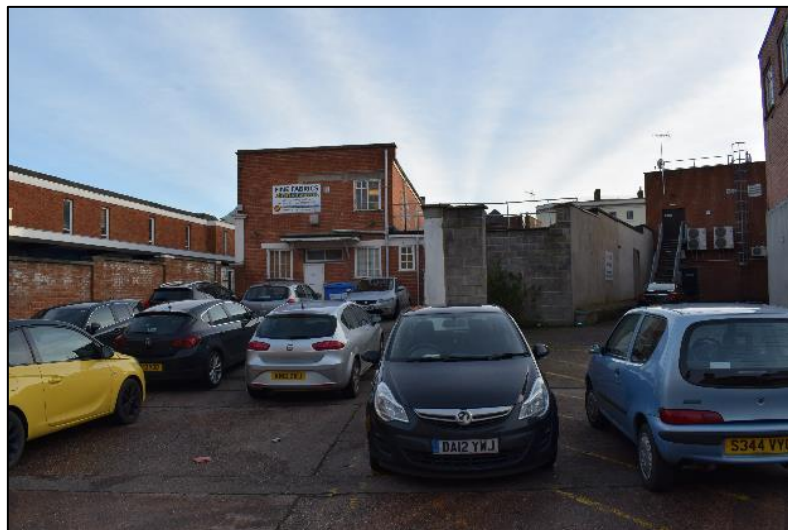
**Photo 8: The service yard to the north of Fine Fabrics**

- 3.4.2 A length of brick wall is located to the north of Fine Fabrics, adjacent to the lane, which has an open service yard on the western side (Photo 8).

- 3.4.4 A small concrete yard is located at the rear of the property. This is bounded by a high concrete block wall to the west and north (Photo 8) and a brick wall forms the southern boundary between the site and the rear of the adjacent properties. The yard contains several small elements of brick walling and a large part has been built up into a terrace on the west side. This terrace is dominated by a large timber shed.

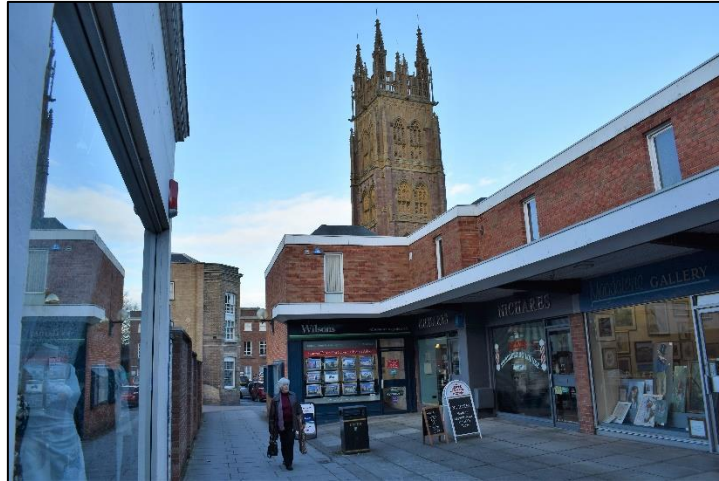
**Photo 9: View of the east side of Magdalene Lane from the south, with the tower of the Church of St Mary Magdalene in the background**

- 3.4.3 The eastern side of Magdalene Lane, opposite the site, is densely lined with modern two storey buildings with large shop windows at ground floor level (Photo 9).

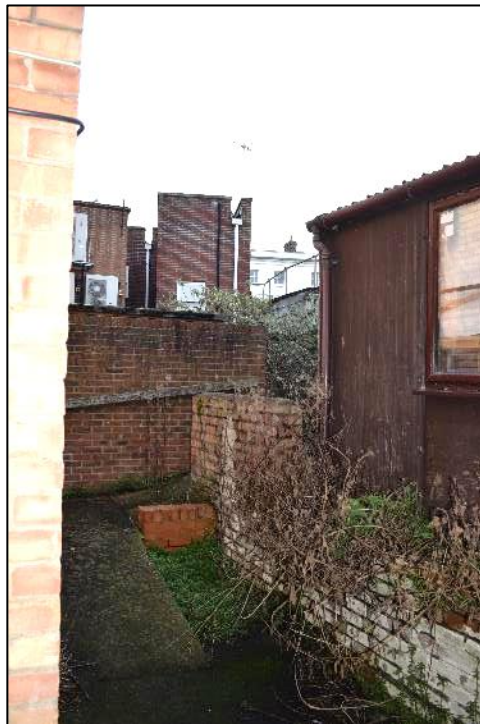
**Photo 10: View of part of the rear yard, looking south**

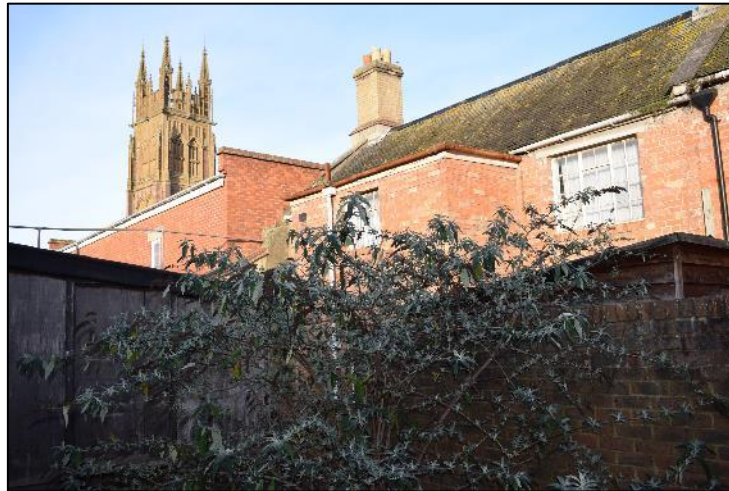
**Photo 11: View of the tower of the Church of St Mary Magdalene, from the rear yard of the site**

- 3.4.5 There are restricted views into and out of the rear yard, largely due to the height of the boundary walls and dense nature of the surrounding buildings to the south (Photo 10). Only the very top of the roofline of the rear extension is visible beyond the high boundary walls from certain positions within the service yard to the north. There are some limited views of the

top section of the tower of the Church of St Mary Magdalene from the rear yard of the property (Photo 11).

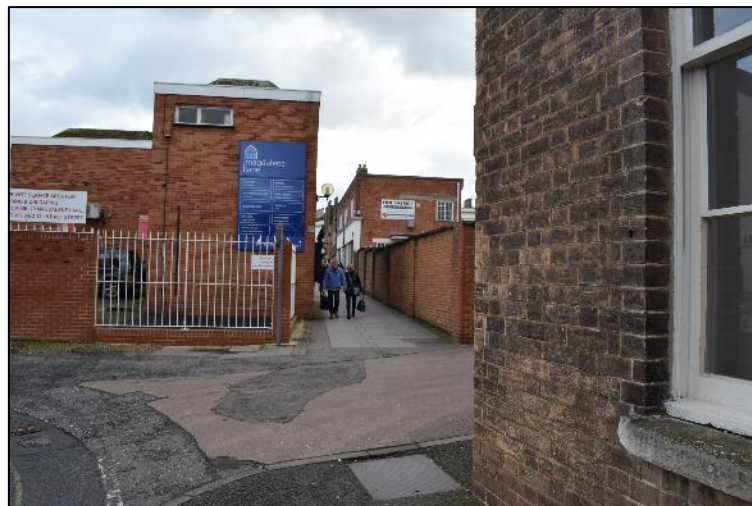
**Photo 12: View from the northern entrance of Magdalene Lane towards the site**

3.4.6 The narrow character of Magdalene Lane means that views of the eastern elevation of the former almshouse are only possible from the entrance to Magdalene Lane from the north (Photo 12), resulting in no intervisibility with Church Square at ground level. The views from the north are dominated by the modern buildings that make up the majority of Magdalene Lane (Photo 12).

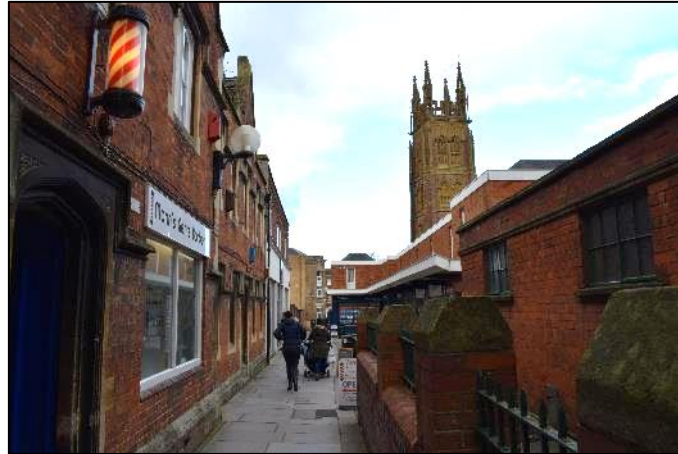
**Photo 13: View along Magdalene Lane from the south, the site is on the left**

3.4.7 Likewise, from the south, once again the narrow character of the lane and the set-back position of the site, means that there is no intervisibility from ground level between East Street and the site. The east elevation of the building is the only element visible and only once the lane opens out, directly adjacent to the site (Photo 13).

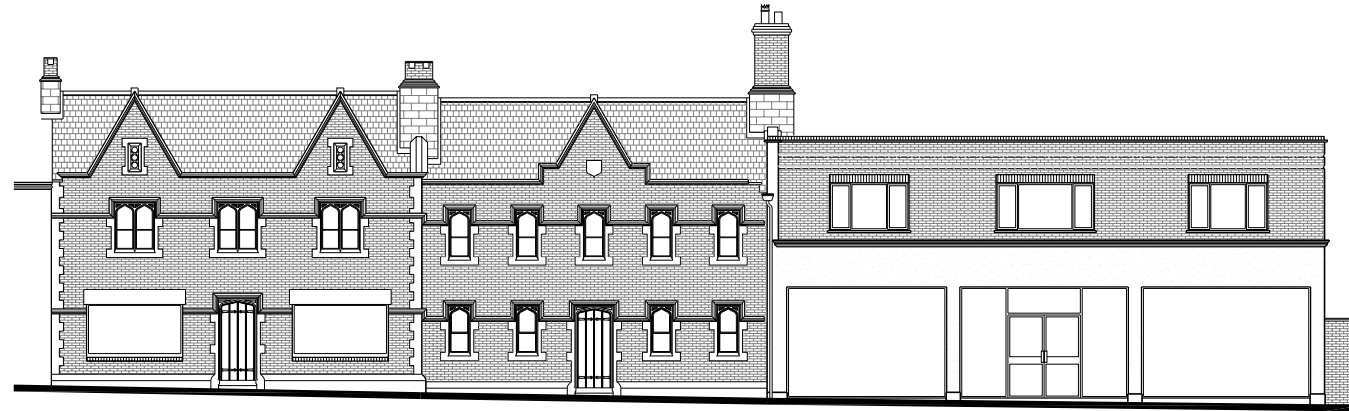
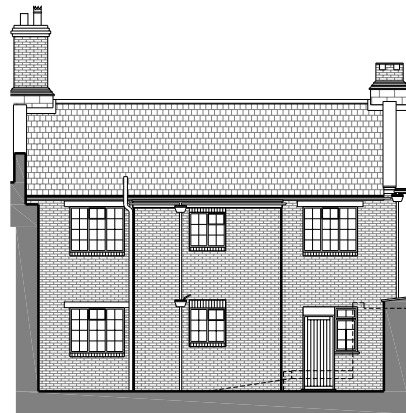
EASTERN ELEVATION (MAGDALENELANE)

WESTERN ELEVATION (COURTYARD)

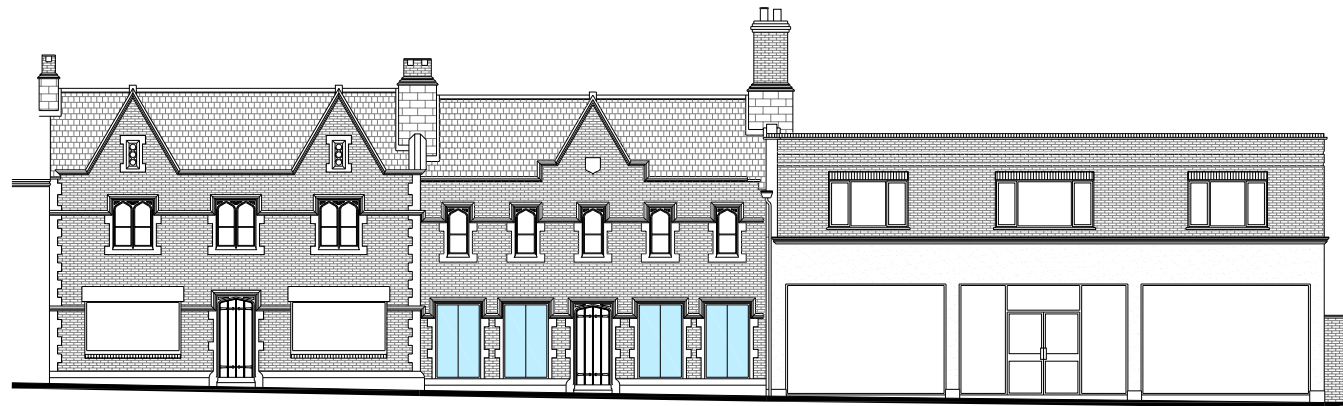
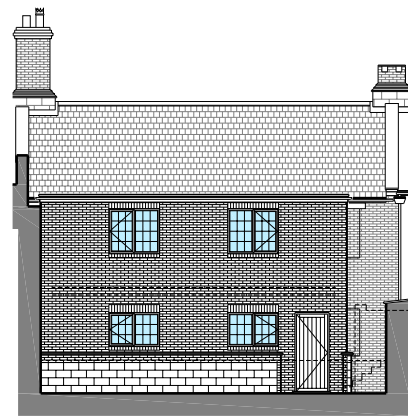
Figure 7: Proposed Elevations -  
Scheme B

EASTERN ELEVATION (MAGDALENE LANE)

WESTERN ELEVATION (COURTYARD)

#### *Proposed removal of the ground floor windows of the former almshouse – Scheme B (Fig 7)*
