RESEARCH REPORT SERIES no. 35-2013

FAIRFIELD HOUSE, STOGURSEY, SOMERSET

TREE-RING ANALYSIS OF TIMBERS

SCIENTIFIC DATING REPORT

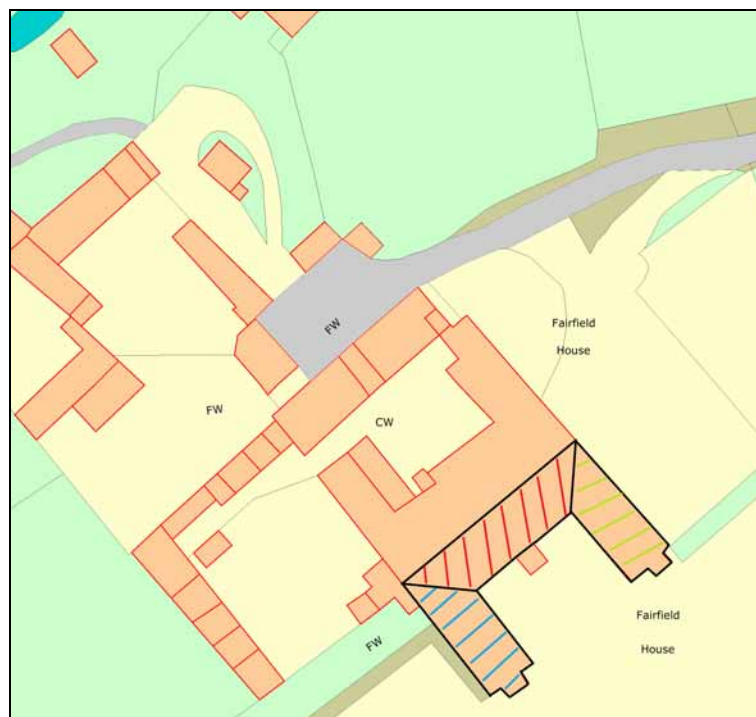
Figure 3: Fairfield House, showing the areas under investigation; East range (hashed green), West range (hashed blue), and Connecting range (hashed red, based on the Ordnance Survey map with permission of the Controller of Her Majesty's Stationery Office, ©Crown Copyright and database right 2013. All rights reserved. Ordnance Survey Licence number 100024900.)

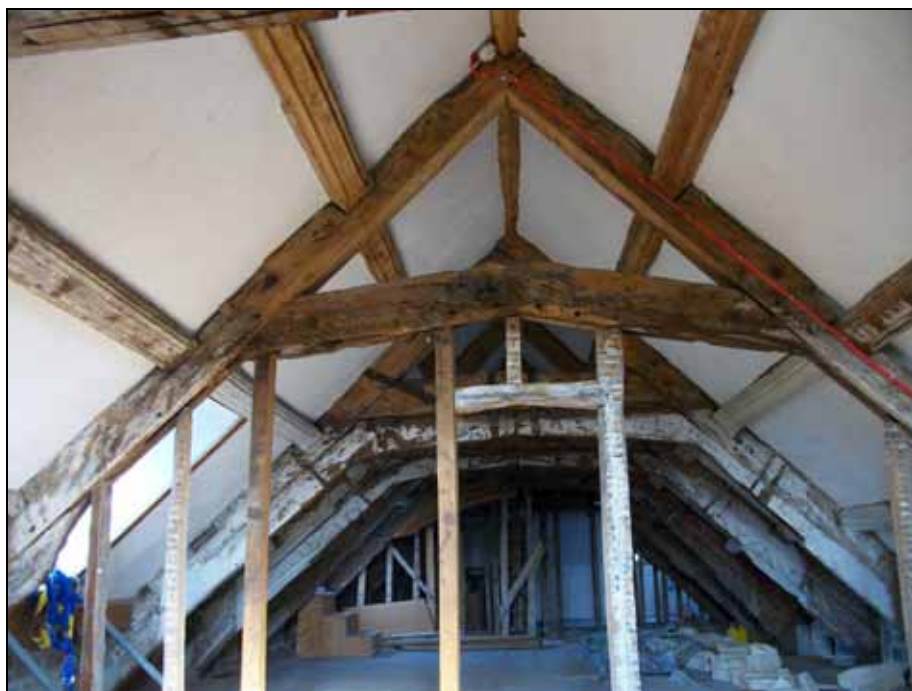
Figure 4: West range roof; truss 3 in the foreground, photograph taken from the south-east (Robert Howard)

The roof over this range consists of seven trusses of principal rafters, collars, and the remains of carved and decorated arch-braces. Some windbraces survive and there is a ridge and three sets of moulded purlins to each slope (Fig 4). This range is believed to be the oldest surviving part of the building, with the roof thought to date to the late-fifteenth century. The southern hipped end is a later modification, undertaken some time after the early eighteenth century as paintings of the house from this period still show the original gable end.

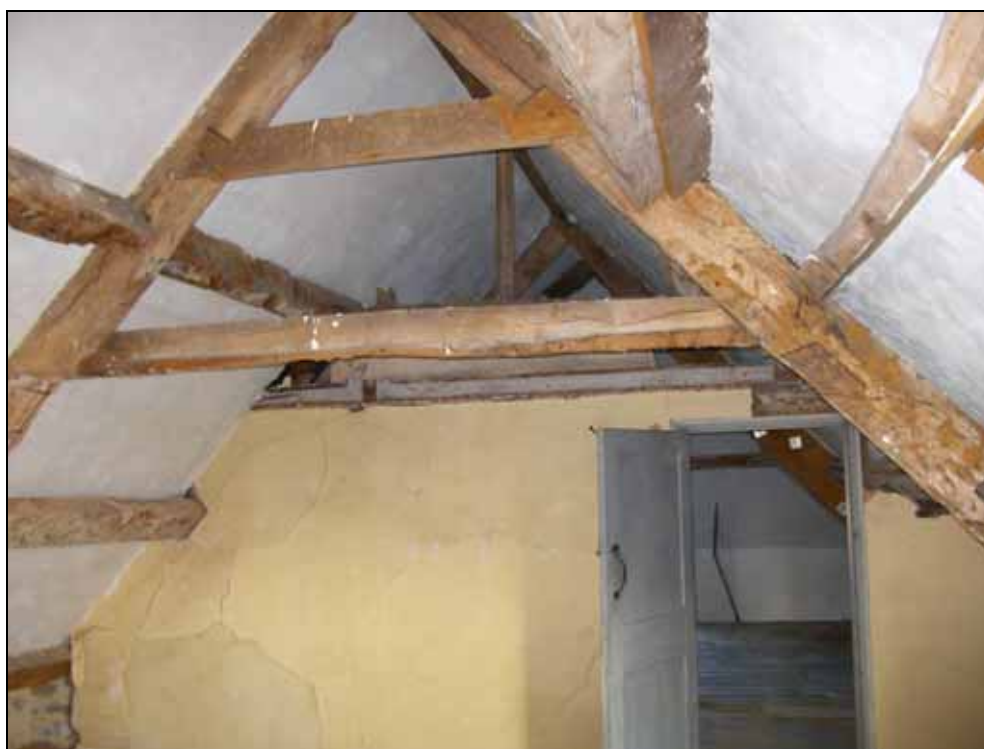
Figure 5: East range roof; truss 19 in the foreground, photograph taken from the south-east (Robert Howard)

The roof over this range is of six trusses consisting of principal rafters and two collars, with ridge and three sets of purlins to each slope (Fig 5). It is thought to date to the sixteenth century. A later modification was made to a hip at the southern end of this roof.

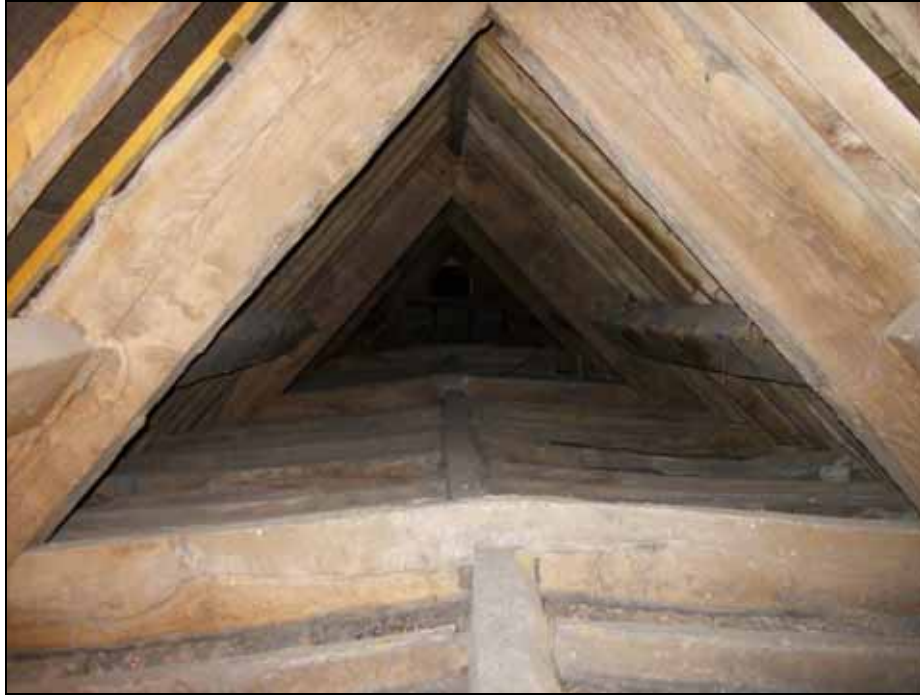
Figure 6: Connecting range roof; truss 15 in the foreground, photograph taken from the north-east (Robert Howard)

The roof of this range has nine trusses of principal rafters and single collar, with ridge and three sets of purlins to each slope (Fig 6). It is possible that this roof might be of two phases which is suggested by a division within the lower walls. The date of this range is however, uncertain.

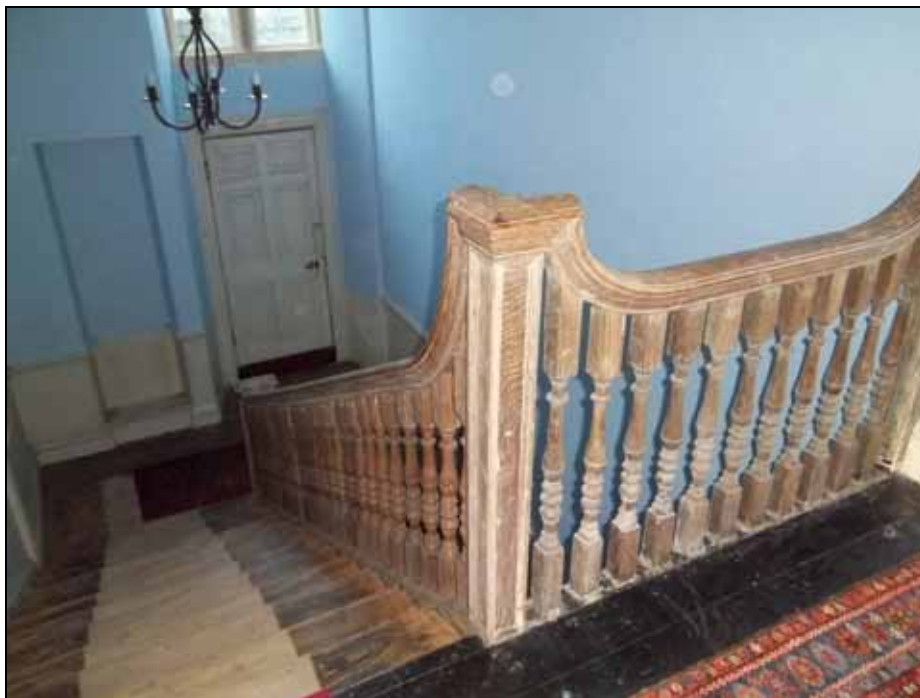
Figure 7: Connecting range; staircase, photograph taken from the first floor (Robert Howard)

The dog-leg with half-landing staircase within this connecting range rises from ground floor to attic level. It has turned balusters, square section newel posts with framed and

planted detailing and ramped handrail rising to merge with the newel caps (Fig 7). It is thought to date to remodelling work carried out in the eighteenth century.

A total of 57 timbers was sampled by coring and additionally, two newel caps of the staircase (Fig 7) in the Connecting range were measured *in situ* using a graticule. Each sample was given the code FRF-D (for Fairfield) and numbered 01–59. Nineteen of these were from the East range roof (FRF-D01–19), 18 from the West range roof (FRF-D20–37), 20 from the Connecting range roof (FRF-D38–57), and the two sets of *in situ* measurements from the staircase newel posts (FRF-D58–9). The location of samples was noted at the time of sampling and where possible, is shown on Figures 8–29. Further details relating to the samples can be found in Table 1.

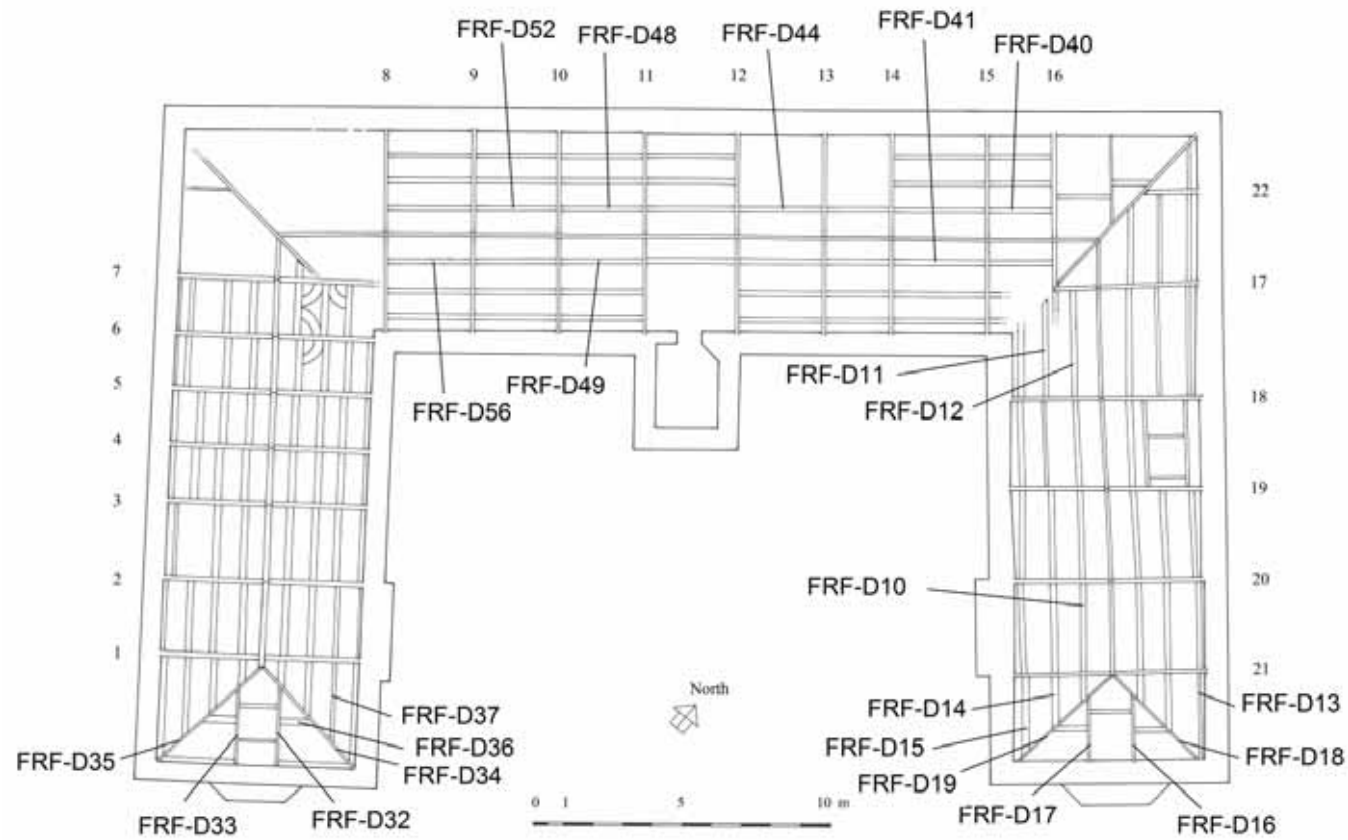
Figure 8: Attic plan, showing truss numbering and the location of samples FRF-D10–19, FRF-D32–7, FRF-D40–41, FRF-D44, FRF-D48–9, FRF-D52, and FRF-D56 (after Alan Graham)

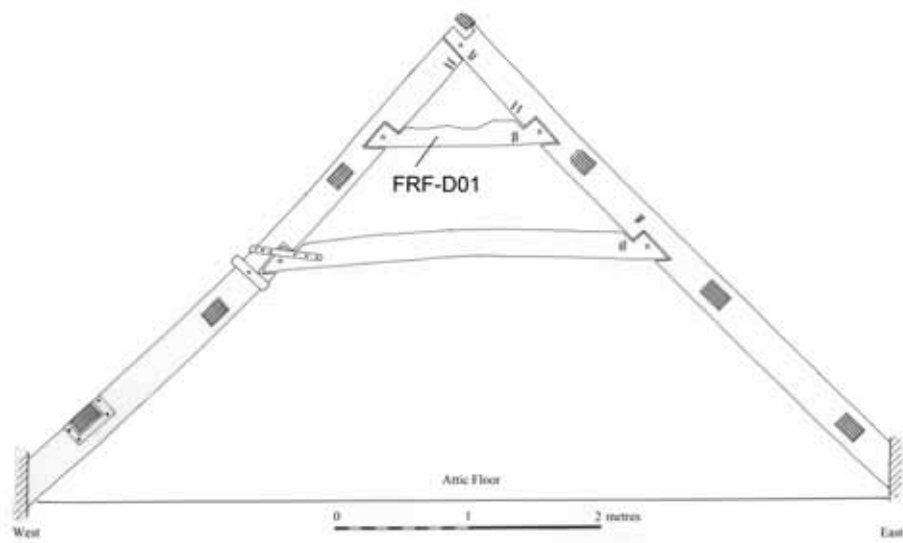
Figure 9: East range; truss 21, showing the location of sample FRF-D01 (Alan Graham)

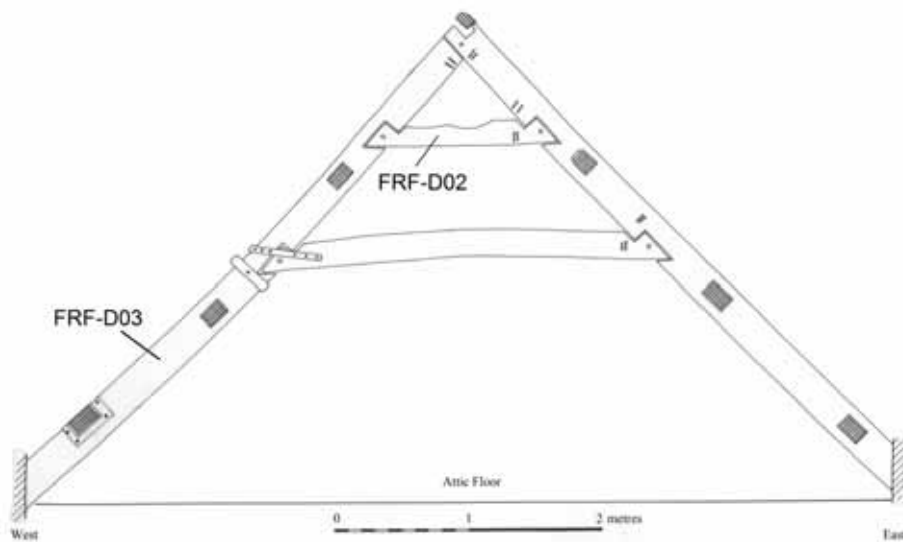
Figure 10: East range; truss 20, showing the location of samples FRF-D02 and FRF-D03 (Alan Graham)

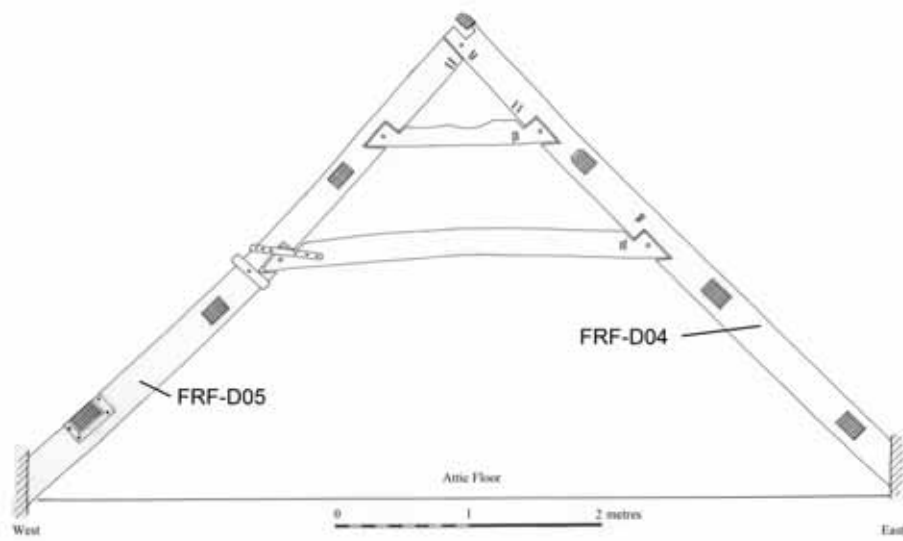
Figure 11: East Range; truss 19, showing the location of samples FRF-D04 and FRF-D05 (Alan Graham)

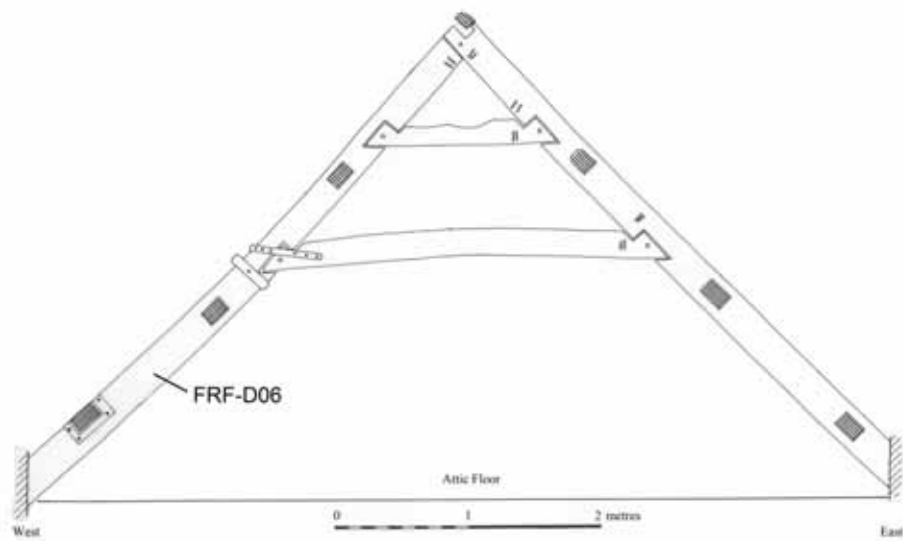
Figure 12: East range; truss 18, showing the location of sample FRF-D06 (Alan Graham)

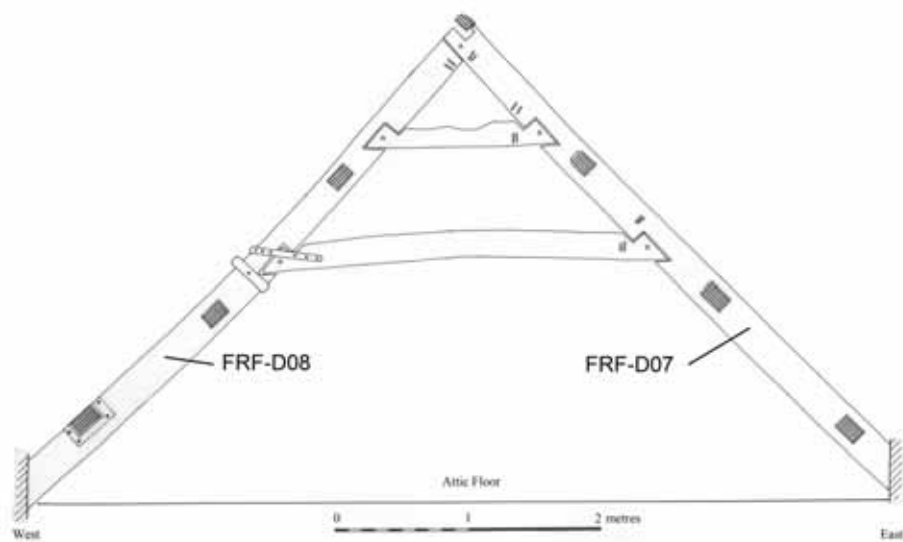
Figure 13: East range; truss 17, showing the location of samples FRF-D07 and FRF-D08 (Alan Graham)

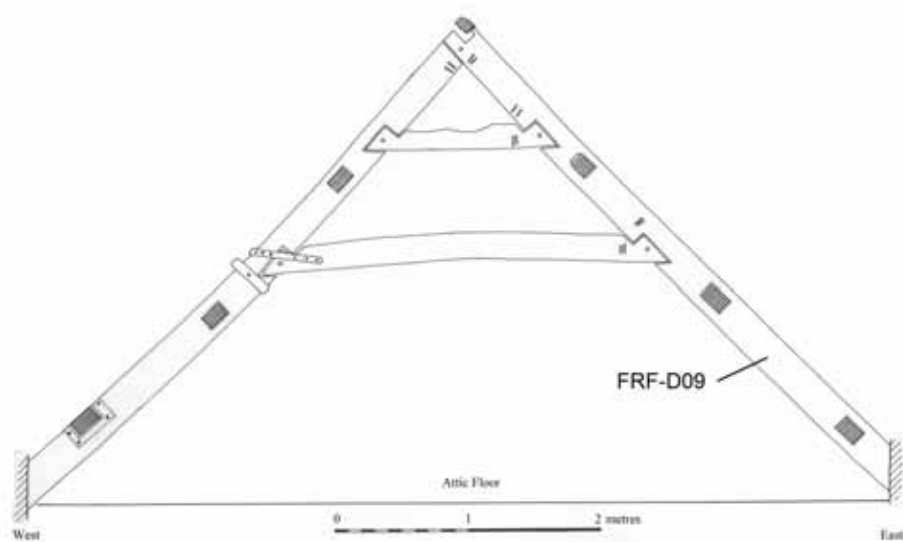
Figure 14: East range; truss 22, showing the location of sample FRF-D09 (Alan Graham)

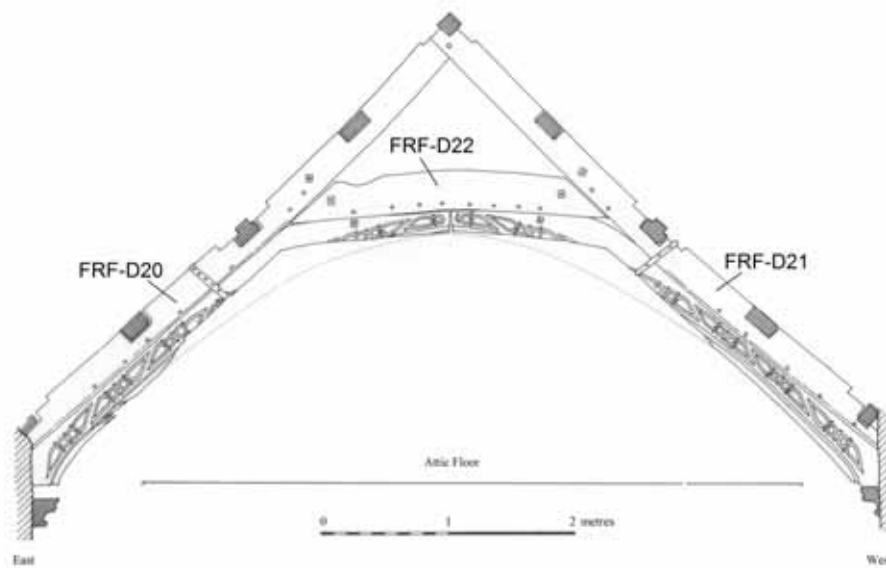
Figure 15: West range; truss 1, showing the location of samples FRF-D20-2 (Alan Graham)

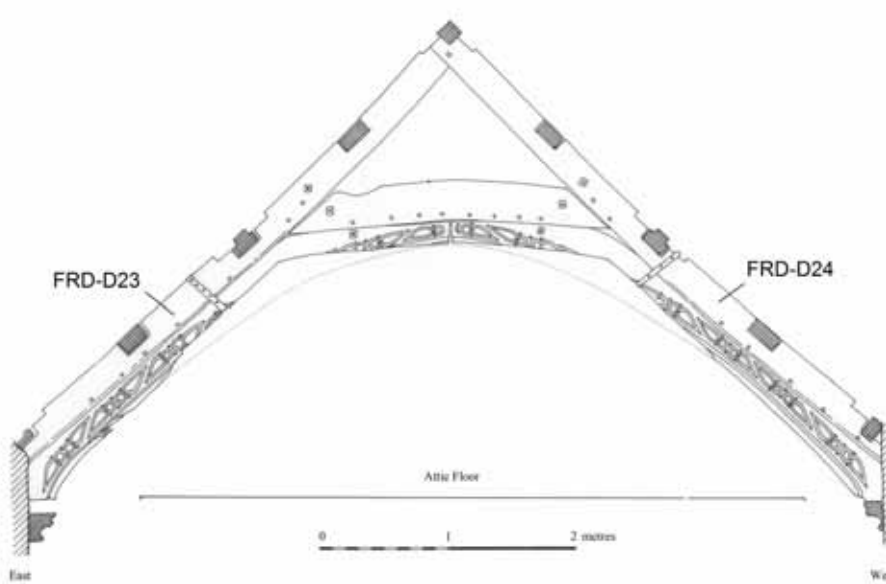
Figure 16: West range; truss 2, showing the location of samples FRF-D23-4 (Alan Graham)

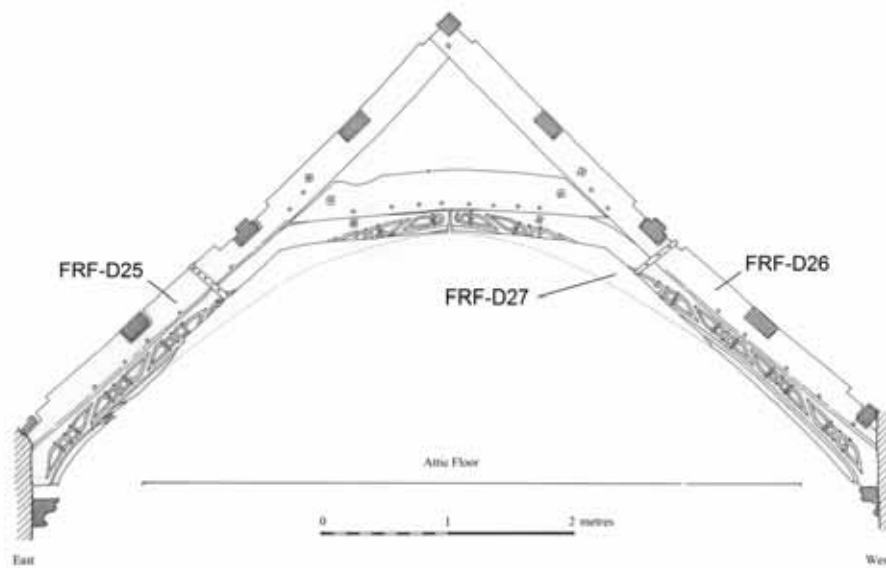
Figure 17: West range; truss 3, showing the location of samples FRF-D25-7 (Alan Graham)

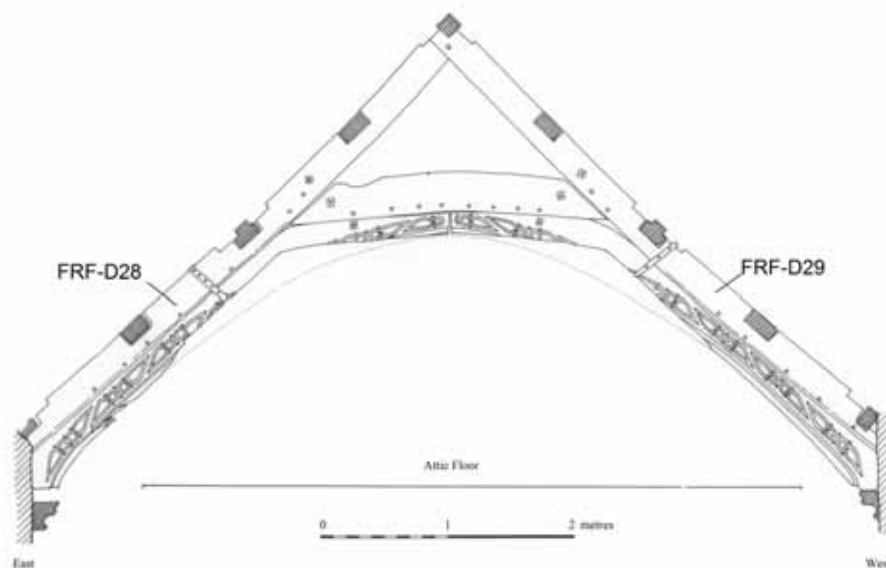
Figure 18: West range; truss 4, showing the location of samples FRF-D28 and FRF-D29 (Alan Graham)

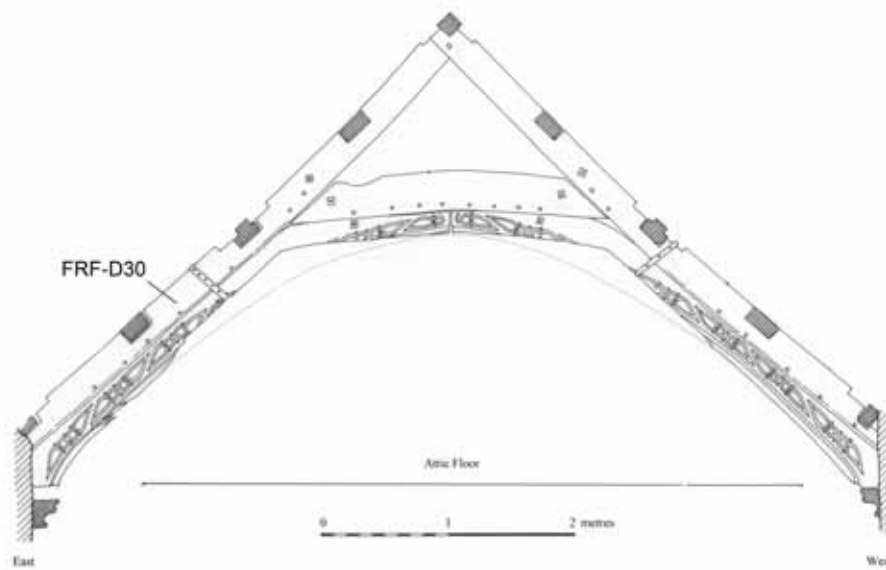
Figure 19: West range; truss 5, showing the location of sample FRF-D30 (Alan Graham)

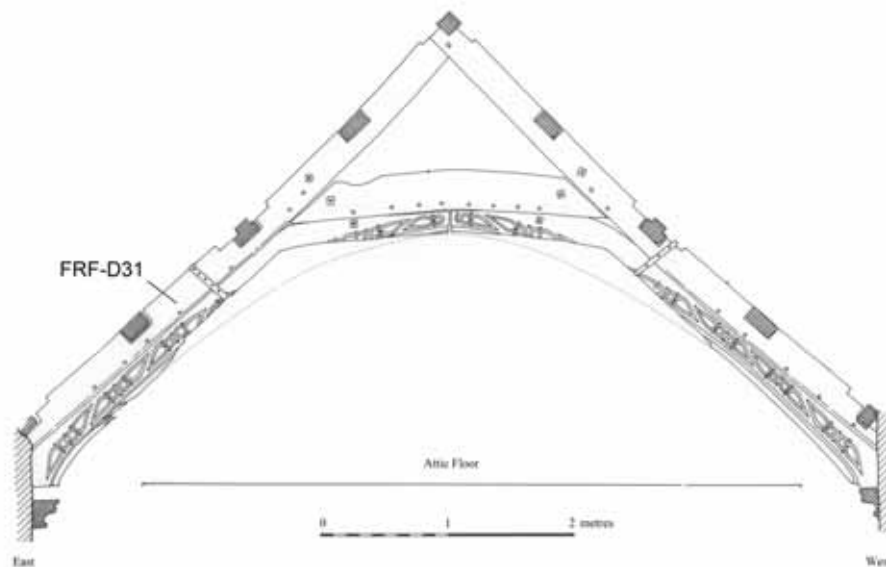
Figure 20: West range; truss 6, showing the location of sample FRF-D31 (Alan Graham)

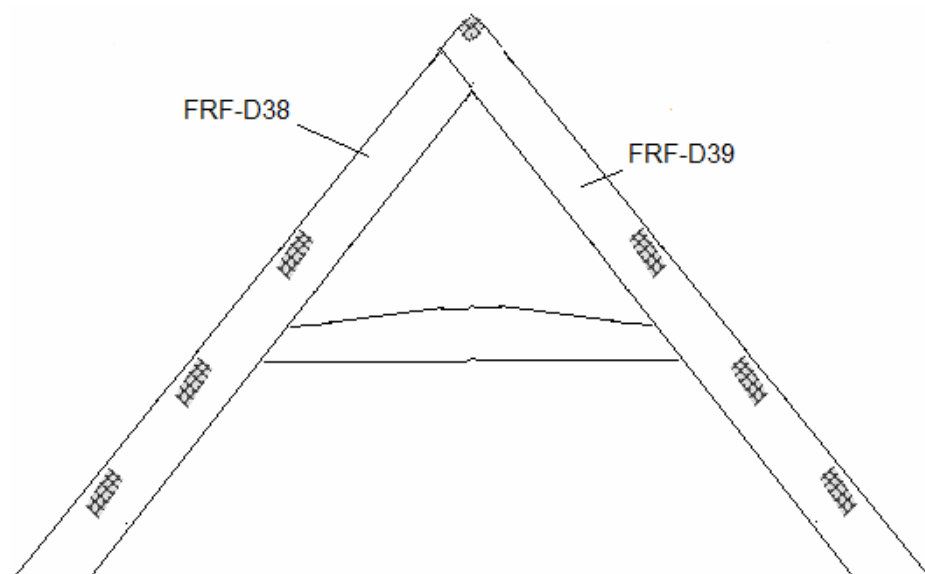
Figure 21: Connecting range; sketch of truss 16, showing the location of samples FRF-D38 and FRF-D39

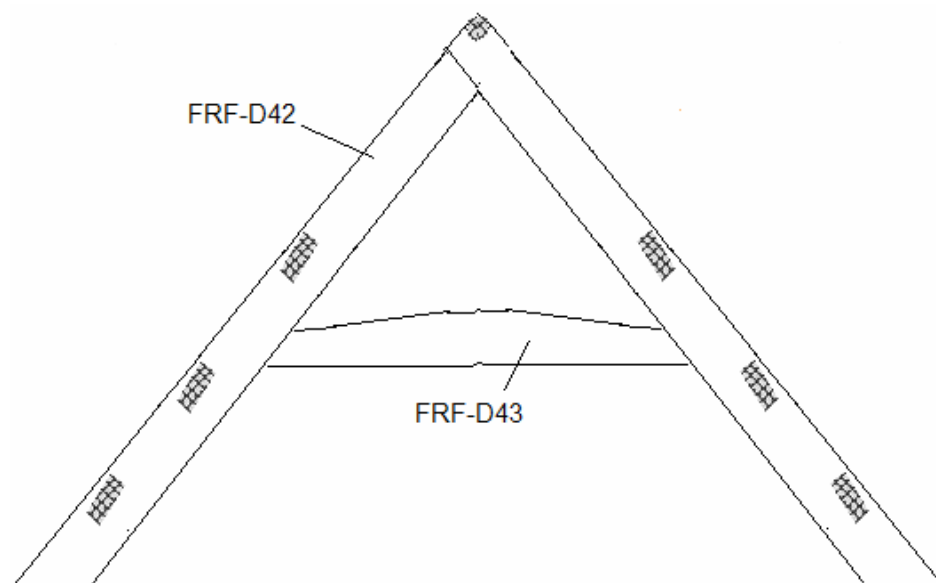
Figure 22: Connecting range; sketch of truss 13, showing the location of samples FRF-D42 and FRF-D43

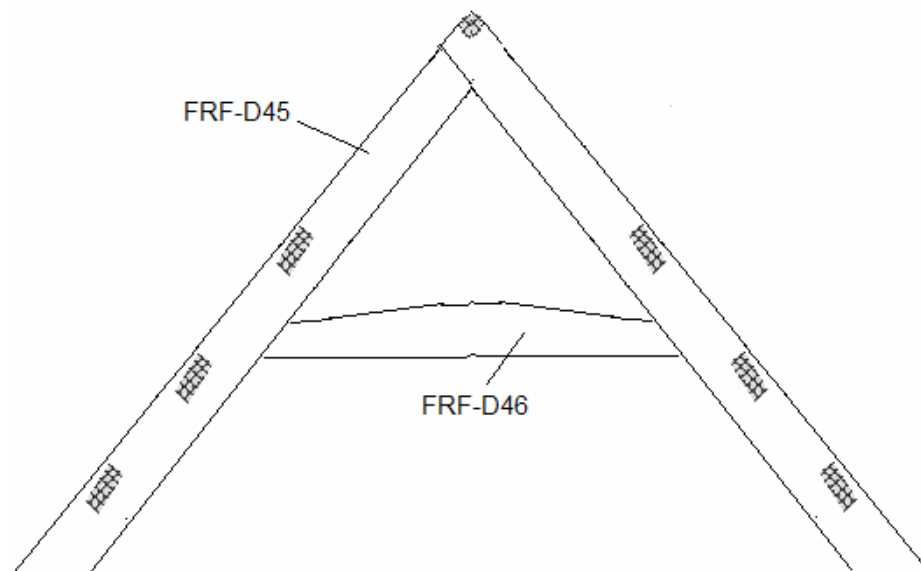
Figure 23: Connecting range; sketch of truss 12, showing the location of samples FRF-D45 and FRF-D46

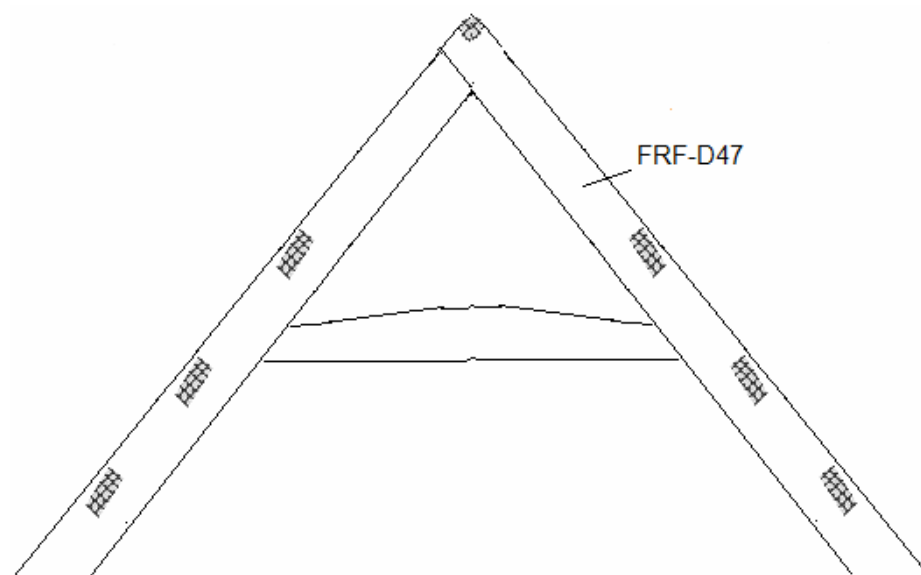
Figure 24: Connecting range; sketch of truss 11, showing the location of sample FRF-D47

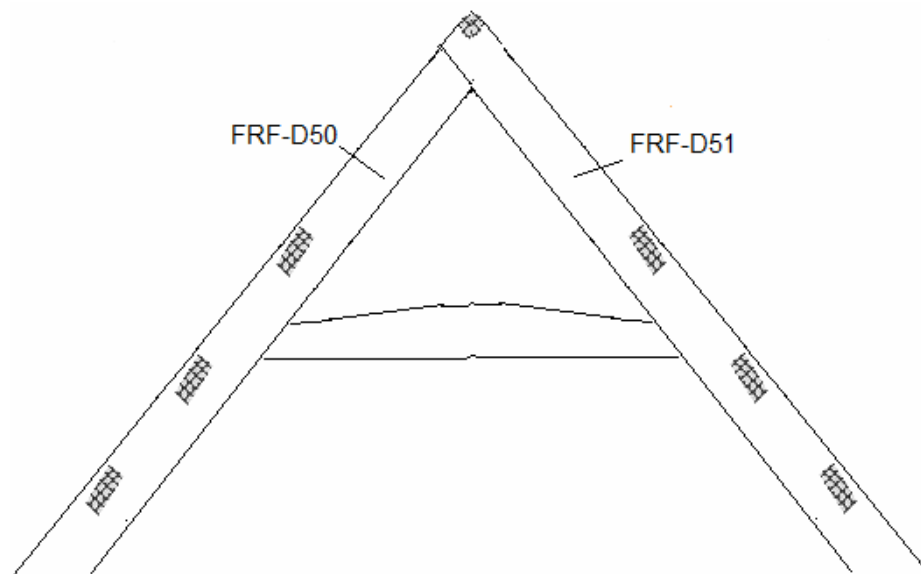
Figure 25: Connecting range; sketch of truss 10, showing the location of samples FRF-D50 and FRF-D51

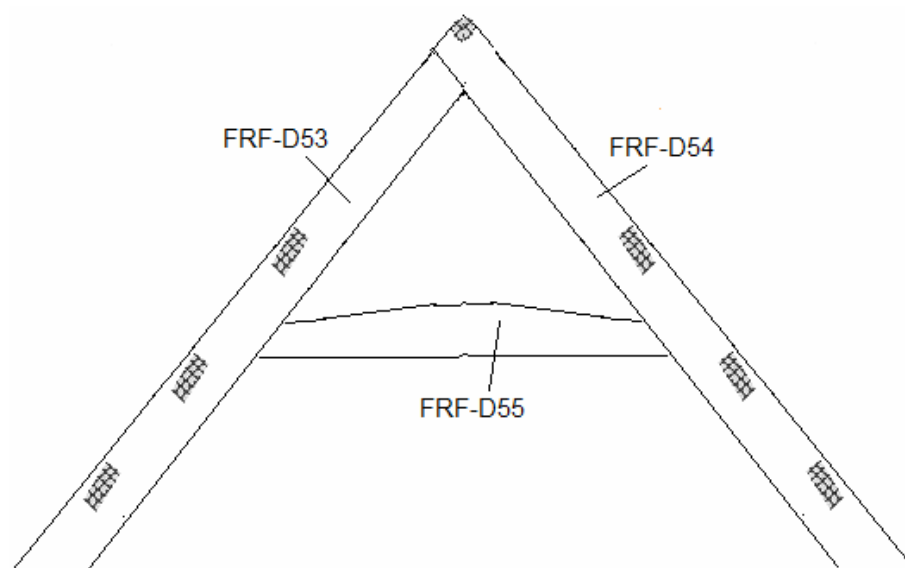
Figure 26: Connecting range; sketch of truss 9, showing the location of samples FRF-D53-5

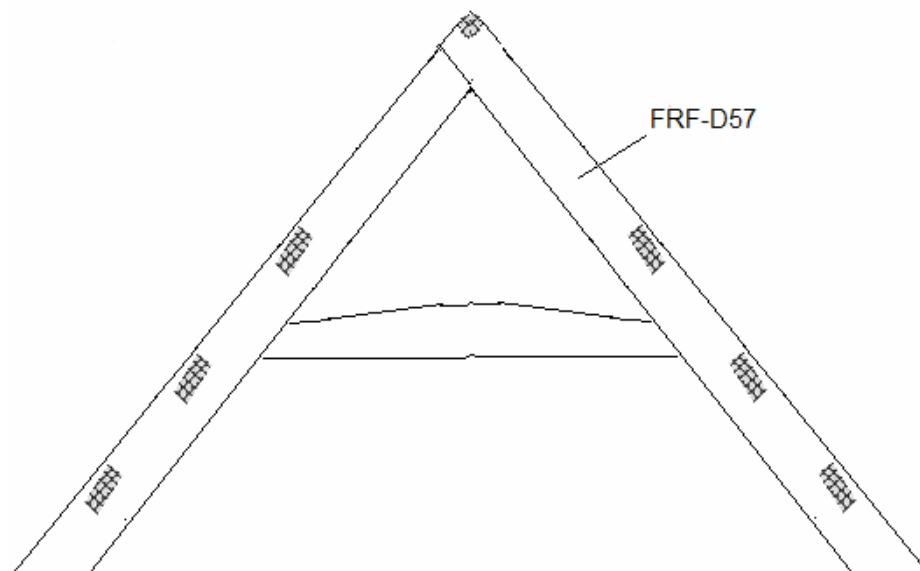
Figure 27: Connecting range; sketch of truss 8, showing the location of sample FRF-D57

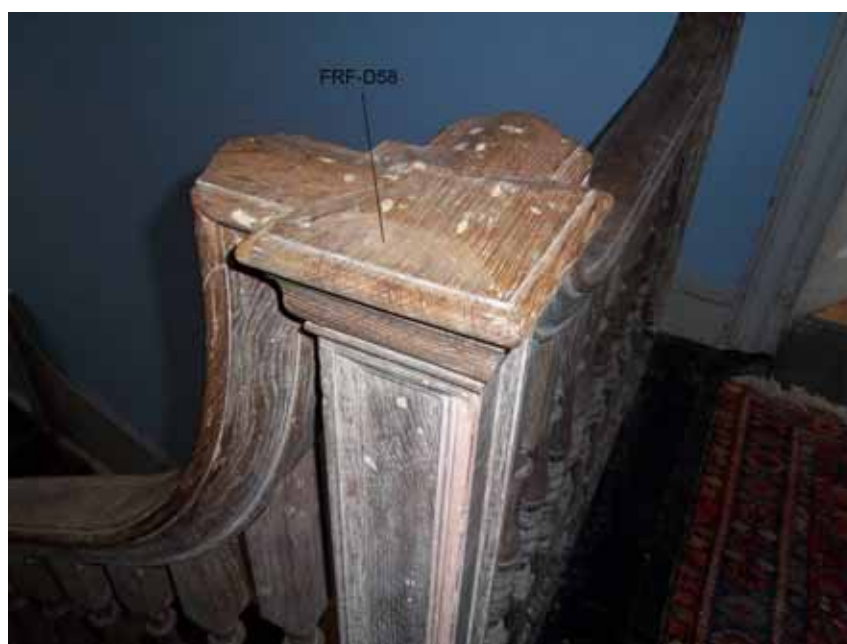
Figure 28: Photograph of first-floor newel post cap, showing the location of sample FRF-D58 in the Connecting range (RobertHoward)

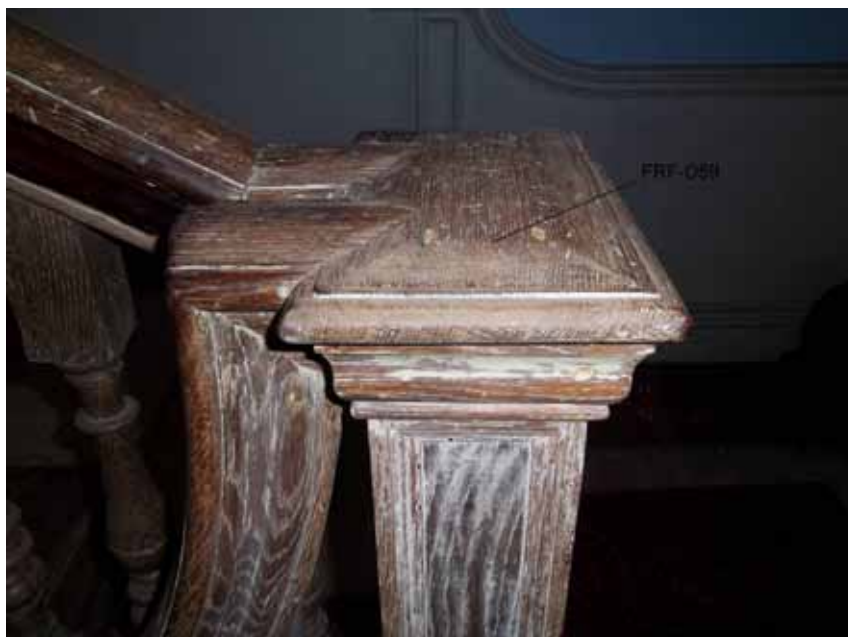
Figure 29: Photograph of the mid-landing newel post cap, showing the location of sample FRF-D59 in the Connecting range (Robert Howard)

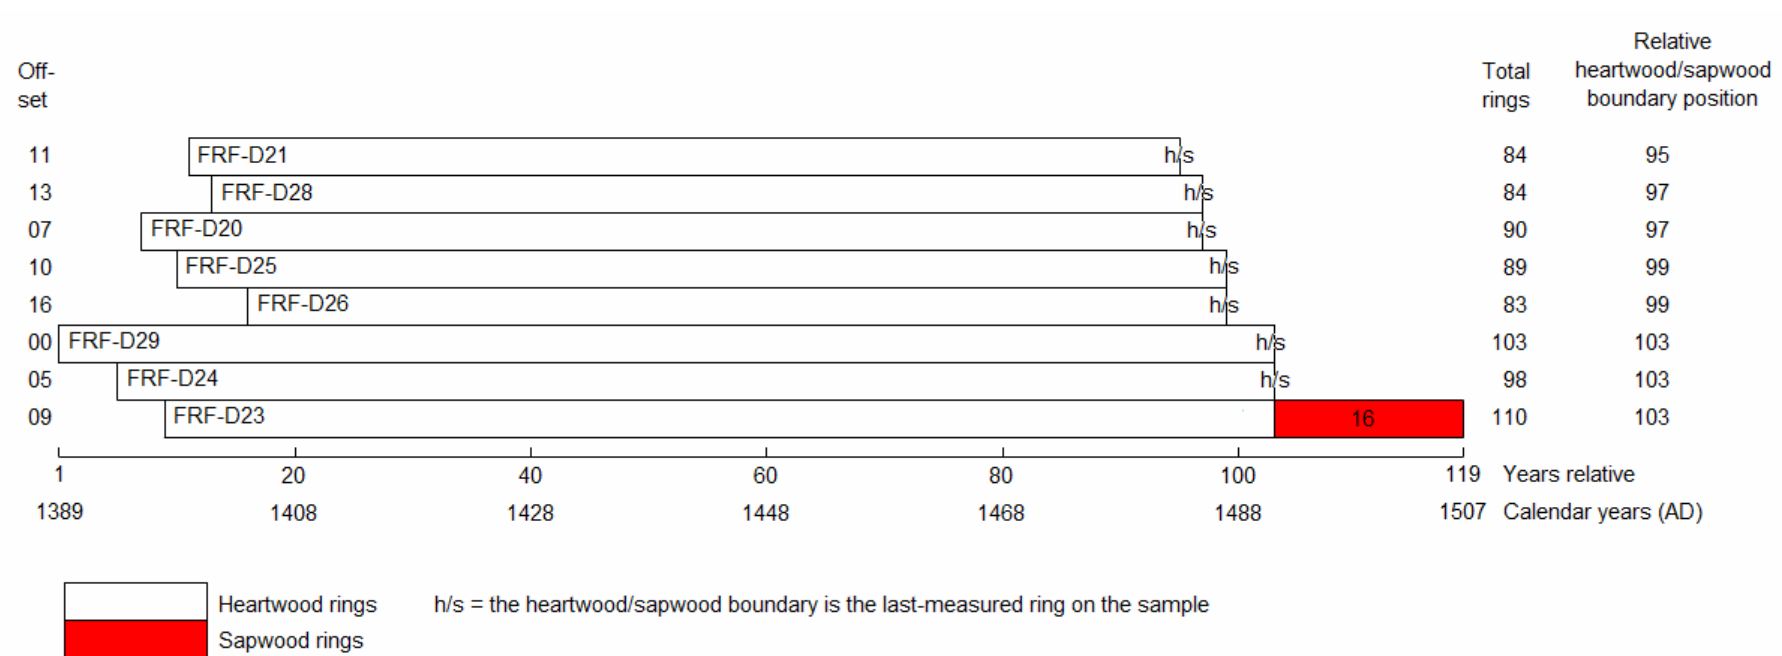
Figure 30: Bar diagram of samples in site sequence FRFDSQ01

Firstly, eight samples from the West range roof matched each other to form FRFDSQ01, a site sequence of 119 rings (Fig 30). This site sequence was compared against a series of relevant reference chronologies where it was found to match consistently and securely at a first-ring date of AD 1389 and a last-measured ring date of AD 1507. The evidence for this dating is given by the *t*-values in Table 2.

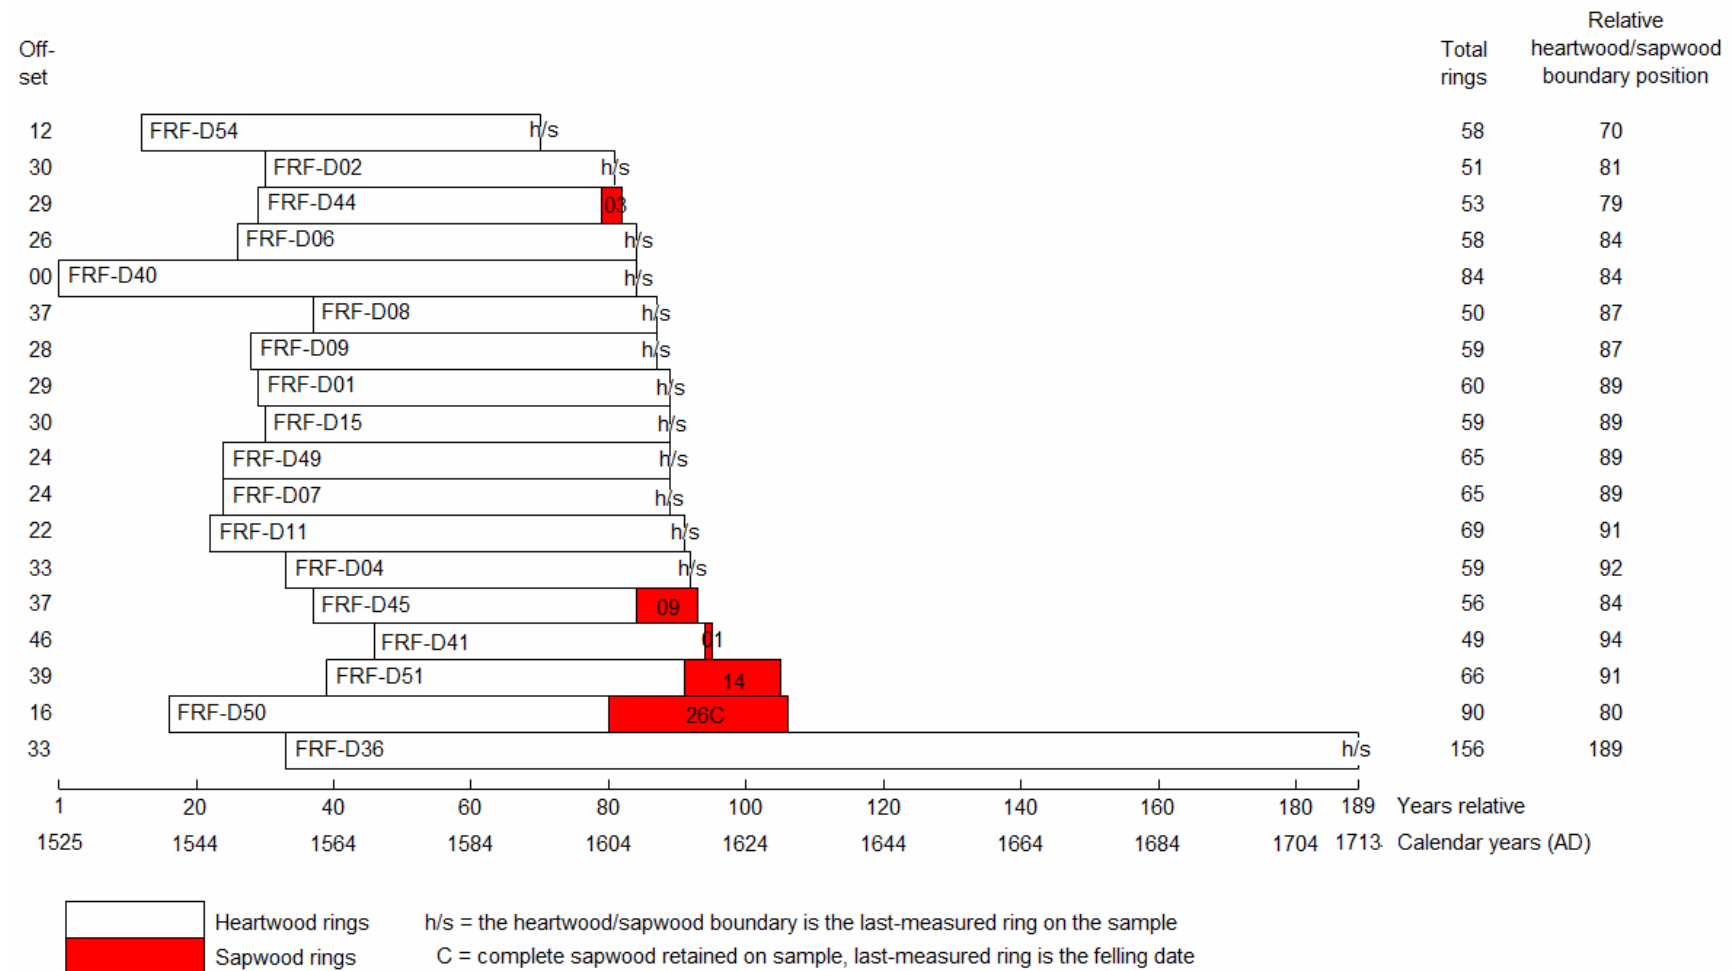
Figure 31: Bar diagram of samples in site sequence FRFDSQ02

Next, 18 samples (eight from the East range, eight from the Connecting range, and one each from the East and West range hips) grouped and were combined at the relevant offset position to form FRFDSQ02, a site sequence of 189 rings (Fig 31). This was found to span the period AD 1525–1713. The evidence for this dating is given by the *t*-values in Table 3.

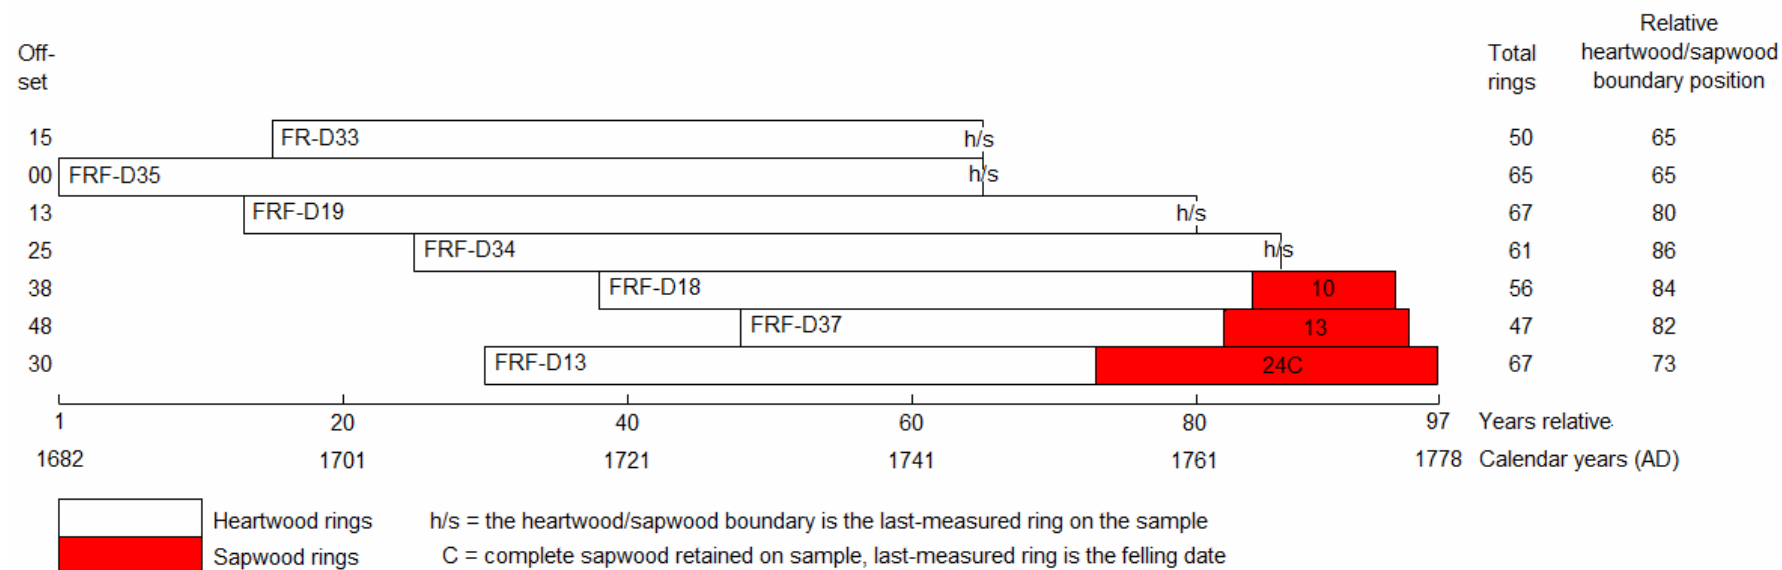
Figure 32: Bar diagram of samples in site sequence FRFDSQ03

Seven samples (three from the East and four from the West range hips) matched and were again combined at the relevant offset positions to form FRFDSQ03, a site sequence of 97 rings (Fig 32). This site sequence was found to match against the reference

chronologies at a first-ring date of AD 1682 and a last-measured ring date of AD 1778. The evidence for this dating is given by the *t*-values in Table 4.

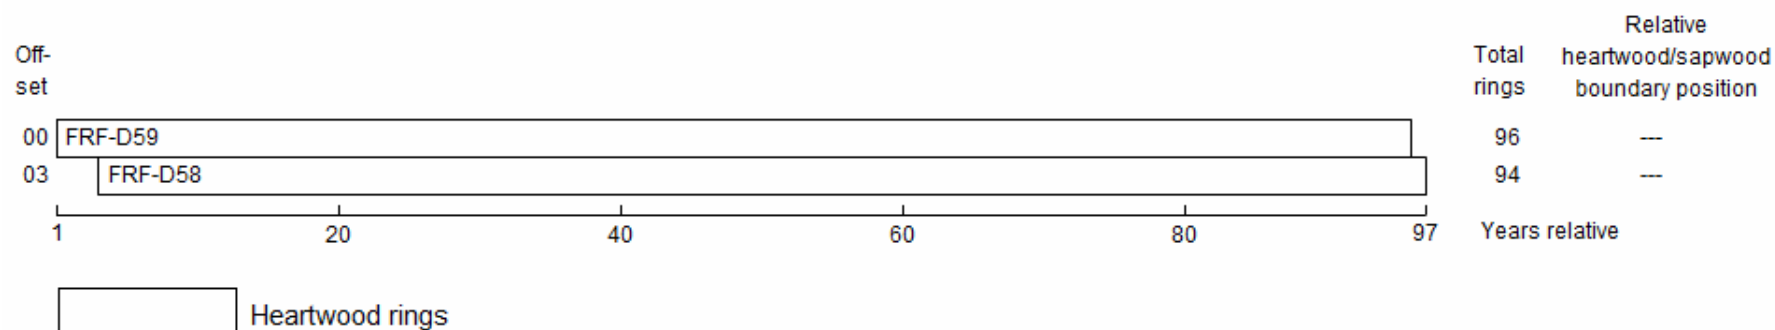
Figure 33: Bar diagram of samples in undated site sequence FRFDSQ04

A further five site sequences were constructed (Figs 33–37). These site sequences contained a maximum of four samples and ranged in length from 70 to 105 rings. They were compared against the reference chronologies but could not be securely matched and are undated. Attempts to date the remaining ungrouped samples were unsuccessful and these are also undated.

Documentary sources state new staircases were inserted in all ranges by Nathaniel Palmer or his son Thomas. Tentative dating identified for the site sequence (FRFDSQ04) containing the two newel post caps from the Connecting range staircase, which would broadly concur with this could not be verified, despite the efforts of various colleagues from England and elsewhere in Europe. Unfortunately, with the site sequence being undated it is still not possible to determine who actually undertook this work.

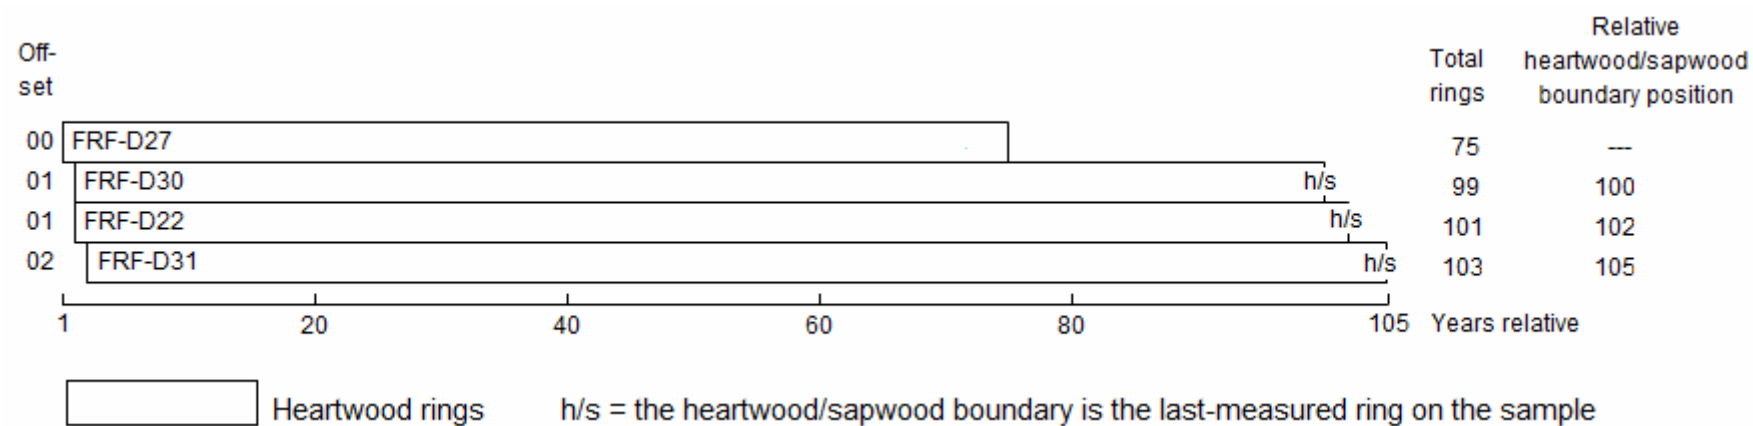
Figure 34: Bar diagram of samples in undated site sequence FRFDSQ05

The four matched but undated samples forming FRFDSQ05 are all from the West range and represent two principal rafters, a collar, and an arch brace from trusses 1, 3, 5 and 6. They are clearly coeval but their dating potential may be hampered by periodic occurrences of growth retardation events shown in their ring sequences.
