RESEARCH REPORT SERIES no. 35-2013

FAIRFIELD HOUSE, STOGURSEY, SOMERSET

TREE-RING ANALYSIS OF TIMBERS

SCIENTIFIC DATING REPORT

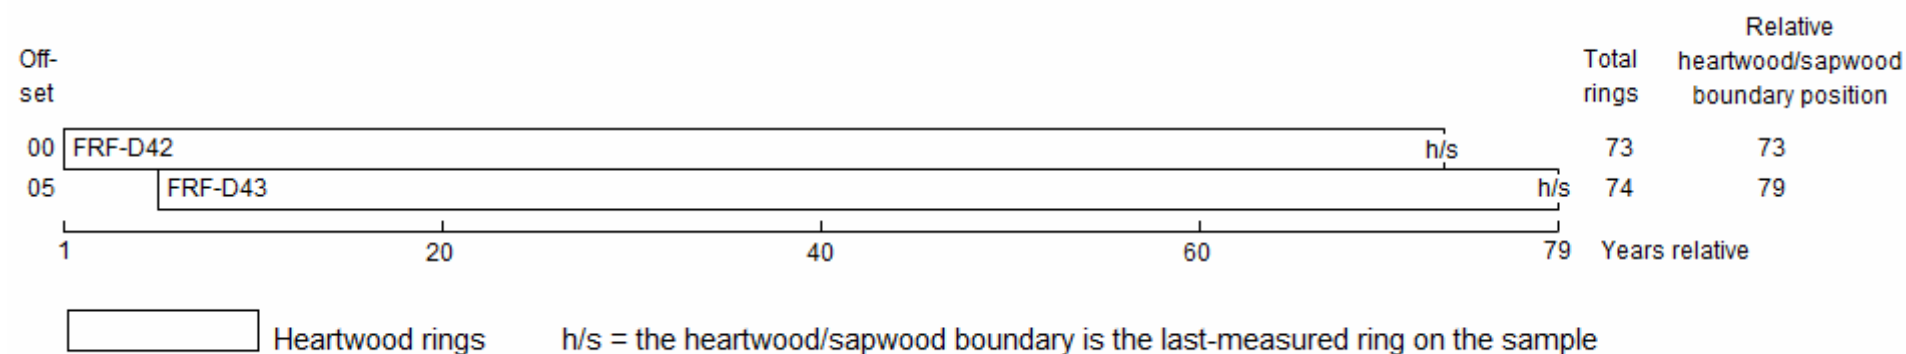
Figure 36: Bar diagram of samples in undated site sequence FRFDSQ07

A further five site sequences were constructed (Figs 33–37). These site sequences contained a maximum of four samples and ranged in length from 70 to 105 rings. They were compared against the reference chronologies but could not be securely matched and are undated. Attempts to date the remaining ungrouped samples were unsuccessful and these are also undated.

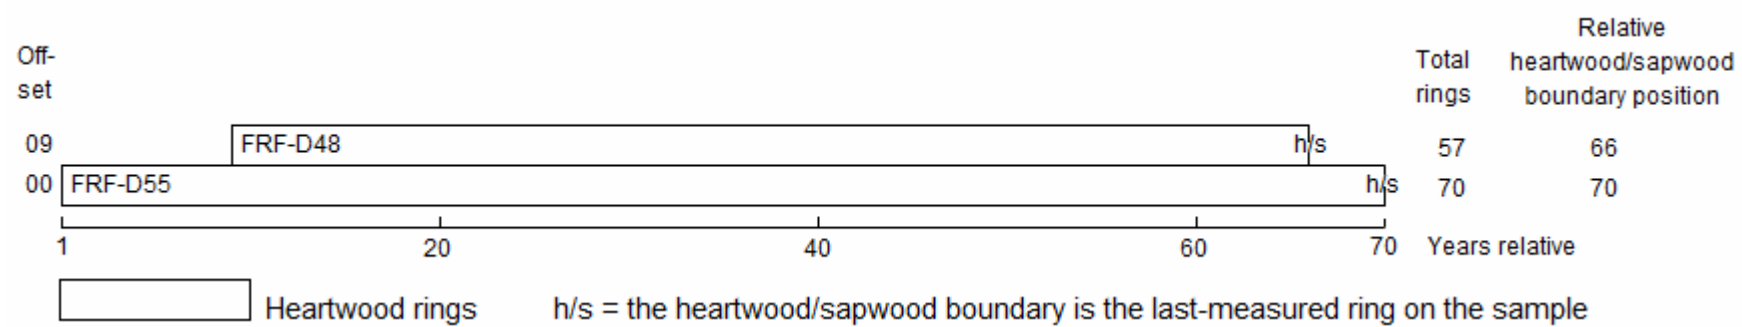
Figure 37: Bar diagram of samples in undated site sequence FRFDSQ08

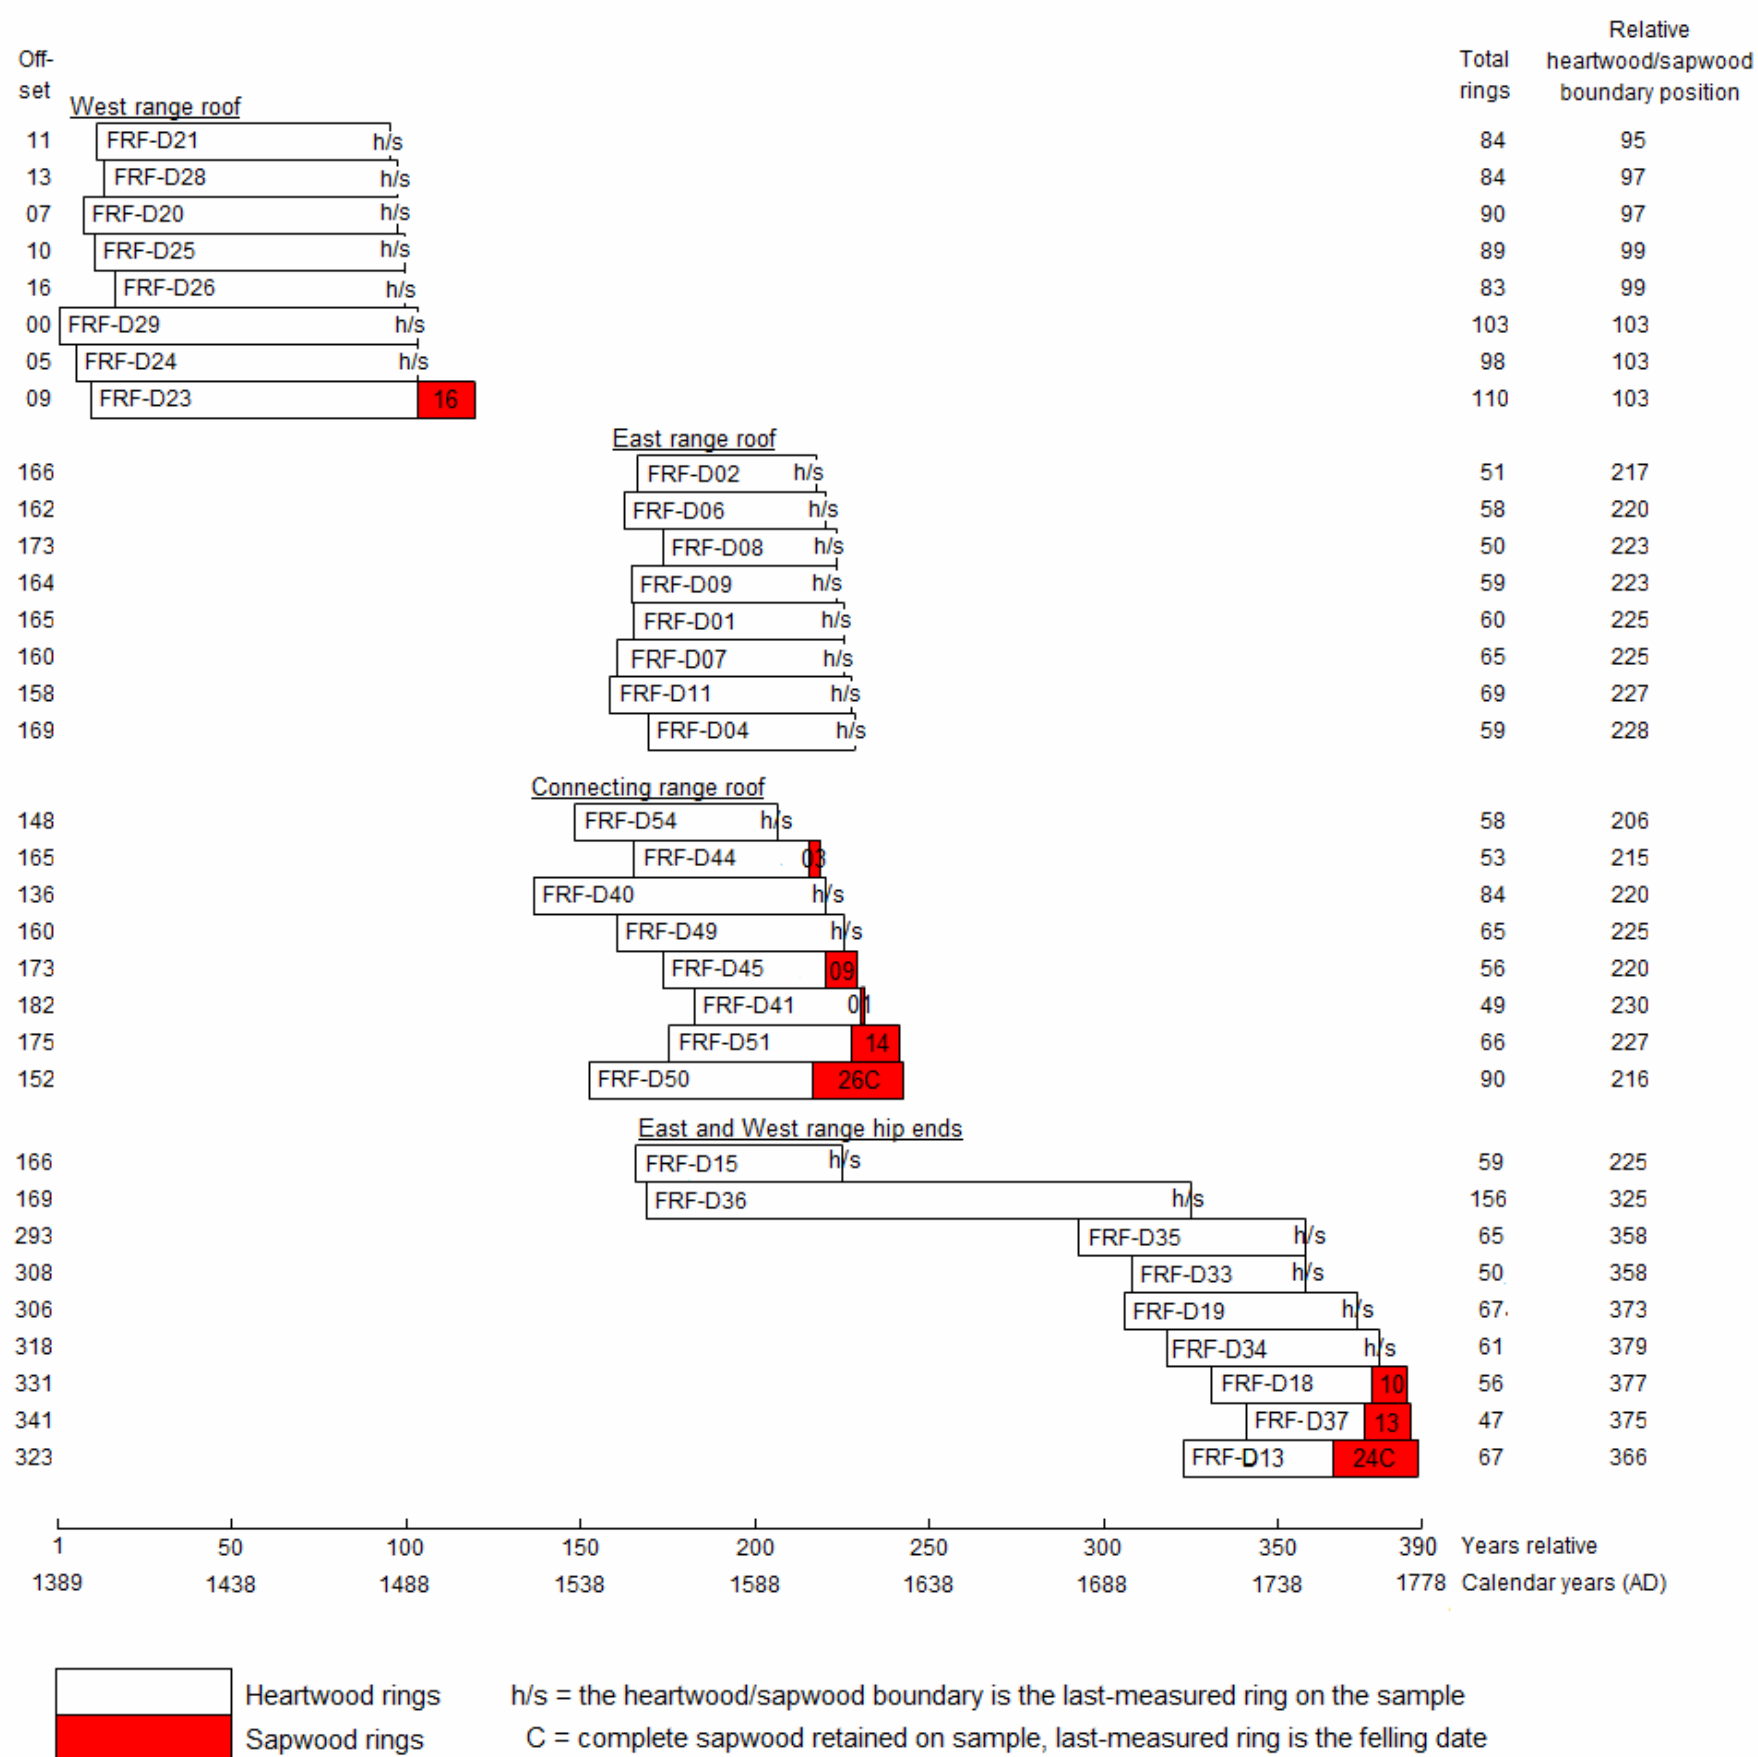
Figure 38: Bar diagram of dated samples, sorted by area

Tree-ring analysis has resulted in the successful dating of three site sequences which together contain 33 samples. To aid interpretation, samples from each area have been dealt with separately (Fig 38).

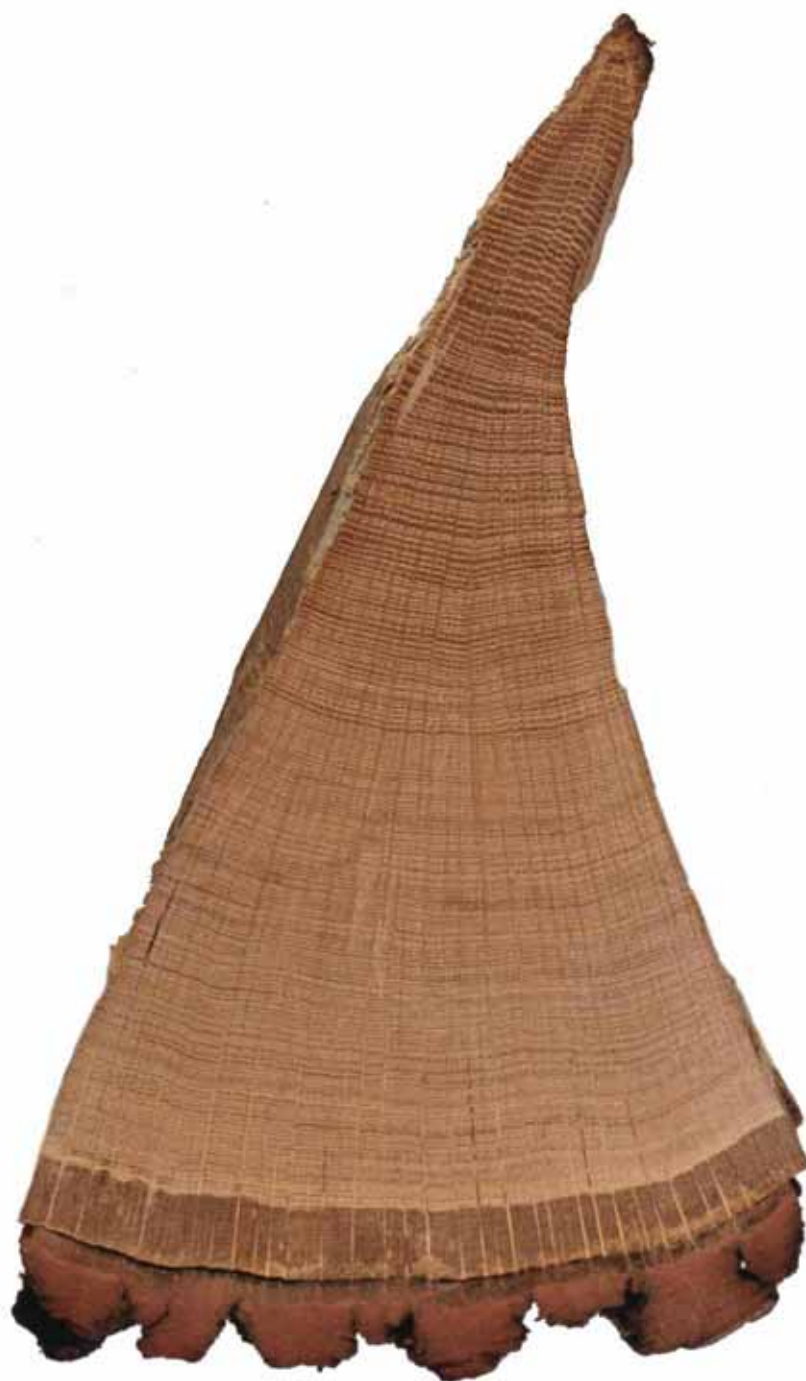
Figure A1: A wedge of oak from a tree felled in 1976. It shows the annual growth rings, one for each year from the innermost ring to the last ring on the outside just inside the bark. The year of each ring can be determined by counting back from the outside ring, which grew in 1976

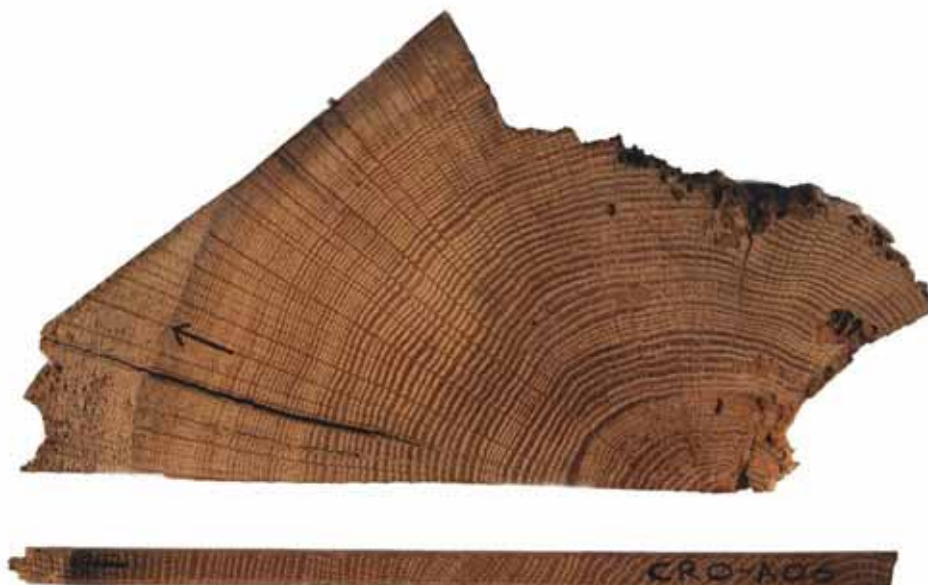
Figure A2: Cross-section of a rafter, showing sapwood rings in the left-hand corner, the arrow points to the heartwood/sapwood boundary (H/S); and a core with sapwood; again the arrow is pointing to the H/S. The core is about the size of a pencil

Quite often some, though not all, of the original outer rings are missing on a timber. The outer rings on an oak, called sapwood rings, are usually lighter than the inner rings, the heartwood, and so are relatively easy to identify. For example, sapwood can be seen in the corner of the rafter and at the outer end of the core in Figure A2, both indicated by arrows. More importantly for dendrochronology, the sapwood is relatively soft and so liable to insect attack and wear and tear. The builder, therefore, may remove some of the sapwood for precisely these reasons. Nevertheless, if at least some of the sapwood rings are left on a sample, we will know that not too many rings have been lost since felling so that the date of the last ring on the sample is only a few years before the date of the original last ring on the tree, and so to the date of felling.

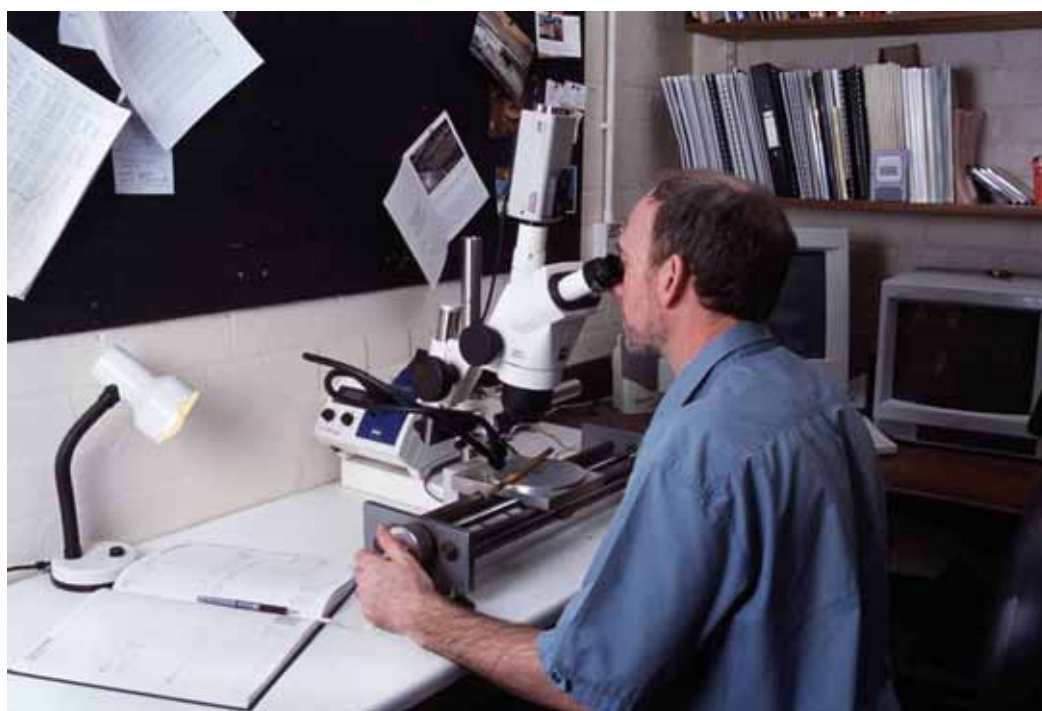
Figure A3: Measuring ring widths under a microscope. The microscope is fixed while the sample is on a moving platform. The total sequence of widths is measured twice to ensure that an error has not been made. This type of apparatus is needed to process a large number of samples on a regular basis

2. **Measuring Ring Widths.** Each core is sanded down with a belt sander using medium-grit paper and then finished by hand with flourgrade-grit paper. The rings are then clearly visible and differentiated from each other with a result very much like that shown in Figure A2. The core is then mounted on a movable table below a microscope and the ring-widths measured individually from the innermost ring to the outermost. The widths are automatically recorded in a computer file as they are measured (see Fig A3).

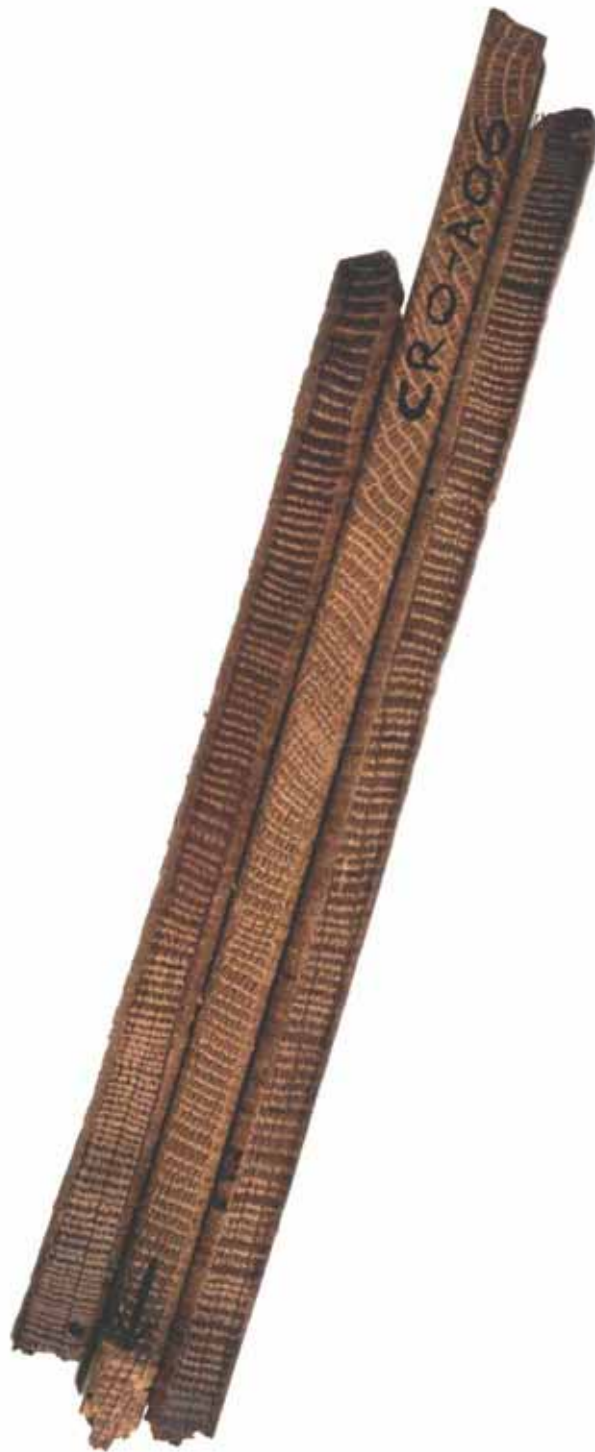
Figure A4: Three cores from timbers in a building. They come from trees growing at the same time. Notice that, although the sequences of widths look similar, they are not identical. This is typical

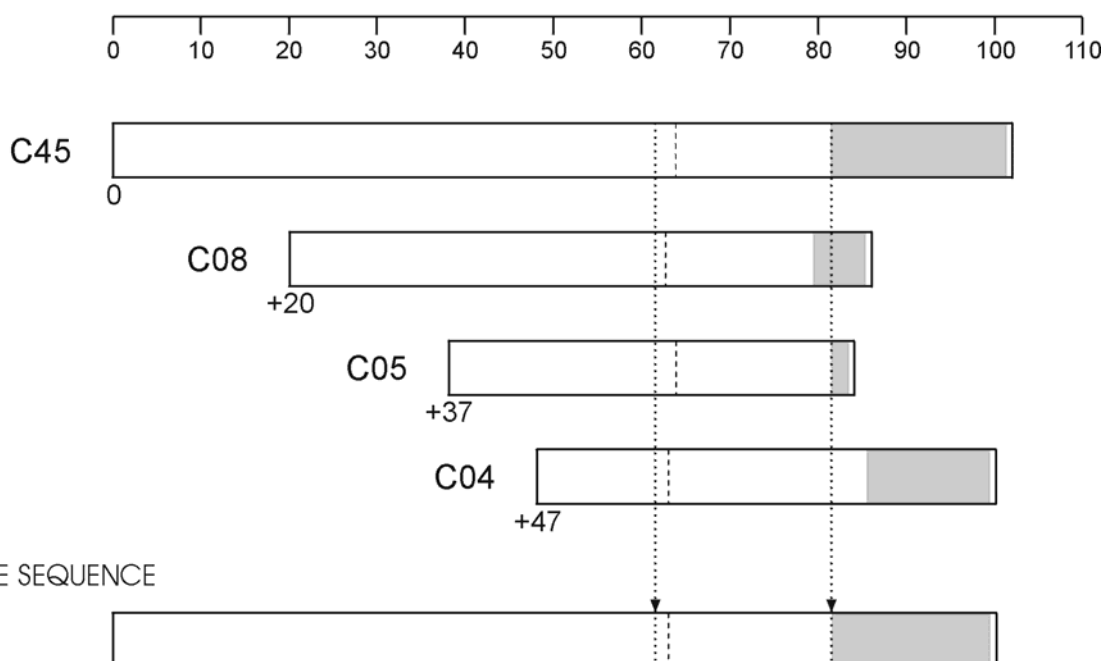
Figure A5: Cross-matching of four sequences from a Lincoln Cathedral roof and the formation of a site sequence from them

The bar diagram represents these sequences without the rings themselves. The length of the bar is proportional to the number of rings in the sequence. Here the four sequences are set at relative positions (offsets) to each other at which they have maximum correlation as measured by the t-values. The t-value/offset matrix contains the maximum t-values below the diagonal and the offsets above it. Thus, the maximum t-value between C08 and C45 occurs at the offset of +20 rings and the t-value is then 5.6. The site sequence is composed of the average of the corresponding widths, as illustrated with one width.

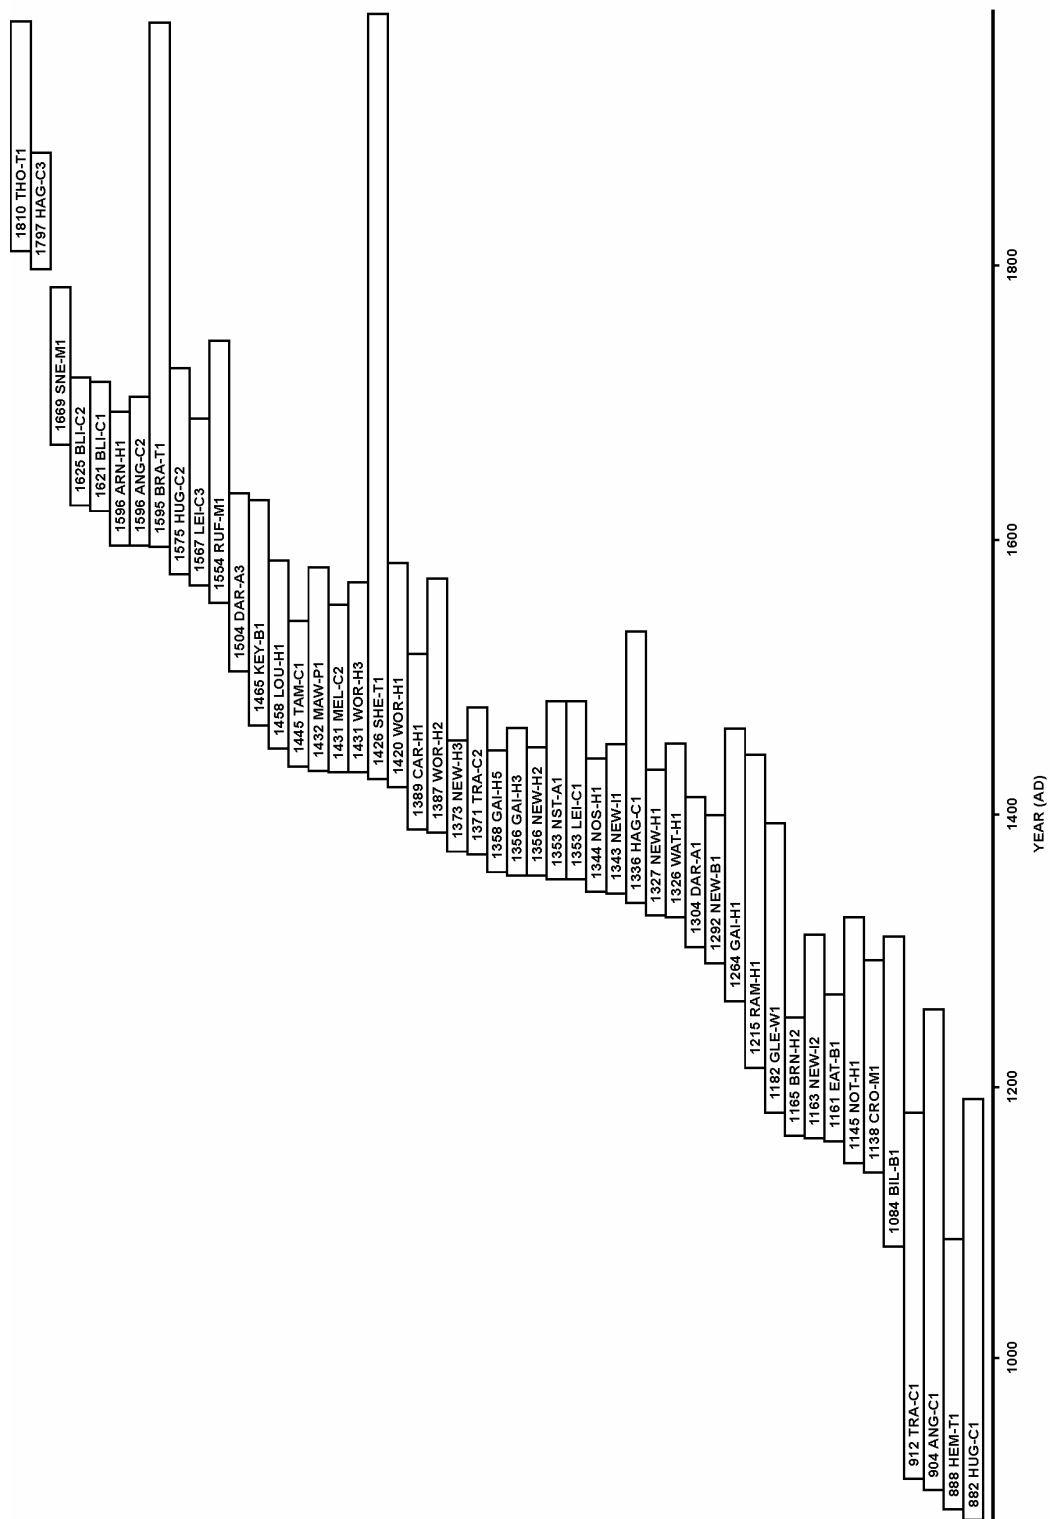
Figure A6: Bar diagram showing the relative positions and dates of the first rings of the component site sequences in the East Midlands Master Dendrochronological Sequence, EM08/87

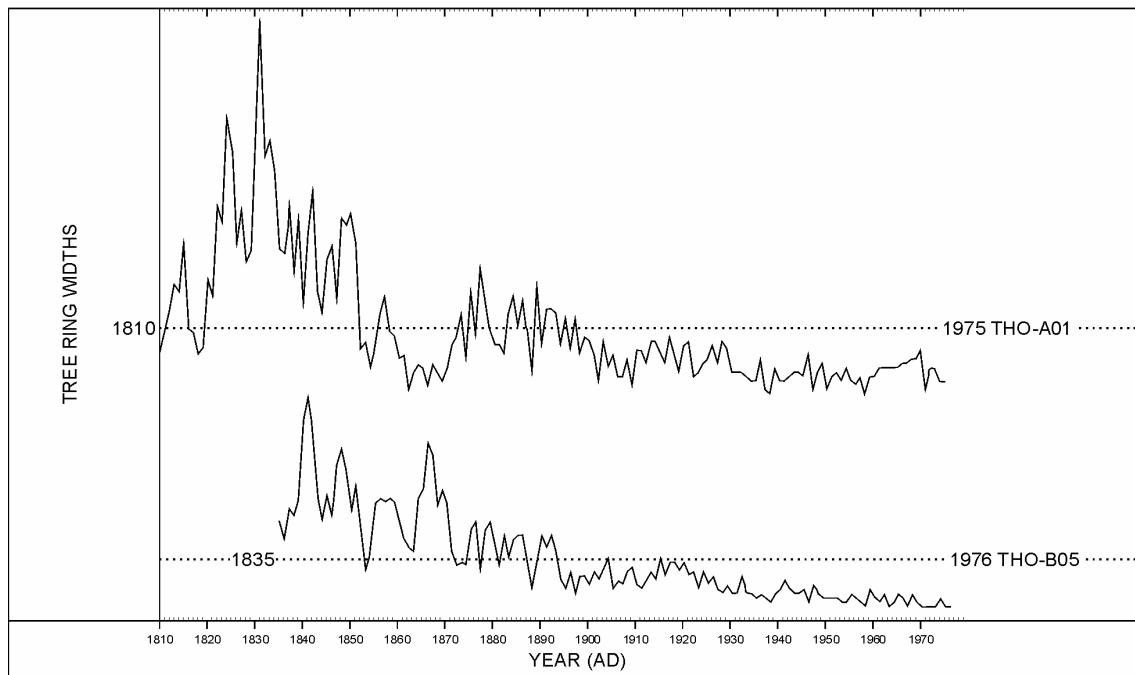
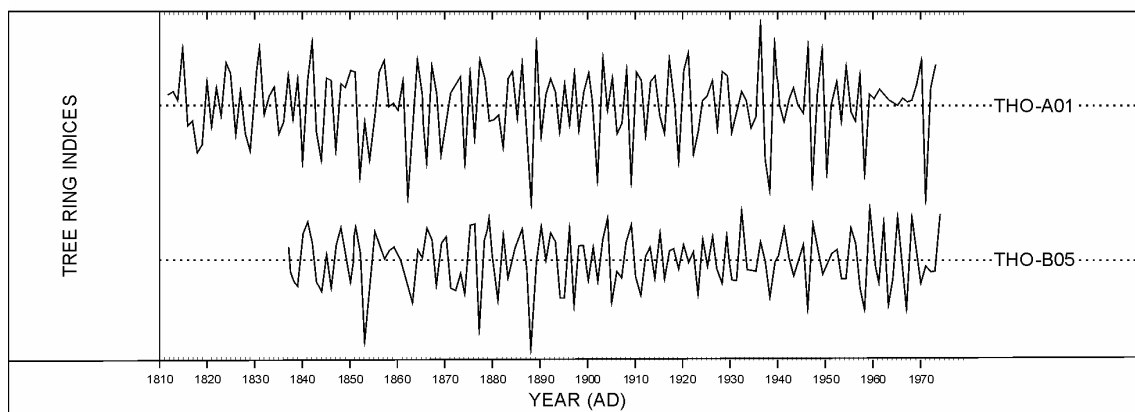
Figure A7 (a): The raw ring-widths of two samples, THO-A01 and THO-B05, whose felling dates are known

Here the ring widths are plotted vertically, one for each year, so that peaks represent wide rings and troughs narrow ones. Notice the growth-trends in each; on average the earlier rings of the young tree are wider than the later ones of the older tree in both sequences
