The church and chapel interiors of John Loughborough Pearson: A selective assessment of significance

Clare Howard and Simon Taylor

Discovery, Innovation and Science in the Historic Environment

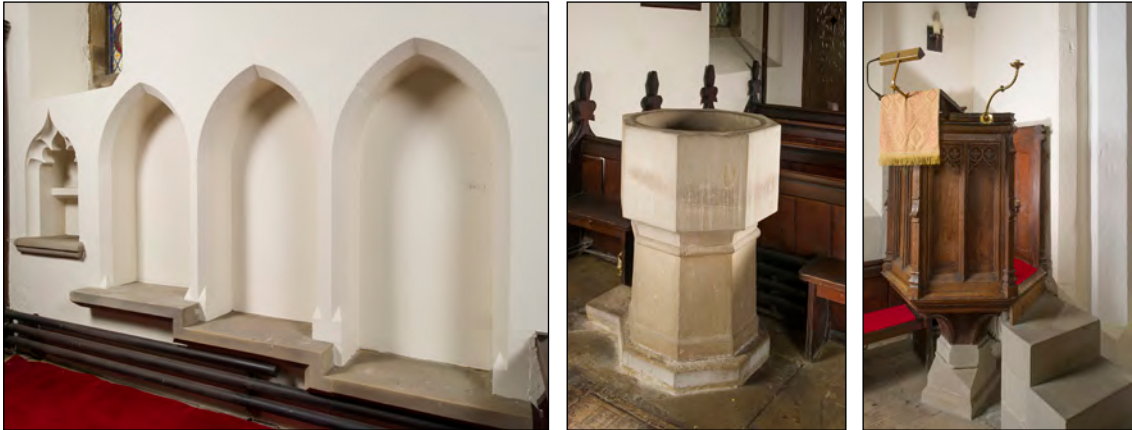
In the layout and proportions of the church at Ellerker, designed around the reused chancel arch of the former medieval chapel, Pearson excelled. He also set a precedent for many of his future restorations where he would aim to retain earlier fabric if possible. Pearson's design was not particularly unusual for its date but it shows that from the very beginning he was an accomplished student of medieval forms, evident in the collar arch-braced roof trusses, the window tracery, carved details to the furnishings and iron strapwork across the doors. His furnishings, however, including the sedilia, font and pulpit (Figures 4 to 6) were fairly plain, with only the upper wooden panels of the pulpit drum displaying detailing in the form of cusped arches and quatrefoils.

Figures 4 to 6: The sedilia (left), font (centre) and pulpit (right) at the Church of St Anne in Ellerker (DP168564, DP168565 and DP168575 © Historic England, photograph: Alun Bull)

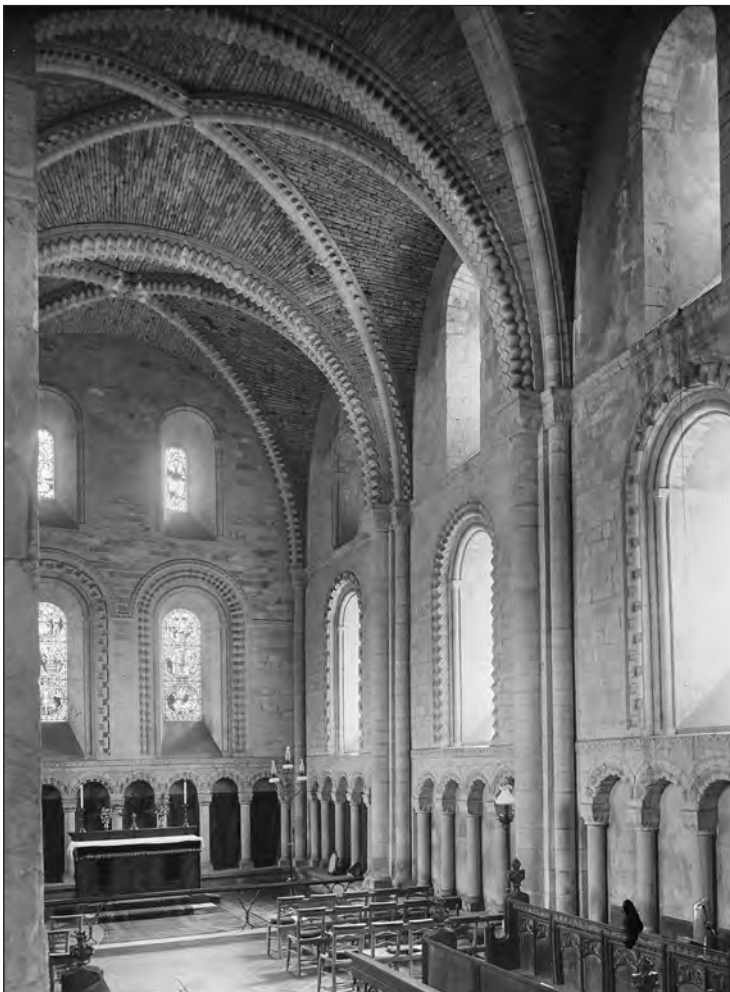
While undertaking a chancel restoration at St Mary's in Stow (Lincolnshire), between 1850 and 1852, Pearson discovered the springers for the former stone-vaulted ceiling and restored it based upon this evidence. Although this was to the detriment of the late medieval roof, he proved that he could engineer stone vaulting without the need for excessive buttressing or piers,³² a discovery which was to prove influential in many of his later designs. From this date onwards, Pearson began to use stone vaulting within selected areas of his churches such as porches or side chapels (Figure 10).

Figure 10: The chancel at St Mary's, Stow, taken from north-west circa 1920-60 (CC83/00752 © Historic England Archive)

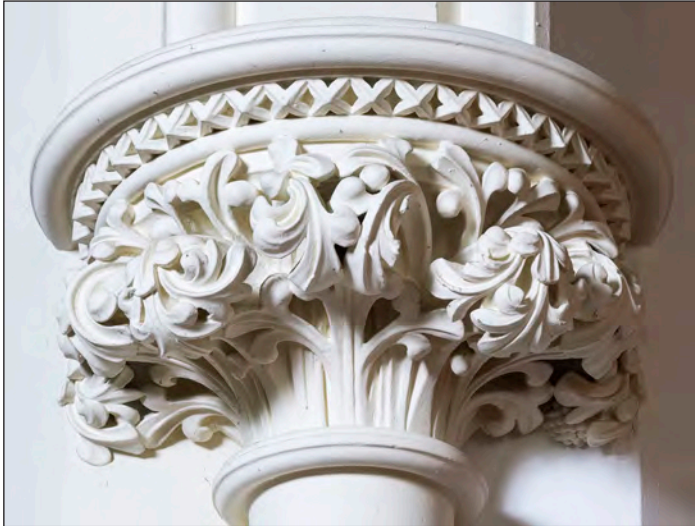
Figure 11: One of the foliate corbels carrying the chancel arch at the Church of St John and St Petroc, Devoran, Cornwall (DP172563 © Historic England, photograph: James O Davies)

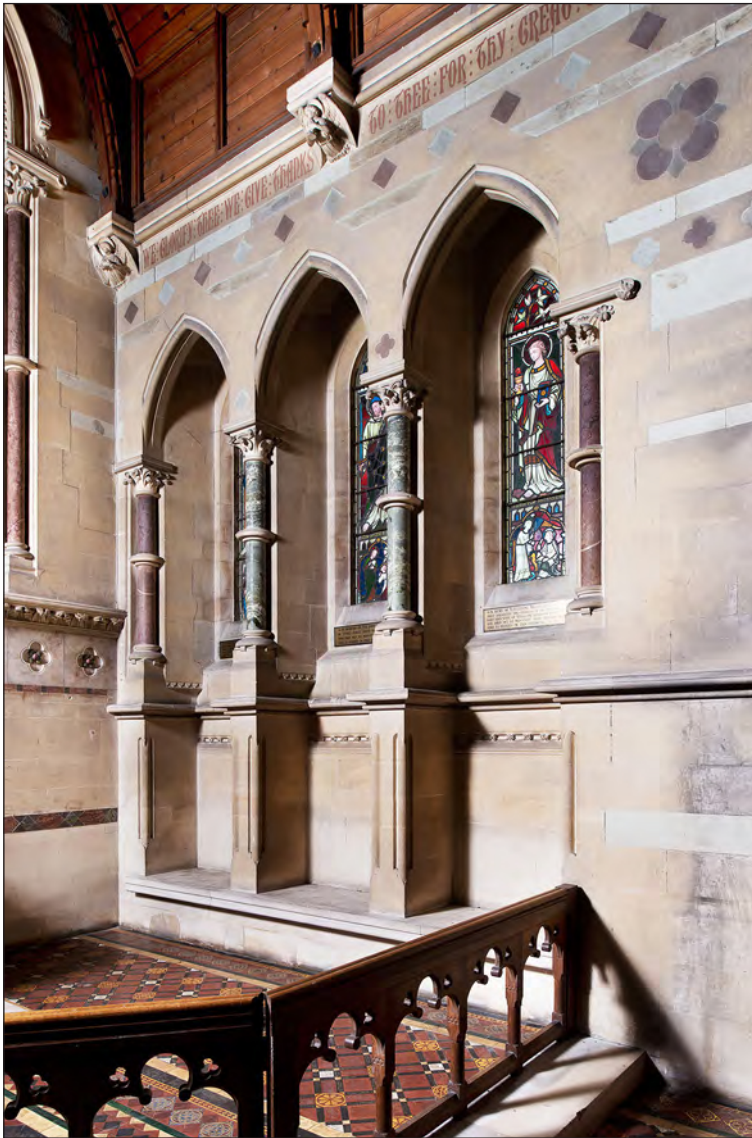
Figure 13: Constructional polychromy in the Church of St James, Titsey (D167319 © Historic England, photograph: James O Davies)

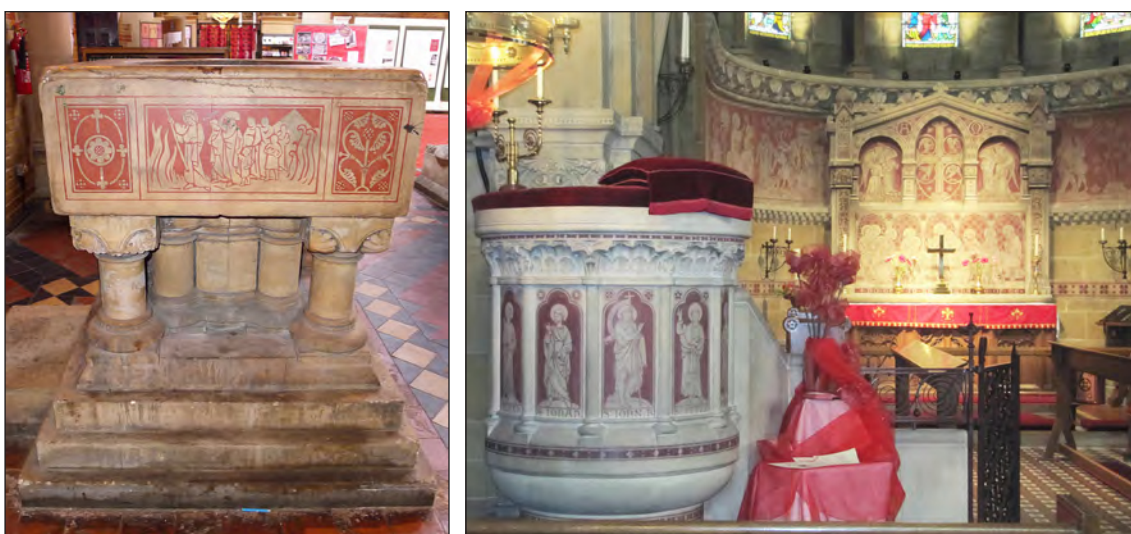
used more strongly contrasting materials – although this is still used carefully – and his decoration is heavier and certainly more sumptuous than usual. The font is almost identical to that at St Michael’s in Braintree while the choir stalls and pews of the nave are very similar to those seen at other Pearson churches, with rounded upper corners to the bench ends.

decoration, had to be reduced to meet the tight budget, the interior remains magnificent and inspiring; the chancel is richly decorated with wall paintings and stained glass by Lavers and Barraud and Clayton and Bell (two of Pearson's favoured stained-glass firms) and the fixtures and fittings are some of the most sumptuous of Pearson's designs, particularly the reredos which follows similar forms seen at Garton-on-the-Wolds (East Yorkshire) and Appleton-le-Moors (North Yorkshire), but is much more richly decorated than either, with inlaid mosaics in gold, red and blue by Antonio Salviati. The font is shorter than others of Pearson's design but is decorated with *sgraffito* (a technique where the design is scratched into the surface to a lower level of a contrasting colour) scenes similar to the pulpit at Appleton-le-Moors (Figure 14 and 15). Pearson's pulpit at Vauxhall is unusual in that it has a rectangular plan and is highly decorative with inlaid mural panels; the large cylindrical base, however, is characteristic of many of his pulpits and fonts.

Figure 14 and 15: The font in the Church of St Peter, Vauxhall (left) and the pulpit and chancel in Christ Church, Appleton-le-Moors (right) (© Historic England, photographs: Clare Howard)

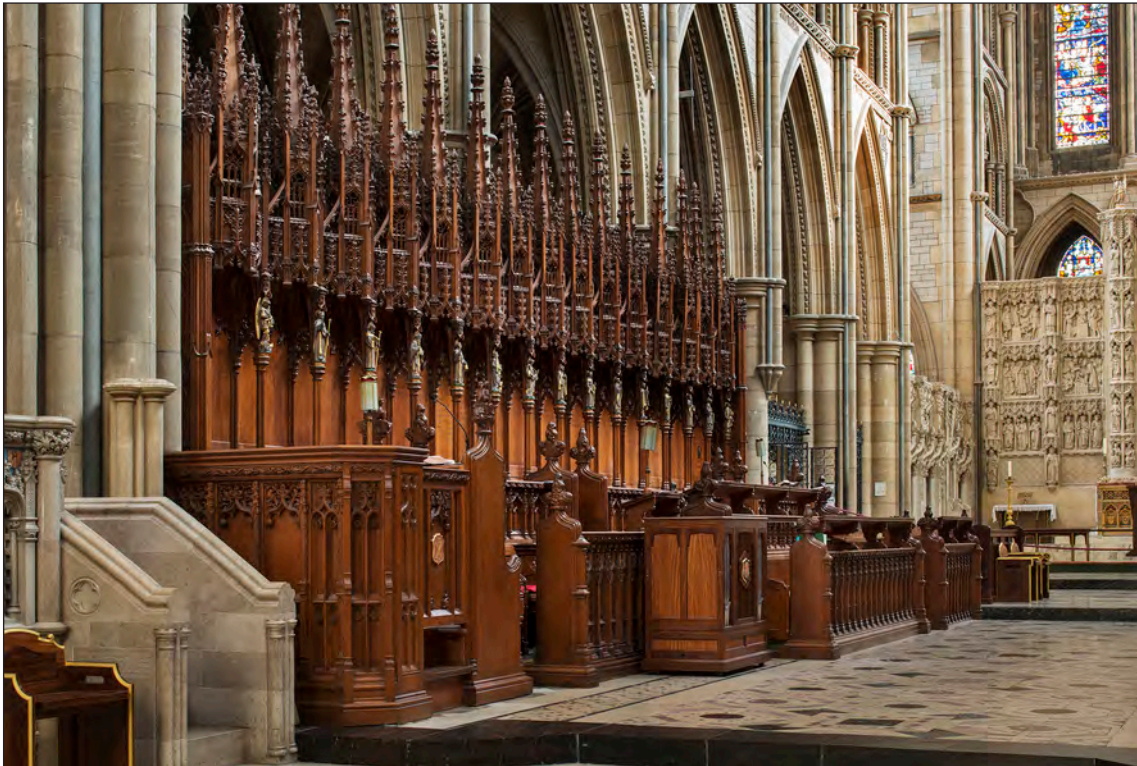
Figure 17: Choir stalls in Truro Cathedral (DP166690 © Historic England, photograph: James O Davies)

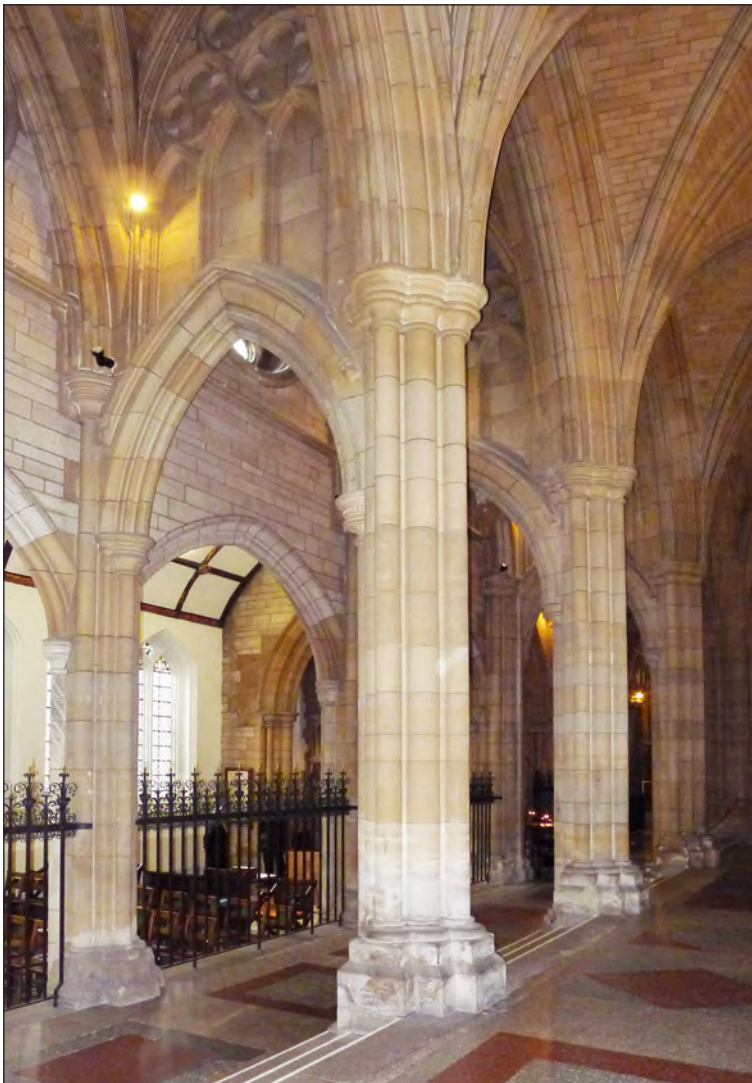
Figure 22: Stone vaulting between the chancel aisle and the incorporated St Mary's Aisle at Truro Cathedral (© Historic England, photograph: Clare Howard)

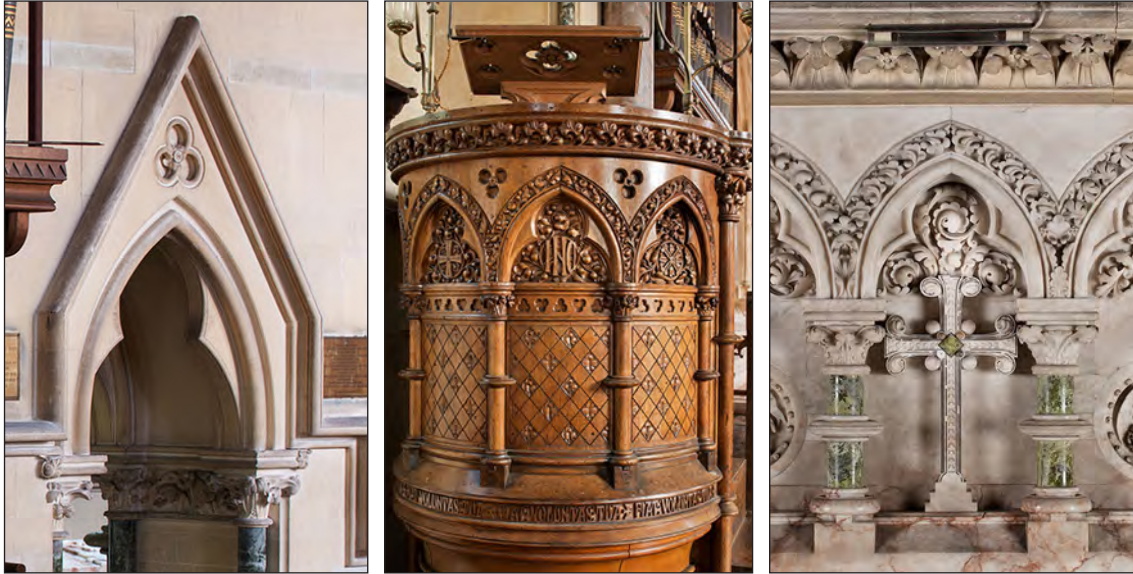
Pearson also made reference to fixtures and fittings in his specifications and correspondence. The specification for the construction of Truro Cathedral, as mentioned above, includes small sketches within the margins to indicate the profiles of stone mouldings, as well as the details of the ironwork and the arrangement of rainwater goods,¹³⁴ while correspondence relating to the furnishing of the cathedral indicates that Pearson designed gas pendant lights of polished brass which were then made by Willey gas engineers of Exeter.¹³⁵ He recommended that the clergy keep the number of memorial brasses to a minimum¹³⁶ and suggested the use of chairs instead of pews.¹³⁷ The latter was probably to save on costs and to allow greater flexibility, but chairs were often the preferred form of seating in large ecclesiastical buildings. At St George's in Cullercoats (Tyne and Wear), the parish magazine states that Pearson not only designed some of the main pieces of church furniture, including the font, pulpit and altar, but also some of the smaller objects such as silver gilt vessels used for Holy Communion and an altar cloth, although without evidence for their appearance we cannot be confident about the identification of these original items.¹³⁸ Identification of Pearson-designed furnishings is, however, sometimes possible if the decorative elements reflect the decoration applied to the building fabric itself, particularly window tracery. This is demonstrated well at the Church of St James in Titsey (Surrey) where the form of the arches, shafts and capitals of the windows, doors and chancel arch is mirrored on elements of the pulpit, reredos and William Leveson-Gower's tomb (Figure 25 to 27).

Figure 25 (left): The chapel doorway in the Church of St James, Titsey (DP167306 © Historic England, photograph: James O Davies)

Figure 26 (centre): The pulpit in the Church of St James, Titsey (DP167301 © Historic England, photograph: James O Davies)

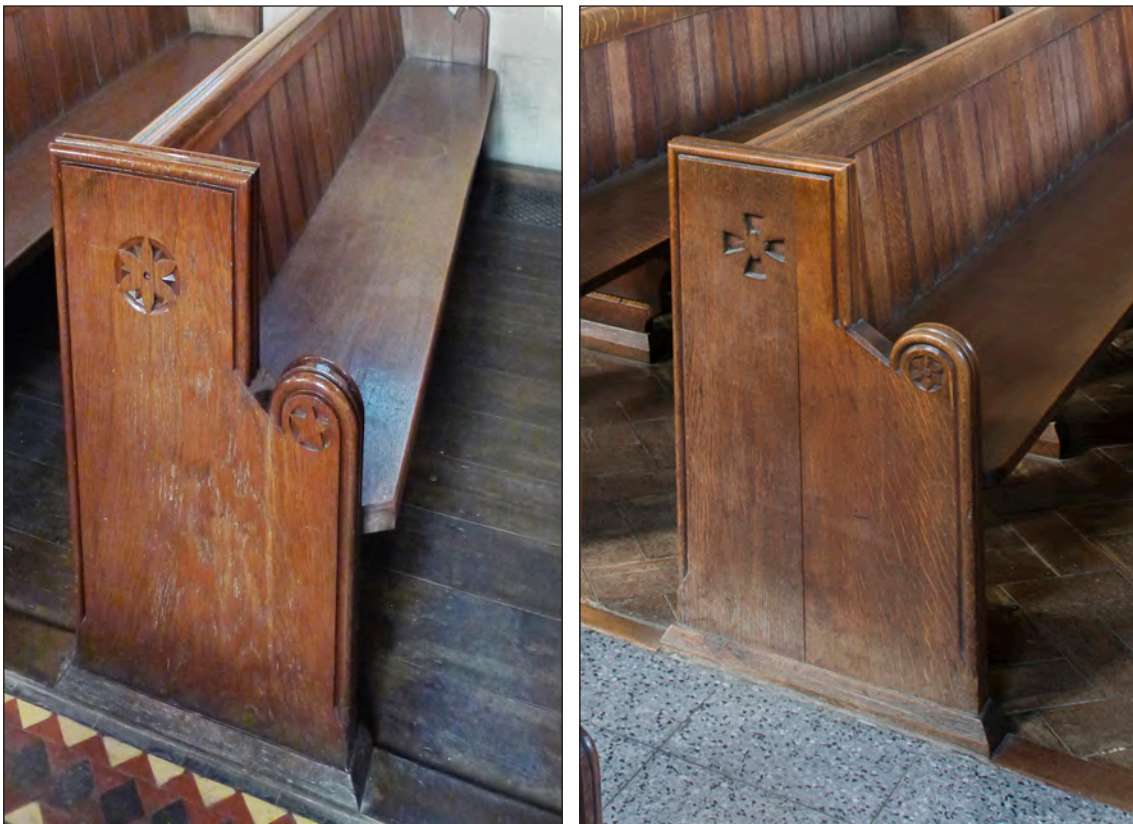
how closely Pearson involved himself in this work. The repetition of pew designs used across his churches suggests the use of his own designs, or at the very least that he was influencing the choice from a craftsman or church furniture catalogue in order to fit the pews both stylistically and proportionally within the overall interior scheme. The former scenario is perhaps more likely given the use of similar pew designs both repeatedly over a long length of time and geographically at much the same time. For example the style of the pews at St James' in Titsey, Surrey (built 1860-1), which have square-headed bench ends and rounded elbows, was replicated over 20 years later at St George's in Cullercoats, Tyne and Wear (built 1882-4) (Figure 28 and 29); whereas the pews at St Peter's in Charlton, Wiltshire (built 1857-8) and St Michael's in Braintree, Essex (built 1857-67) both have square-heads with upper moulded edges, while the pews at St Mary's in Hambleton, North Yorkshire (built 1881-2) and St Margaret's in Horsforth, West Yorkshire (built 1877-83) have flat-headed bench ends with concave-sides and rounded elbows.

Figure 28 and 29: The pews at the Church of St James, Titsey (left) (© Historic England, photograph: Simon Taylor) and similar pews at the Church of St George, Cullercoats (right) (DP168601 © Historic England, photograph: Alun Bull)

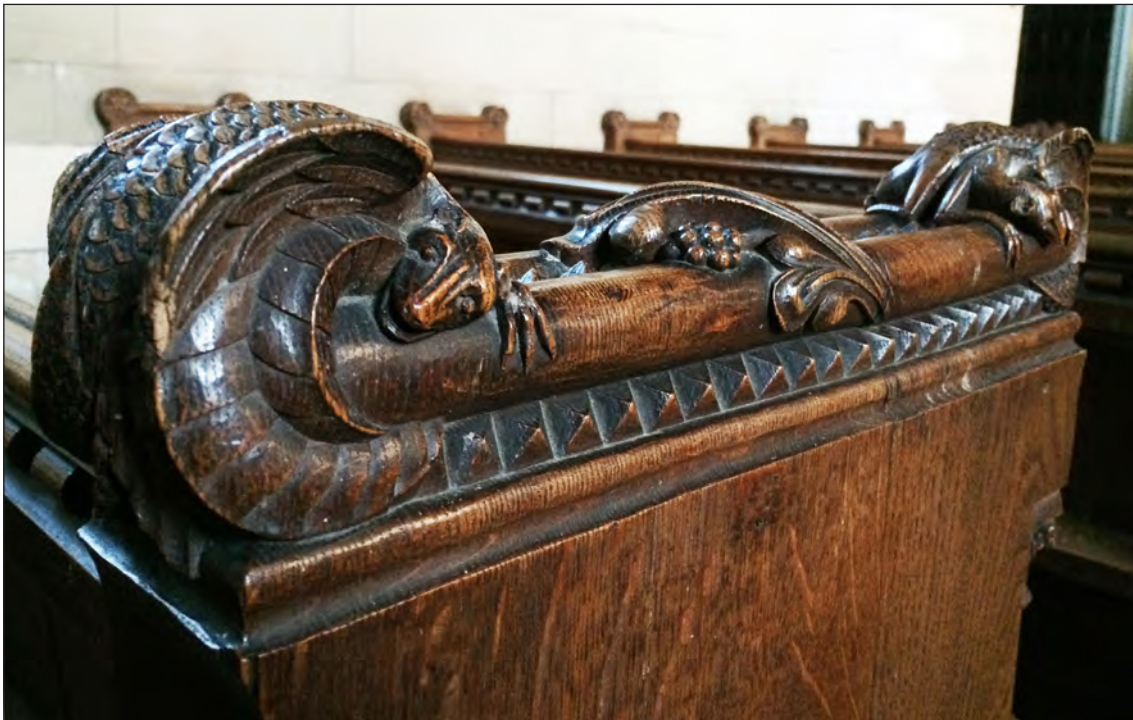
The more intricate pew and bench ends were probably designed as bespoke pieces by the architect, as and when the budget allowed. This was also probably true of choir stalls which were more elaborate than the pews. Often, however, the carvings themselves are very distinctive, suggesting that while the architect set the overall parameters of the designs, certain aspects of the detailing may have been strongly influenced by the craftsman. Good examples of these can be seen at the Church of St Mary in Dalton Holme where individual carvings of animals curl around the top of some of the pew ends (Figure 30). According to the *Beverley and East Riding Recorder*, 10 August 1861, the pews were carved by Henry

Ringham of Ipswich who was well known, particularly in the Suffolk area, for his elaborate carvings often incorporating animals.¹⁴³

Figure 30: Carved detailing to the bench ends at the Church of St Mary, Dalton Holme (© Historic England, photograph: Clare Howard)

Pearson does not appear to have favoured a specific design for his pews, although rounded elbows (generally a popular design during this period) seem dominant. The majority of the pews are constructed of oak where the budget allowed, or pitch pine, and Pearson always combined pews with wooden flooring, in blocks separated by tiled alleys. It is worth noting that, until 1876 when the rules were changed,¹⁴⁴ the ICBS would reduce the grant awarded to a church building project if chairs were specified instead of pews, and so it was only in some of Pearson's later and larger churches that chairs were used, including at the Catholic Apostolic Church (chairs are used in the aisles and chapels while pews were used in the nave) and Truro Cathedral, whilst other larger churches built before 1876, such as St Peter's, Vauxhall (London), were filled with pews throughout. The church chairs are fairly standard designs which were most likely chosen from catalogues rather than being designed individually by the architect.

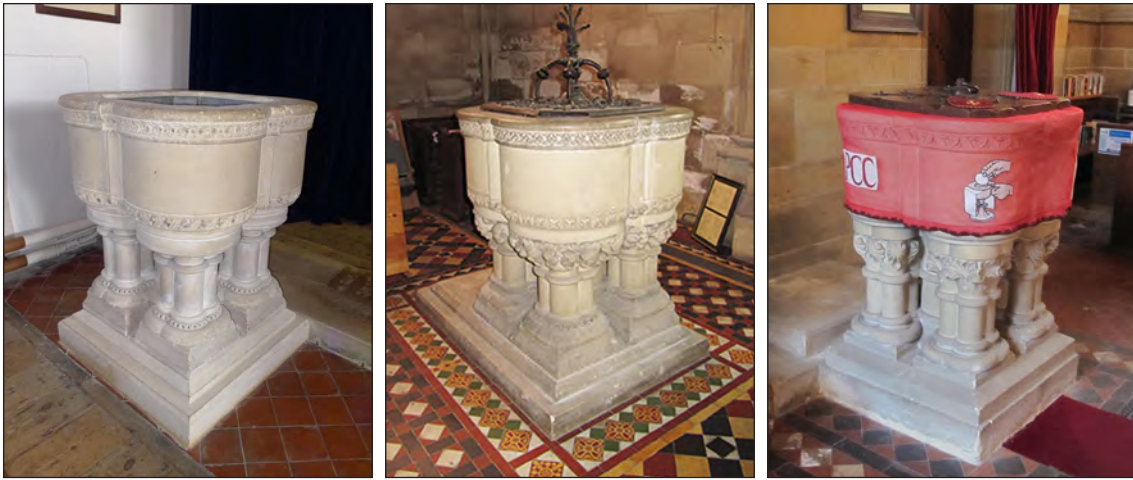
Figures 31 to 33: The font at the Church of St Michael, Braintree (left); the font at the Church of St Mary, Dalton Holme (centre) and the font at Christ Church, Appleton-le-Moors (right) (© Historic England, photographs: Clare Howard)

Pearson's designs for chancel and choir screens, altar tables, reredoses, sedilia, pulpits and fonts received the most attention in his interior schemes. These are often fairly modest, perhaps with minimal dog-tooth, nail-head or foliate detailing and sometimes with carved arched panels. But for his higher-status, larger and more expensive projects such as Truro Cathedral and the Catholic Apostolic Church, his furnishings are far more elaborate – with the use of more opulent colours and materials and elaborate carved detailing – perhaps facilitated by a larger budget and driven by greater demands of the client. Pearson sometimes reused designs for furnishings, perhaps with slight alterations to lend individuality; this is particularly true of his fonts, those at St Michael's in Braintree (Essex),

St Mary's in Dalton Holme (East Yorkshire) and Christ Church in Appleton-le-Moors (North Yorkshire) all share very similar characteristics and were all designed in the 1850s and 1860s (Figures 31 to 33). This close repetition suggests that Pearson probably did keep copies of his designs for church furnishings among his papers at Mansfield Street.

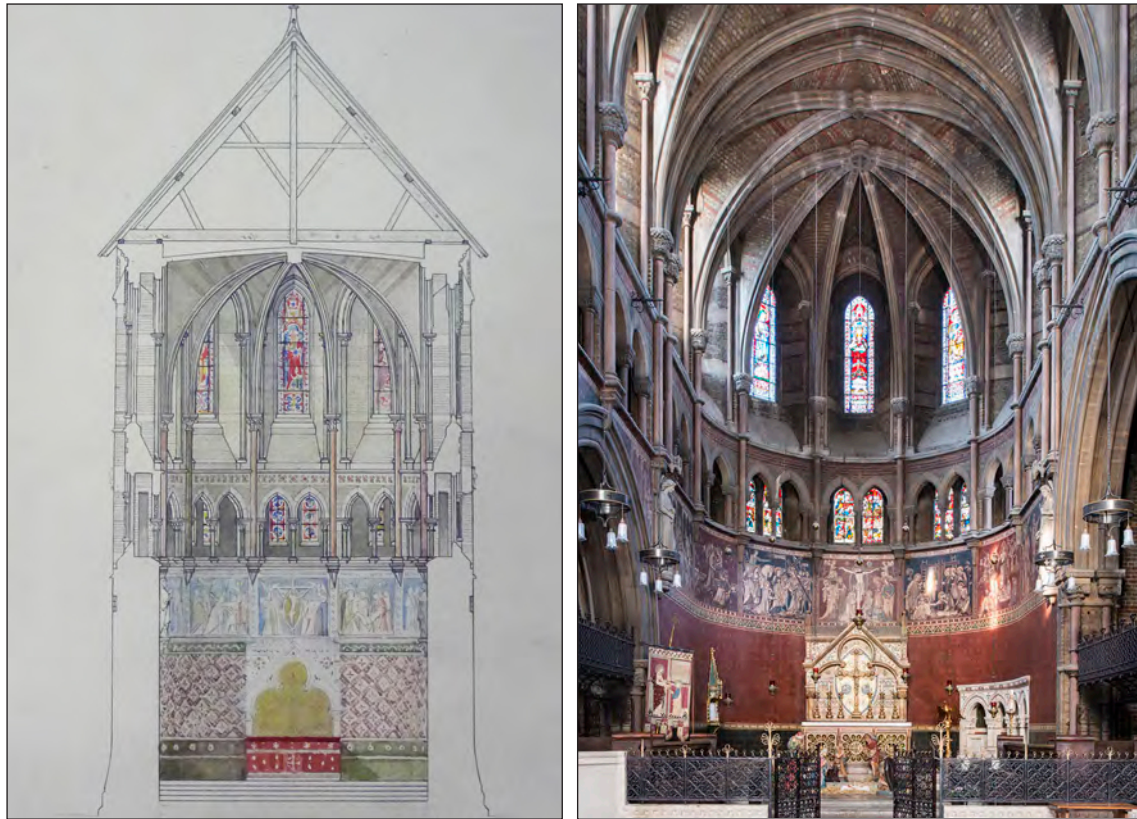
Figure 36 and 37: Pearson's cross section through the chancel at the Church of St Peter, Vauxhall (left) (PB 313/5 13 © RIBA Collections) and the executed designs in the chancel at the Church of St Peter, Vauxhall (right) (DP168601 © Historic England, photograph: James O Davies)

The majority of Pearson's designs depict windows with plain leaded glass. This was sometimes because of a limited initial budget but in anticipation of re-glazing with commemorative stained glass by private donors over time. Often, however, particularly with nave clerestory windows, it was done deliberately in order to create contrasts between the central and well-lit nave and chancel, and the darker aisles and side chapels. Where Pearson used stained glass in his original designs he tended to place it within the sanctuary to enrich the holiest parts of the building. Unfortunately, no individual drawn stained-glass window designs by Pearson came to light during this research, probably for the usual reasons: because these were lost, damaged or destroyed by the craftsmen or the architect himself, or through the clearing out of the architects' premises in the mid-20th century. It is also likely that, as with the fixtures and fittings, Pearson worked closely with specialist glaziers to achieve the final product and for stained glass he was willing to rely on the glazier to produce designs within the parameters of his specifications or at least to his rough sketches. Certainly within his written specifications he states that all specialist tradesmen are to be chosen and appointed by the architect.¹⁵³ As mentioned above, Pearson did occasionally hint at the intended designs for stained glass and wall murals in his architectural drawings. The best example of this found during the course of this research is the cross section through the chancel of St Peter's Vauxhall (London) which shows the decorations in colour. Although rough and lacking in detail, the drawings show enough to confirm that the executed scheme followed the designs reasonably closely, and that the overall composition and colour choices were Pearson's and not necessarily those of the craftsman (Figures 36 and 37).

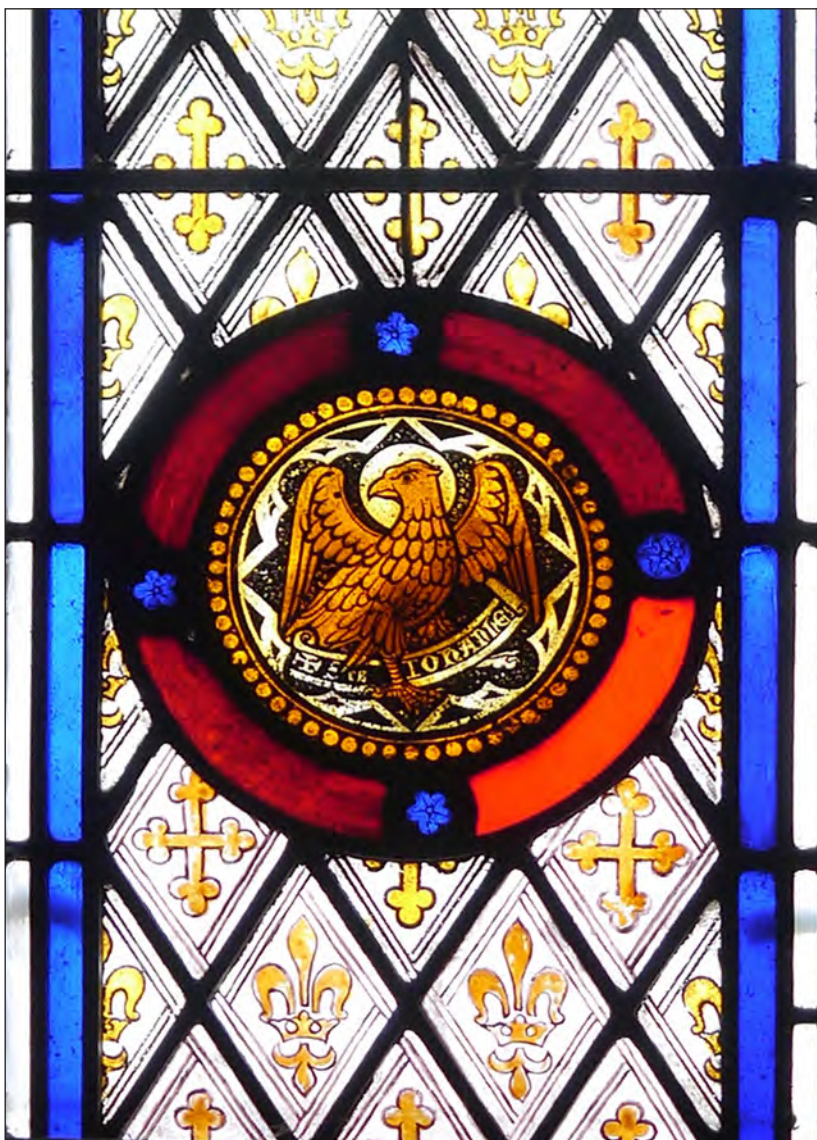
Figure 38: Stained glass by William Wailes in the Church of St Anne, Ellerker (© Historic England, photograph Clare Howard)

From the very beginning of his independent career Pearson preferred to use William Wailes of Newcastle (1808-81) to design and make the stained glass within his churches (Figure 38). His choice may have been influenced by the fact that Pugin also used Wailes, albeit briefly at around the time the church at Ellerker (East Yorkshire) was under construction in the early 1840s. Wailes produced work for Pearson throughout the country but seems to have been involved in the smaller commissions. He received a mixture of reviews for his work and the Ecclesiologists claimed that at Holy Trinity Church, Bessborough Gardens (London), built 1848-52, he had 'assuredly not done justice to his employers' and that his work was often a 'lottery'.¹⁵⁶ It is possible that for this reason, and certainly for the larger and more elaborate schemes where funds were more plentiful, Pearson preferred to use the artists Richard Clayton (1827-1913) and Alfred Bell (1832-95). Their workshop in Regent Street, London became very successful in the late 19th century, not just in the design and production of stained glass, but also for other decorative forms including murals. Clayton became well known following his work at Wells Cathedral for Anthony Salvin in the late 1840s, while Bell worked as an apprentice in G G Scott's studio from 1847. The two were probably introduced by Scott and established their firm in the mid-1850s; their first commission was for the nave clerestory windows in Westminster Abbey church in 1856.¹⁵⁷ In the early years of the business, the firm designed stained glass but did not have the facilities to manufacture it and subsequently collaborated with other firms including Ward and Hughes (Soho, London) and later Heaton and Butler (Covent Garden, London).¹⁵⁸ Given that Pearson could equally have commissioned manufacture of his own designs, but didn't, suggests that, at least in the late 1850s and early 1860s, he did not create his own

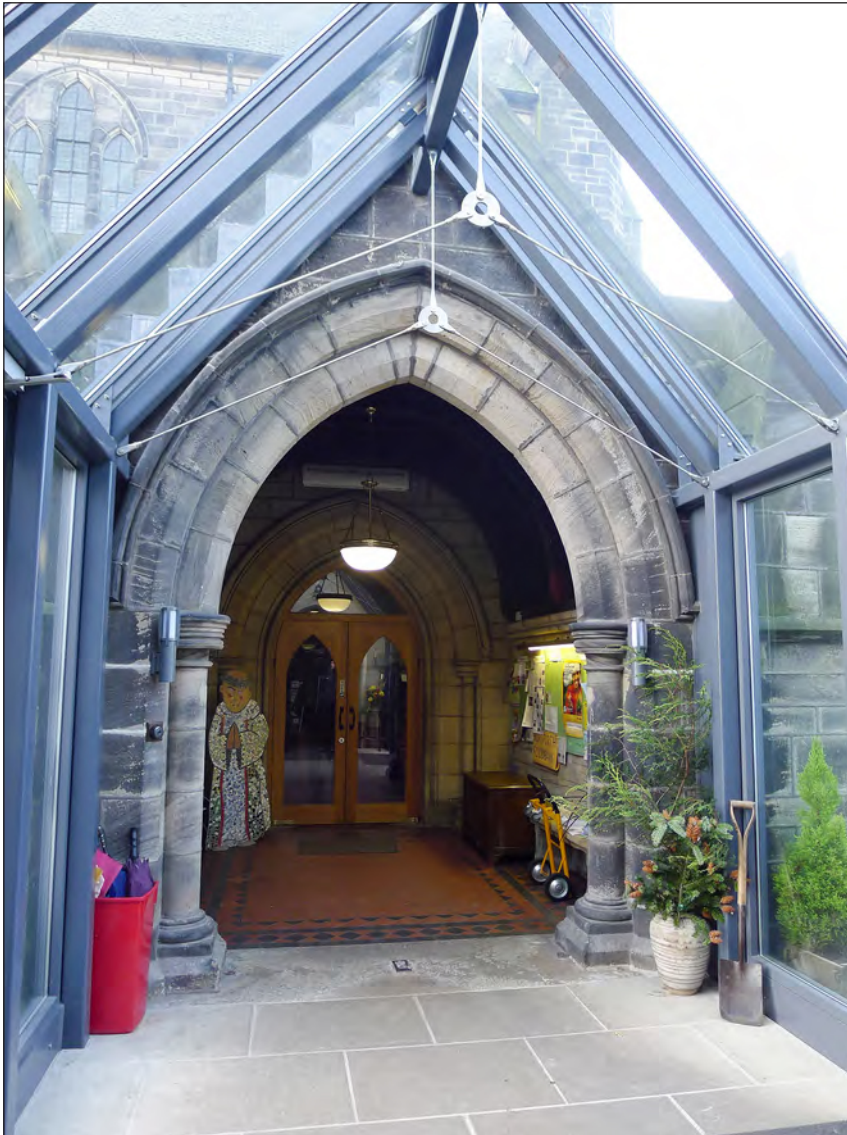
Figure 40: Glazed corridor linking church porch with the later parish centre at the Church of St Margaret, Horsforth (© Historic England, photograph: Clare Howard)

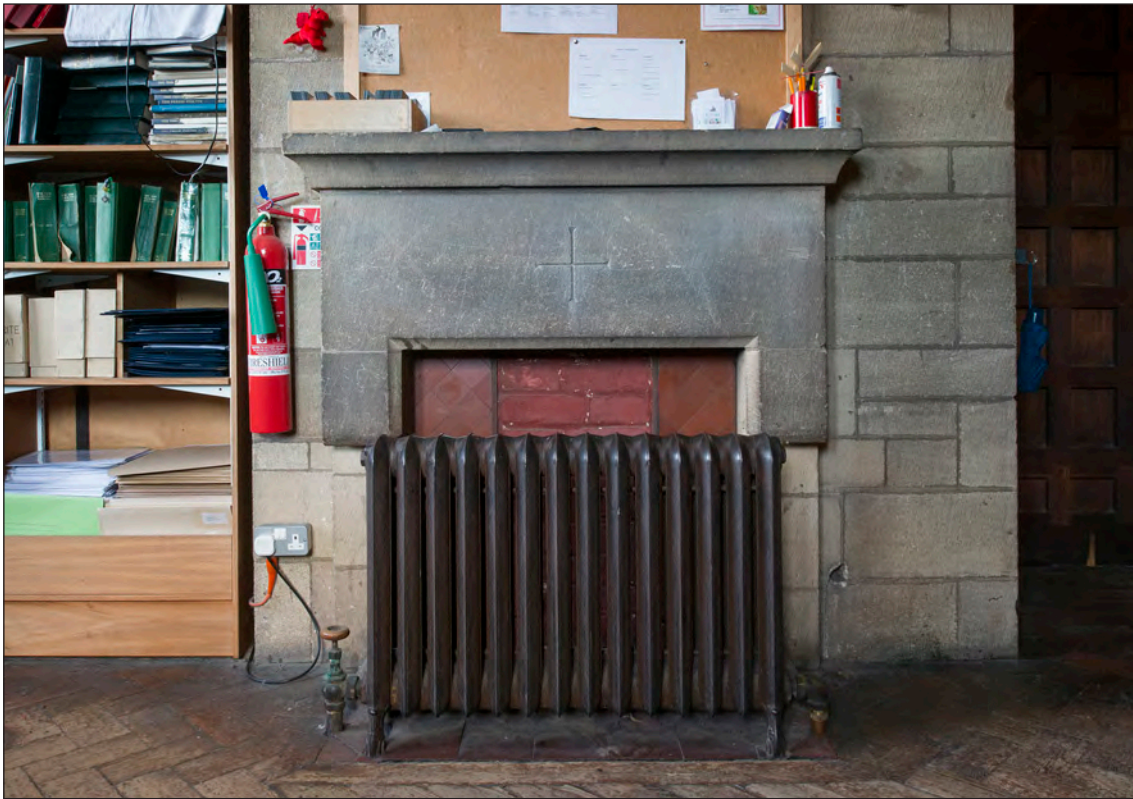
Figure 41: A radiator inserted in front of a fireplace in the vestry at the Church of St George, Cullercoats (DPI68612 © Historic England, photograph: Alun Bull)

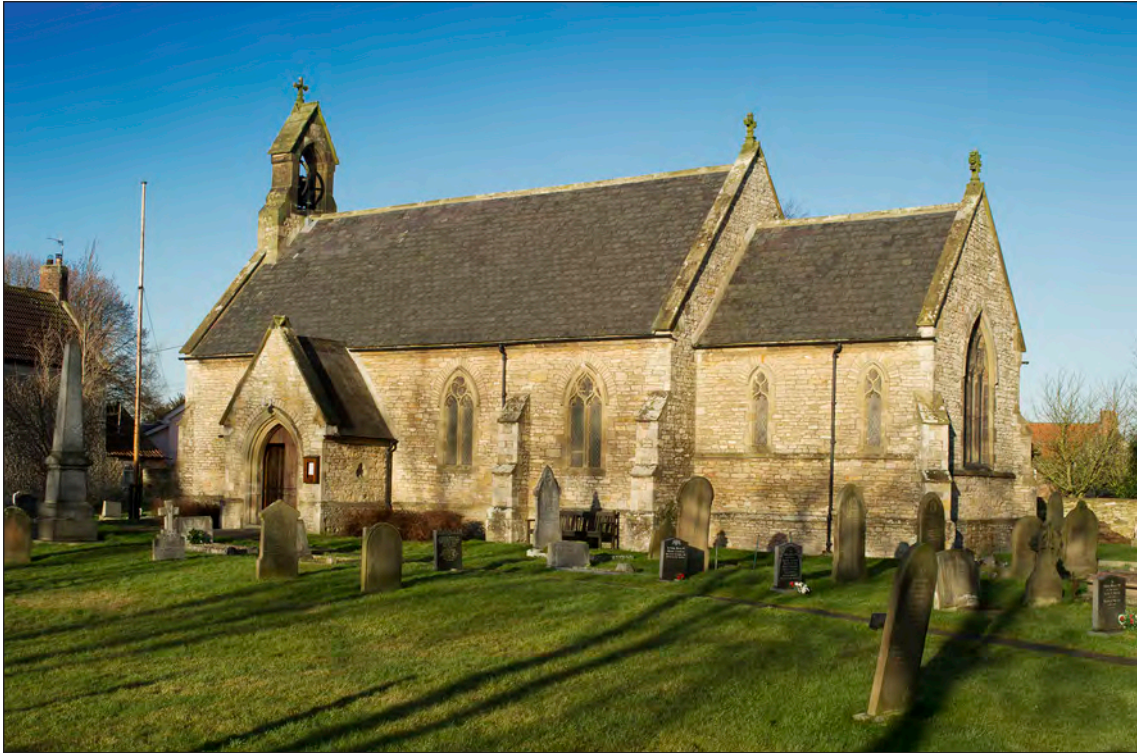
Figure 44: The Church of St Anne, Ellerker, taken from the south-east (D168569 © Historic England, photograph: Alun Bull)

The Church of St Anne is located in the centre of the small village of Ellerker, set within an enclosed churchyard and aligned roughly west to east at the south end of Church Lane which provides the main point of access to the churchyard. The church is constructed of roughly-coursed stone rubble, with dressed stone quoins, string courses and window and door surrounds (Figure 44). It has pitched roofs which are covered with slate. A low plinth continues around the base of the whole of the building, with the exception of the later extensions, and the nave and chancel are supported by stepped buttresses.

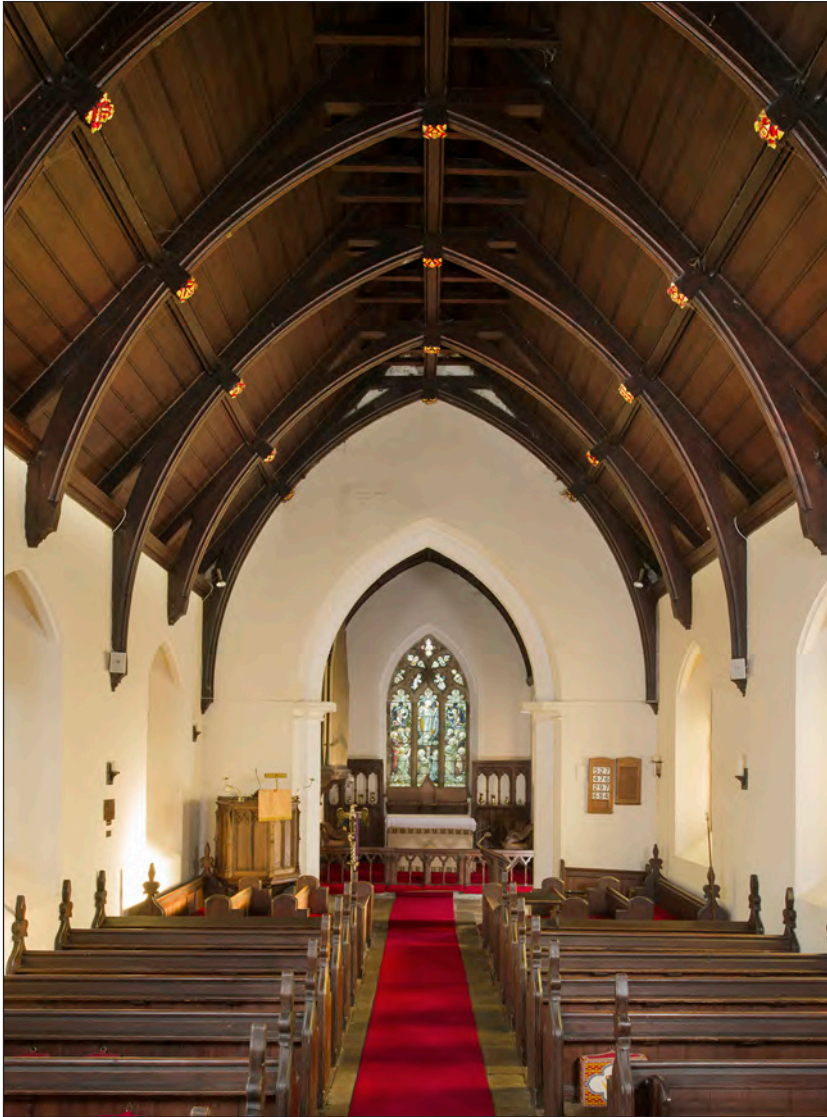
Figure 45: The nave of the Church of St Anne, Ellerker, taken from the west (D168572 © Historic England, photograph: Alun Bull)

Entered through the pointed doorway from the porch, the aisle-less and undivided nave has a central alley paved with stone flags, contrasting with the areas of the pews which have wide wooden floorboards (Figure 45). Almost all of Pearson's churches have, or had, tiled alleys so it is possible that the stone flags were reused from the earlier chapel. The nave is open to an arch-braced collar roof of eight bays, probably of oak, with moulded butt purlins, collar purlins and wall plates. At the intersection of each arch brace with a purlin, there is a carved fleuron-shaped timber boss painted gold and red. The arch-braces spring alternately from high or low positions along the north and south walls of the nave to allow for the window openings. The nave is lit by seven two-light windows: three on the south side and four on the north, in addition to two narrower windows with cusped ogee tracery in the west wall. The windows in the north and south walls of the nave are set within deep

pointed-arched openings with sloping sills, and contain pairs of cusped or trefoil-headed lights surmounted by a roundel, quatrefoil or cusped trefoil, the tracery for each window on the north and south sides of the nave being of different designs. Three pairs of windows have matching tracery, whilst the second most easterly window in the north wall is of unique design. Some of the windows retain original green-tinted, diamond-lead glass panes (as described at the time of the consecration in 1844¹⁴), but some of these appear to have been replaced with textured glass (*see below*); all of the windows, however, retain a coloured, decorative border incorporating floral motifs in stained glass (also as described in 1844¹⁵). The two cusped lights on the west wall similarly contain replaced leaded glazing with a border of red stained glass.

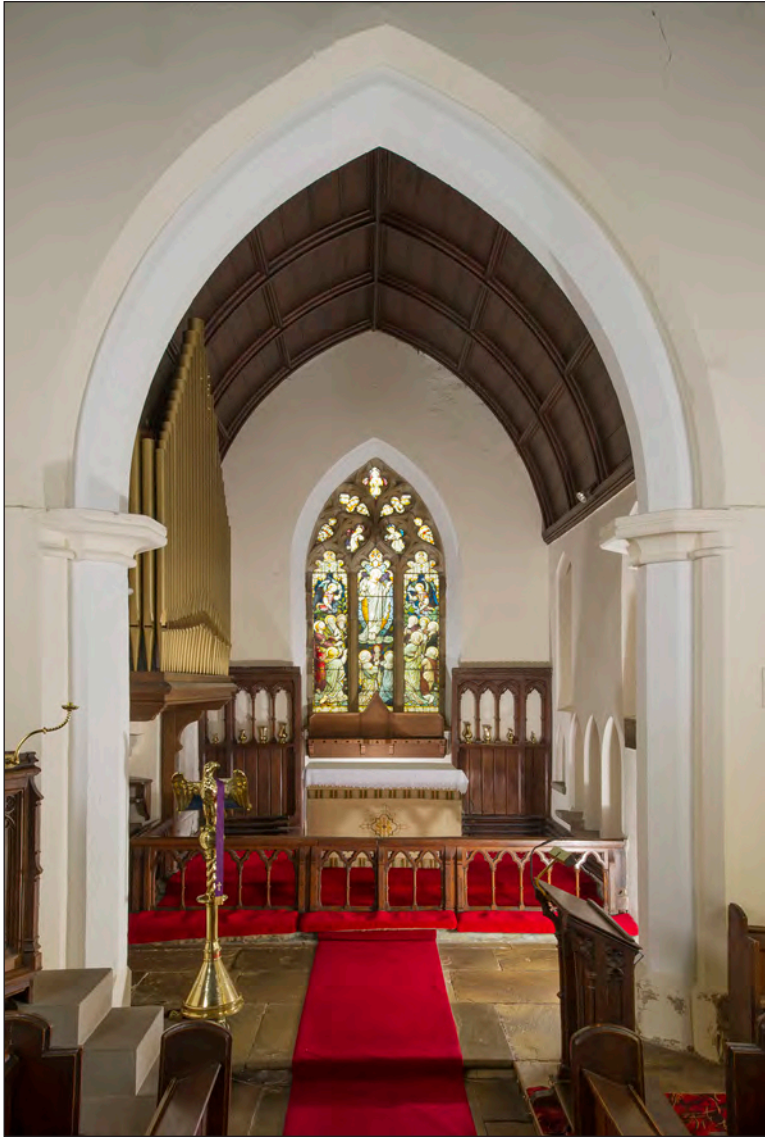
Figure 46: The chancel of the Church of St Anne, Ellerker, taken from the west (D168574 © Historic England, photograph: Alun Bull)

A low step and tall pointed chancel arch, with relatively simple chamfered moulding and prominent moulded impost capitals, separates the nave from the chancel (Figure 46). There is documentary evidence to suggest that this arch was re-used from the earlier, otherwise lost, chapel: the similarity in its measurements to that described in an application form describing the old chapel in 1843, one year before Pearson's interventions,¹⁸ and that it is described as such in the account of the consecration in 1844. It has changed in appearance since then, as it has lost the 1844 paintings of subjects connected with the life of Jesus (which are also described as located on the underside of the arch in 1844).¹⁹

with cusped pointed arches. Behind the altar is a wooden reredos, formed of two sections on either side of the east window, and composed of an upper tier of open trefoil-headed arches with blind square panelling below and moulded billet cornice above. The form of this reredos and its awkward situation flanking the east window, have led to different interpretations of its origin. One suggestion is that it was originally one piece and spanned the width of the chancel, covering the lower section of the east window, and that the middle section was removed when the window was replaced in 1897.²⁶ Alternatively, the style of the carving on the reredos, combined with the evidence of alterations and previous fixings not in accordance with its current location, suggest that it was originally part of a screen situated elsewhere in the chapel – perhaps the parcloze intended in 1844 to separate the chancel from the vestry²⁷ – or indeed another place of worship, and was later adapted for its current use. In this case, its current form and location could be the result of the installation of the new window in the 1890s.

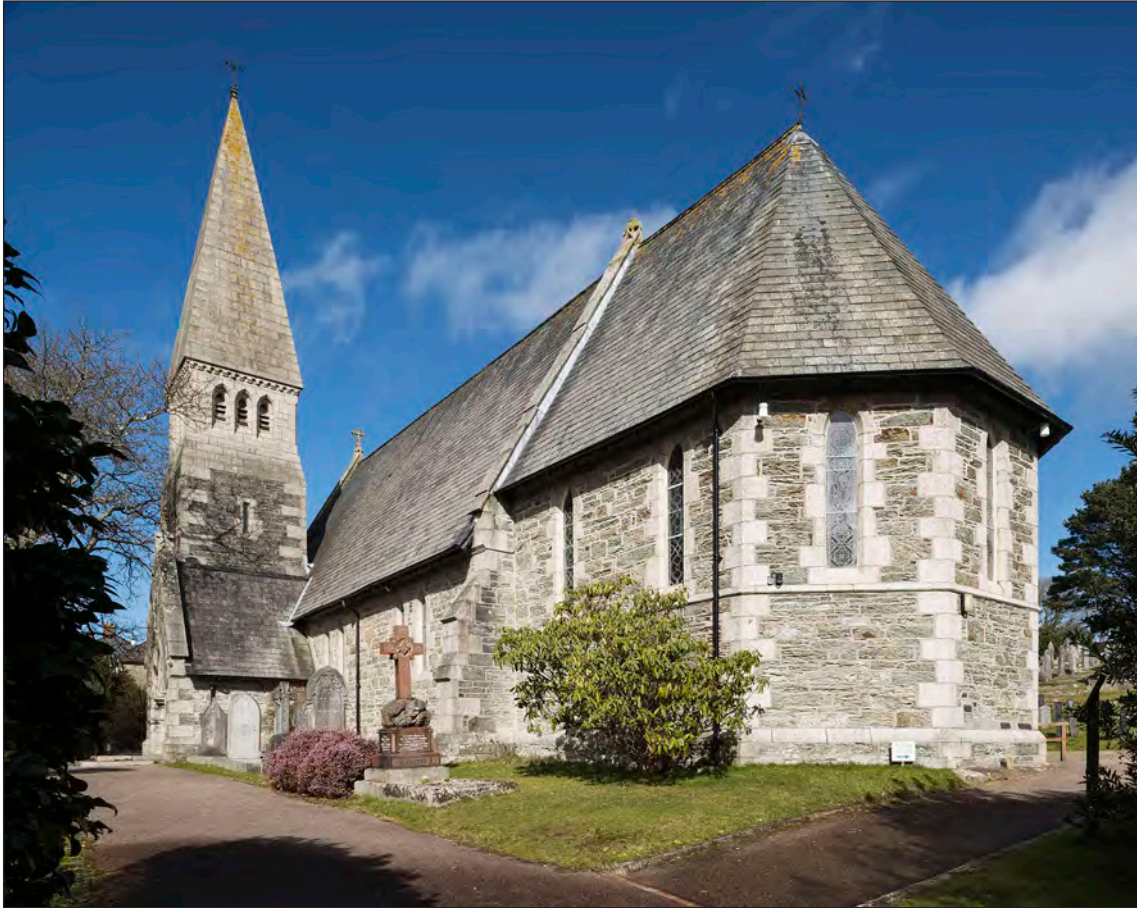
Figure 48: The Church of St John and St Petroc, Devoran, taken from the south (DP172549 © Historic England, photograph: James O Davies)

The Church of St John and St Petroc is located on the north side of the hamlet, on a hill overlooking the majority of the buildings which sprawl down the hillside towards the estuary and is aligned north-west to south-east. The church appears to have been built largely in accordance with Pearson's designs of 1854, with a long aisle-less nave, south porch and south-west tower, a chancel, with canted apse and with a small rectangular vestry on the north side (Figure 48). It is of uncoursed slatestone blocks and granite dressings with a steeply pitched roof covered with slate. The porch adjoins the tower and the latter rises in hipped stages to a compressed belfry stage from which rises a pyramidal spire. The style is Early English Gothic.

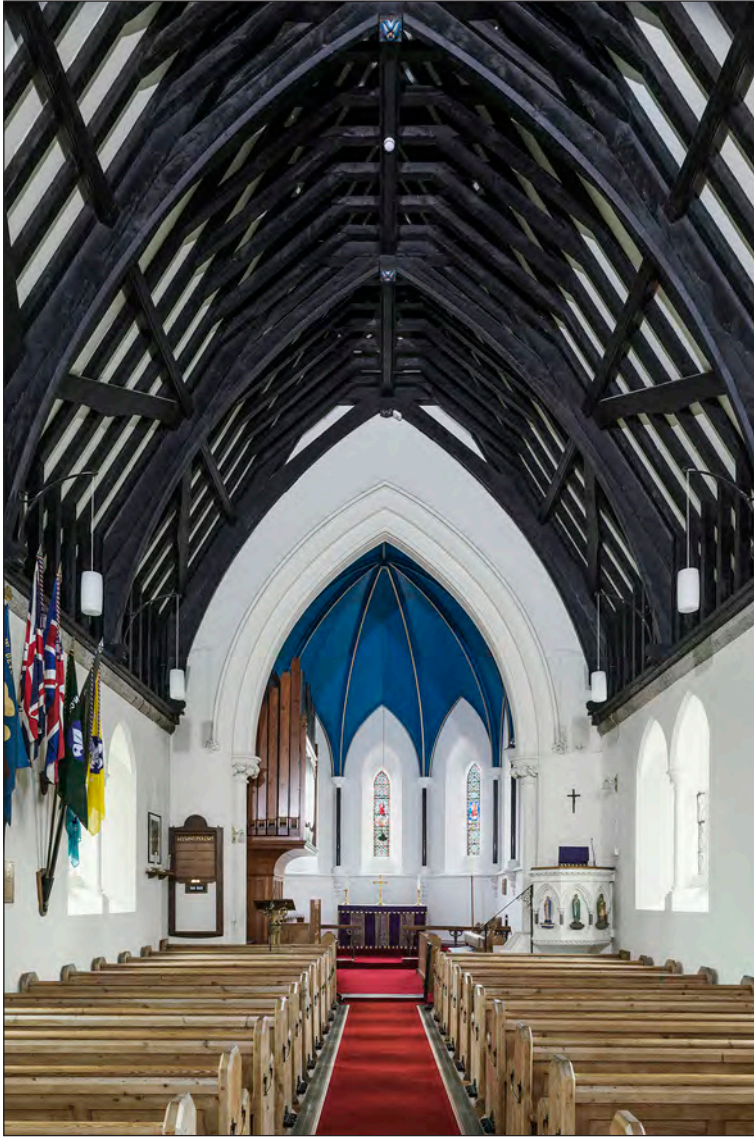
Figure 49: The nave of the Church of St John and St Petroc, Devoran, taken from the north-west (DP172553 © Historic England, photograph: James O Davies)

The congregation enter the aisle-less nave via the porch at the west end of its south wall. The nave (Figure 49) has a timber arch-braced collar roof of six bays with butt purlins and diagonal bracing, collar purlin, and ashlar pieces connecting the common rafters with the inner wall plates. The nave is lit by three two-light windows from the north and by two similar windows from the south. These windows have lancet lights and matching rear-arches which are supported by central shafts. There are also three tall lancet windows in the west wall. A central alley separates a reduced file of 13 pews on the north from a file of 10 on the south side. An octagonal stone font, Pearson's in style, with a square base occupies an off-centre position towards the rear of the church, as shown in Pearson's plan, and a painted semi-octagonal pulpit is similarly situated, as planned, on the south side of the east end of the nave. The pulpit is of Caen stone and painted white. It is reached from the north by three steps and its three outer faces have an arcade of pointed arches, with cusping, supported by engaged marble shafts. Below the arches are small incised trefoils and below these is a moulded band with dog-tooth detailing. Above the arches are small incised quatrefoils and a projecting moulded entablature decorated with trefoils. The pews are of pine, now stripped of any varnish, and simply finished with chamfered ends and umbrella racks. In slight contrast to the layout shown on Pearson's plan, the northern file of pews extends all the way to the chancel arch.
