The church and chapel interiors of John Loughborough Pearson: A selective assessment of significance

Clare Howard and Simon Taylor

Discovery, Innovation and Science in the Historic Environment

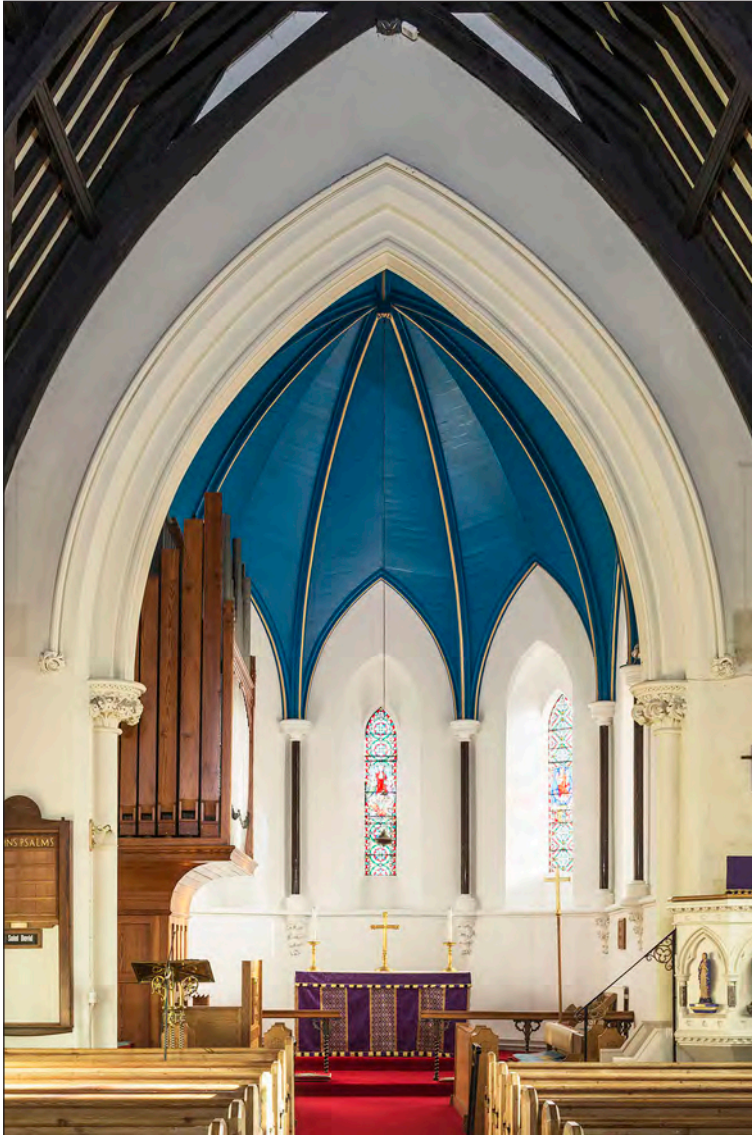
Figure 50: The chancel of the Church of St John and St Petroc, Devoran, taken from the north-west (DP172562 © Historic England, photograph: James O Davies)

The chancel (Figure 50) is separated from the nave by a pointed chancel arch with a hood mould and an inner arch which springs from engaged columns with foliated capitals. It is on three levels; the choir area is one step up from the nave, the sanctuary is a further step up and there is a wide altar plinth. The chancel has a polygonal timber vault carried on slender marble shafts which rise from moulded corbels with foliated drops. The chancel is lit by lancet windows, with stained glass, in each of the faces of the apse and by two further lancets in the south wall. Pearson's plan shows choir seats on either side of the chancel, evidently in the form of a chair with desk and an adjacent bench long enough for two people, but only on the south side are a chair, desk and bench present today and, although similar in style to the pews in the nave, the timber is considerably thinner and less substantial and it is likely that they were installed at the same time as the present organ (*see below*). Altar rails separate the sanctuary from the choir as shown on Pearson's plan. Originally joined by a hinged central section which is now missing, each rail is of moulded wood and is supported by three cast-iron barley-sugar legs with wide side braces pierced by trefoils with additional *fleur-de-lis* detailing. The sanctuary has a niche set into the north wall with an embellished

pointed arch, and an equally embellished hood mould, which springs from engaged marble columns. The projecting shelf has a chamfered lip and chevroned cornice. The niche contains a memorial tablet, possibly of slate, to John Phillpotts, MP for Gloucester and his wife Sara, both of whom died in 1849. The inscription also states that the chancel was built by their surviving children in their memory. A doorway in the north wall leads into a small rectangular vestry.

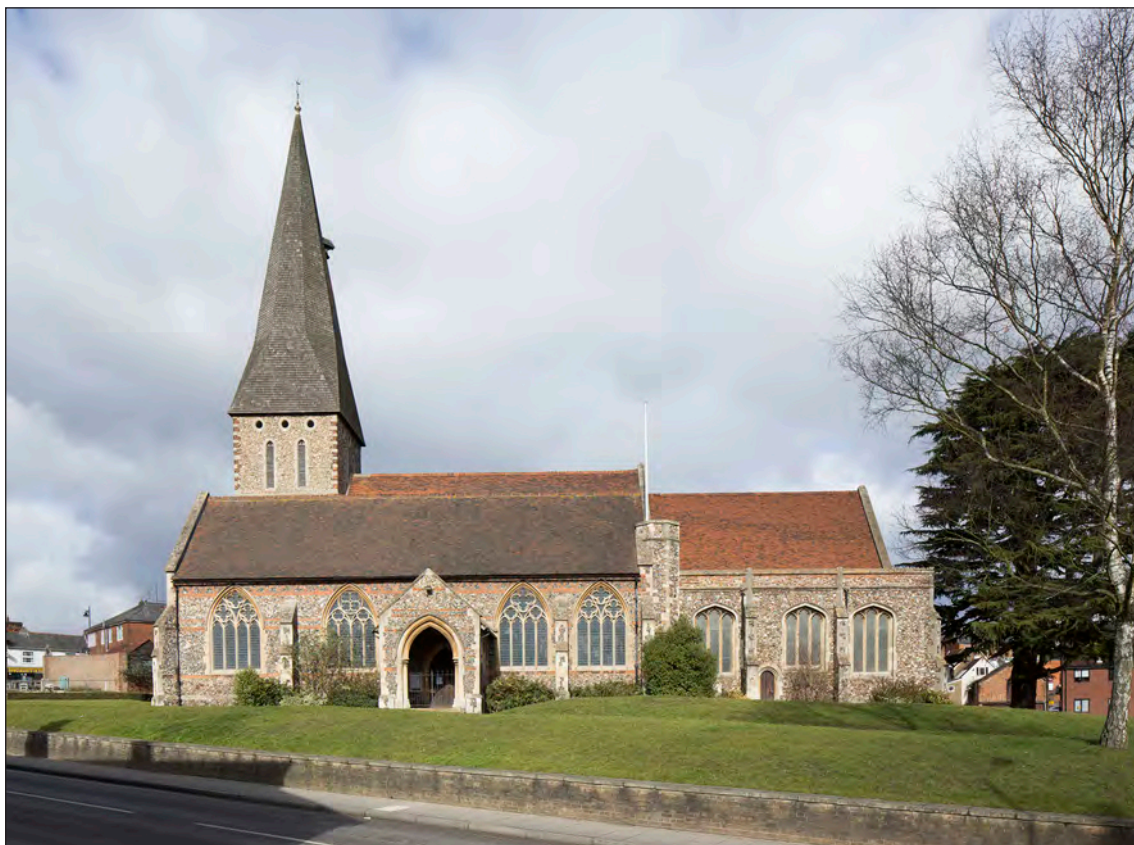
Figure 53: The Church of Michael, Braintree, taken from the south (DP172369 © Historic England, photograph: Pat Payne)

The Church of St Michael at Braintree is conventionally aligned east to west and has a three-bay nave with deep aisles to the north and south, a projecting west tower (with a shingled broach spire), a chancel with choir and sanctuary and deep aisles, and a vestry in the north-east corner (Figure 53). The congregation enter via opposed north and south porches roughly central to each aisle. The minister originally reached the vestry by an external doorway in the east end of its north wall (one of Pearson's modifications) and from there reached the sanctuary via a door in the south wall. There is a further external doorway in the centre of the south wall of the south chancel aisle (a pre-Pearson feature) and a spiral stair in an octagonal turret set within the angle between the south chancel and nave aisles; the stair formerly gave access to the lost galleries and is presumably now largely redundant except for providing access to the church's flagpole.

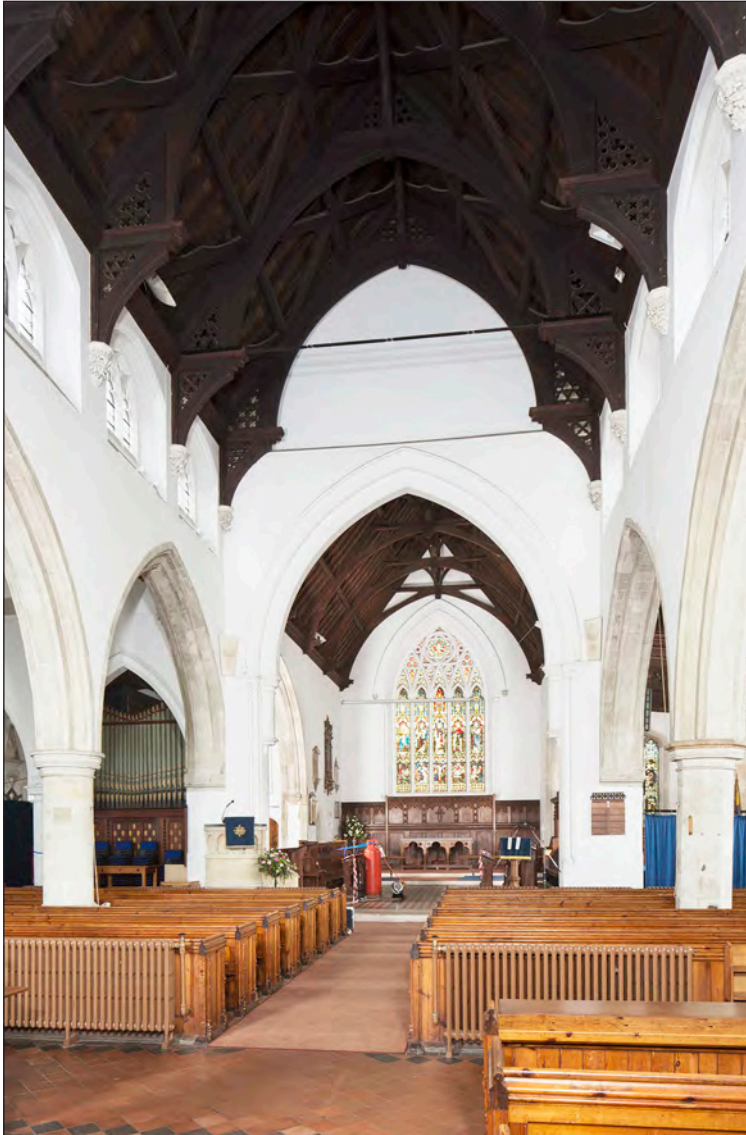
Figure 54: The nave of the Church of St Michael, Braintree, taken from the west (DP172370 © Historic England, photograph: Pat Payne)

The three-bay nave (Figure 54) is entered directly from either the north or south porch. It has a six-bay arch-braced collar-rafter roof with diagonal bracing and is separated from the aisles by restored 13th-century⁶⁸ arcades of pointed arches on alternating circular and octagonal piers which support a clerestory. The clerestory windows (six on each side) are set within embrasures with pointed arches and have three lights each with intersecting tracery. The alleys are floored with red and black clay tiles and the pewed areas with wooden blocks. The nave now contains 20 pews in four files, either side of a central alley and the north to south alley linking the porches, which extend into the aisles on either side. Comparison with Pearson's plan of 1866 suggests that a total of six pews have been removed from the rear of the nave and two from the front. The font has also been moved from its earlier position, towards the rear of the central alley and has been placed at the east end of the north aisle, probably when changes were made to the rear of the nave and south aisle in the late 20th century. The timber pews are set on sleeper beams and are flat topped with moulded hand rails and the sides each have a pair of moulded pilaster strips in the form of buttresses.

The pulpit is of white ashlar and is positioned as shown on Pearson's plan of 1866, on the north side of the nave and, hard up against the chancel arch, it is reached by three winding steps from the south-east. It is circular, however, rather than octagonal as the plan shows – although it is most likely Pearson's design – and its upper section is decorated with a blind arcade of two-centred arches with engaged circular columns with roll mouldings. The spandrels are embellished with floral mouldings.

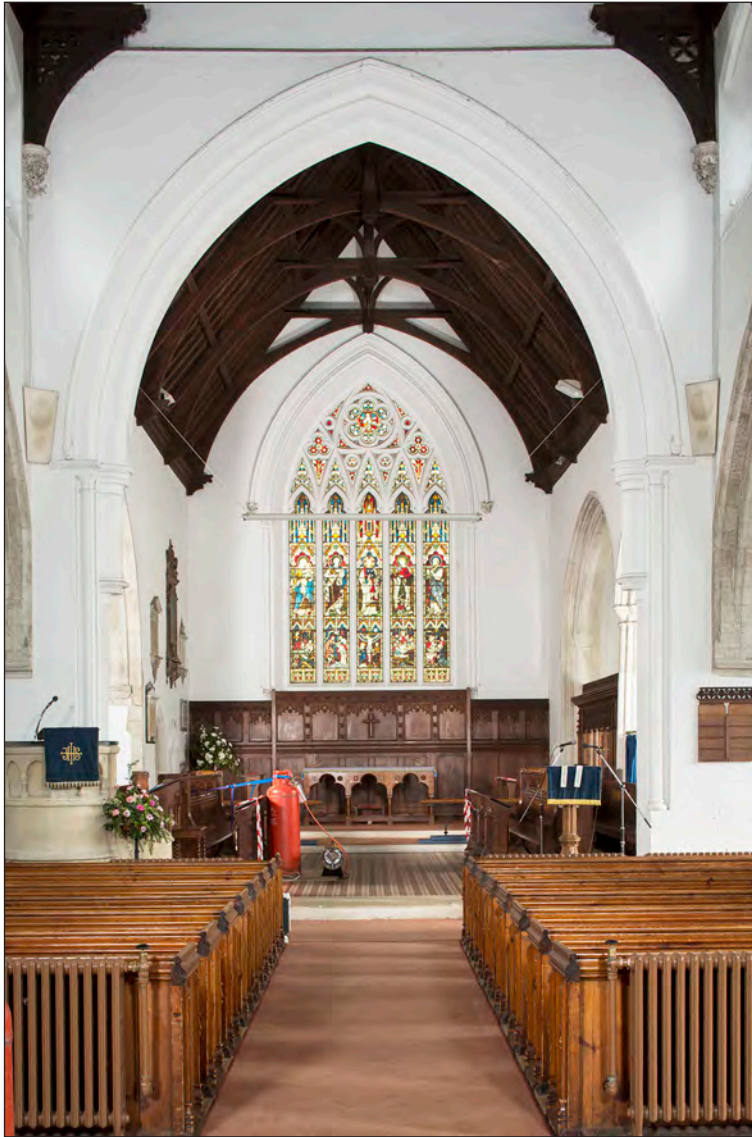
Figure 55: The chancel of the Church of St Michael, Braintree, taken from the west (DP172375 © Historic England, photograph: Pat Payne)

The chancel (Figure 55) is separated from the nave by a pointed chancel arch, by Pearson, of two chamfered orders springing from circular engaged columns. It has a four-bay, king-post roof and is lit from the east by a large, five-light window with elaborate tracery, similar to in style to those in the north and south aisles, of Pearson's design. The choir is one step up from the nave and has a floor of plain black and red clay tiles and encaustic tiles. It is furnished with opposed choir stalls – with chamfered elbows, crosses carved into the ends and upper backs pierced with trefoils – rear benches and reading desks, all set onto sleeper beams. The sanctuary is on two levels above the choir, as shown on Pearson's plan of 1866, but there is no pedestal for the altar and the altar rail – of moulded timber with wrought-iron scrollwork legs – is set at the lower level, rather than the upper as shown on Pearson's plan. The altar table has eight turned legs with trefoil arches and paterae in the spandrels. The guidebook of 2009 states that the altar pedestal had been removed by the 1960s and that the table was also moved away from the wall at this time. There is a Victorian piscina set into the south wall of the sanctuary with a four-centred arch and elaborate hood mould with labels. It is matched by a corresponding larger niche in the north wall with a trefoil head, springing from engaged columns and enriched with dog-tooth detailing, beneath a two-centred hood mould. An elaborately corbelled shelf projects from the base.

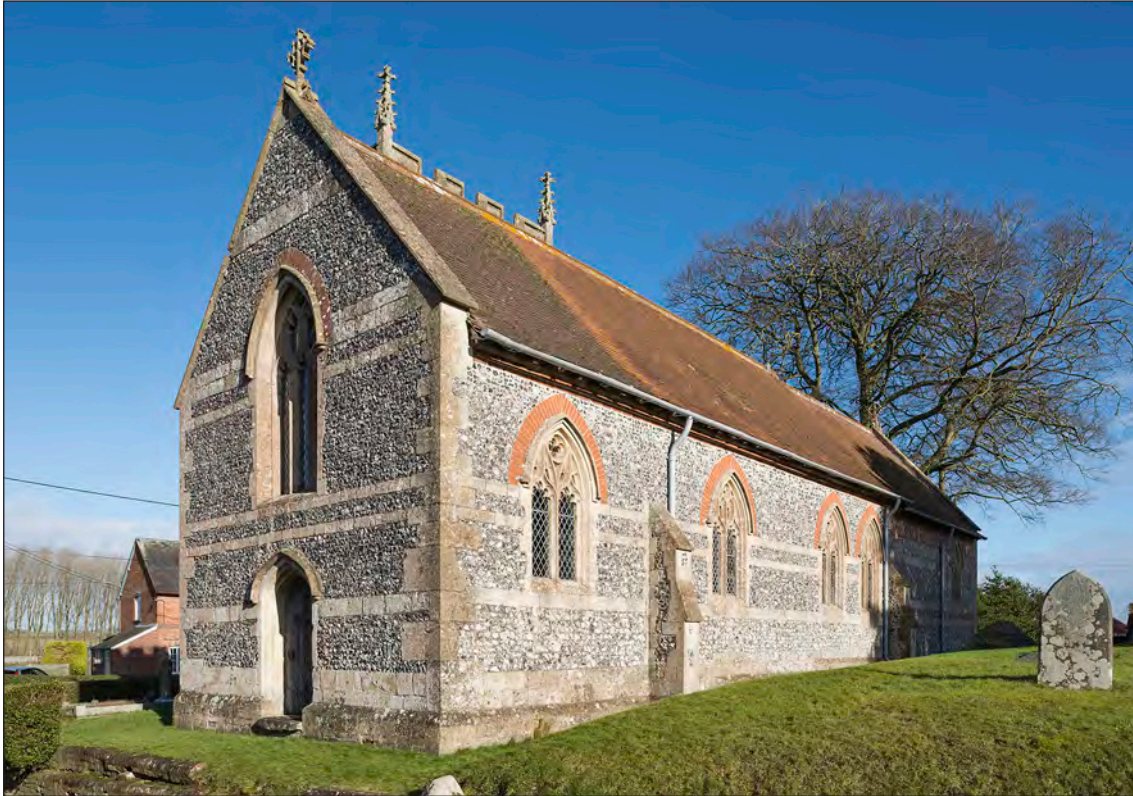
Figure 58: The Church of St Peter, Charlton, taken from the south-west (DP164987 © Historic England, photograph Steven Baker)

The rebuilt Church of St Peter at Charlton is aligned east to west (Figure 58) and has a continuous nave and chancel, both without aisles, of 1857-8 built of flint with stone dressings and bands and pointed red-brick arches to the windows. The roof is covered with red clay tiles and the chancel roof is marginally lower than that of the nave. The nave is attached to a Perpendicular-style north tower of probable early 16th-century date and an evidently re-built north chapel, also originally of early 16th-century date, built of local sandstone.⁹⁰ The tower is of three stages and has crocketed finials at its corners; both it and the north chapel have crenellated parapets and carved heraldry. There is no vestry. The interior walls are plastered and whitewashed and there is no stained glass.

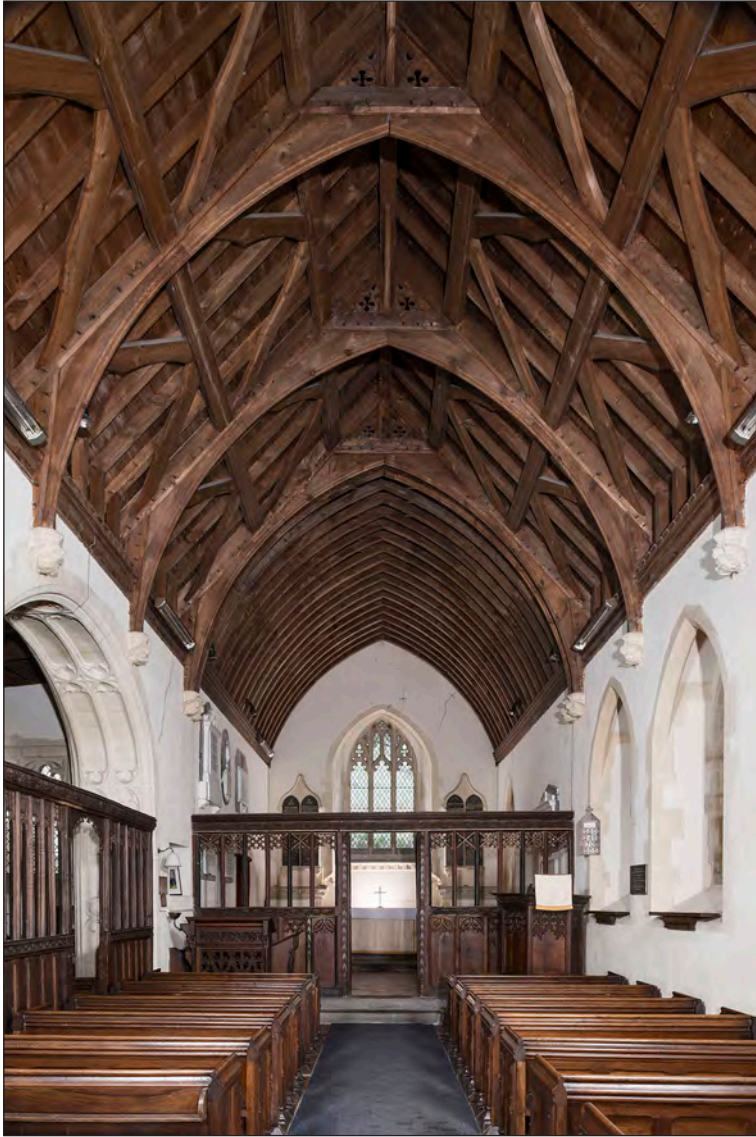
Figure 59: The nave of the Church of St Peter, Charlton, taken from the west (DP164988 © Historic England, photograph Steven Baker)

Pearson's nave (Figure 59) has a six-bay arch-braced collar roof with two tiers of roll-moulded and stopped purlins with cusped bracing. There are panels carved with quatrefoils above the collars and the principals rise from stone corbels carved as angels bearing the instruments of the Passion. There is brattishing to the wall plates. The nave is lit from the south by four two-light windows with pointed cusped arches and from the west by a high-set three-light window, also with a pointed arch and tracery, below which is an external doorway without a porch or lobby. The nave has a central alley which is paved with stone slabs, now covered by carpet, and the pewed areas which flank it have timber flooring, giving way to red and black clay tiles around the font and towards the front of the nave. The pews are of oak with square ends and buttresses and are presumably of 1858. In style they are similar to the pews found at other Pearson churches of about this date. The elaborate stone font was carved by Salmon of Devizes⁹² and is positioned as shown on Pearson's plan of February 1857. It has an octagonal bowl (with florets in quatrefoils around it) and stem on a spurred square base. It is dated 1858 and bears the names of the Fowles and a Latin motto on the base and has an oak cover with an iron cross. The pulpit, which is, unusually, positioned on the south side at the front of the nave, is hexagonal and of oak with blind tracery panels. It is also of 1858 and was carved in Cambridge,⁹³ probably by Rattee and Kett of Cambridge, a firm Pearson turned to during other commissions. On the north side of the nave is a reading desk, facing west, also of oak with pierced tracery; like the pulpit it is of 1858 and was carved in Cambridge, probably also the work of Rattee and Kett.⁹⁴

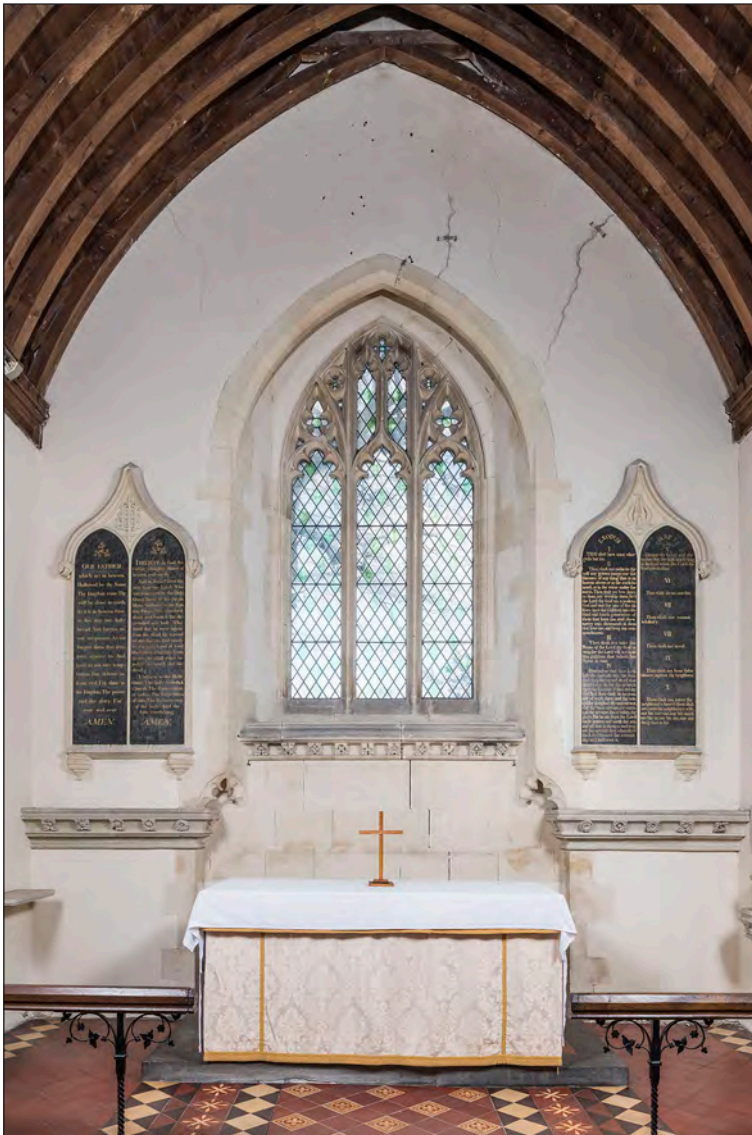
Figure 60: The chancel of the Church of St Peter, Charlton, taken from the west (DP164995 © Historic England, photograph: Steven Baker)

Council for the Care of Churches report of 1988, the altar is of oak, has carved octagonal legs and is almost certainly of 1858.⁹⁵ The east wall has a moulded band with fleurons on either side of the altar and another above it, within the reveal of the east window, which is flanked by cusped ogee arches. There is a stone credence shelf on the north wall and the east window is flanked by the Ten Commandments incised into slate panels and set within ogee-headed frames.

Although a vestry is shown on the north side of the chancel on both of the known ground-floor plans of *circa* 1887-8, this was not executed, but there is an external doorway in the north wall of the choir. The doorway has a simple chamfered ashlar surround with a segmental head but the timber door is set with its outer plank surface facing into the church while the heavy bracing, strap hinges and even the lock are on the outside. Furthermore, the door is set flush with the inner face of the wall and so is deeply recessed within the thickness of the wall when viewed from the outside. This, combined with the complete lack of external embellishment to the external door surround, suggest that it was always intended to be an interior doorway allowing access to the chancel from the pending vestry.

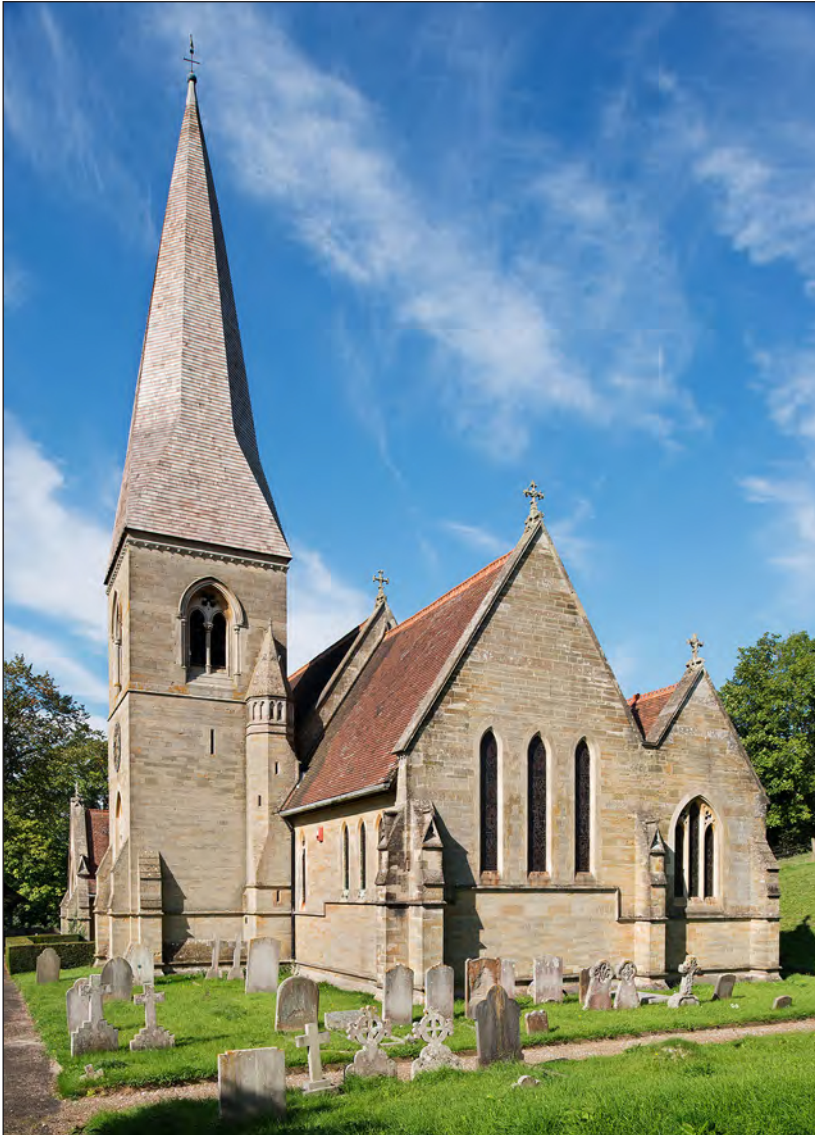
Figure 61: The Church of St James, Titsey, taken from the east (DP167290 © Historic England, photograph: James O Davies)

The Church of St James is aligned south-west to north-east, rather than west to east as is more conventional, and is situated at the corner of Pilgrims Lane and Titsey Hill, overlooking Titsey Place. The church consists of a south porch, nave, chancel, south transept, north side chapel and north vestry. The exterior is constructed of Limpsfield sandstone enlivened by bands of Bath stone and Bath stone dressings, with pitched roofs covered with red clay tiles (Figure 61). There is a tower attached to the south side of the building over the south transept which has a broach spire covered with shingles. Like the majority of Pearson's churches, it is a mixture of the Early English and Decorated styles which is largely manifested in the window tracery but also in the decorative flourishes. Internally, the walls are faced with Bath stone interlaced with bands of green firestone from Godstone¹¹² in subtle tones as well as other embellishments.

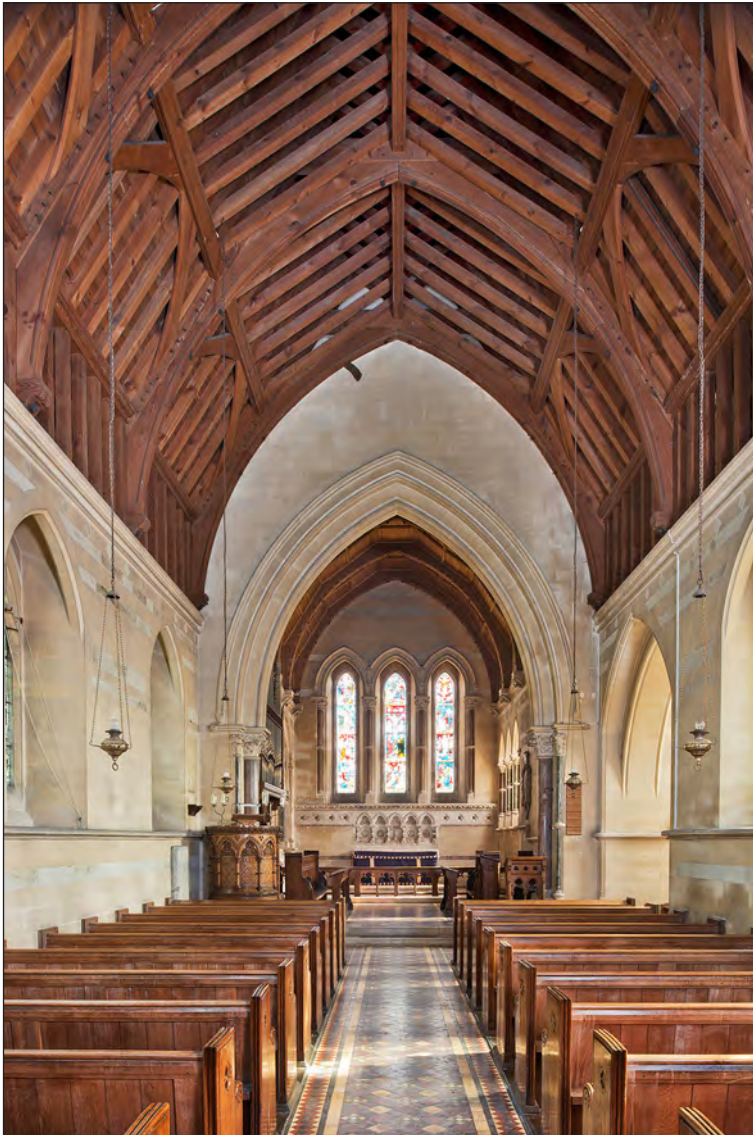
Figure 62: The nave in the Church of St James, Titsey, taken from the south-west (DP167294 © Historic England, photograph: James O Davies)

The rectangular nave is typical of Pearson's earlier churches with an impressive timber arch-braced collar roof of Baltic red deal (Figure 62).¹¹⁴ The roof is particularly steep and is of five bays with large moulded arch braces, collar purlin and butt purlins. It is strengthened by large wind braces between the arch braces and the purlins. The Bath stone walls of the nave are enlivened by inlaid bands and squares of green firestone, a moulded stone cornice along its side walls and a moulded stone string course which runs throughout the nave and steps up to the base of the window sills along the south-west wall. The nave is lit by three double lancet windows with trefoils set within deep, arched openings in the north wall and two matching windows in the south wall, while in the west wall are two taller lancet windows and a separate quatrefoil set within a roundel. All were most likely designed and fitted with clear leaded glass in 1861 but each window has incrementally been filled with stained glass in memory of members of the Gresham and Leveson-Gower families (*see below*). The floor is covered with wooden boards in the pewed areas but with square and rectangular, colourful tiles within the aisles. The square, stone, table font stands to the east of the nave doorway, towards the rear of the church, and is supported by a large central, square, stem and four short, pink, marble shafts with elaborate foliated capitals upon a square stone base. The upper square top of the font has moulded edges to its top and bottom and a narrow line of nail-head detailing to its upper edge. The basin has a flat oak cover over with a large iron lifting ring at its centre. The floor tiles, which include some small encaustic tiles, around the font demarcate the area of the baptistery and are more elaborate than those found elsewhere in the nave.

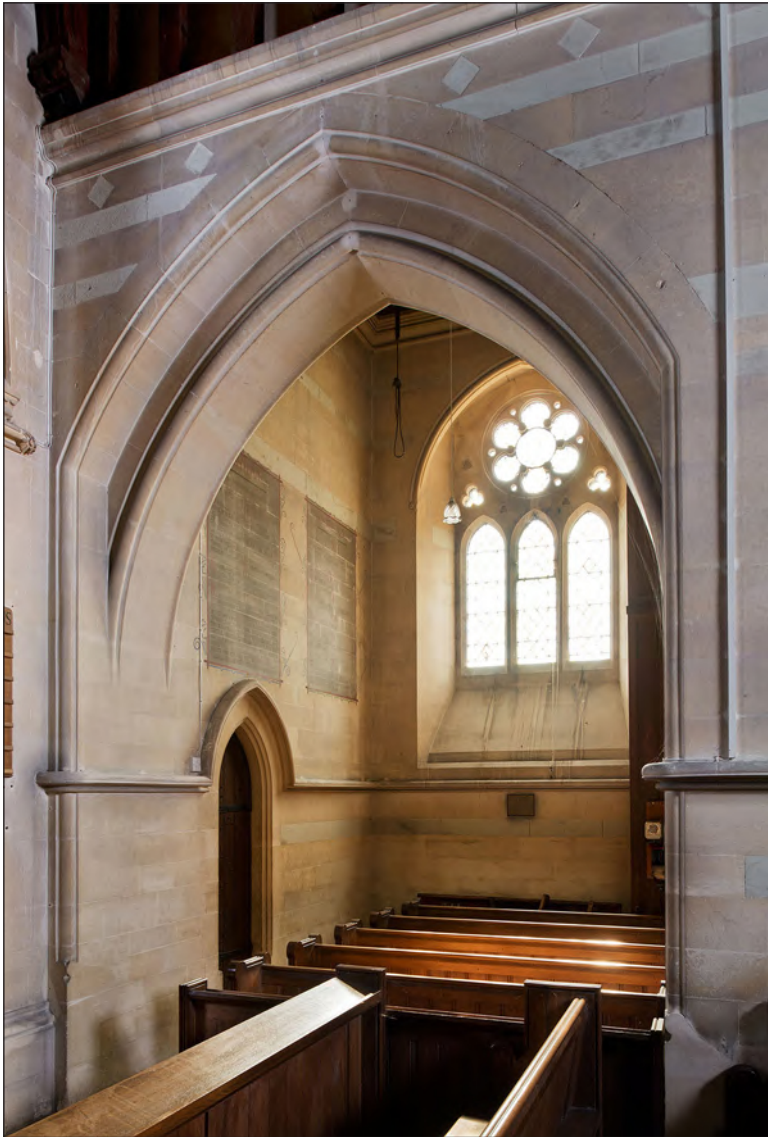
Figure 63: The south transept in the Church of St James, Titsey, taken from the west (DP167295 © Historic England, photograph: James O Davies)

The south transept, directly below the tower, is separated from the nave by a tall pointed arch set within the south wall of the nave (Figure 63). The ceiling over the transept is of flat timber construction supported by timber beams and with an opening for the bell pulls. Both the bands of firestone and moulded string course within the nave continue into the south transept which is lit by a three-light window with an octofoil and two smaller trefoils above, all set within deep, arched openings, in the south wall. The windows contain what appears to be pre-19th-century glass bearing the Greshams motto, ‘fiat voluntas tua’, although whether this glass was reused and installed as part of the 1861 phase, or later in the building’s history, is unclear. A pointed-arched doorway in the east wall opens on to a stone spiral staircase which leads to the upper storey or belfry of the tower. The transept is fitted out with five smaller wooden pews, of simpler design than those in the nave with square bench ends finished with rounded detailing to the upper corners, used to seat children.¹¹⁷

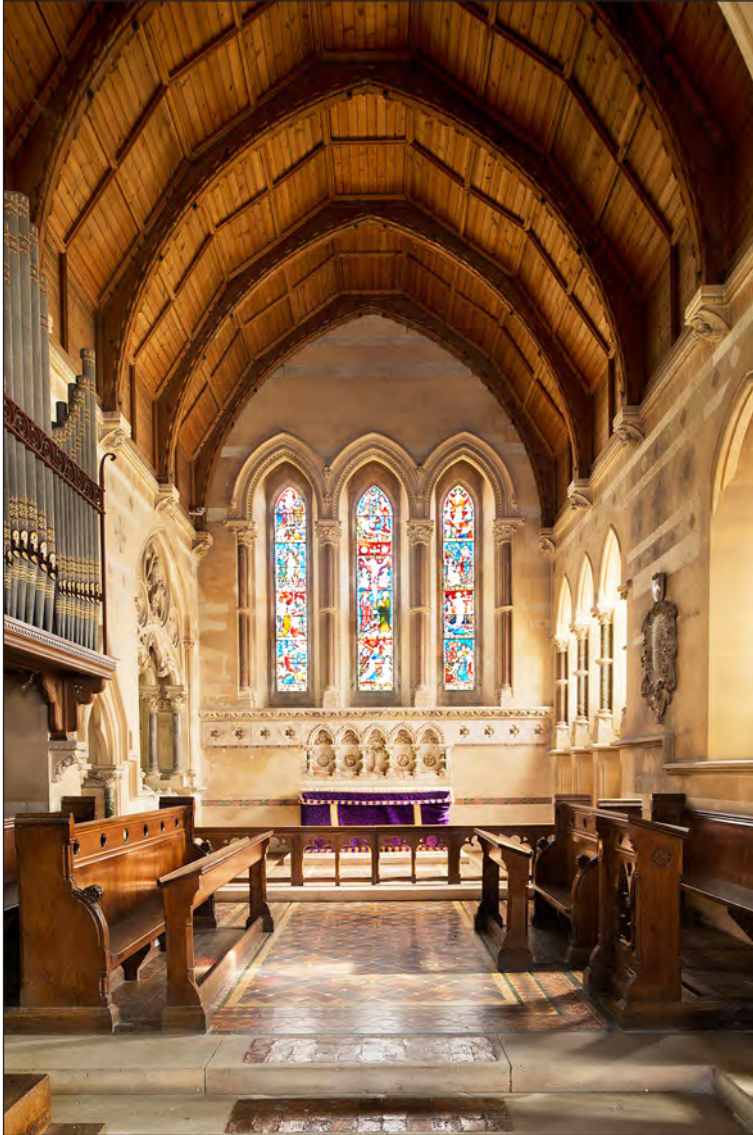
Figure 64: The chancel in the Church of St James, Titsey, taken from the southwest (DPI67297 © Historic England, photograph: James O Davies)

The division of the nave and chancel is more pronounced than in many of Pearson's churches, with a tall pointed chancel arch of three orders supported by cylindrical shafts of Devonshire pink marble¹¹⁸ and smaller shafts of grey marble (which support the hood mould over the arch) with carefully moulded foliated stone capitals. At the base of the columns are two stone steps and in the centre of each of these steps is a small panel of what appear to be medieval glazed tiles (as explained above). As with most of Pearson's churches, the rich interior decoration is more intense within the chancel (Figure 64). The whole of the chancel is covered with a timber arch-braced roof but, unlike the nave, the trusses are supported by carved stone corbels with angels and the rafters are covered with boarding. As with the nave, the walls continue to be inlaid with bands of green firestone but these are intermixed with quatrefoil and diamond patterns of different coloured stone. At the very top of the walls, reading from the west end of the north-west wall to the right and along the south-east wall, the following words are written in red paint:

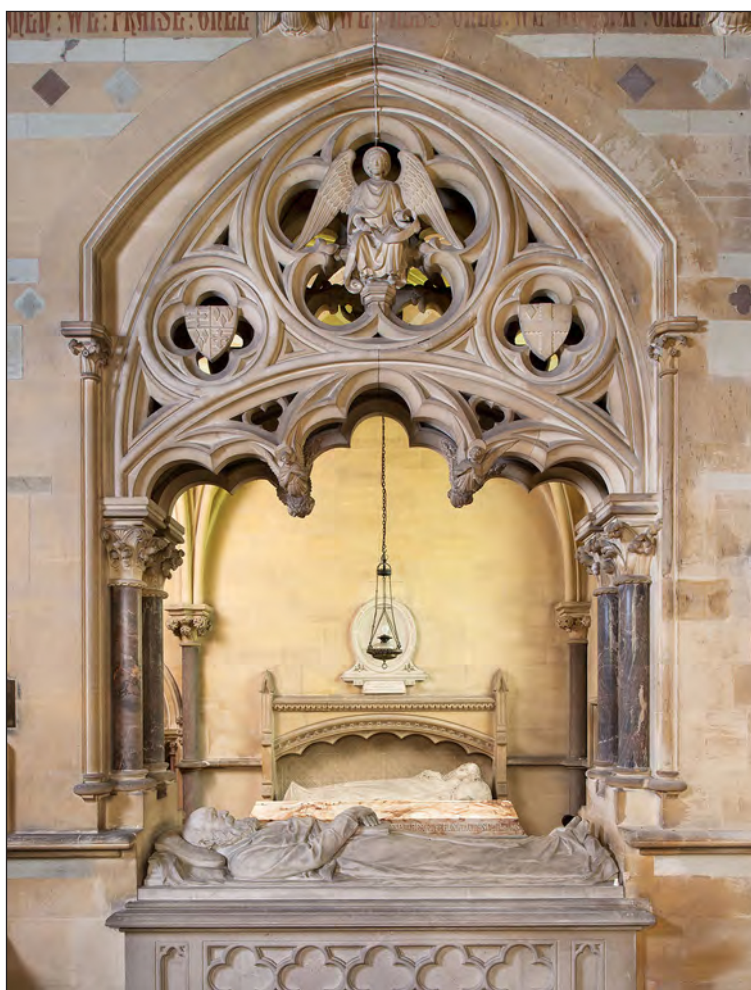
Figure 65: The screen between the chapel and chancel and canopied tomb in the Church of St James, Titsey, taken from the south-west (DP167313 © Historic England, photograph: James O Davies)

To the north of the altar and set within an arched opening in the in the north-west wall of the chancel, between the chancel and the Leveson-Gower chapel, is an impressive, double, richly-carved, Decorated-style tracery screen. It is supported by grey marble shafts with foliated capitals which now forms a canopy over the effigy and tomb of Granville Leveson-Gower (died 1895) who took over as patron when his father, William, died in 1860 (Figure 65). It is known from the 1861 newspaper article that a canopy screen was designed and executed by Pearson and this is described as ‘an open screen of the Decorated style, the arches double, and double marble shafts’.¹²⁷ However, a second undated and unsigned painting of the screen (painted before the tomb was inserted in *circa* 1895) hung in the church suggests that the original screen consisted of three cusped arches supported by marble shafts and foliated capitals. If the depiction is to be believed, only the pointed-arched niche and outer shafts with capitals survive from Pearson’s original design, the remainder being altered to accommodate the tomb in *circa* 1895.

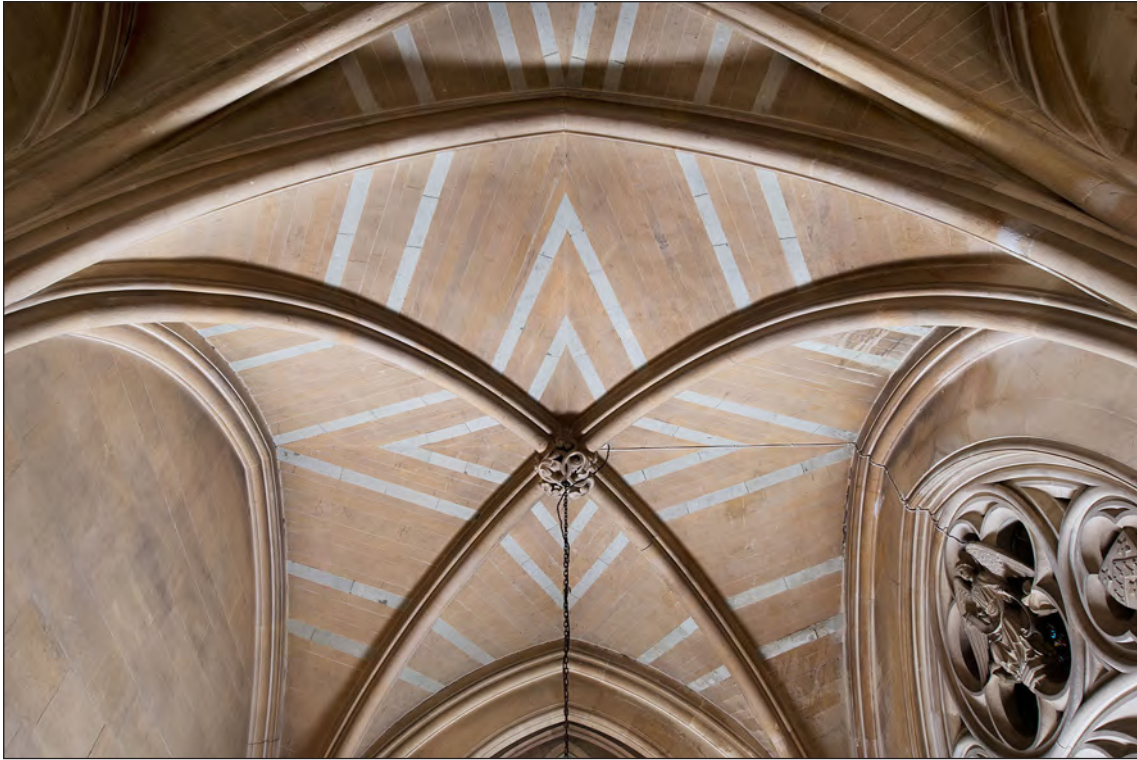
Figure 66: The vaulted ceiling in the chapel, the Church of St James, Titsey (DP167318 © Historic England, photograph: James O Davies)

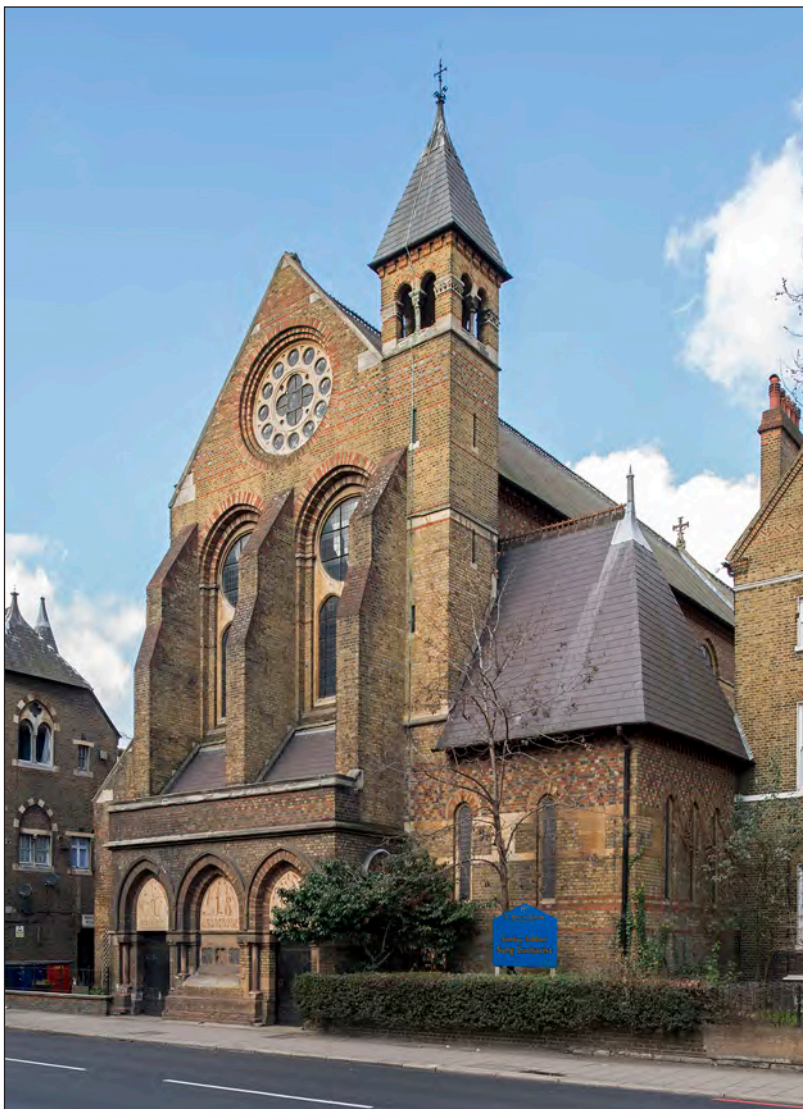
Figure 69: The Church of St Peter, Vauxhall, taken from the south-east (DP164363 © Historic England, photograph: Lucy Millson-Watkins)

The church is constructed of polychrome brickwork (mostly yellow London stock brick with red brick detailing) with ashlar stone dressings while the roofs are pitched and are covered with slate (Figure 69). It is principally in the 13th-century style, although it includes some classical details such as the capitals of the nave columns and overall proportions, particularly within the nave arcade, which have been proportioned in accordance with the Golden Section. The apsidal chancel has elements of Early English and Norman church architecture and the overall plan form of St Peter's is notable as previously other Pearson churches, St John and St Petroc, Devoran aside, have all been of a traditional English plan, whereas Vauxhall's is markedly Romanesque.¹⁶⁹

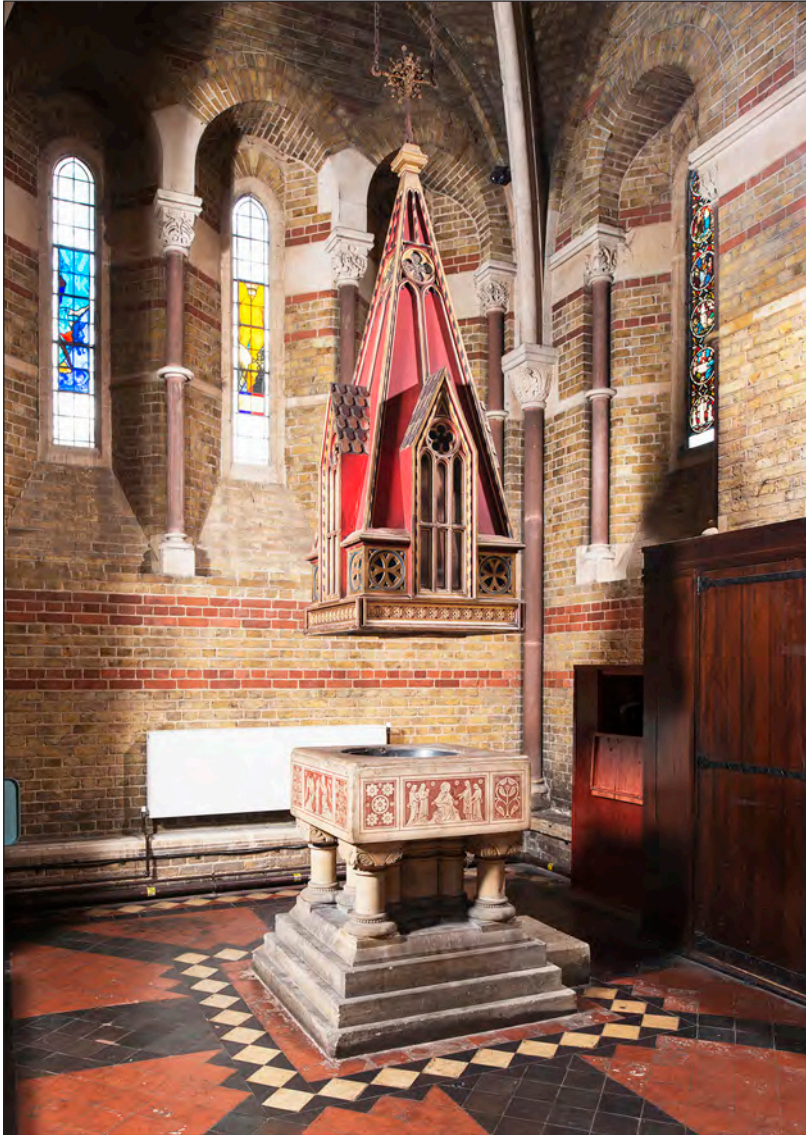
Figure 70: The baptistery of the Church of St Peter, Vauxhall (DP166604 © Historic England, photograph: James O Davies)

The baptistery is located to the east of the main entrance from the narthex, occupying a dedicated space which is roughly square in plan (Figure 70). Like the remainder of the church, this space has a vaulted ceiling formed of stone ribs with brick infill and a central carved stone boss, from which the mechanism for lifting the font cover is suspended. The baptistery is lit by three lancets in the east wall, and two similar ones in the south wall, all within splayed openings. The windows in the south wall contain stained glass installed by Clayton and Bell in 1865¹⁷¹ whereas those in the east wall have stained glass which was added more recently (*see below*). Befitting of its role and significance, the space is laid with red, black and buff tiles arranged in a more decorative pattern than those found in the nave or aisles.

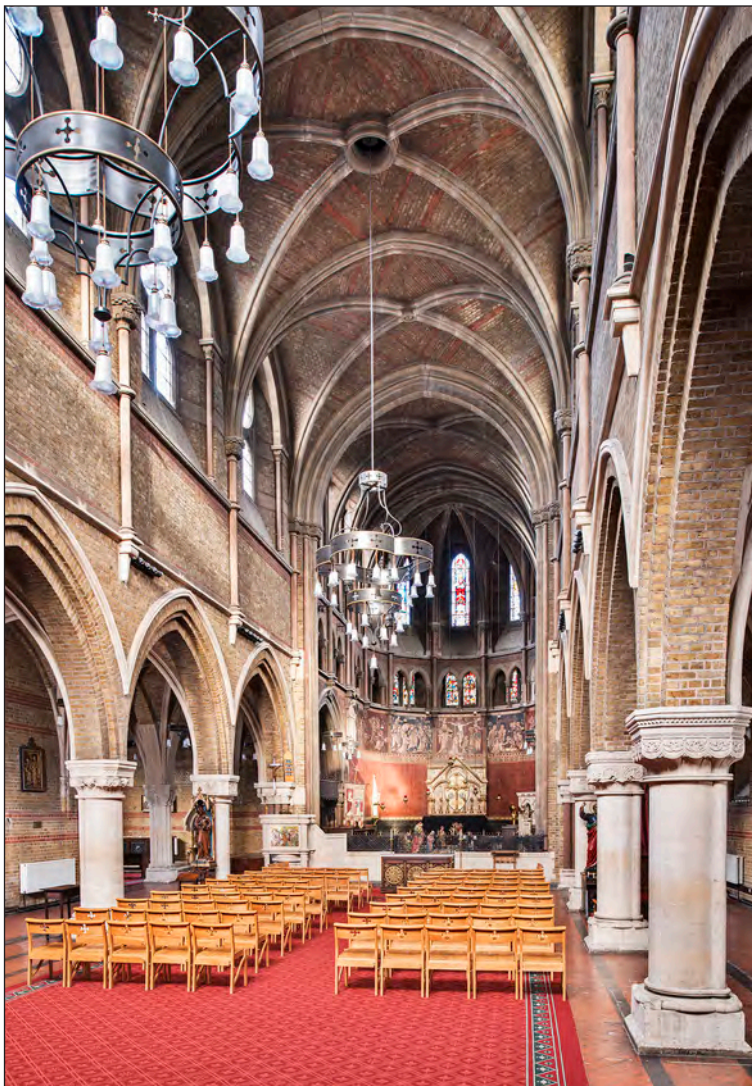
Figure 71: The nave of the Church of St Peter, Vauxhall (DP166600 © Historic England, photograph: James O Davies)

The five-bay nave is separated from the aisles by stone piers decorated with capitals, each one unique in style, emulating 12th- and 13th-century designs – billets, dog toothing, nail-heads, leaf and *fleur-de-lis* motifs (Figure 71). The northernmost piers on both sides of the

nave, closest to the chancel, contain carvings in relief of biblical figures in shallow arches. The pointed arches of the nave arcades are formed of brick and are double chamfered, with continuous stone hood mould dressings above. Above this is a horizontal stone string course which is punctuated by stone corbels with pointed drops supporting cylindrical shafts of pink stone which are in turn surmounted by carved stone capitals. The ribs of the quadripartite vaulted ceiling are sprung from these stone corbels and at the intersection of the ribs, there are either small decorated stone bosses, or larger hollow bosses with fittings for the suspension of metal lamp pendants. The pendants hanging from the vaulting in the nave are not original, although they do likely bear some resemblance; the church was lit by 'circles of gas, hanging from the underside of the nave arches' in 1865.¹⁷⁵ The nave is lit at clerestory level by windows formed of relatively simple tracery; each nave bay contains plate-tracery windows with large roundels and below these is a blank triforium which was originally intended to be painted with scenes of the Old Testament on the north side and from the New Testament on the south side.¹⁷⁶ A contemporary account of the church suggests that one of these may have been painted when the church was first opened, but when and why this was removed is unclear.¹⁷⁷

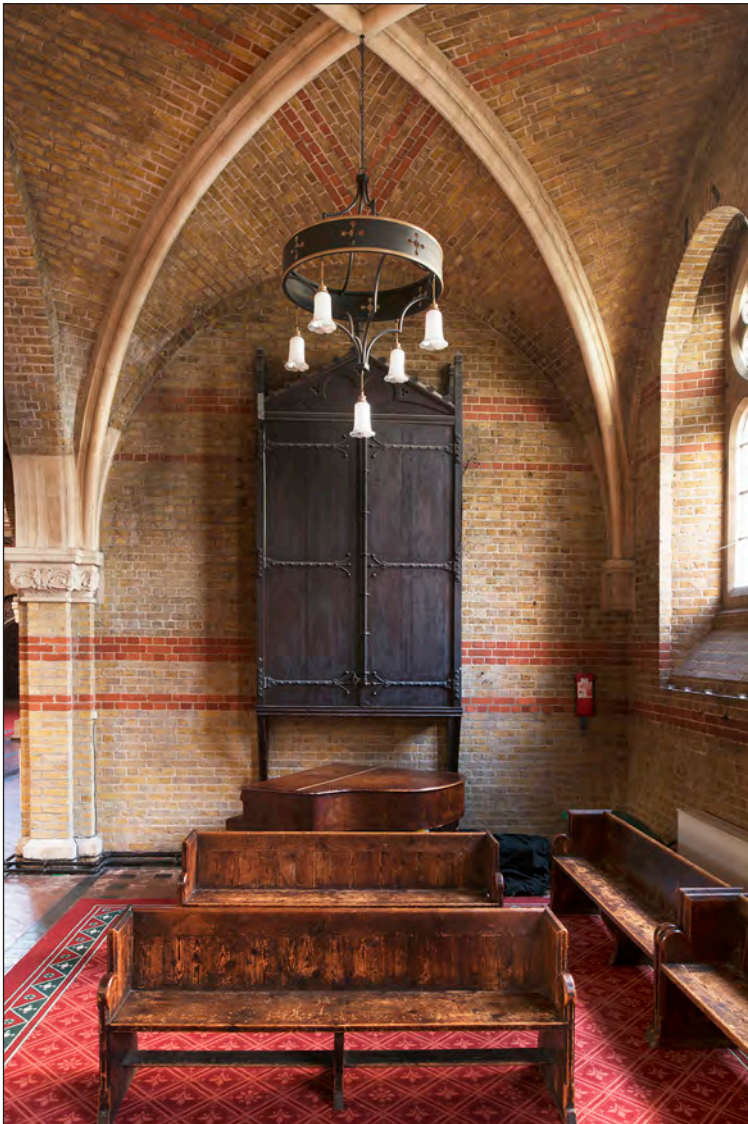
Figure 72: The west transept of the Church of St Peter, Vauxhall (DP166629 © Historic England, photograph: James O Davies)

bay has two two-light plate-tracery windows with sexfoils above each couplet, while the northern bay has a single composite arrangement of a stepped three-light window. As with the nave and aisles, this space is laid with red and black tiles. The wooden banner cupboard with gabled head and double-leaf doors with iron strapwork, attached to the south wall, is thought to have been designed by Pearson as part of the first phase of the church.¹⁸³ The simple wooden pews with the square bench ends and rounded elbows are also probably part of the first phase of the church and their size suggests these may have been the benches used for children within the transept albeit realigned east-west rather than north-south, the latter being the original arrangement as suggested by Pearson's 1861 plan.¹⁸⁴

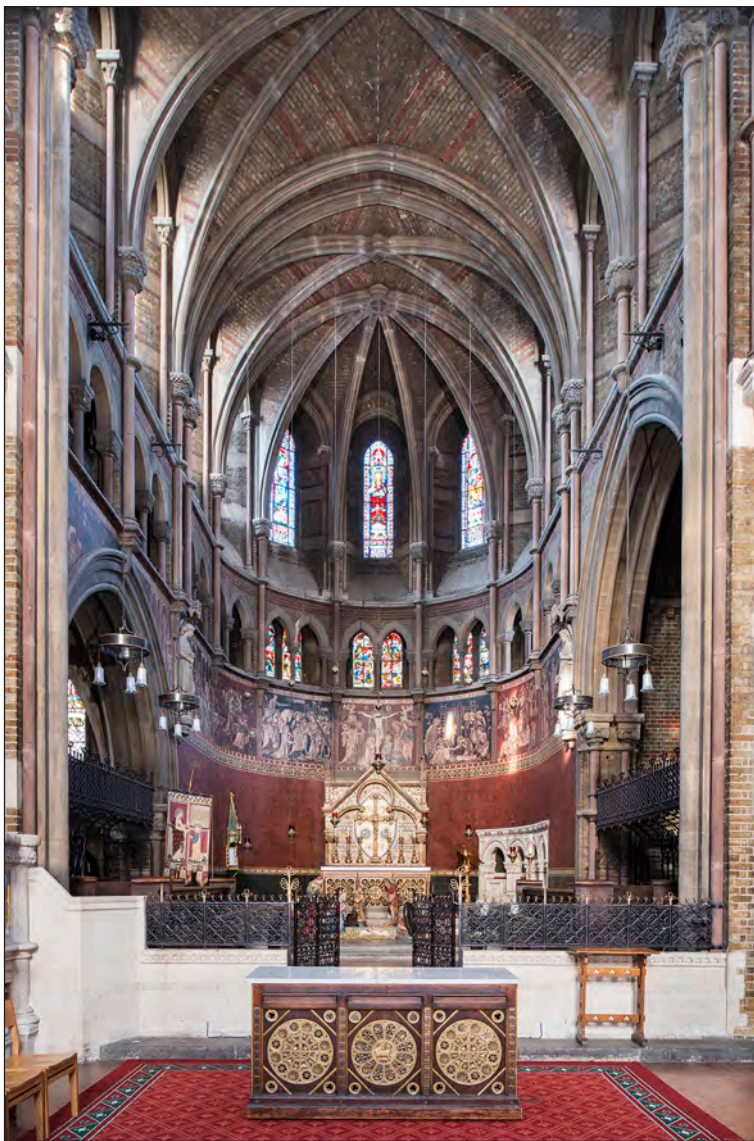
Figure 73: The chancel of the Church of St Peter, Vauxhall (DP166612 © Historic England, photograph: James O Davies)

two steps above the level of the nave. The vaulting above the choir is sexpartite, in contrast to the quadripartite vaulting of the nave, but it continues in the same style with thick stone ribs and brick fill. The choir is lit at clerestory level by pairs of lancet windows in the east and west elevations and below these is a triforium gallery punctuated by two pairs of arches which spring from carved stone capitals and cylindrical shafts. Below the triforium, the choir is separated from the side aisles by large pointed arches (the eastern of these is larger than the western arch, presumably to accommodate the organ) closed with wrought-iron screens added in 1867.¹⁸⁵ A central alley, of red and black tiles, leads from the nave steps to the sanctuary while the flanking areas, which contain the choir stalls, have wooden boards. There are two sets of choir stalls, each with three benches and accompanying desks; the bench ends have rounded tops, rounded elbows and small shaft and capital and quatrefoil detailing, sharing characteristics of other benches found at other Pearson churches and, therefore, most likely designed by the architect, or at least chosen by him from a catalogue perhaps of the same craftsman.
