The church and chapel interiors of John Loughborough Pearson: A selective assessment of significance

Clare Howard and Simon Taylor

Discovery, Innovation and Science in the Historic Environment

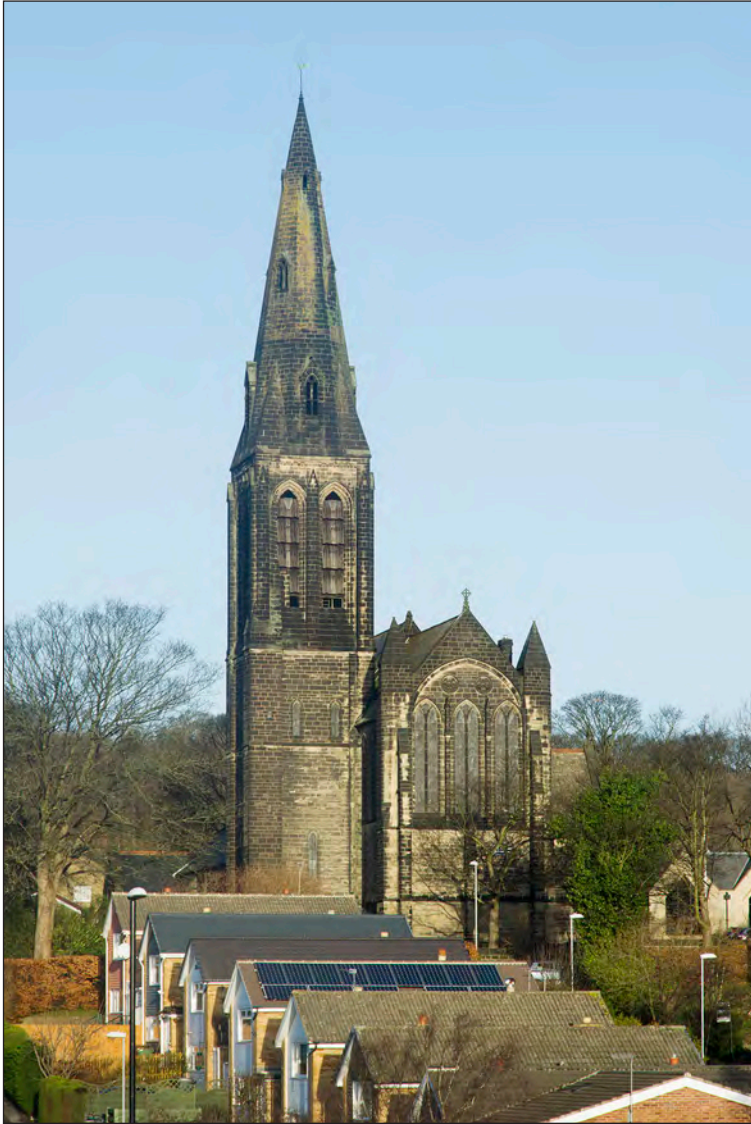
Figure 75: The Church of St Margaret, Horsforth, taken from the south-east (DP168505 © Historic England, photograph: Alun Bull)

Built in several stages, the Church of St Margaret at Horsforth has a five-bay nave with north and south aisles and porches (Figure 75). There is a further narrow side aisle to the north. The chancel consists of a choir and sanctuary; the north aisle extends as far

as the east end of the choir, forming a choir aisle, and beyond is a vestry above a semi-subterranean chamber which is probably the heating chamber, but was not inspected during the site visit. The square tower is situated at the east end of the south aisle beside the choir. St Margaret's church is aligned south-east to north-west, but is here referred to as if it was conventionally aligned east to west, and is built of Yorkshire gritstone, with slate-covered roofs, in 'Severe'²¹⁴ Early English style. The interior is plastered, and painted white, with exposed ashlar dressings.

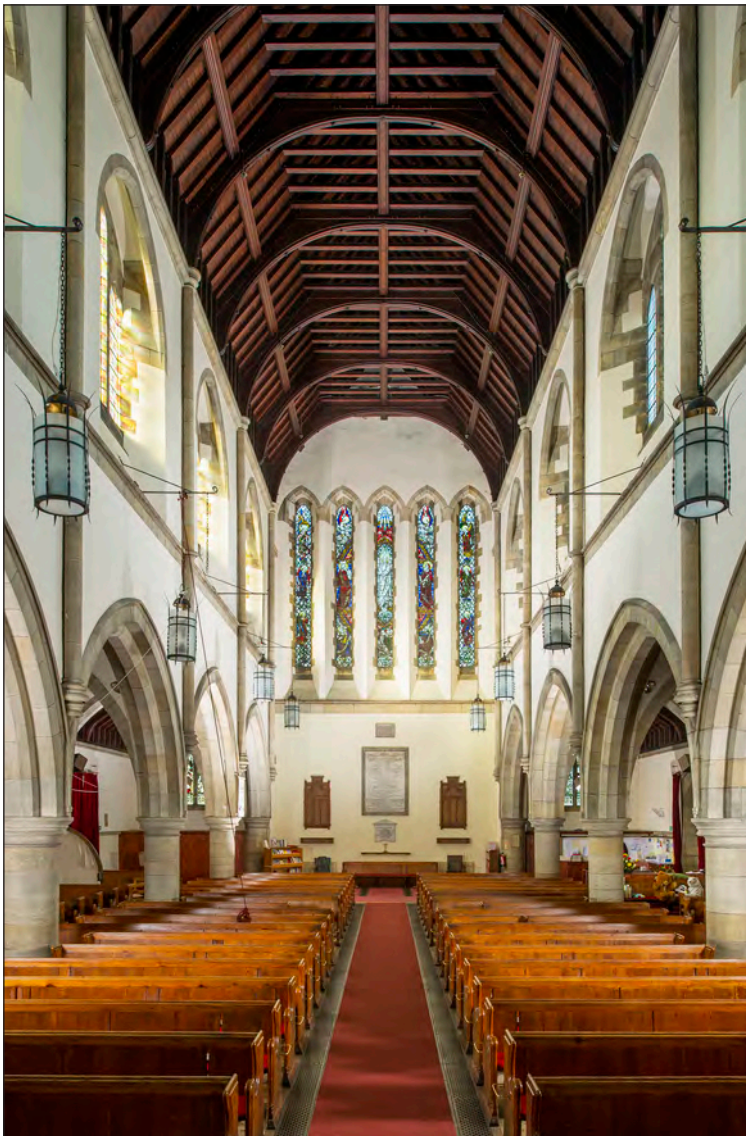
Figure 76: The nave of the Church of St Margaret, Horsforth, taken from the south east (DP168507 © Historic England, photograph: Alun Bull)

The nave (Figure 76) was originally entered by the congregation from the north and south aisles, in turn reached from the porches, although these had yet to be built when the church was first used (*see above*). The north porch is now primarily used for this purpose. The nave has a clerestory carried on arcades of five equilateral arches, which spring from simple round columns with moulded caps, and is lit by opposed windows also with pointed equilateral arches, plate tracery and three lancet-lights apiece. The nave is also lit from the west by a large window consisting of five narrow lancets of equal height, all set within deep splayed and now containing stained glass (*see below*). The nave has an arch-braced collar roof of ten bays, alternate principals rising from engaged stone shafts rising in turn from the spandrels of the arcades below, with collar purlin and single side purlins and ashlar pieces.

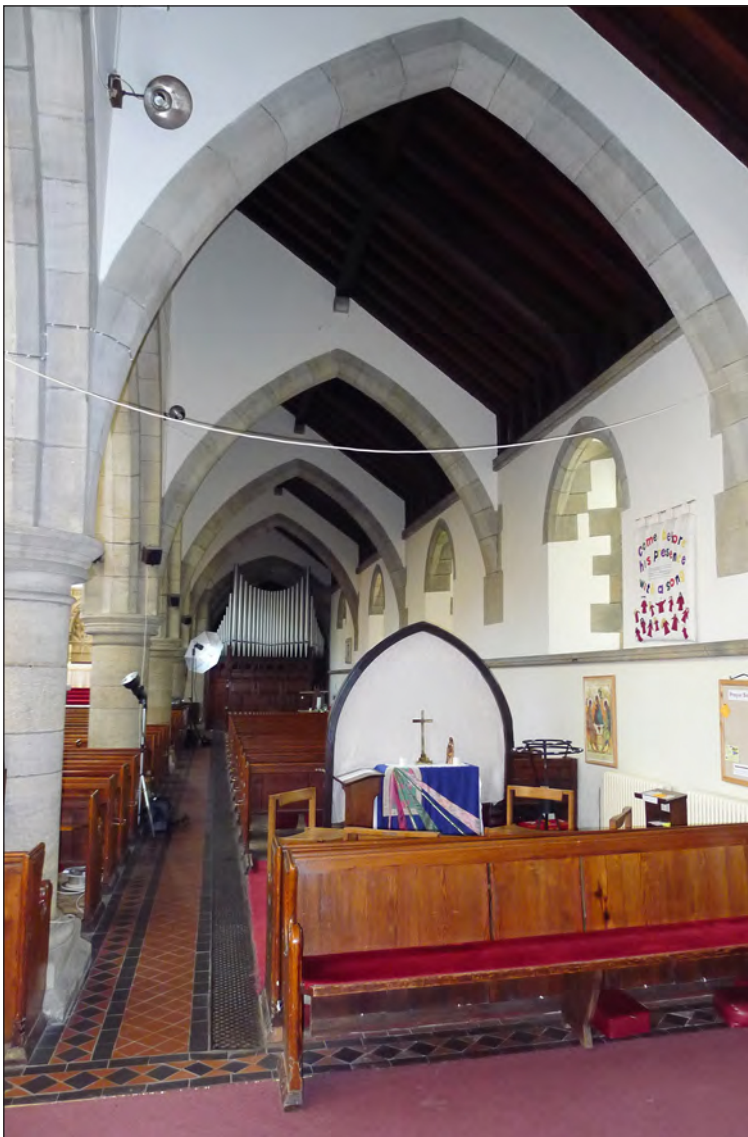
Figure 77: The north aisle of the Church of St Margaret, Horsforth, taken from the south east (© Historic England, photograph: Clare Howard)

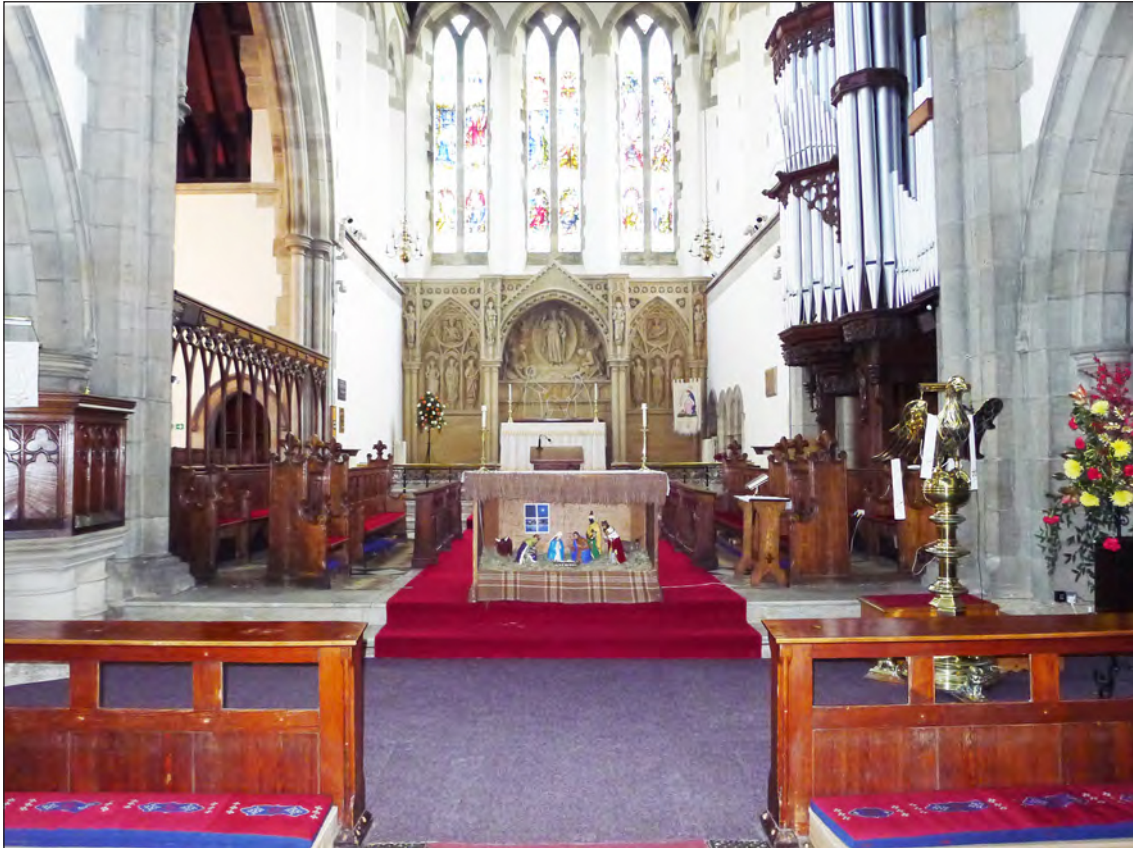
Figure 78: The chancel of the Church of St Margaret, Horsforth, taken from the north-west (© Historic England, photograph: Clare Howard)

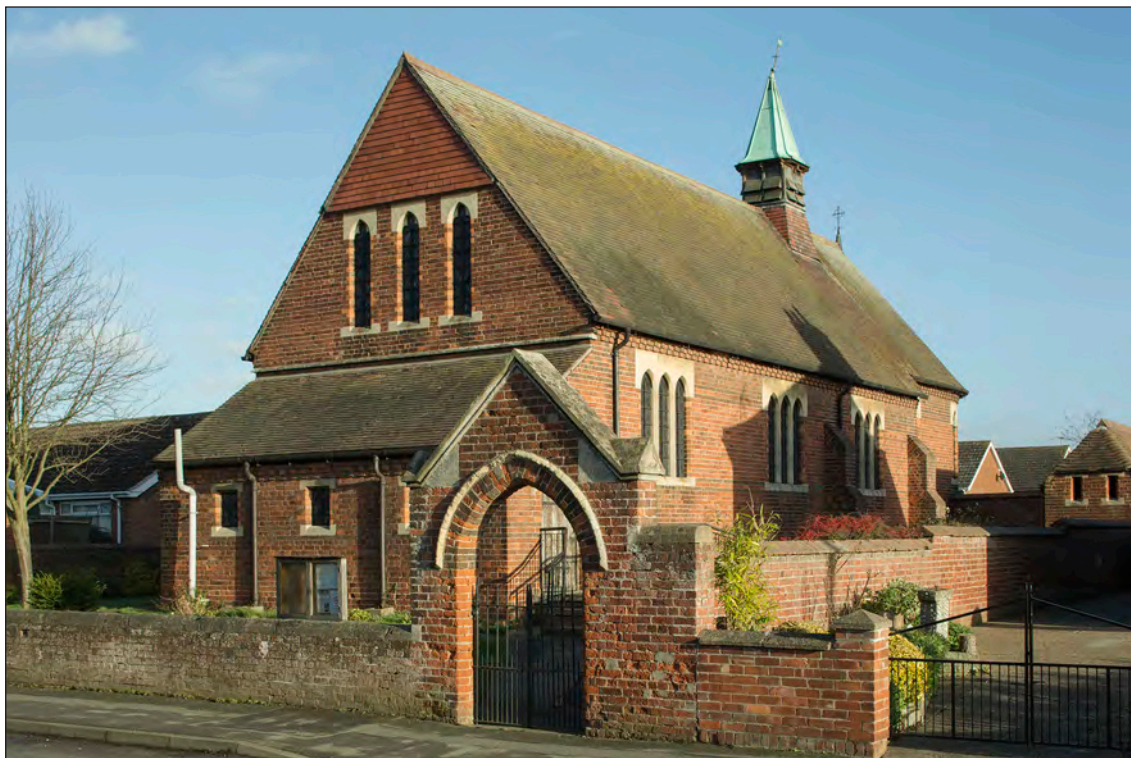
Figure 79: The Church of St Hugh, Sturton by Stow, taken from the south-west (D172344 © Historic England, photograph: Pat Payne)

The Church of St Hugh is conventionally aligned west to east on the eastern side of High Street, the main road leading to Stow, in the centre of the village of Sturton by Stow. It is constructed of red brick with brown brick bands, laid in the English bond, with stone dressings and has a pitched roof covered with red clay tiles (Figure 79). There is a simple wooden fleche – with a pyramidal, copper roof and a sloping base covered with clay shingles – set at the east end of the nave roof which is accompanied by a wrought-iron cross finial at the apex of the chancel roof. The church consists of a western narthex with former

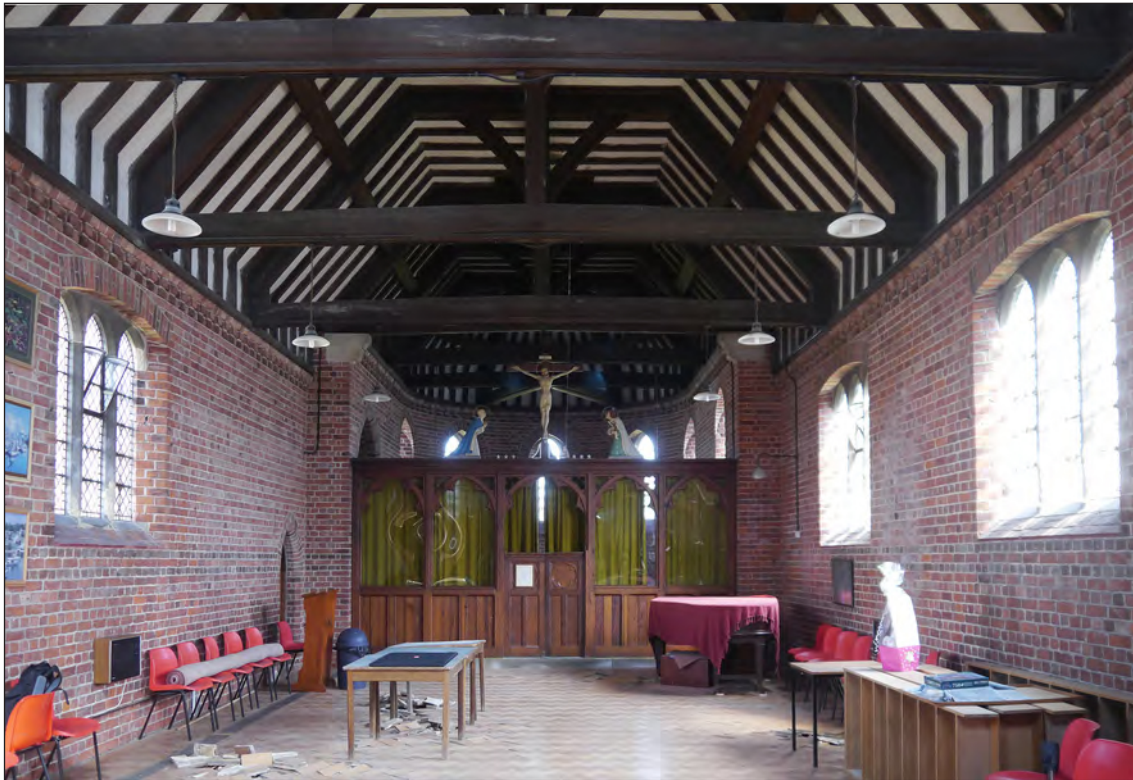
Figure 81: The nave of the Church of St Hugh, Sturton by Stow, taken from the west (© Historic England, photograph: Clare Howard)

The rectangular five-bay nave is entered from the narthex through a pointed-arched doorway, with chamfered brick surround, located in the centre of the west wall. The roof over the nave is of simple crown-post type – an unusual design for Pearson, the majority of his roof designs being arch-braced collar types or full-blown stone vaults – and is boarded and plastered above the collars and butt purlins. The chamfered tie beams – which carry the crown posts – span the width of the nave, are set on timber wall plates and are connected to the principals and commons by ashlar pieces (Figure 81). The bare brick walls are enlivened somewhat by a double brick square-billet cornice set just below the timber wall plates (it functions as a corbel-table underneath the sills of the windows in the western elevation) and double bands of slightly darker brick located just below the window sills

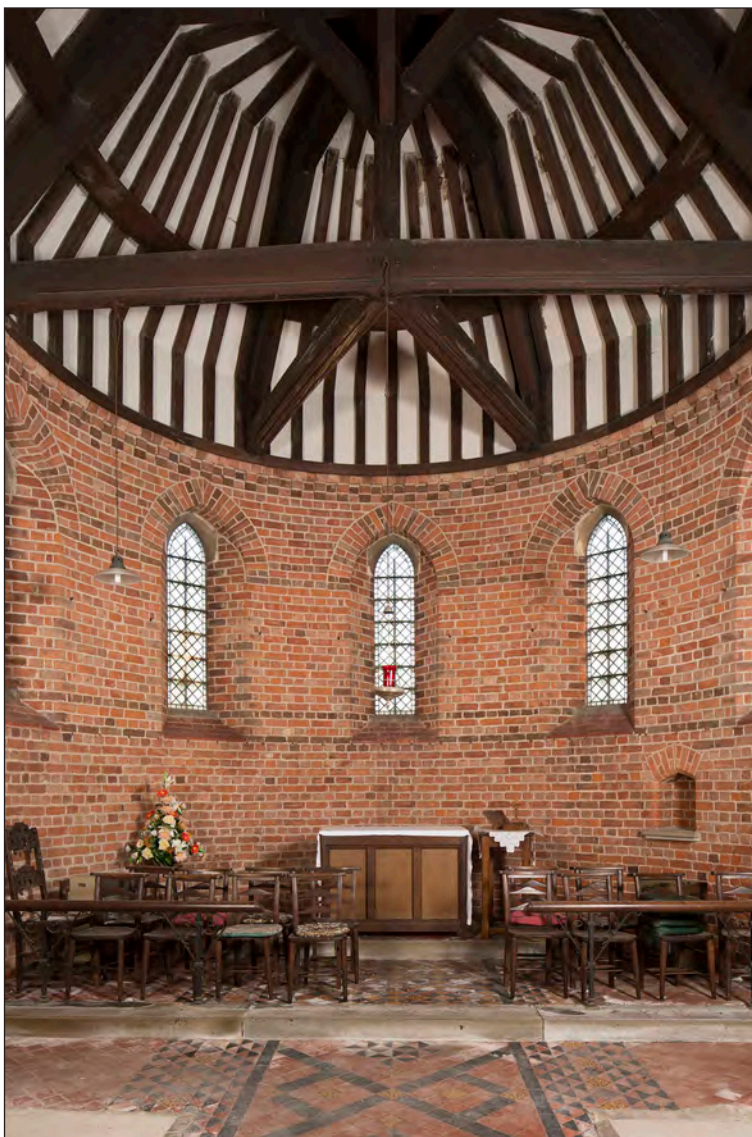
Figure 82: The chancel of the Church of St Hugh, Sturton by Stow, taken from the west (D172356 © Historic England, photograph: Pat Payne)

The chancel is narrower than, and on a level above, the nave but there is no chancel arch. Instead, moulded stone tie-beam corbels and a carved timber screen mark the division. The screen is composed of five cusped arches; the central of these heads a doorway, the others windows. The screen (and a curtain behind it) is mentioned in a contemporary description of 1879-80; it is unclear whether it was designed by Pearson himself but the simple and insubstantial design together with the fact that he probably did not oversee construction, suggests not. Certainly the figures above the screen and the Perspex panels are a later addition (*see below*).²⁴¹ The chancel roof is also of crown-post type and is boarded and plastered above the collar plate and rafters. The tie beam closest to the apse is supported by two further beams set at 45 degree angles from the horizontal tie beam. The double square-billet cornice continues below the wall plate but is set at a slightly lower level than that of the nave, accentuating the height of the roof structure. The chancel is lit by six lancet windows set within the apse, all of which have opaque diamond-leaded cathedral glass (Figure 82).

As expected, progression to the holiest part of the building, the sanctuary, is symbolised by a step up from the choir and is partitioned from it by an altar rail composed of scrolled wrought-iron supports and a wooden rail – probably an early 20th-century addition. As with the choir, the floor of the sanctuary is laid with red and black tiles although with a greater number of encaustic tiles in the central alley. The altar itself is also raised on a plinth inlaid with tiles, upon which is set a simple, moveable, wooden altar table (a later addition). There is a simple, small, arched aumbry with projecting stone shelf, recessed into the south wall.

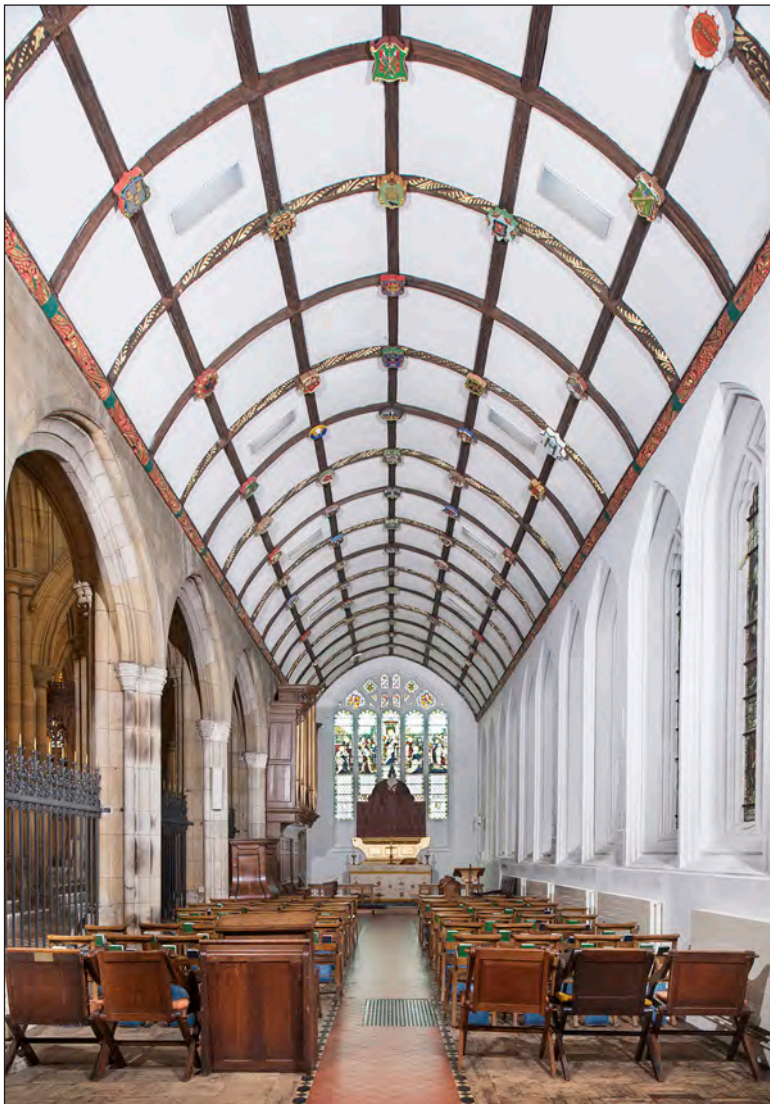
Figure 86: St Mary's Aisle, Truro Cathedral, taken from the east (DP166660 © Historic England, photograph: James O Davies)

The earliest part of the cathedral is the small chapel to the south-east corner of the building which was previously the south aisle of the former early 16th-century parish Church of St Mary. The church had been heavily modified in the 18th and early 19th centuries and was in a serious state of decay by the time the cathedral was commenced; this led to some opposition against re-using the aisle as part of the new cathedral, largely because of the cost to restore it, but Pearson was adamant that the aisle should be retained.²⁷⁵ Some of the architectural details and stonework of the demolished parts of the building were also reused in the new cathedral, but other features such as the east window of the former chancel were donated to other churches around the county.²⁷⁶

St Mary's Aisle (Figure 86), as it is commonly known, is of six bays with a seventh bay, which appears to be used as a baptistery, at its western end, set underneath the bell tower and separated from the main aisle by a pointed arch. The chapel has a wagon-roof composed of moulded timber ribs and butt purlins and carved wall plates. The intersection

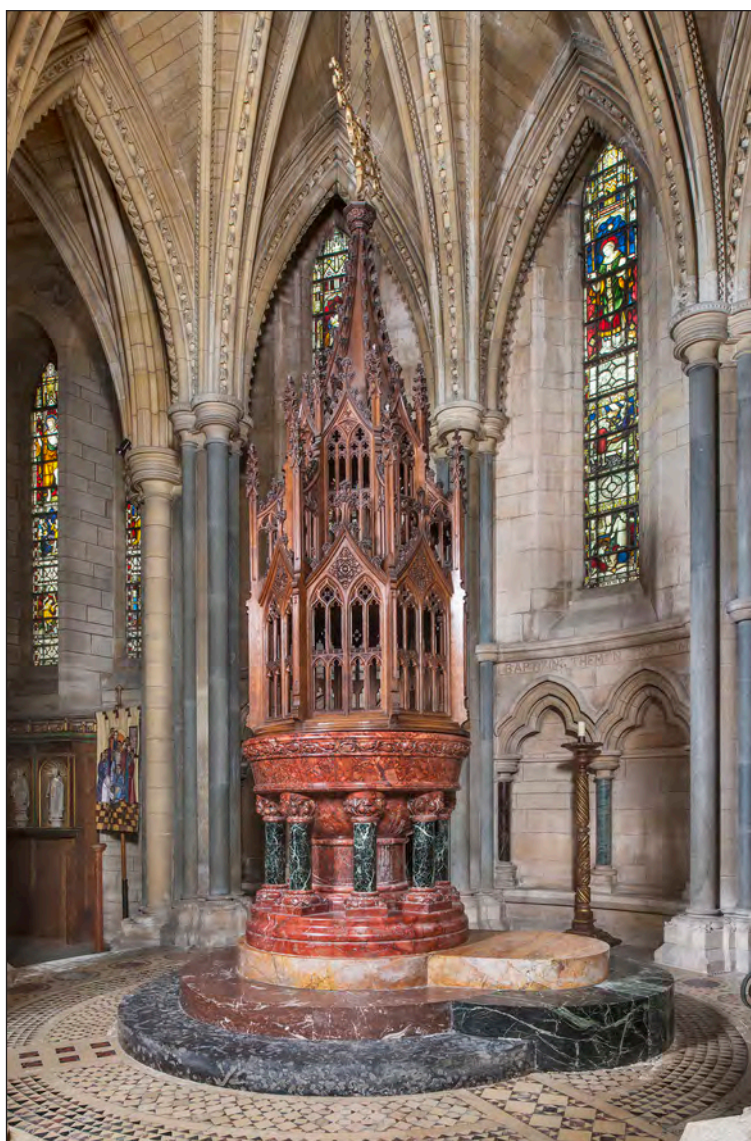
Figure 87: The baptistery of Truro Cathedral, taken from the east (DP166726 © Historic England, photograph: James O Davies)

The baptistery is separated from the small chapel by a tall pointed arch which is supported by piers with clustered shafts and ring-moulded capitals. The baptistery itself is circular and is set within an apsidal bay which projects beyond the nave aisle (Figure 87). The circular part of the construction has an octapartite vaulted ceiling with eight principal ribs, springing from ring-moulded capitals above clustered piers, and intermediate ridge ribs which are finished with carved stone bosses. The ribs are adorned with dog-toothing

while some of the shafts are of grey Polyphant stone.²⁸² The outer wall of the baptistery is decorated with an arcade of trefoil-headed arches supported by shafts of green Lizard serpentine with moulded stone capitals; above these are lancet windows containing stained glass, as fitted in 1887.²⁸³ The floor of the baptistery is laid with patterns of coloured marble and, in contrast to this, the font is raised on a three-tier plinth, each step composed of a different richly coloured marble. The circular font, sculpted by Robert Davison of Marylebone Road in London,²⁸⁴ is carved of a vibrant red marble (Breccia Rosso Antico²⁸⁵) with a central cylindrical stem supporting the bowl and smaller shafts of black marble (with white veins) with red marble capitals surrounding it. A richly carved, pinnacled, oak font cover is suspended by a chain and pulley system which is attached to the central boss in the ceiling.

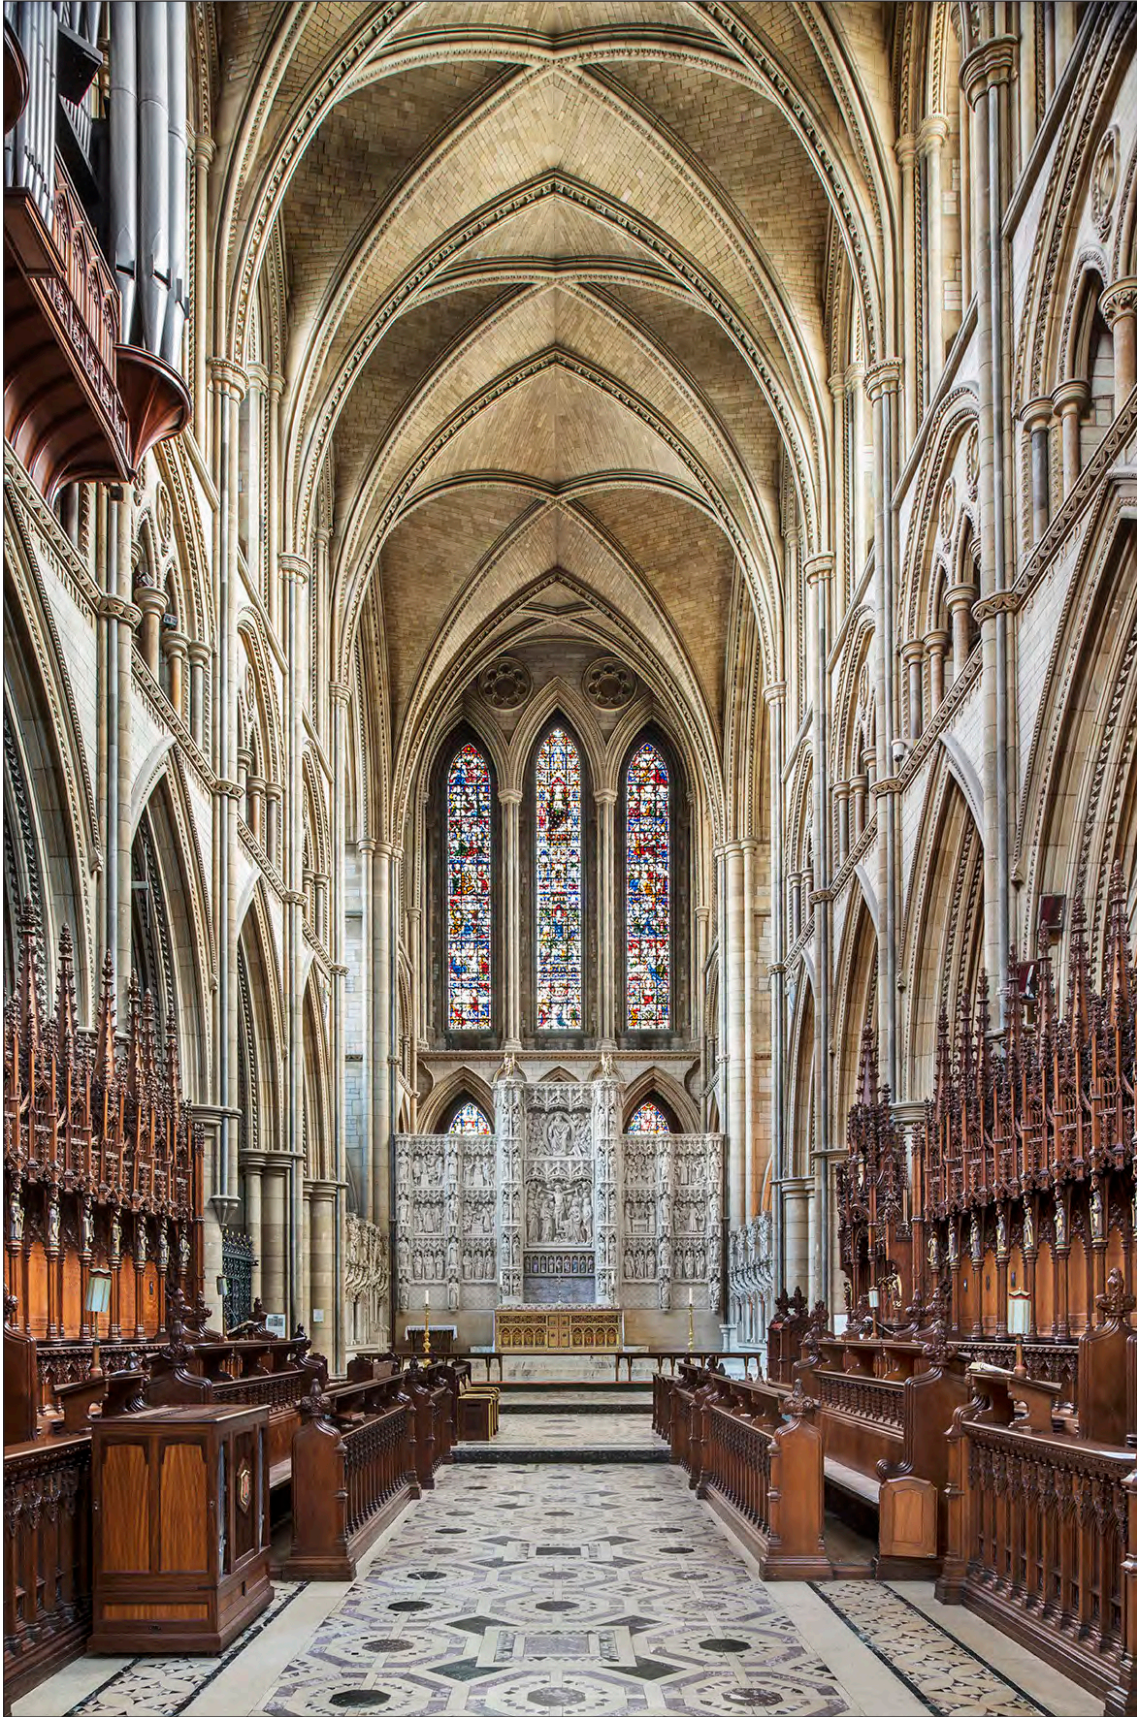
Figure 89: The Choir of Truro Cathedral, taken from the east (DP166707 © Historic England, photograph: James O Davies)

As expected, the choir, intended to seat the chapter, clergy and choristers, contains a greater intensity of decoration although much of the architectural forms are continued from the nave, transepts and crossing (Figure 89). The choir of the chancel is five-bays long and, like the nave, is separated from its aisles by an arcade of pointed arches supported by clustered shafts and moulded capitals, with triforium and clerestory above. Clustered shafts, enriched with grey Polyphant stone and set between the arcade arches, extend to clerestory level where the ribs of the quadripartite ceiling spring from moulded capitals. The ribs, like the arcade arches, are decorated with carved dog-tooth moulding. The lower part of the arcade arches are closed with hammered-iron screens and gates, the latter provide access to the chancel aisles. Above the arcade arches are carved words in relief reading from left to right, starting at the western end of the north wall and finishing at the western end of the south wall, as follows: 'THE PATH OF THE JUST IS AS THE SHINING LIGHT THAT SHINETH MORE AND MORE UNTO THE PERFECT DAY'. At the beginning of the sentence is the shield of the Robartes family with their motto 'QUAE SUPRA' and at the end is the shield of the Pole Carew family with the motto 'POLLET VIRTUS' to commemorate the donations by Lord Robartes in memory of his wife who was a member of the Pole Carew family.²⁹² Above the words and shields is a carved stone bay-leaf frieze which continues around the clustered shafts. The triforium openings are composed of three pointed arches carried on cylindrical shafts with ring-moulded capitals, every other capital being decorated with nail-head mouldings. The arches are set within a wide pointed arch which is also supported by cylindrical shafts of Polyphant stone with ring-moulded capitals. The arch and the hood mould above it are finished with dog-tooth mouldings and within the tympanum of this arch are two blind trefoils and two ball-flower mouldings. The clerestory level is lit by pairs of pointed lancet windows containing opaque leaded glass, fronted by pairs of pointed rear-arches with quatrefoils carried on cylindrical shafts and decorated with dog-tooth mouldings. The two western triforium and clerestory openings accommodate the organ pipes of the Father Willis organ which was installed in 1887 and has only been minimally altered since this date.²⁹³

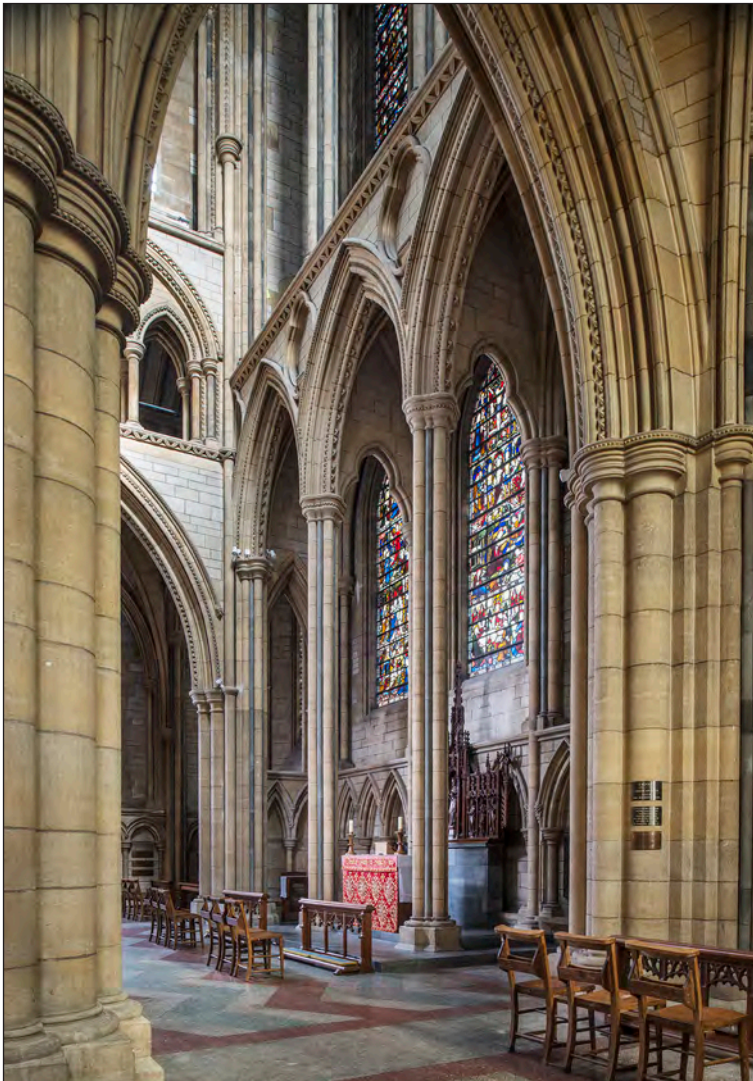
The retrochoir, at the very eastern end of the cathedral, is raised from the chancel aisles by three steps at the south-east and north-east corner of the sanctuary (Figure 91). It is separated from the sanctuary by the Bath stone reredos which is decorated on this side by pairs of blind arches with quatrefoils. The retro-choir is rectangular in shape and is separated from its aisles by pointed arches with three-light triforium openings and two-light clerestory windows above, matching those found in the choir. The eastern elevation is set forward and is separated from the altar by an arcade of three pointed arches, with three recessed stained-glass windows complete with rear-arches, above. Again, the ceiling over the retrochoir is composed of quadripartite stone vaulting and the ribs are carried by moulded capitals and corbels above clustered piers which are enriched with Polyphant stone. The north and south walls of the aisles have an arcade of round-headed arches (the eastern-most bays are pointed arches) carried on cylindrical shafts with ring-moulded capitals. Above the western bays of arcading are two-light windows with blind quatrefoils containing stained glass. The eastern bay of the north wall contains an additional single lancet window which is also filled with stained glass. The central altar is lit by three lancet windows each containing stained glass while the bays at either side of the central altar also have pointed lancet windows containing stained glass.

Figure 91: The retrochoir of Truro Cathedral, taken from the east (DP166702 © Historic England, photograph: James O Davies)

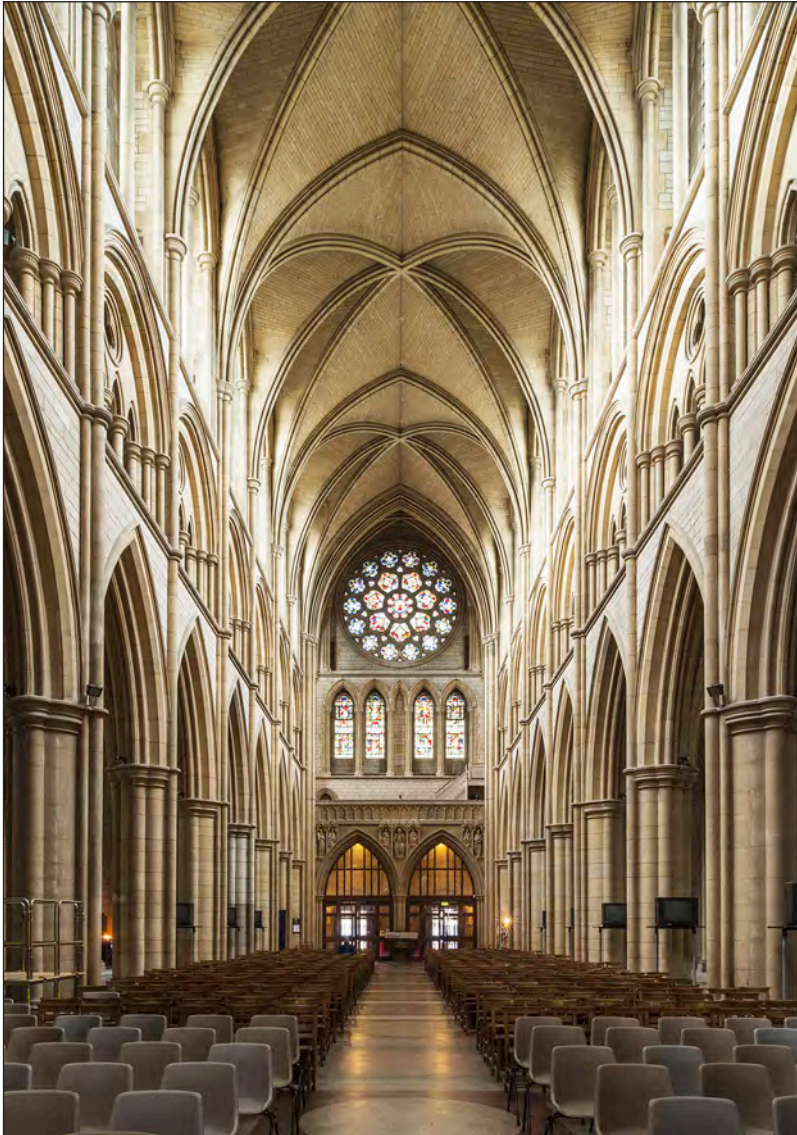
Figure 92: The nave of Truro Cathedral, taken from the east (DP172583 © Historic England, photograph: James O Davies)

The floor of the nave and aisles is laid with terrazzo in large circle and square patterns. The seating areas are not floored with wood-block as was typical with churches designed by J L Pearson and it is not clear if the terrazzo is a later replacement or a change to the original design. The nave is filled with rows of typical wooden church seats with saddle seat, upper and middle rail to the seat back and a book pocket; there are also some 20th-century

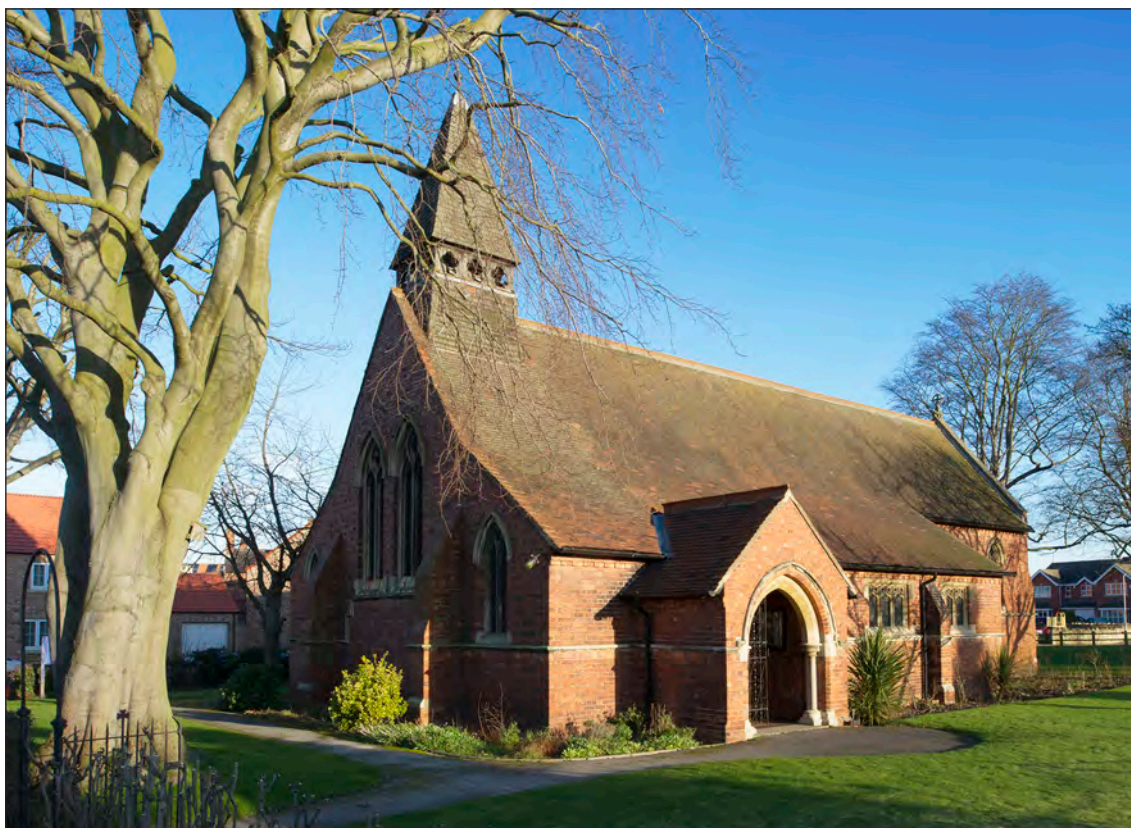
Figure 94: *The Church of St Mary, Hambleton, taken from the south-west (DP168532 © Historic England, photograph: Alun Bull)*

The Church of St Mary was a new building built on a previously empty plot between Station Road and the main road to Selby. It is aligned north-east to south-west, rather than true west to east, probably dictated by the size, shape and orientation of its plot. The church is constructed of red brick, laid in English bond, with stone dressings and has a pitched roof covered with red clay tiles (Figure 94). The bell is housed in a simple pyramidal fleche, with shingled sides and quatrefoil soundholes, set at the west end of the nave roof. Pearson used the Decorated Gothic style for St Mary's, principally manifested as reticulated window tracery. As with many of Pearson's other 'cheap churches', the internal walls are of bare red brick enlivened by pale stone ashlar dressings, string courses and bands of darker brick. The roofs are of timber, most likely deal. The church consists of a three-bay nave, north and south aisles, a chancel, organ chamber and vestry, all laid out as depicted on the plan included within the ICBS grant application of 1881 (*see above*).³³⁰

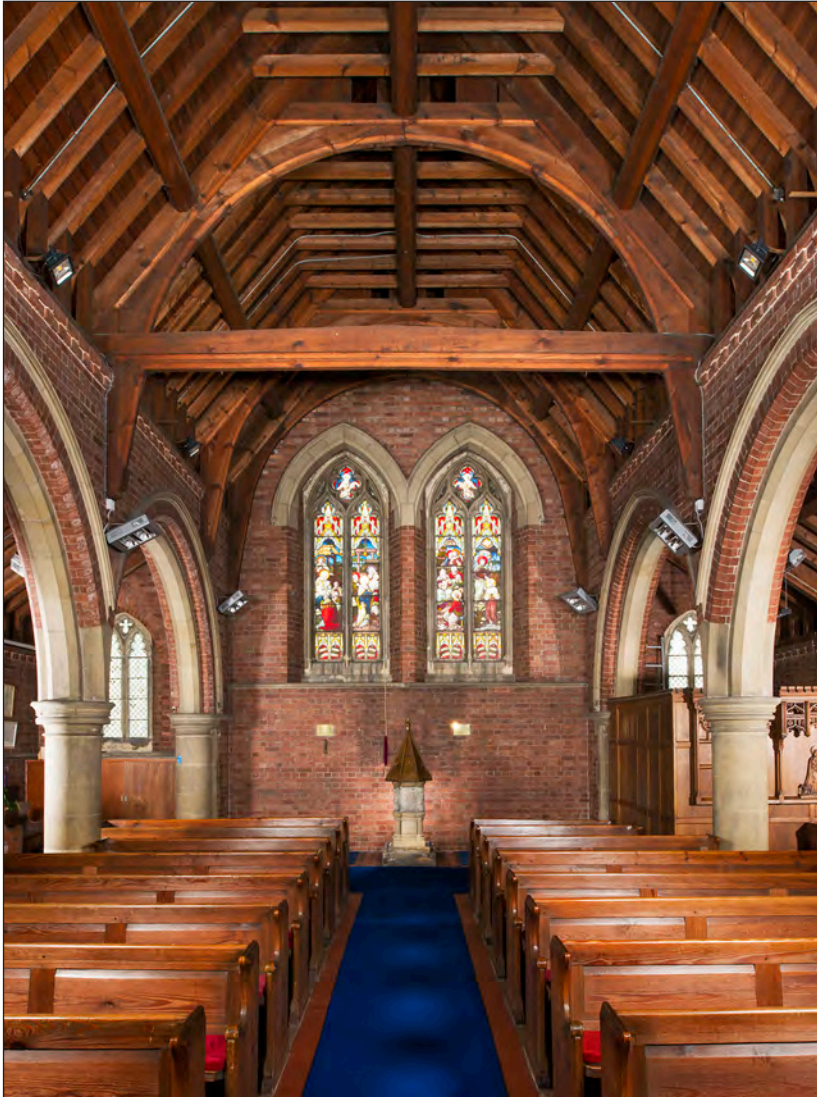
The nave is rectangular and has aisles to the north and south which are separated from the nave by an arcade of pointed arches which spring from circular ashlar piers with ring-moulded capitals and bases (Figure 95). The arches themselves are of brick and stone with stone hood moulds. The roof, a typical Pearson design, is steeply pitched and is of arch-braced collar type. It is four bays long, with ashlar pieces, moulded butt purlins, collar purlin and tie beams of heavy scantling. In 1882, *The York Herald* reported that the timber for the roof had come from Memel, now in Lithuania.³³¹ The tie beams are an unusual, but apparently original, component and almost obstruct the view of the chancel window from the nave. The side walls have a brick square-billet cornice while the walls of the aisles, rear wall of the nave and north-east wall of the chancel have a continuous moulded stone string-course at window-sill level, which steps up along the rear wall of the nave and north-east wall of the chancel.

Figure 95: The nave of the Church of St Mary, Hambleton (DP168547 © Historic England, photograph: Alun Bull)

As with most of Pearson's churches, the floor of the church is of wood block in the areas of the pews while plain red and black clay tiles are used for the alleys. There are two two-light, stained-glass windows, with reticulated tracery, in the west wall of the nave. Each window

consists of paired lancets with cusped ogee heads and quatrefoil above. The southern window depicts the Adoration of the Magi and the Presentation of Christ in the Temple while the northern window shows Christ among the Doctors and his Baptism by John the Baptist. Both windows are dedicated to William Thomas Smith (1810-82) who died just before the church was completed. They were probably installed as part of the original building phase and were paid for by the Smith family.³³² The west windows light not only the nave but also the area around the unusual font which is positioned centrally at the rear of the nave and is flanked by pairs of pews.

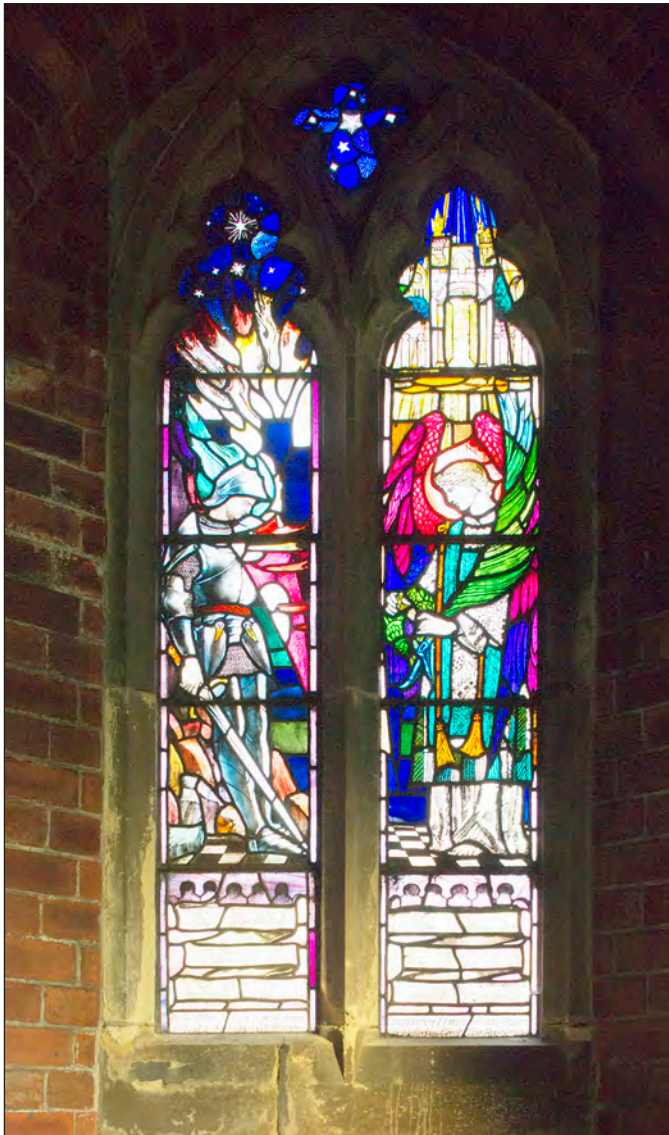
Figure 97: The stained-glass window designed by Christopher Whall, St Mary's Hambleton (DP168545 © Historic England, photograph: Alun Bull)

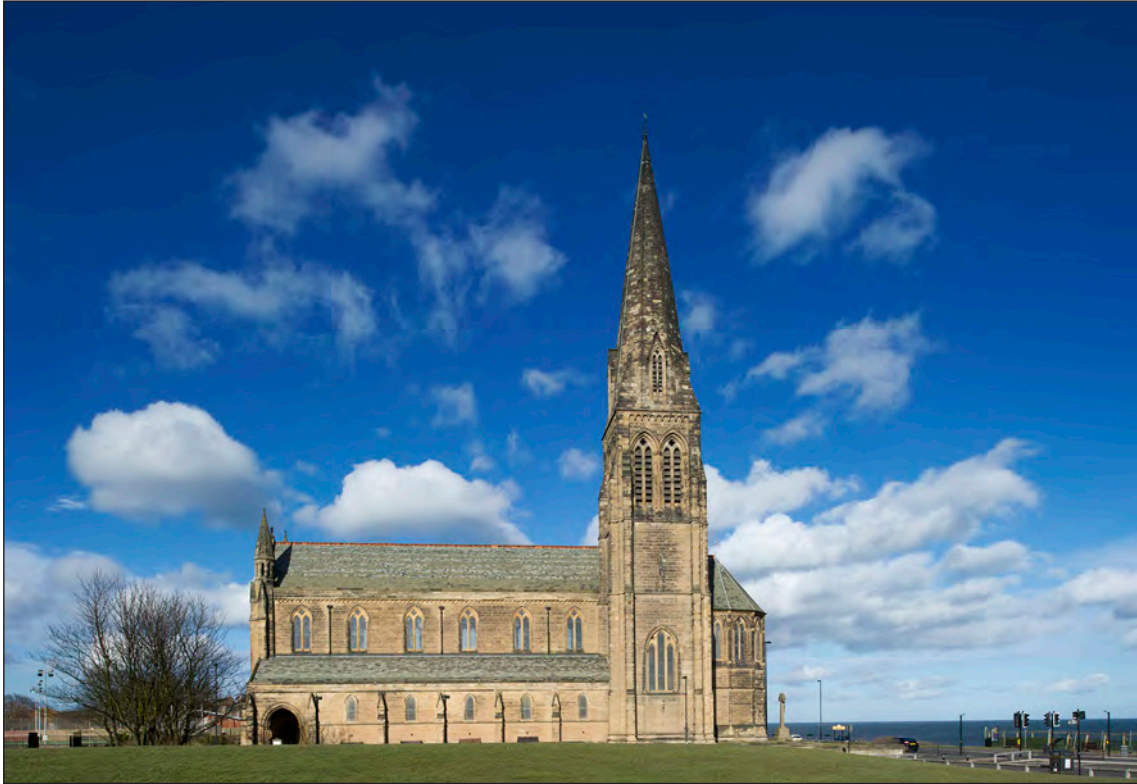
Figure 99: St George's Church, Cullercoats, taken from the south (DP168590 © Historic England, photograph: Alun Bull)

The Church of St George is aligned west to east at the corner of Beverley Gardens and Grand Parade, overlooking the sea. It is constructed of coursed, irregular, squared sandstone with sandstone dressings and a pitched slate roof. There is a tall bell tower capped by a broach spire at the south-east corner of the building and the western elevation is finished with octagonal spirelets, providing hints of French influences. As with most of Pearson's churches, it is designed in the Early English style which is largely manifested in the form of the plate-tracery windows and its internal bare stone walls which are relieved by string courses and stone-vaulted ceilings. The church follows a typical layout with a five-bay nave, north and south aisles, transepts, chancel, apsidal sanctuary and north vestry; all laid out as shown on the unsigned, undated plan mentioned above (Figure 98 and 99). Like many of his larger churches, Pearson used the Golden Section to determine the proportions of the building, particularly within the nave arcade.³⁶³ This Renaissance principle uses ratios so that the total length of one larger section and one smaller section divided by the larger section is the same ratio as the larger section to the smaller.³⁶⁴

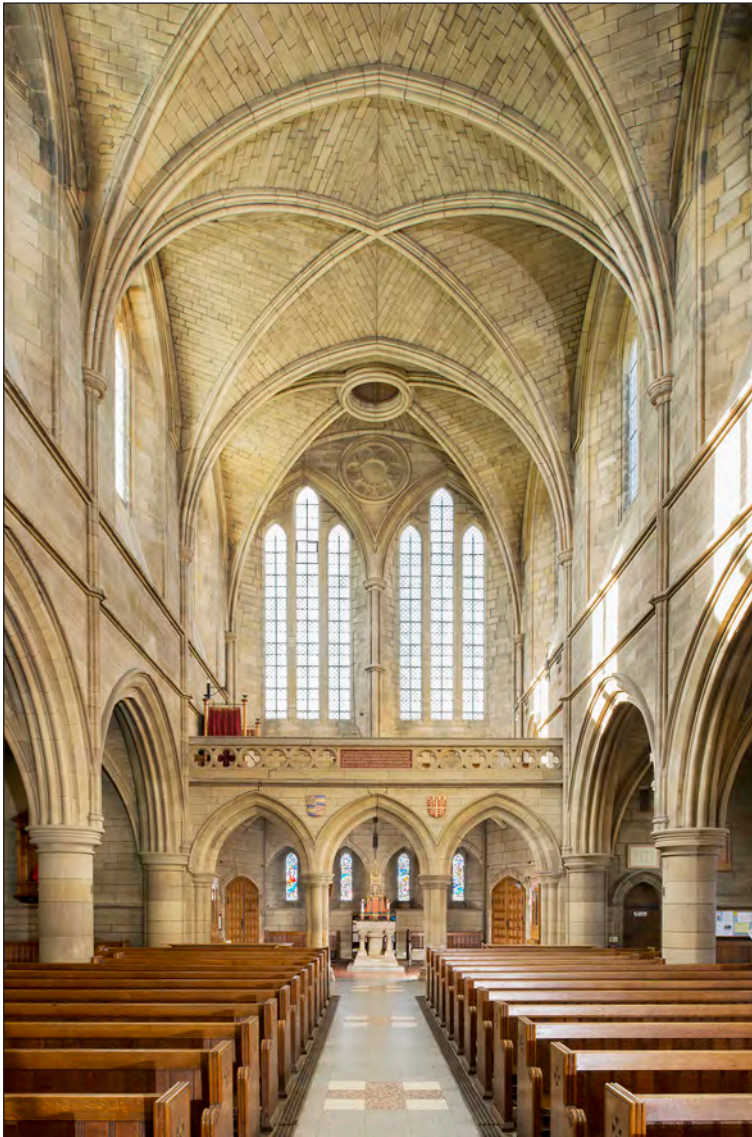
The rectangular nave is of five bays and has north and south aisles which are separated from the nave by an arcade of pointed arches which spring from cylindrical ashlar piers with ring-moulded capitals (Figure 100). Above the nave arcades, the nave elevations rise to clerestory level which is lit by plate-tracery windows formed of pairs of pointed lancets with quatrefoils. A blind triforium is suggested by a pair of moulded stone string courses; this is a feature that Pearson often used in his larger churches, influenced by his studies of abbeys and monasteries.³⁶⁶ Clustered shafts extend from the capitals of the arcade piers to create the ribs of a quadripartite stone-vaulted ceiling. The floor is covered with wood blocks where the pews are located but is terrazzo in the aisles and incorporates the standard of St George with a red cross on a white background. This design is continued into the aisles and is most likely a later addition since in the 1957 edition of the parish magazine, the floor in the Lady Chapel is described as a wood-block floor and subsequent editions of the magazine refer to the 're-tiling' of the nave.³⁶⁷

Figure 100: The nave, showing baptistery underneath gallery, at the Church of St George in Cullercoats, (DP168585 © Historic England, photograph: Alun Bull)

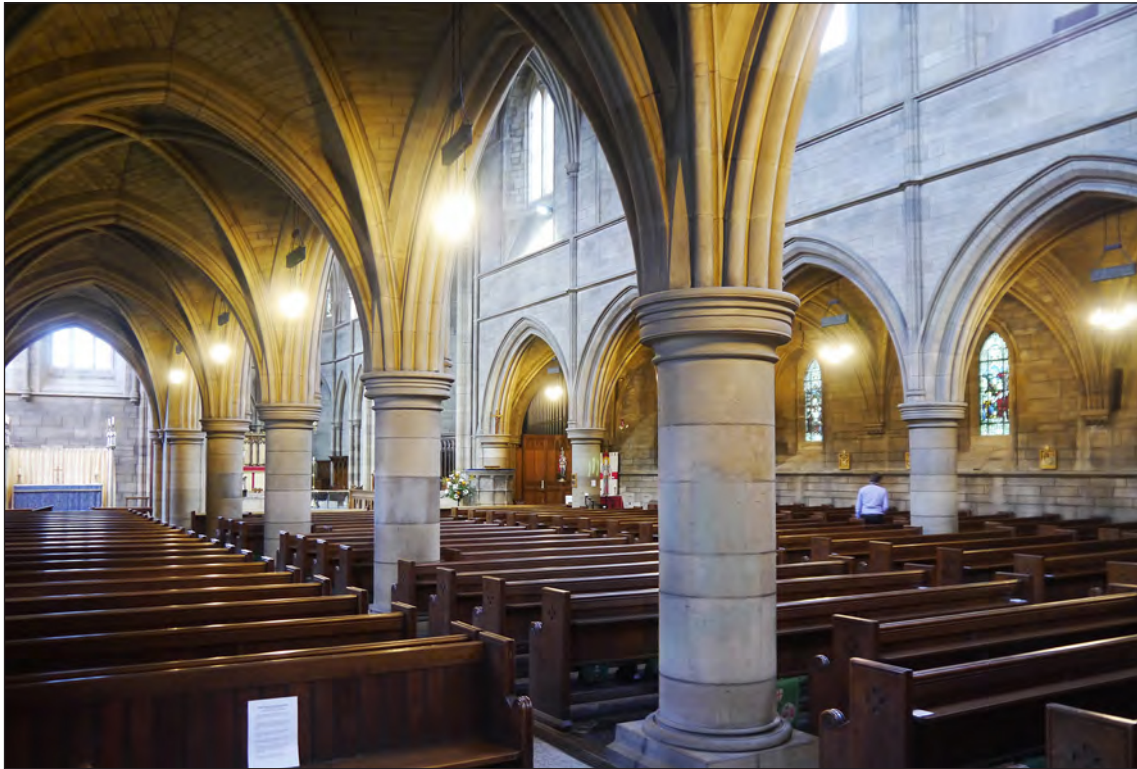
The north wall of the north aisle has four pointed-lancet windows with sloping sills terminating in a moulded stone string course which runs along the whole of the aisle elevation (Figure 101). Most of the windows in the north aisle contain leaded textured glass

Figure 101: View from the north aisle of the Church of St George, Cullercoats, (© Historic England, photograph: Simon Taylor)

as Pearson intended with the exception of the eastern-most window (designed by Kempe and inserted in 1907) and the western-most window which has some stained glass panes designed by children and inserted in the 1930s. The south aisle mirrors that of the north aisle but contains a fifth window at its east end; all have stained glass inserted in 1907-14. The east end of the aisle is currently used as St George's Chapel and is screened from the south transept by a panelled wooden partition added in 1939.³⁶⁹ There are 21 pews in the north aisle but only 16 in the south aisle suggesting that some of the pews may have been removed to create the chapel. Those that remain match the design of those in the body of the nave but are shorter in length.
