The church and chapel interiors of John Loughborough Pearson: A selective assessment of significance

Clare Howard and Simon Taylor

Discovery, Innovation and Science in the Historic Environment

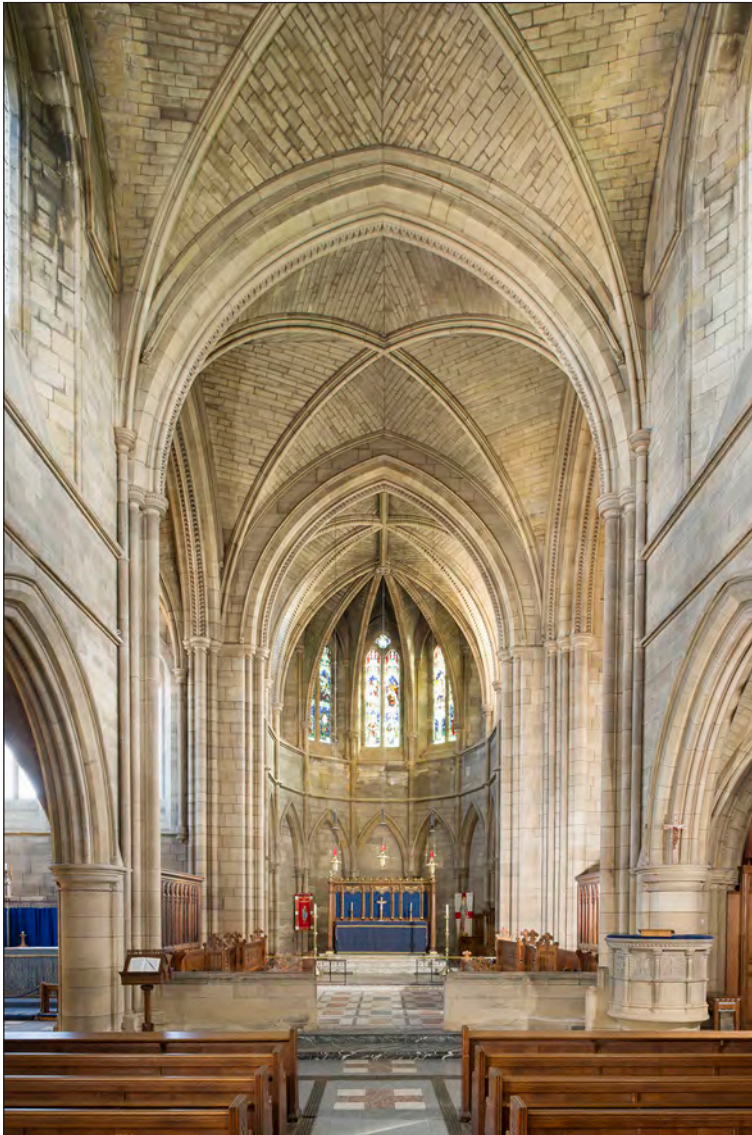
Like so many of Pearson's churches, the distinction between the nave and choir is subtle; marked by flanking clustered columns, two black marble steps (the marble most likely a later addition over existing stone steps) and a dwarf stone wall. The transition from the nave to the choir immediately becomes apparent by the increased richness of the decoration particularly in the colourful mosaic floor (added in 1906 to the designs of Frank Pearson),³⁷⁰ carved wooden screens and elaborately carved choir stalls (Figure 102). The screens which partition the choir from the organ in the south transept and the Lady Chapel in the north transept have blind square panels to their lower half and open pointed arches to the upper half. The stalls are similar to those in the nave with rounded elbows but have more elaborate

Figure 102: The chancel of the Church of St George, Cullercoats (DP168582 © Historic England, photograph: Alun Bull)

curved details to the top rail of the stall ends. The central benches, one on each side of the choir, have *fleur-de-lis* poppyheads and open quatrefoil panels to the seat back.

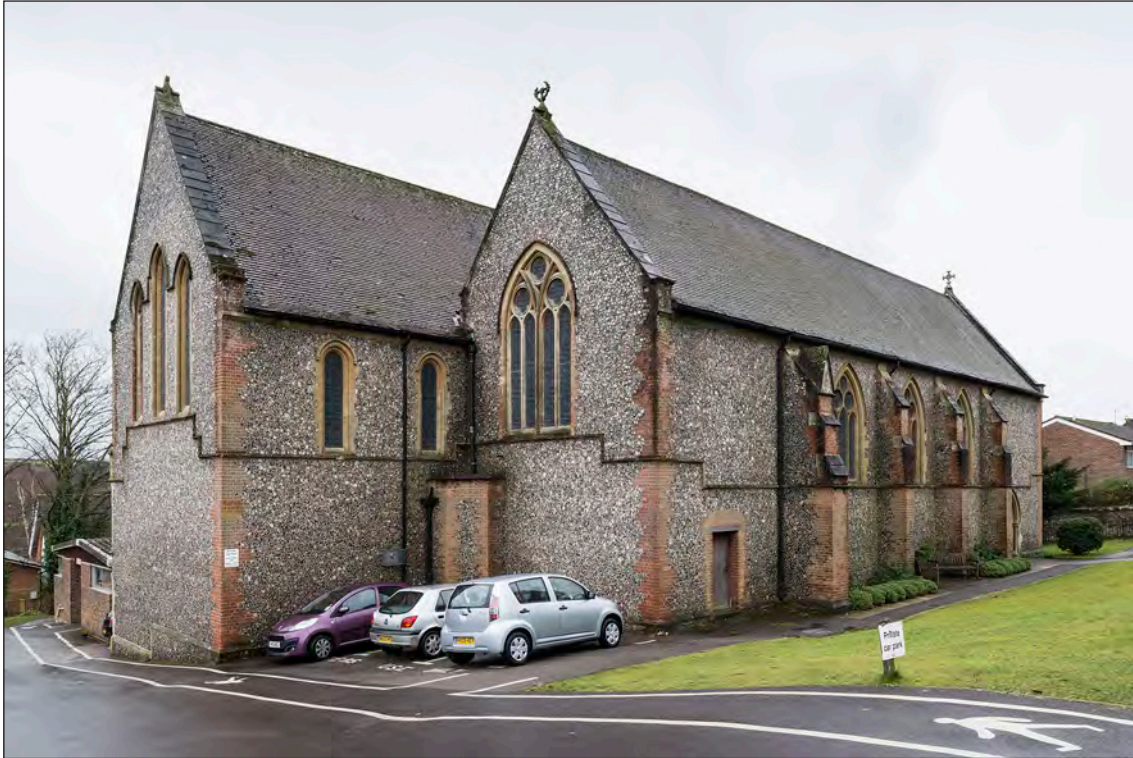
The Church of All Saints is aligned approximately east to west on the south side of Petersfield Road (Figure 106). It consists of a nave and north aisle of near equal width, and a chancel with choir and sanctuary. The north aisle is extended beyond the end of the nave by one bay, through an arch, to form a north choir aisle. There are four stepped buttresses on the north side and three buttresses on the south side of the church plus a single central west buttress. A projection from the south elevation, at the junction of the nave and chancel, forms a stair turret which presumably contains the vice stair intended to serve the planned tower. Part of the tower wall also projects beyond the turret with tothing to facilitate later completion. Further tothing and an ashlar door jamb with the beginning of an arch to the east of the projection indicate the intended position of the vestries and tower. The church is of flint with stone and red brick dressings and internally the walls, chancel arch and arcade are of local clunch (from the quarries of Mr L J Carter).⁴²¹ The nave and chancel and the north aisle each have steeply pitched roofs covered with slate.

Figure 106: *The Church of All Saints at Highcliffe, taken from the north east (DP172520 © Historic England, photograph: James O Davies)*

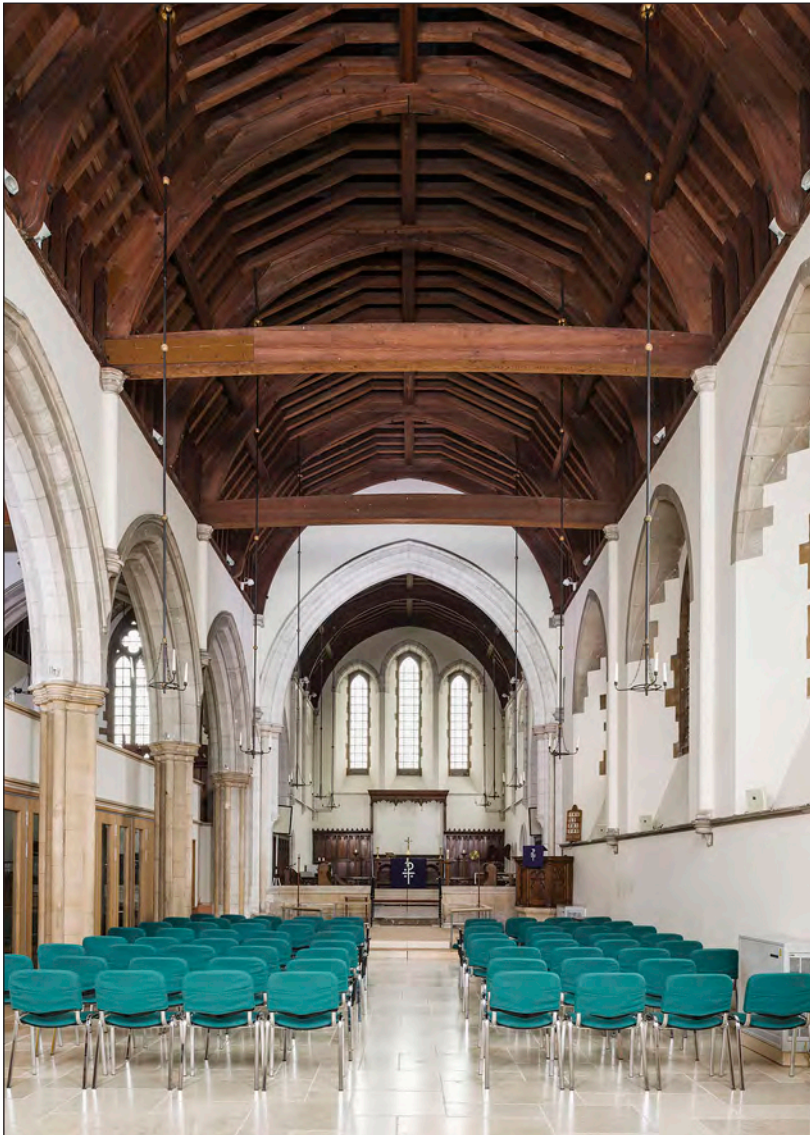
in front of the west window at the centre-rear of the nave. At the front of the nave on the south side is a polygonal pulpit reached by three stone steps with an ashlar pedestal and timber top with blind tracery panels with cusping. There is a simple corresponding lectern on the north side of the nave as shown on Pearson's later plans.

Figure 107: The nave of the Church of All Saints, Highcliffe, taken from the west (DP172525 © Historic England, photograph: James O Davies).

The congregation enter the nave via a doorway at the west end of the south wall. Because of the fall of the land, the doorway is reached by a flight of ten external stone steps on a red brick base. The doorway has a moulded outer equilateral arch, with hood, of ashlar which springs from engaged columns and an inner chamfered arch of plain ashlar. The two-leaf door is of studded timber with long strap hinges. The nave (Figure 107) is lit from the west by a large window with plate tracery – five lancets and two quatrefoils – filled with plain glass and by three windows with Geometrical bar tracery – three lancets each – from the south. The middle of these southern three is the only window in the church with stained glass; it is dedicated to the memory of the Reverend Ninian Hozier Barr, rector of the parish, for whom the church was built and who died on 27 March 1891. The window is by James Powell and Sons of Whitefriars, London and was installed in 1893.⁴²² The design depicts the Acts of Mercy – the marriage at Cana, Jesus’s rebuke to the winds, the healing at the pool, the miracle of the five loaves and two fish, the restoration of sight to two blind men upon departure from Jericho and Lazarus raised from the dead. The nave has a five-bay arch-braced collar roof with large, clumsy tie beams, the ends of which are supported on carved corbels atop long engaged shafts. There are single tiers of trenched purlins and a collar purlin. The roof is of Memel timber⁴²³ boarded with pitch pine on the back of the rafters. Pearson’s plans of the nave show it without fitted pews and the original chairs have long since been removed, as has the original font (replaced by a Norman font from St Peter’s, Chesil), although it evidently occupied the approximate position of the present one, directly

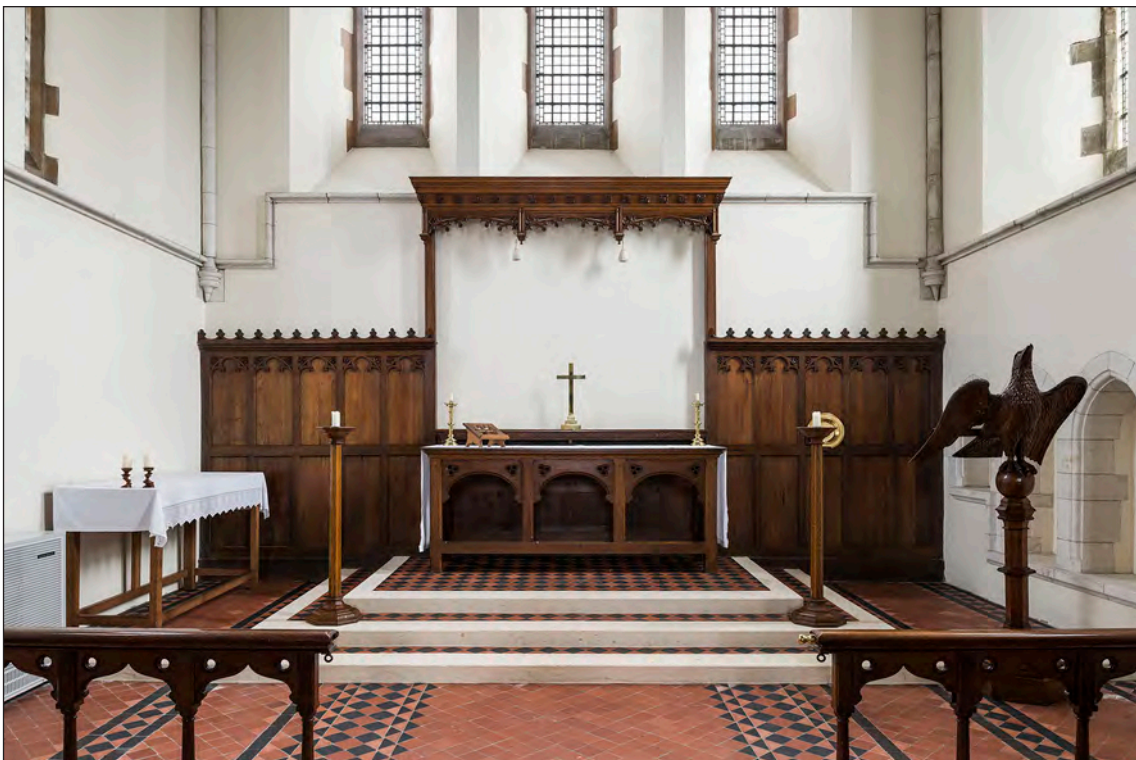
The chancel (Figure 108) is three steps up from the nave and is separated from it by a low stone screen and a double-chamfered equilateral chancel arch of clunch. It is floored with diamond-set red and black clay tiles and has a roof like that of the nave but without the heavy tie-beams. The choir is equipped with two pairs of opposed wooden choir stalls – panelled and with blind, cusped tracery and carved quatrefoils – and reading desks plus similar priest's seats and desks to the sides. Behind each pair is a fine timber screen with trefoil-headed panels and carved trefoils in the spandrels. The provenance of the choir stalls, seats and desks is uncertain – they might have been brought from St Peter's, Chesil, in the 1950s (*see below*) – but they are accurately mounted within areas of wood-block flooring and are respected by the surrounding pattern of clay floor tiles, suggesting they were designed for All Saints', a position supported by the plan of the chancel and vestries of 1895 (*see above*) and by notes prepared in 1965 for visitors to the church by the incumbent rector which do not list the choir stalls amongst the artefacts brought from St Peter's in 1956.⁴²⁴ Behind the choir stalls on the south side of the chancel is a large opening with an equilateral head of smooth white clunch, now blocked, intended as the gateway to the ground floor of the intended tower. To its left is a doorway, also with a smooth clunch surround, equilateral arch and also a hood mould, originally intended to provide access to and from the proposed vestries and external eastern doorway. On the north side a corresponding archway opens into the north side chapel or chancel aisle, and to its right is a doorway and three steps up to the short dog-leg passage around the arch pier, a passage which if the lost block to the north of the chancel was indeed a vestry (*see above*), would have allowed the priest direct access to the chancel.

Figure 108: The chancel of the Church of All Saints, Highcliffe, taken from the west (DPI172546 © Historic England, photograph: James O Davies).

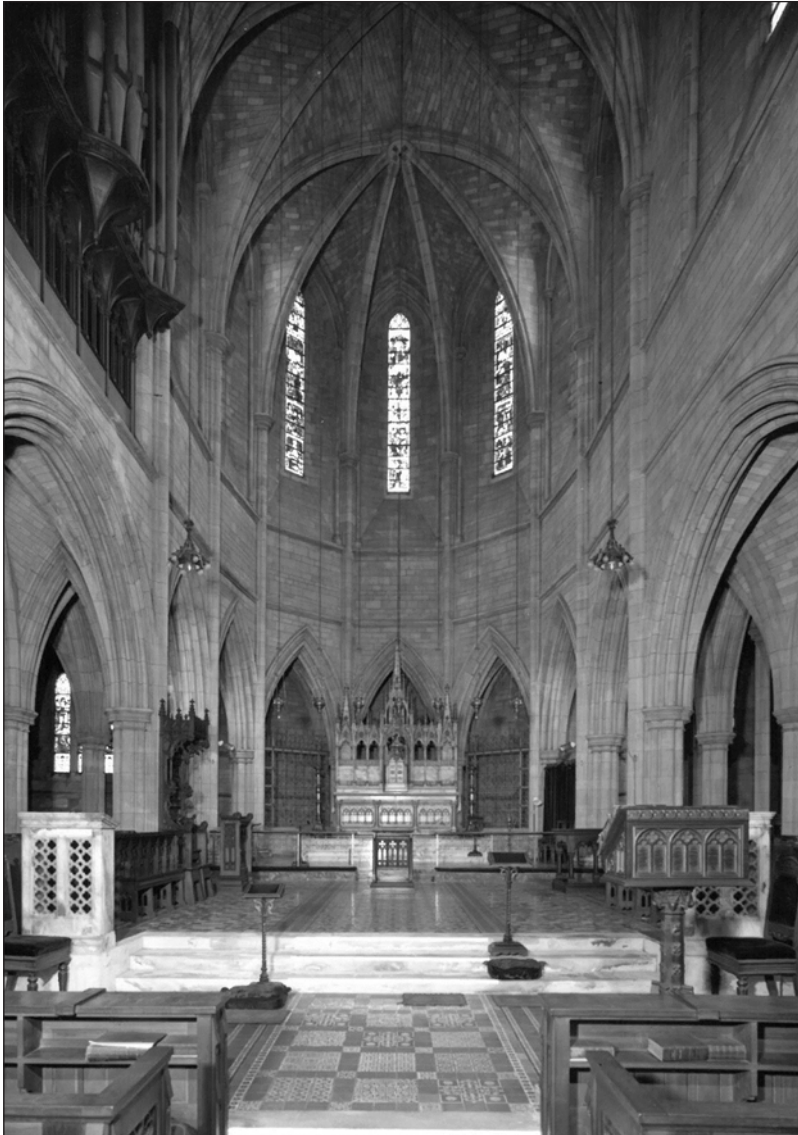
Across this floor, a further three steps lead to a second level which is fronted at either side with pinkish marble lecterns with front panels composed of multiple open quatrefoils; the lecterns are used for the reading of the Gospel and the Epistle. This level of the chancel is much more richly decorated than the level below which again reinforces the concept of progression. The floor is filled with red, black and white tiles inter-mixed with gold and red encaustic tiles arranged in patterns to demarcate the central alley and flanking alleys to the high altar. At the base of each of the flanking arcade arches is a set of seven wooden

misericords with prayer desks in front; these were reserved for the priests. The misericords have shaped, scooped backs with rounded details between each seat and a simple incised moulding to the upper rail which continues into the shaped arm-rests and rounded elbows. The backs of the misericords, which can be viewed from the side chapels, are panelled; each panel contains two tiers of cusped arches which matches the back of the Deacons' stalls found within the crossing. The front of the prayer desks are also punctuated by pairs of interlinked cusped arches with intersecting tracery. The misericords are shown in plan form on Pearson's 1891 plans but the accompanying prayer desks are shown in two halves and the existing prayer desk may therefore, be a diversion from this design or a later replacement.

Figure 112: The chancel of the Catholic Apostolic Church, Maida Avenue, taken from the north-west in 1967 (67/00909 © Historic England Archives)

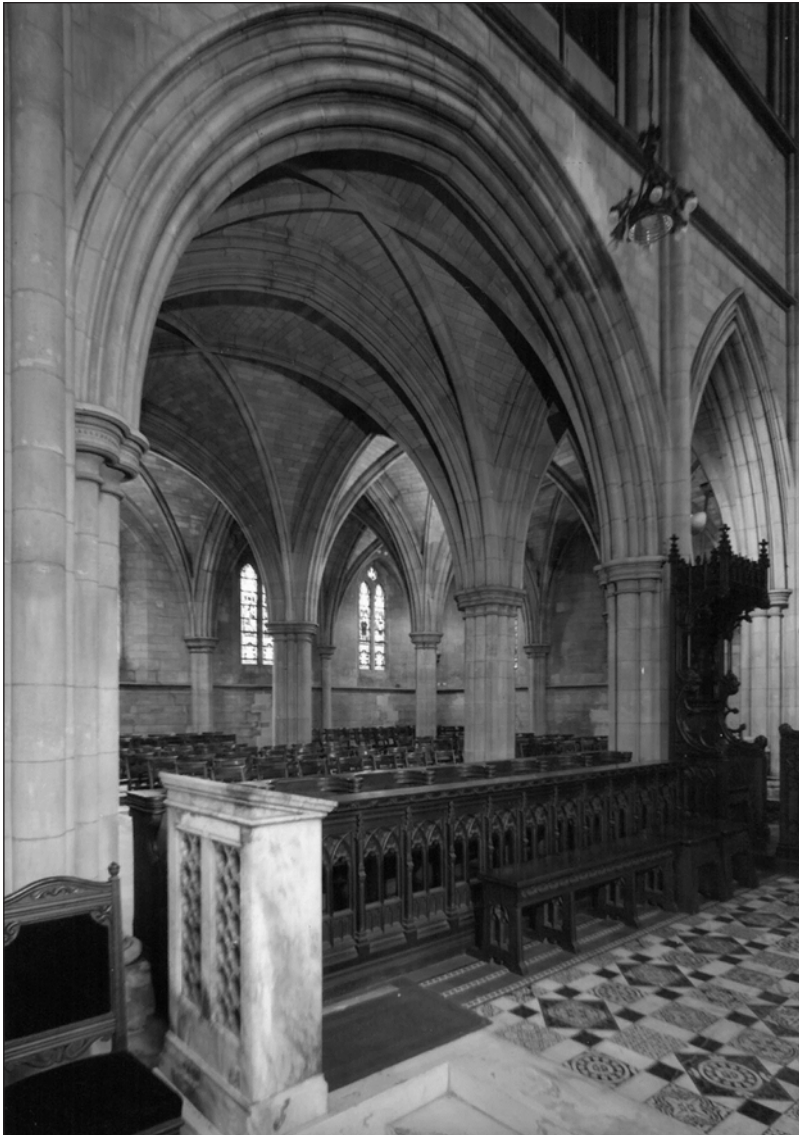
The space is lit by four two-light plate tracery windows with roundels in the north wall and by two stepped three-light plate-tracery windows in the east wall. The windows are filled with stained glass which depicts scenes from the Gospels but, according to Pearson's 1891 designs, he intended the windows to have clear glass; this suggests that the stained glass is a slightly later replacement. Access directly from the external passageway on the north side of the church is provided through a doorway in the north-west corner of the room. There is also direct access from the chapel to the sanctuary so that members of the congregation could approach the altar to take communion.

Figure 113: The north chapel of the Catholic Apostolic Church, Maida Avenue, taken from the west in 1967 (67/00904 © Historic England Archives)

From the north chancel aisle, the ambulatory forms a passage behind the altar which was possibly used for ceremonial processions. The ambulatory has two single lancet windows, both filled with stained glass which again appears to be a later replacement since Pearson illustrated clear glass in his 1891 designs. Above the north chapel is a first-floor organ chamber accessed via a spiral staircase on the western side of the chapel itself. The chamber was not inspected as part of the research but Pearson's 1891 drawings show that it was a purpose-built space. However, his drawings do not show the organ and the present instrument is a later replacement.

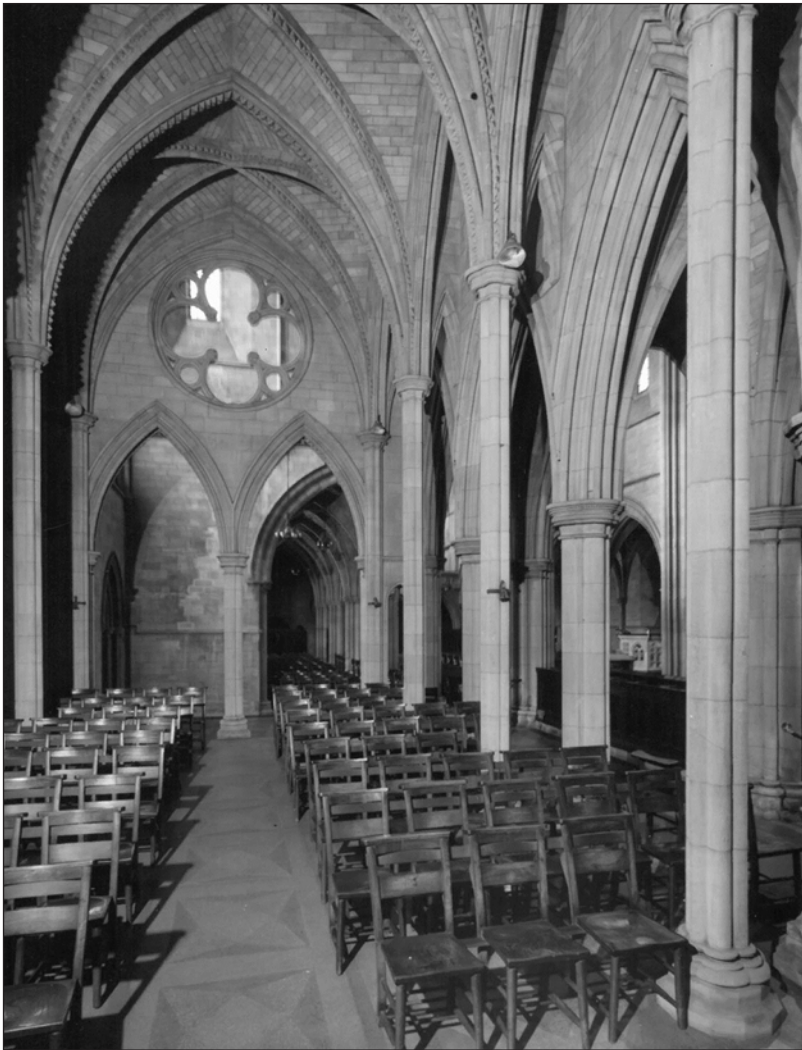
The south side of the ambulatory opens onto the south chancel aisle which, like the north chapel, is separated from the south chapel by the clustered columns of the ambulatory. The exception on this side of the chancel is that there are more columns on the south side of the aisle and these are paired with smaller columns within the chapel which offers the south chapel greater seclusion from the south chancel aisle (Figure 114). The design of this space, with its different rhythm of columns, windows and apsidal east end for the altar, gives this chapel its own separate identity. The south chancel aisle continues the ambulatory and is accessed from the south transept via a pointed archway, again with circular shafts and moulded capitals. To the south of this archway is a short, very narrow pointed archway with open spandrels above which leads to the minute aisle of the south chapel. To the right of this is a large doorway formed of two pointed arches separated by a pillar (also known as a *trumeau*) of four attached shafts with moulded capital and base; within the moulding of the arches themselves is dog-tooth detailing. Facing the transept, a round shaft with foliate capital rises from the column capital between the two arches; it supports a canopied niche containing a statue of Jesus the Good Shepherd which, according to one of the present trustees, was gifted to the church by Pearson himself.⁴⁴⁴ Above, the tympanum of the arch is pierced by a large quatrefoil circumscribed within a circle. Beneath it, five stone steps reinforce the idea of progression from the transept into the south chapel.

Figure 114: The south chapel of the Catholic Apostolic Church, Maida Avenue, taken from the south-east in 1967 (67/00907 © Historic England Archives)

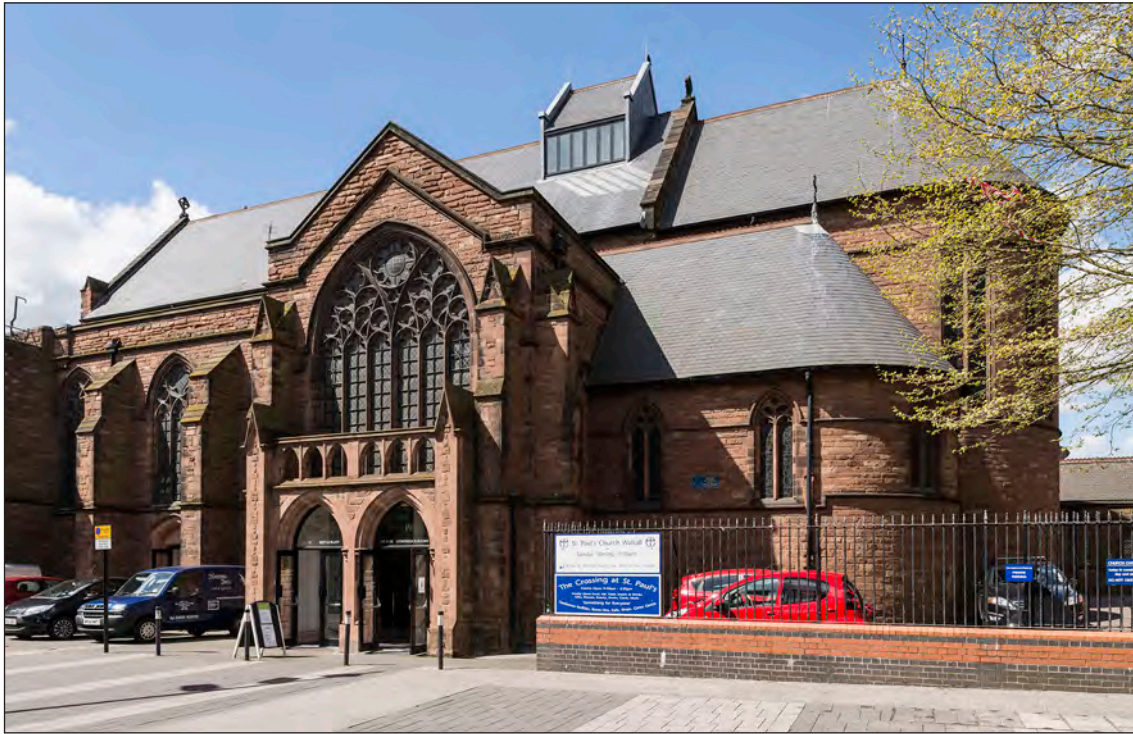
Figure 116: The Church of St Paul, Walsall, taken from the east (DP172965 © Historic England, photograph: Steven Baker)

The Church of St Paul is aligned roughly south-west to north-east, possibly due to the position of a stream to the east of the church which restricted a strict, east-west alignment. It is constructed of squared, dark red Codsall sandstone laid in courses of differing sizes, with high pitched roofs covered with slate (Figure 116). A gabled lantern has been added to the nave roof, over the crossing, as part of the 1980s conversion. The interior walls throughout the church are constructed of brick which is plastered and painted, aside from the chapel, which features oak panelling. Although much truncated by partitions added during the conversion of the building into a multi-purpose enterprise centre in the 1990s, the church comprises north-west and south-east porches, a five-bay nave with north and south aisles, apsidal sanctuary, a southern Lady Chapel, a double aisle north of the chancel with organ chamber over and shallow transepts. The style throughout is that of late 13th/14th-century Gothic architecture and this is principally manifested in the window tracery.

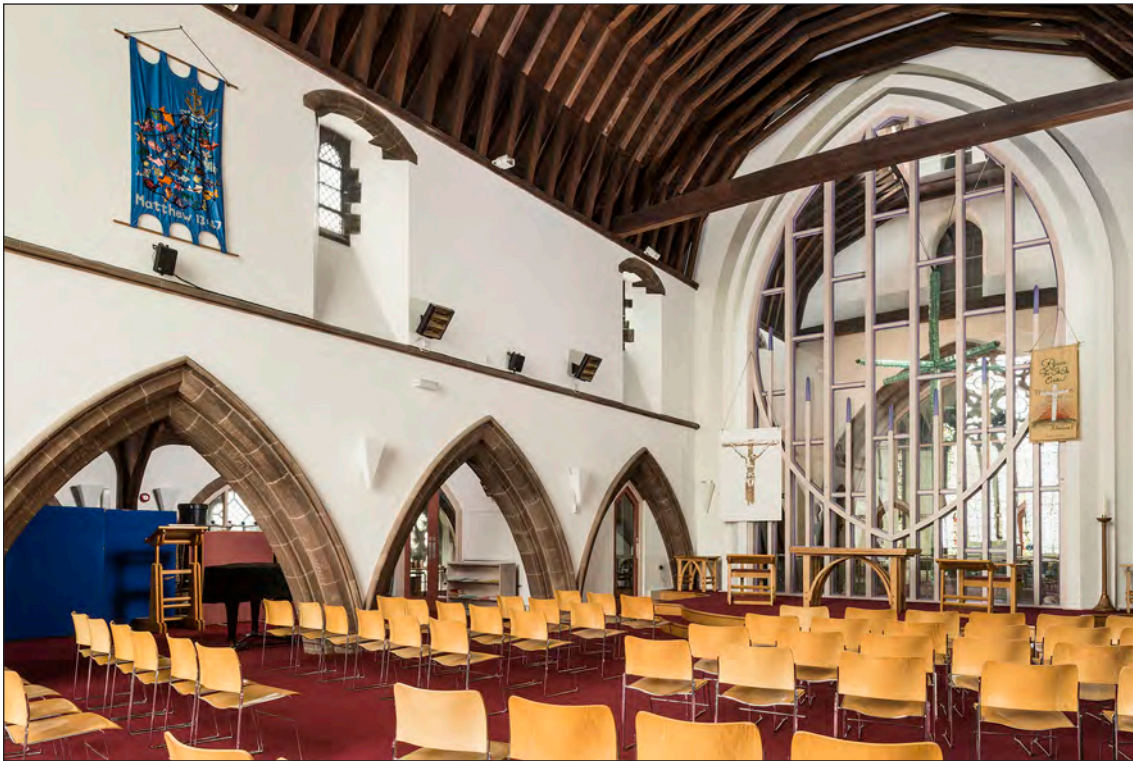
Figure 117: The new church within the roof of the former nave in the Church of St Paul, Walsall, taken from the south (DPI72989 © Historic England, photograph: Steven Baker)

The rectangular nave, currently used as the atrium of the shopping centre, was originally accessed from the porches via the north-west and south-east aisles. Arcades of pointed arches, supported by alternate octagonal and cylindrical piers, separate the nave from its aisles and have been retained within the converted building, albeit truncated by inserted floors (Figure 117). The crossing of the nave and transepts is marked by wider arches supported by clustered piers. The high clerestory windows of the nave take the form of short, pointed lancets with diamond-leaded glass and there is a stone-string course running below the sills of the windows. The roof is composed of trussed common rafters with double collars and struts and there are three tie beams placed at intervals throughout the former nave. The space is largely lit by the large seven-light window in the south-west elevation, where two sets of three lancets rise to support ogees within which the tracery forms daggers; at the apex of the window is a circle containing four quatrefoils and more daggers. The window is glazed with diamond-leaded textured glass. As with other Pearson churches, the floor was laid with wood blocks in the areas of the seating and with red clay tiles in the alleys,⁴⁷³ but these coverings were removed and replaced as part of the conversion.

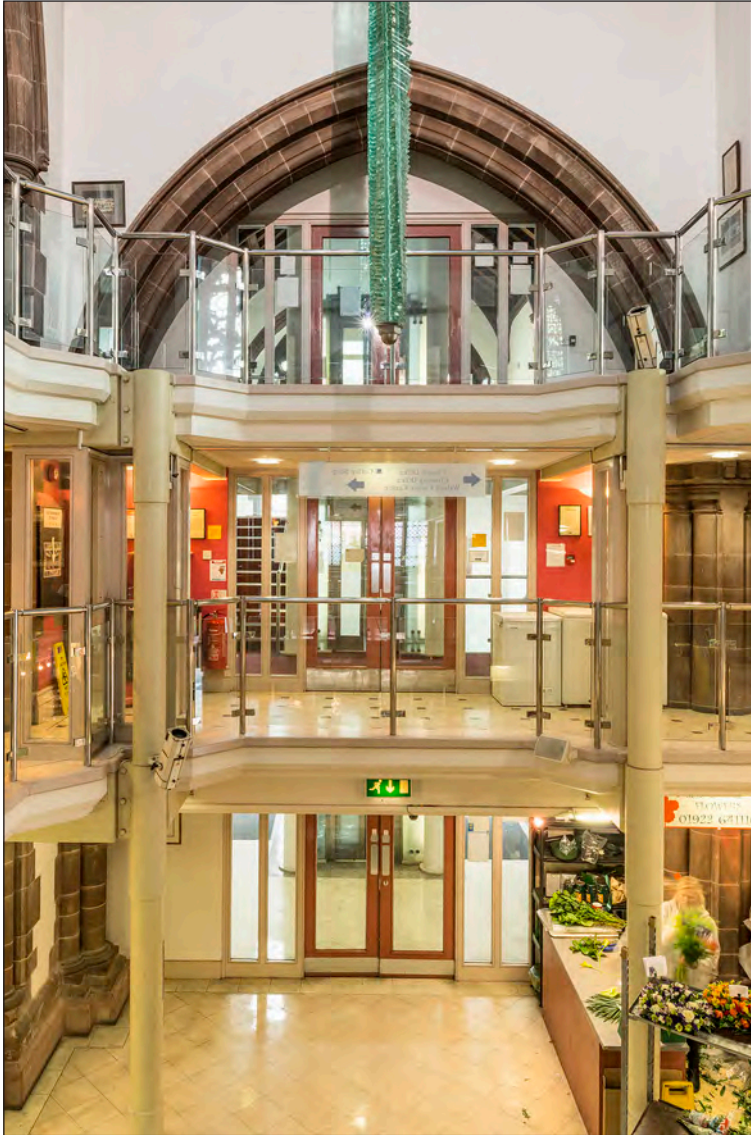
The short transepts (Figure 118) extend from the north-western ends of the aisles and were designed to provide additional light into the crossing with the use of large six-light windows of vaguely Decorated tracery containing diamond-lead textured glass. All internal fittings were removed in the 1990s reworking of the building.

Figure 118: Former south-east transept of the Church of St Paul, Walsall, taken from the south (DP172980 © Historic England, photograph: Steven Baker)

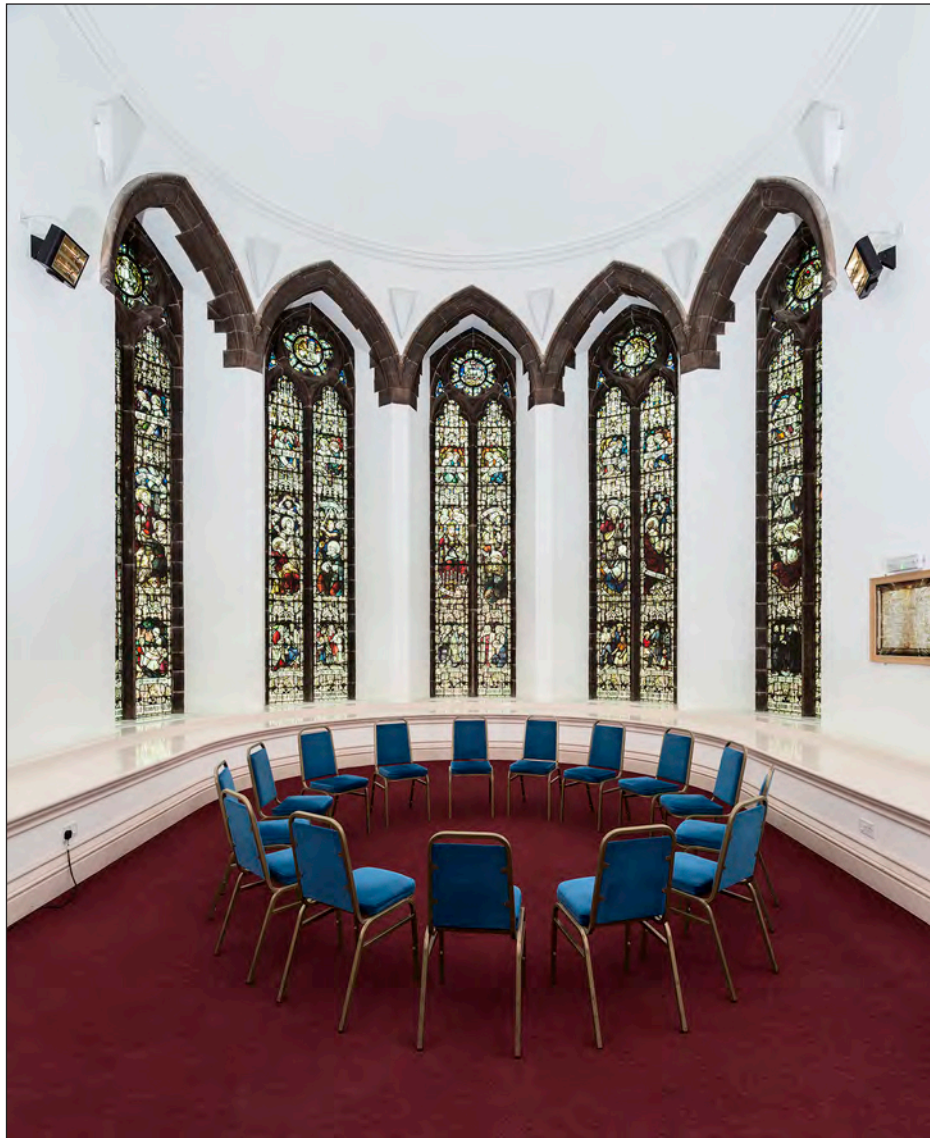
The apsidal chancel was separated from the nave by a tall pointed arch of two orders supported by clustered columns and ring-moulded capitals. The chancel arch was accompanied by a low stone wall but this has since been removed.⁴⁷⁶ Pairs of open double arches with cylindrical shafts in the north-west and south-east walls of the chancel previously opened onto side chapels but these have since been boarded over to separate the individual shops at ground-floor level. Very little of the fabric of the original chancel can be discerned in the current layout although the shape of the space with its apsidal end can be seen in the plan of the converted building. Five two-light windows with trefoil heads and sexfoils above – with the exception of the second window from the left which has a cinquefoil – are arranged within the apse and contain stained glass which was added around 1900 (*see below*). The windows probably originally contained diamond-lead glass which can be seen elsewhere in the building (Figure 119).

Figure 119: Upper part of former chapel in the Church of St Paul in Walsall, taken from the south-west (DP172992 © Historic England, photograph: Steven Baker)

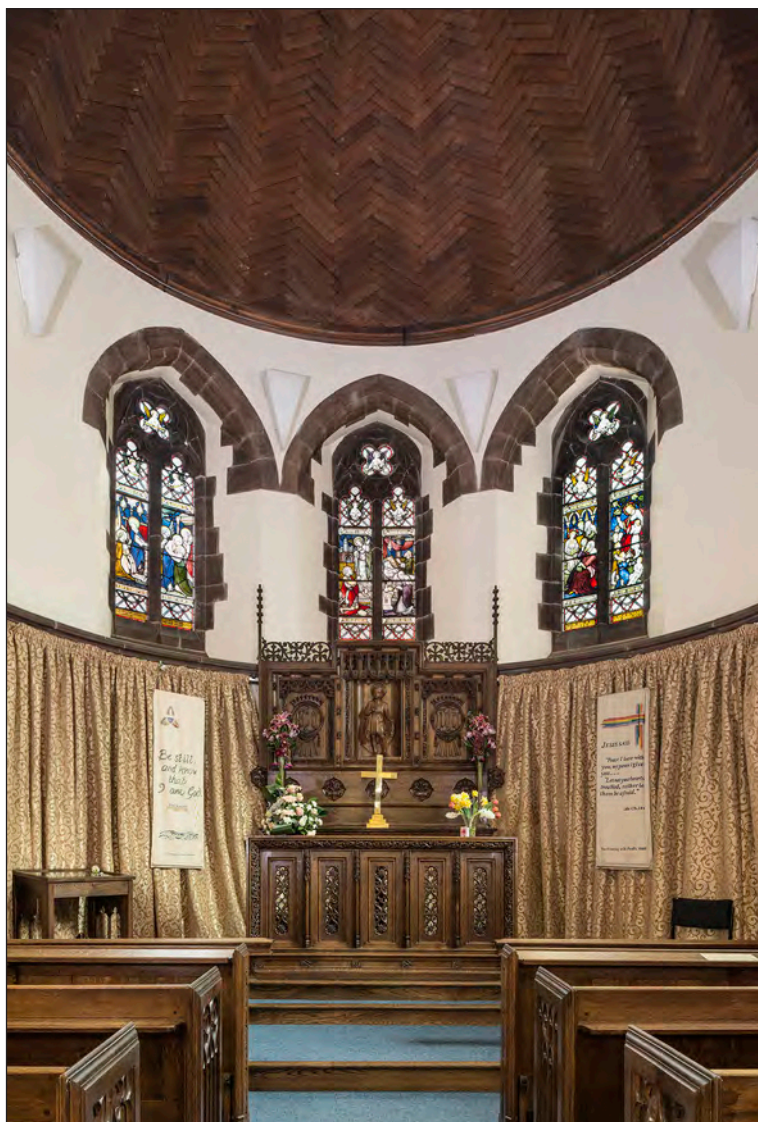
The chapel to the south-east side of the chancel (Figure 120) is the best preserved part of the church and has been retained as a small chapel within the converted enterprise centre. The chapel has an apsidal north-east end and a vaulted ceiling which is covered with wooden boards arranged in a herringbone pattern. The tall arch supported by cylindrical columns and ring-moulded capitals on the north-west side of the chapel opened onto the chancel prior to the conversion, while the large pointed arch with cylindrical piers on the south-west

side opened onto the south-east aisle. The chapel is lit by five two-light tracery windows consisting of trefoil-headed lancets with daggers and quatrefoil above. These are filled with stained glass dating from 1894 onwards and therefore, probably contained diamond-led glass prior to this date. The two files of pews (added around 1949, *see below*) replaced loose chairs⁴⁷⁸ which may have dated from the opening of the church in 1893.

Figure 120: The Lady Chapel of the Church of St Paul, Walsall, taken from the south-west (DP172982 © Historic England, photograph: Steven Baker)

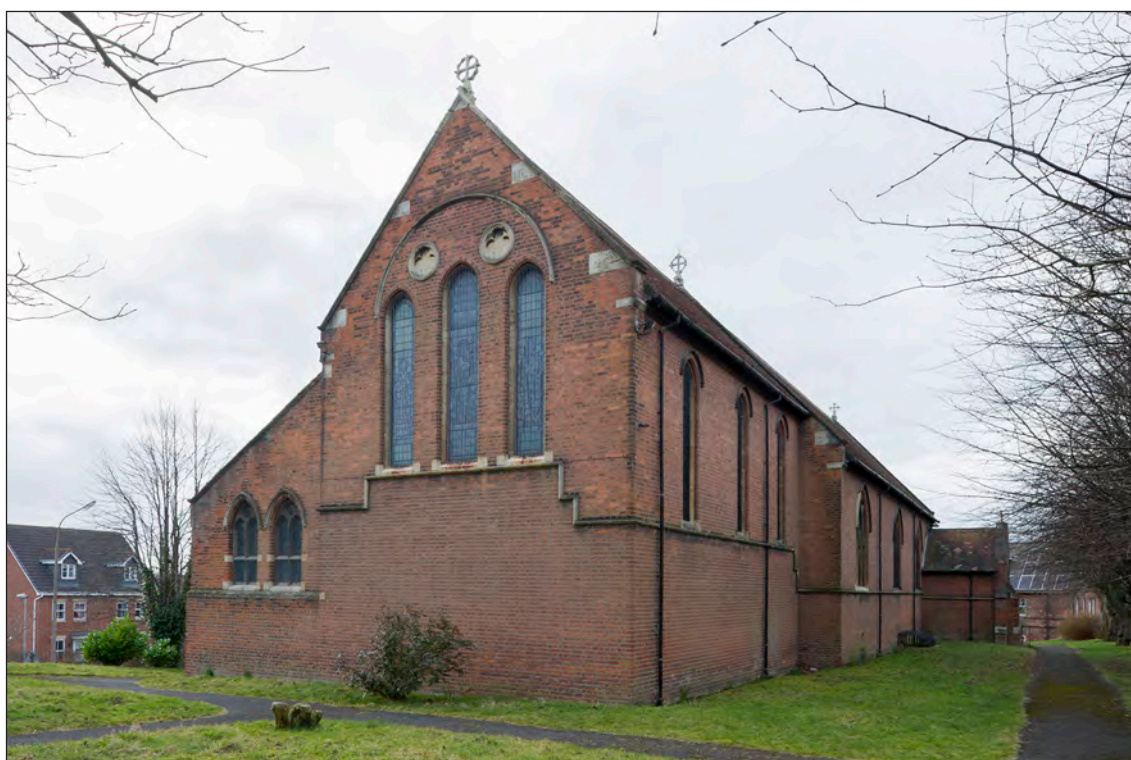
The Church of St Luke occupies a prominent position, partly terraced into the side of a hill and close to its crest, between Winnington Lane and Dyar Terrace; the ground slopes steeply away to the south-west. It is conventionally aligned, west to east. The church is constructed of local red brick with stone dressings and has roofs covered with red-clay tiles (Figure 121). The nave is stabilised on its southern (down-slope) side by a sizable central buttress and there is an angle buttress at the south-west corner.

Figure 121: The Church of St Luke, Winnington, taken from the north-east (DP168665 © Historic England, photograph: Alun Bull)

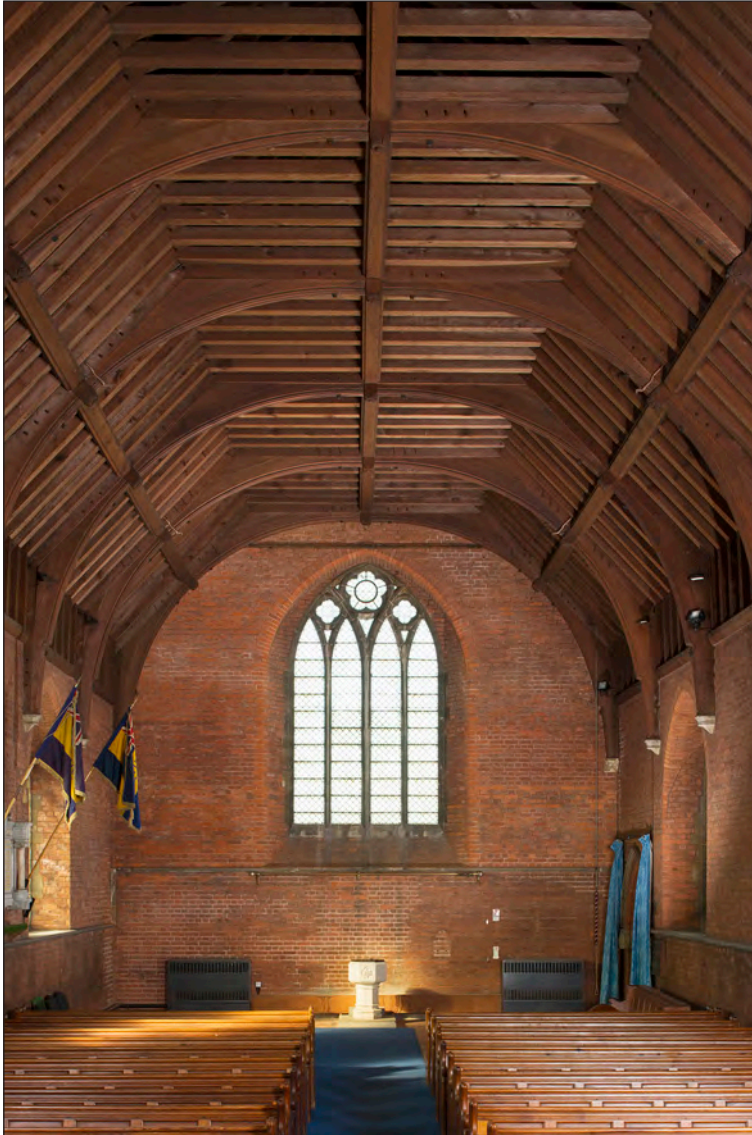
The large aisle-less nave (Figure 123) is closed off from the porch by a double-leaf timber door which fits the pointed arch of the doorway. The nave has a timber double-arch-braced collar roof of six bays with moulded butt purlins, collar purlin, and ashlar pieces connecting the common rafters with the inner wall plates. There are also carved timber bosses where the purlins are met by the braces. The wall posts which support the principals rise from carved stone corbels set within the bare brickwork of the nave walls. The easternmost bay is wider than the rest, to accommodate the redundant tower arch on the south side, and the centre of the bay is strengthened with additional arch bracing accordingly. Such arch bracing, along with the bosses at the intersection of purlins and braces, bears a close resemblance to the nave roof of Pearson's first church at Ellerker. The blocked tower arch is of similar dimensions to the chancel arch and, as described above, the blocking is clearly visible from both exterior and interior.

The nave is lit by a large four-light west window; its simple Y tracery with a cinquefoil and two quatrefoils above is set within a pointed arch. There are five three-light side windows with splayed embrasures, three on the south side (one with intersecting tracery and two with lancet bar tracery incorporating quatrefoils and trefoils) and two on the north side (both with intersecting Y tracery). Only the easternmost window on the north side contains stained glass, the others being filled with opaque glazing, but this is a later addition and all the windows were originally glazed with opaque panes of tinted glass.⁵¹⁰ The central alley is floored with plain red square Staffordshire clay tiles,⁵¹¹ though these are now covered by carpeting, while red and black diamond-set square tiles remain exposed near the font at the west end of the nave and help to demarcate this space. The seating areas of the nave (originally occupied by chairs which were replaced with pews in 1955) have floors laid with wooden blocks.

Figure 123: The nave within the Church of St Luke, Winnington (DP168640 © Historic England, photograph: Alun Bull)

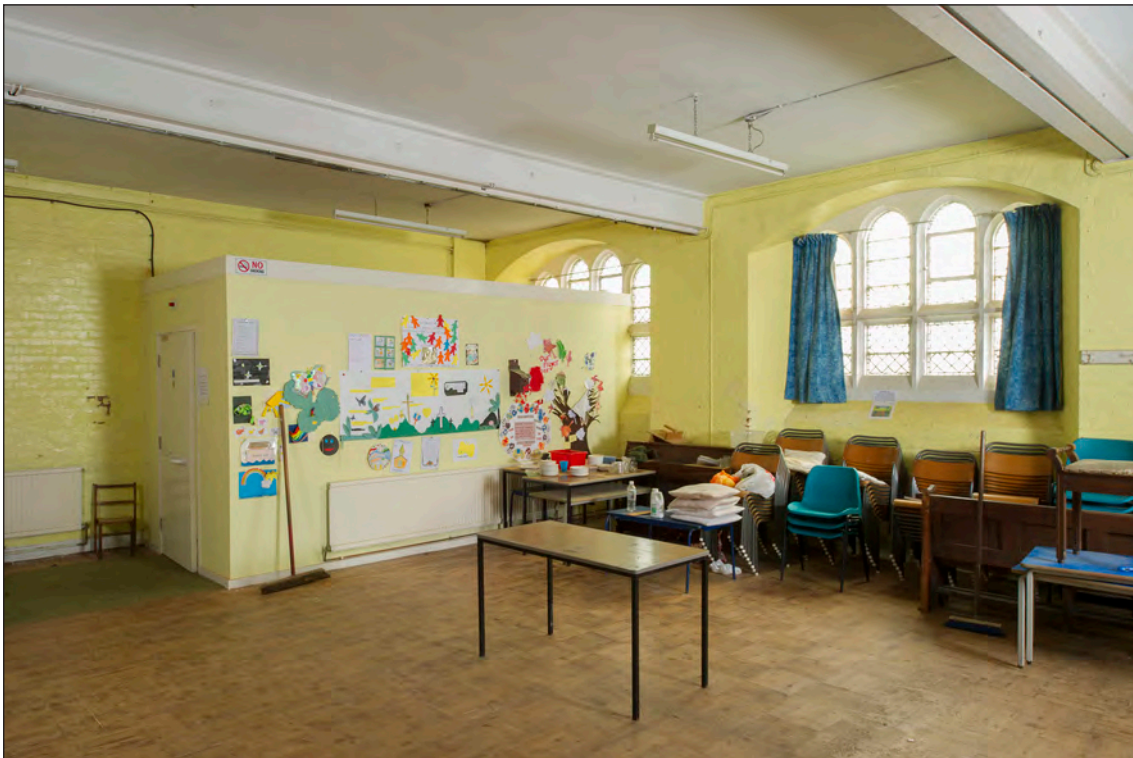
Beneath the nave is a large room, now known as the parish room, which makes use of the partially terraced nature of the church into the hillside (Figure 125). The room is reached externally from the south through a wooden door within a pointed arch of brick with ashlar mouldings and hood. The interior brick wall surfaces are painted and the roof is unceiled, leaving the massive steel I-beams which carry the nave floor exposed. The room has been sub-divided to provide a kitchen to the west, a lavatory to the east and a wooden internal lobby on the inside of the door. The floor is laid with wood blocks in a similar style to those of the pewed area of the nave and the stalled area of the choir, while the tiled floor in the kitchen appears to be late 20th century. The parish room has five windows of identical arrangement: four-light lancets of two heights with transoms and opaque, tinted glazing, two of which are in the south wall, two in the west, and one in an arched recess in the north wall. This north window is set below the external ground level on the north side of the church, with light provided via a light well set against the north elevation of the church; at the time of survey it was partly boarded over. It is difficult to date the internal fixtures and fittings from what is visible today, but aside from the insertion of the lavatory, kitchen and lobby, the space is almost certainly as it was at the time of the church's construction. The furniture all appears to date from the mid- to late 20th century. It is likely that the space was originally used as a school room (or class room), and was most recently used by the church as a space for parish meetings, coffee mornings and Sunday schools. To utilise such a space under a church for a parish or school room is highly unusual for an Anglican church, and is thought to be unique amongst Pearson's churches.

Figure 125: The parish room underneath the nave within the Church of St Luke, Winnington (DP168670 © Historic England, photograph: Alun Bull)
