# Norman's Bay Wreck, Pevensey Bay, East Sussex Conservation Statement and Management Plan

## Norman's Bay Wreck, Pevensey Bay, East Sussex: Conservation Statement and Management Plan

NGR: TQ 69960 03146

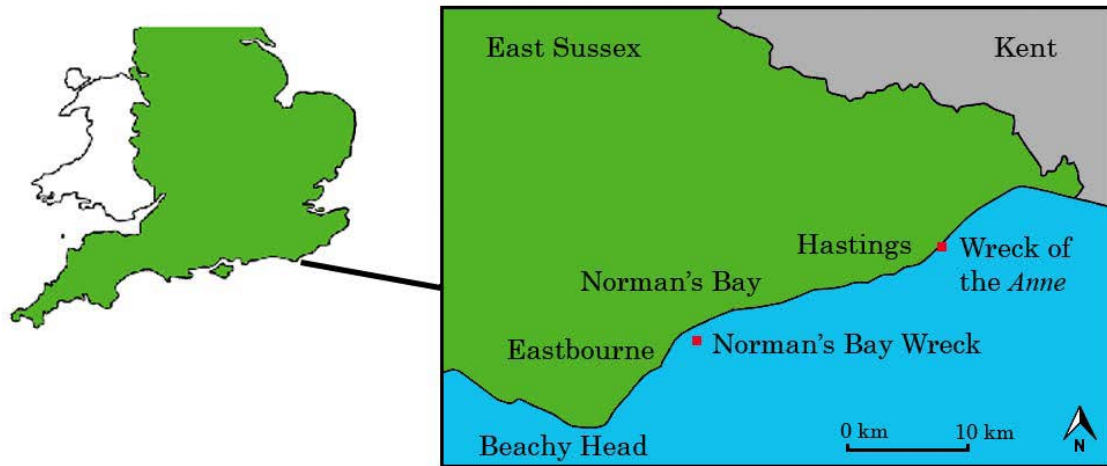
Fig. 1: Location of the Norman's Bay Wreck site and the location of The *Anne* Protected Wreck site. These two wrecks are potentially from the same sea battle that took place in AD 1690.

- 2.1.4 The recorded position of the centre of the Norman's Bay Wreck is Latitude 50° 48.1767' N and Longitude 00° 24.6380' E (WGS 84) (Fig.1). The charted depth recorded at this location by the United Kingdom Hydrographic Office (UKHO) is six metres. The tidal range on the site is nearly eight meters on a spring tide, with diver recorded depths over the last five years ranging from seven to 15 meters, depending on the state of the tide. The predominant tidal direction in this location is east to west on the rising flood tide and

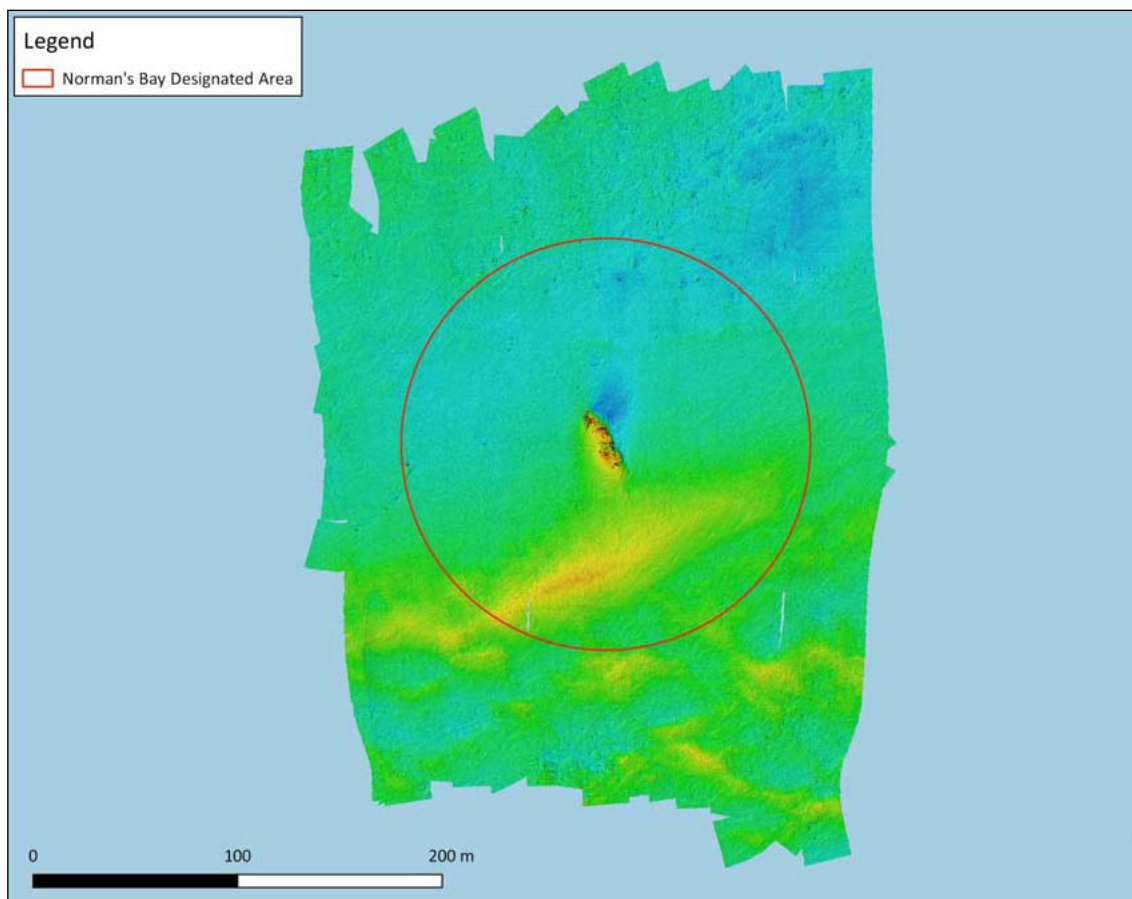
Fig. 2: Total extent of multibeam sonar survey of the Norman's Bay Wreck designation area, undertaken in 2016 by MSDS Marine Ltd on behalf of the Nautical Archaeology Society.

- 2.1.5 The topography surrounding the wreck is mostly flat (Figs 2 & 3). The seabed around the site is mostly composed of a compressed sand and aggregate mixture covered with a fine layer of slit and loose sand. A large number of mussels (*Mytilus edulis*) can be found within this sediment (Wessex Archaeology 2006a) as well as *Lanice conchilga* worms. Depending on the time of year, nearly all the hard surfaces on the site are covered with mussels and on many occasions the mussels have to be removed during survey tasks, which then very quickly recolonize the cleared area. Wessex Archaeology reported large colonies of mussels in September 2005, but none in the May 2006 suggesting their number swell during the warmer times of year in English coastal waters (Wessex Archaeology 2006b). All exposed timbers observed on the wreck, including those sampled for dendrochronology were badly damaged by Piddock (*Pholas dactylus*) (Nayling / English Heritage 2008).

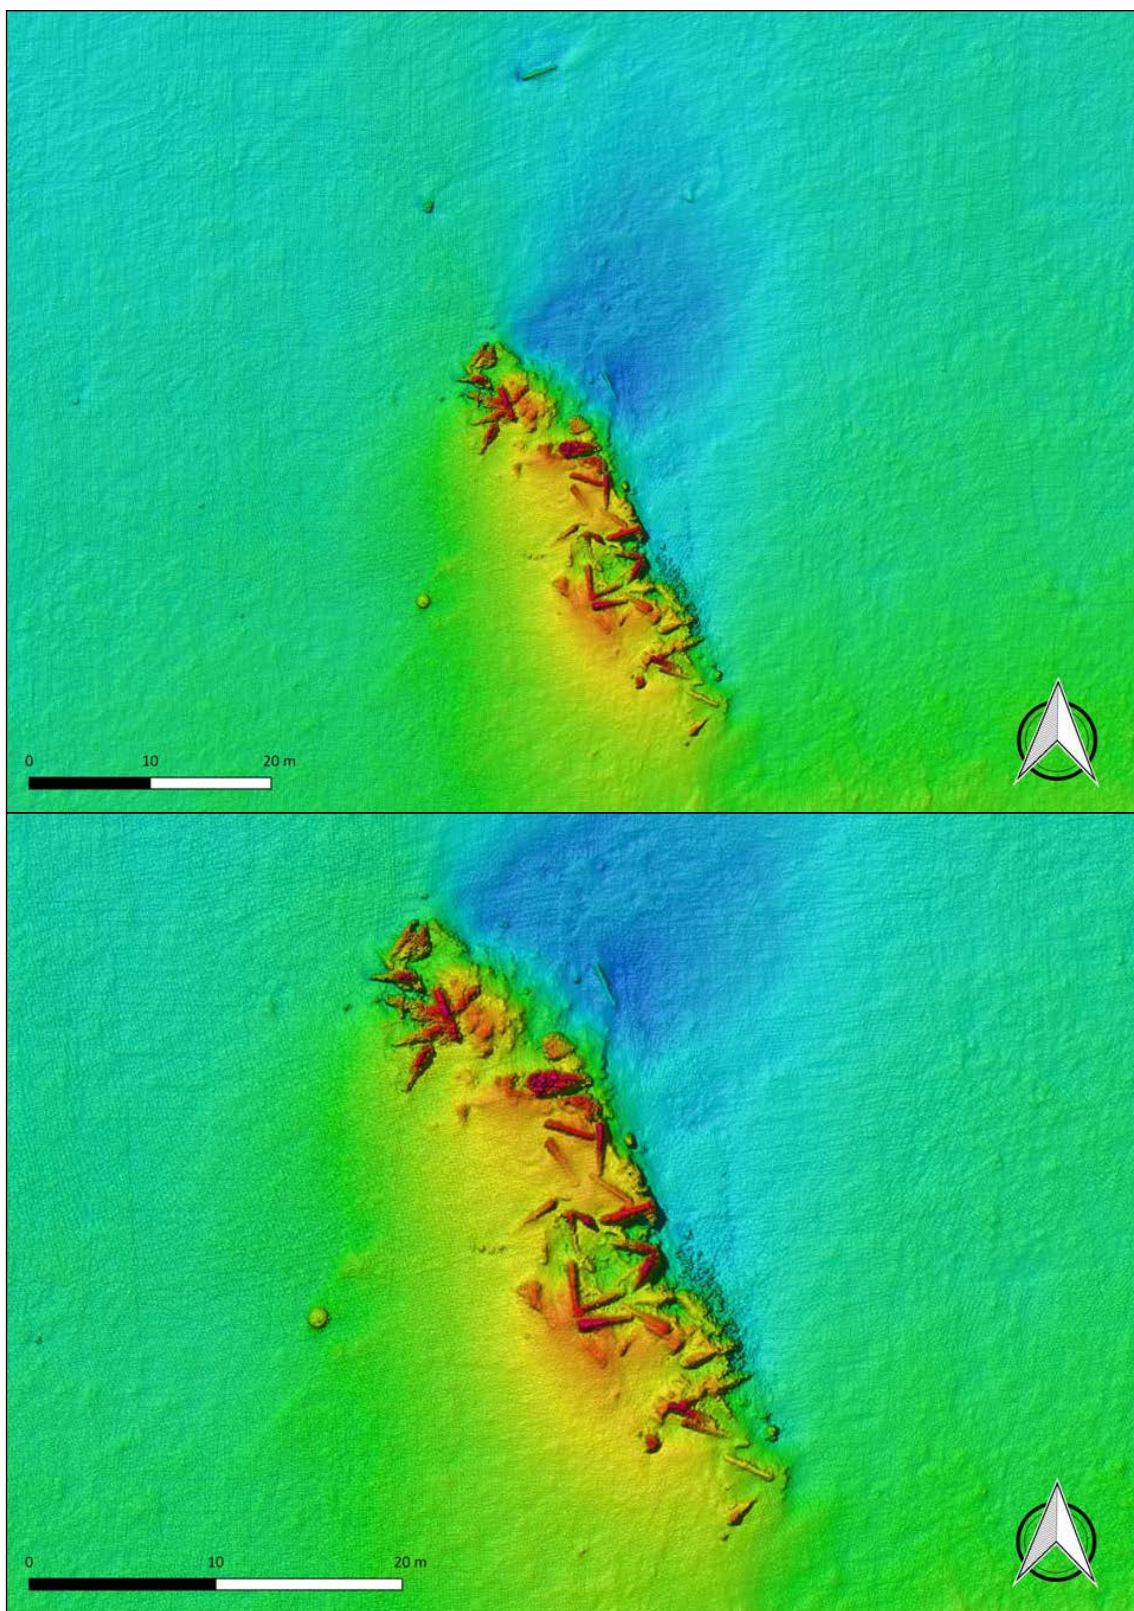
Fig. 3: Multibeam sonar survey of the Norman's Bay Wreck undertaken in 2016 by MSDS Marine Ltd on behalf of the Nautical Archaeology Society.

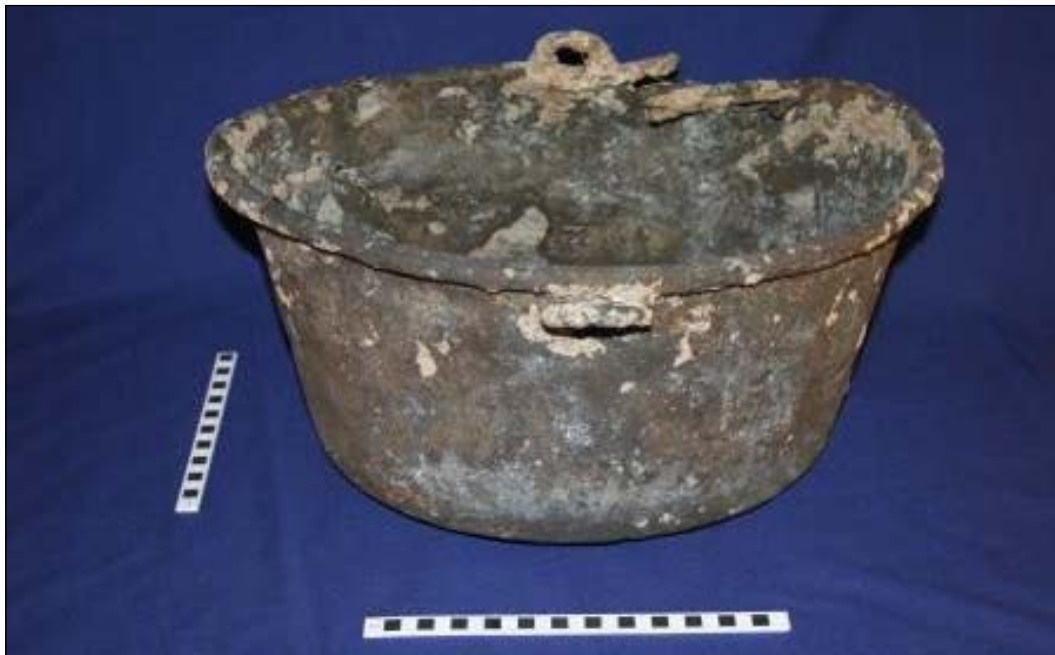
Fig. 4: Copper cauldron on display in the Shipwreck Museum, Hastings (Scale 25cm)

- 2.2.6 As previously described, a copper alloy cauldron (Museum ID HASSH 676) was recovered by an anonymous local diver and is now on display in The Shipwreck Museum in Hastings, East Sussex with a label stating it was recovered in 1999 from the Norman's Bay Wreck. The cauldron measures 48.5cm in diameter at the rim and 37cm in diameter at its base and is 23cm tall. The rim is turned over with two handles present on opposite sides (Fig. 4). A number of other small items including a wrought iron bolt, a concretion and a cast iron shot (45mm diameter) were also recovered by divers and anonymously handed in during 2006 (English Heritage List Entry Number: 1000084 / Receiver of Wreck Droit Number 158/06).

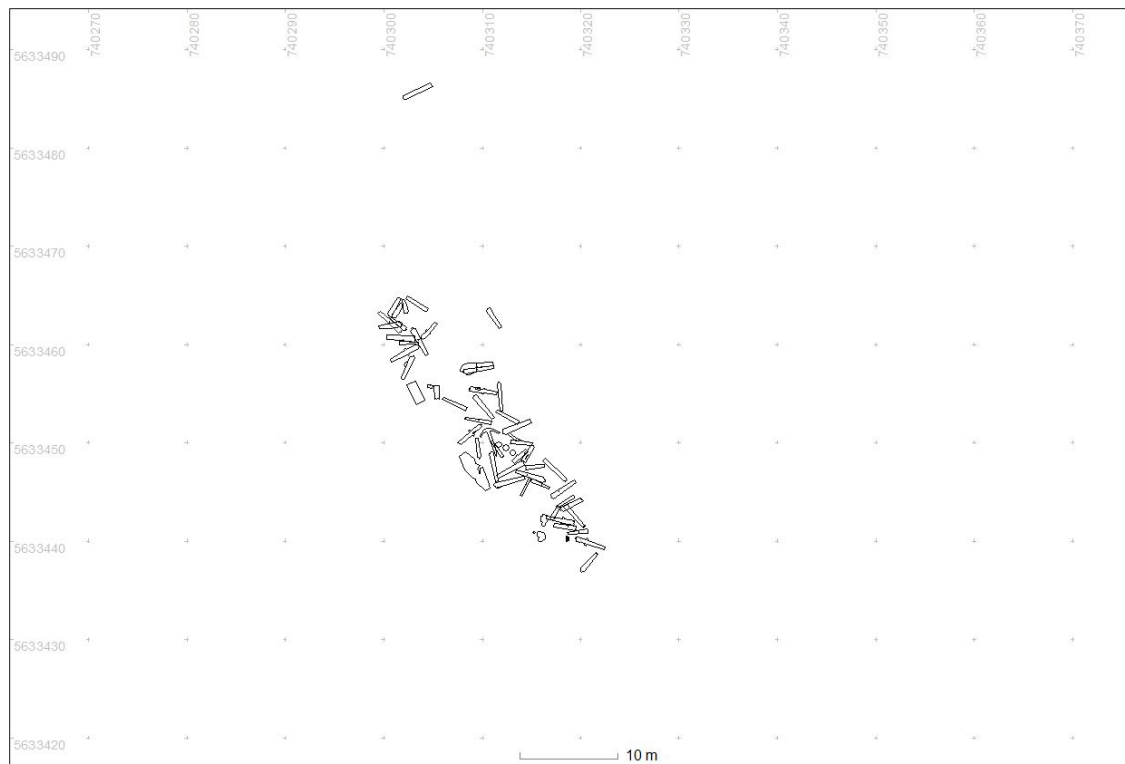
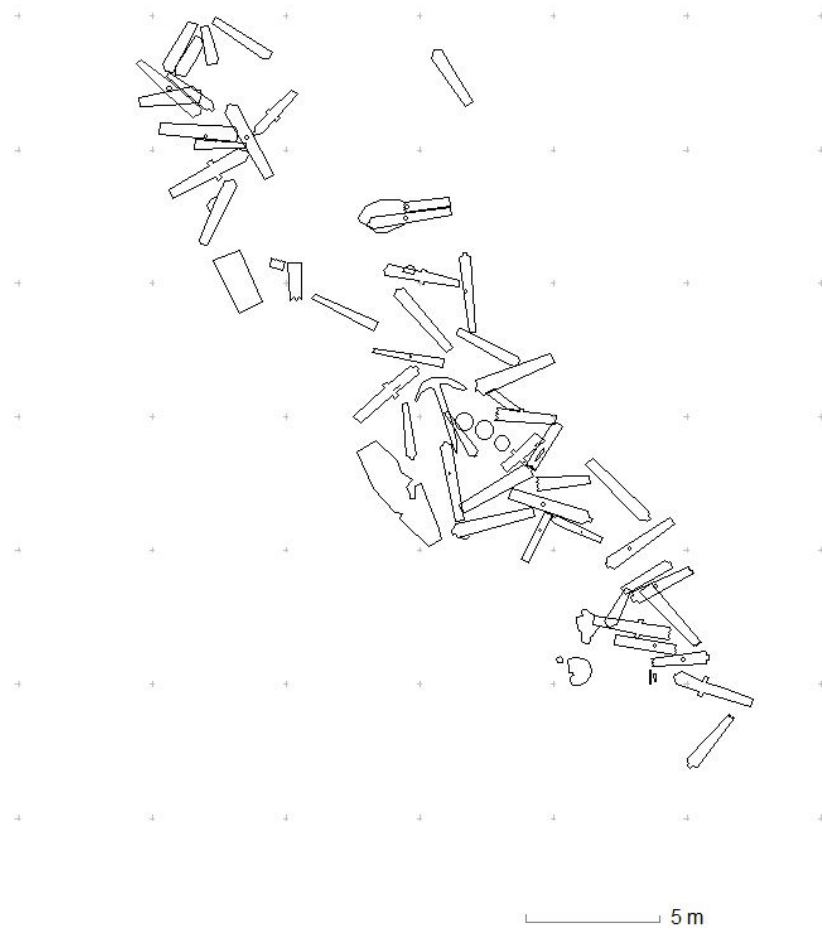
Fig. 5: Site plan of the Norman's Bay Wreck (NAS 2016)

- 2.2.1 The Norman's Bay Wreck is still being researched and recorded by the NAS with new finds being made every year. The site plan is an ever evolving view of the assemblage on the seabed. The first site plan was created by Wessex Archaeology during their undesignated site assessment visit in September 2005. This plan was published in their 2006 report for English Heritage as part of the contract for Archaeological Services in Relation to the Protection of Wrecks Act (1973) (Wessex Archaeology 2006a). All subsequent visits by both Wessex Archaeology and the NAS have used this site plan as a basis for their surveys. The methodology employed to generate the 2006 plan involved the use of a GPS diver tracking system allowing an accurate position to within one metre (Wessex Archaeology 2006a: 3). The level of accuracy from this GPS system has been relied upon for all subsequent diver surveys.
