THE WESTERN HEIGHTS DOVER, KENT

Report No 2: The Citadel

SURVEY REPORT

LAND-FRONT FORTRESS AND BARRACKS 1779-1950

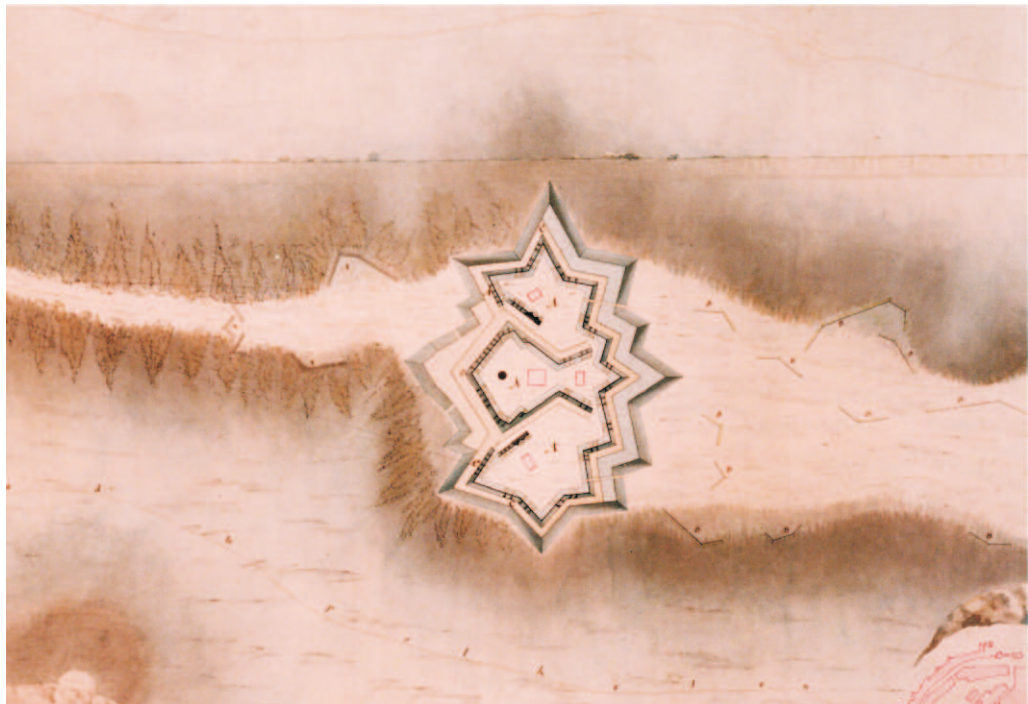
Figure 3
*Lieutenant Page's
design for the Citadel,
dated 1784 (extract of
PRO: MR/1/1345 © The
Public Record Office)*

Nevertheless, this modest plan was soon transformed into an ambitious scheme for more substantial fortifications, combining both permanent and temporary elements. Their design, by the engineer officer Lieutenant Thomas Hyde Page, is revealed on a plan dated 1784 which shows a large bastioned fortification spanning the western end of the Heights, the earliest representation of the main work which was to become the Citadel. Other minor works are shown along the ridge (Fig 3).

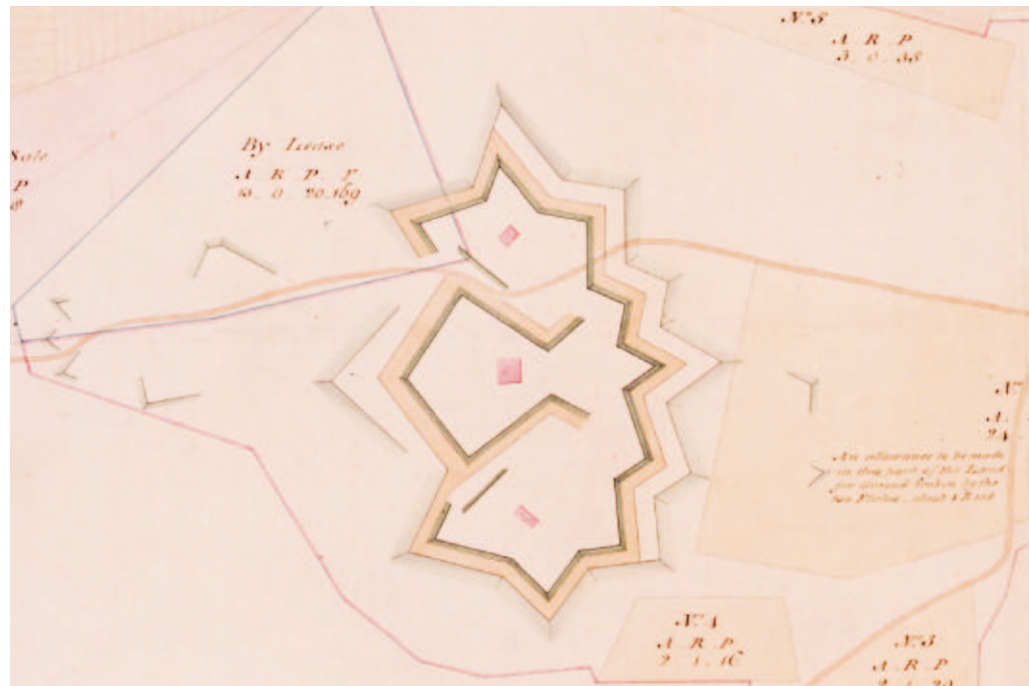
Figure 4
Lieutenant Hay's plan of the Citadel, dated 1787. The guardhouses are shown in pink (extract of PRO: MPH/1/248/6 © The Public Record Office)

The present Main Entrance replaced an earlier one which passed through the gorge rampart further to the north (it had been built during the American War and is shown on Lt Hay's plan of 1787 (Fig 4; PRO: MPH/1/248/6)). A proposal plan, dated October 1809, shows the old entrance and a new one close to the present Main Entrance; both are simple revetted passages reached via bridges over the gorge ditch (PRO: MPH/1/228/3). That work on this new entrance was started and abandoned before the end of the Napoleonic Wars is suggested by the labelling of a '*breach*' on a plan of 1813, and confirmed by a clear break in both rampart and ditch on another of 1830 (Fig 7; PRO: MR/1/1346; WO/55/2562/8). It was presumably this breach that was made good in works approved in March 1853 (PRO: WO/55/785). In 1858, a report describes a decaying timber hut as the guard house at the entrance to the Citadel, presumably the original entrance as shown in 1787 and still indicated as a bridge spanning the ditch on a survey of 1851 (PRO: WO/33/587; WO/55/2931).

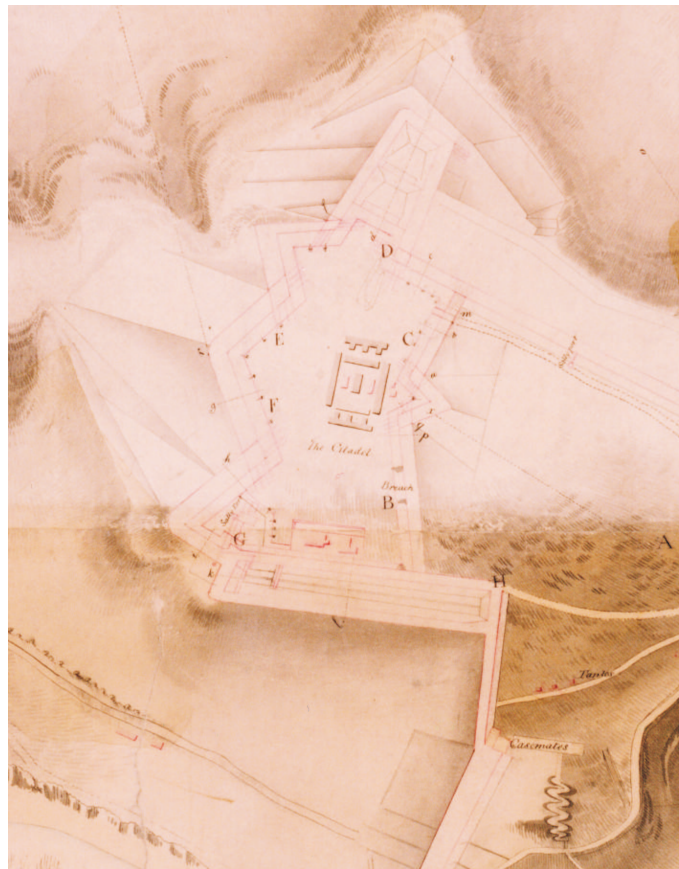
Figure 7
The Citadel in 1813
(extract of PRO:
MR/1/1346 © The
Public Record Office)

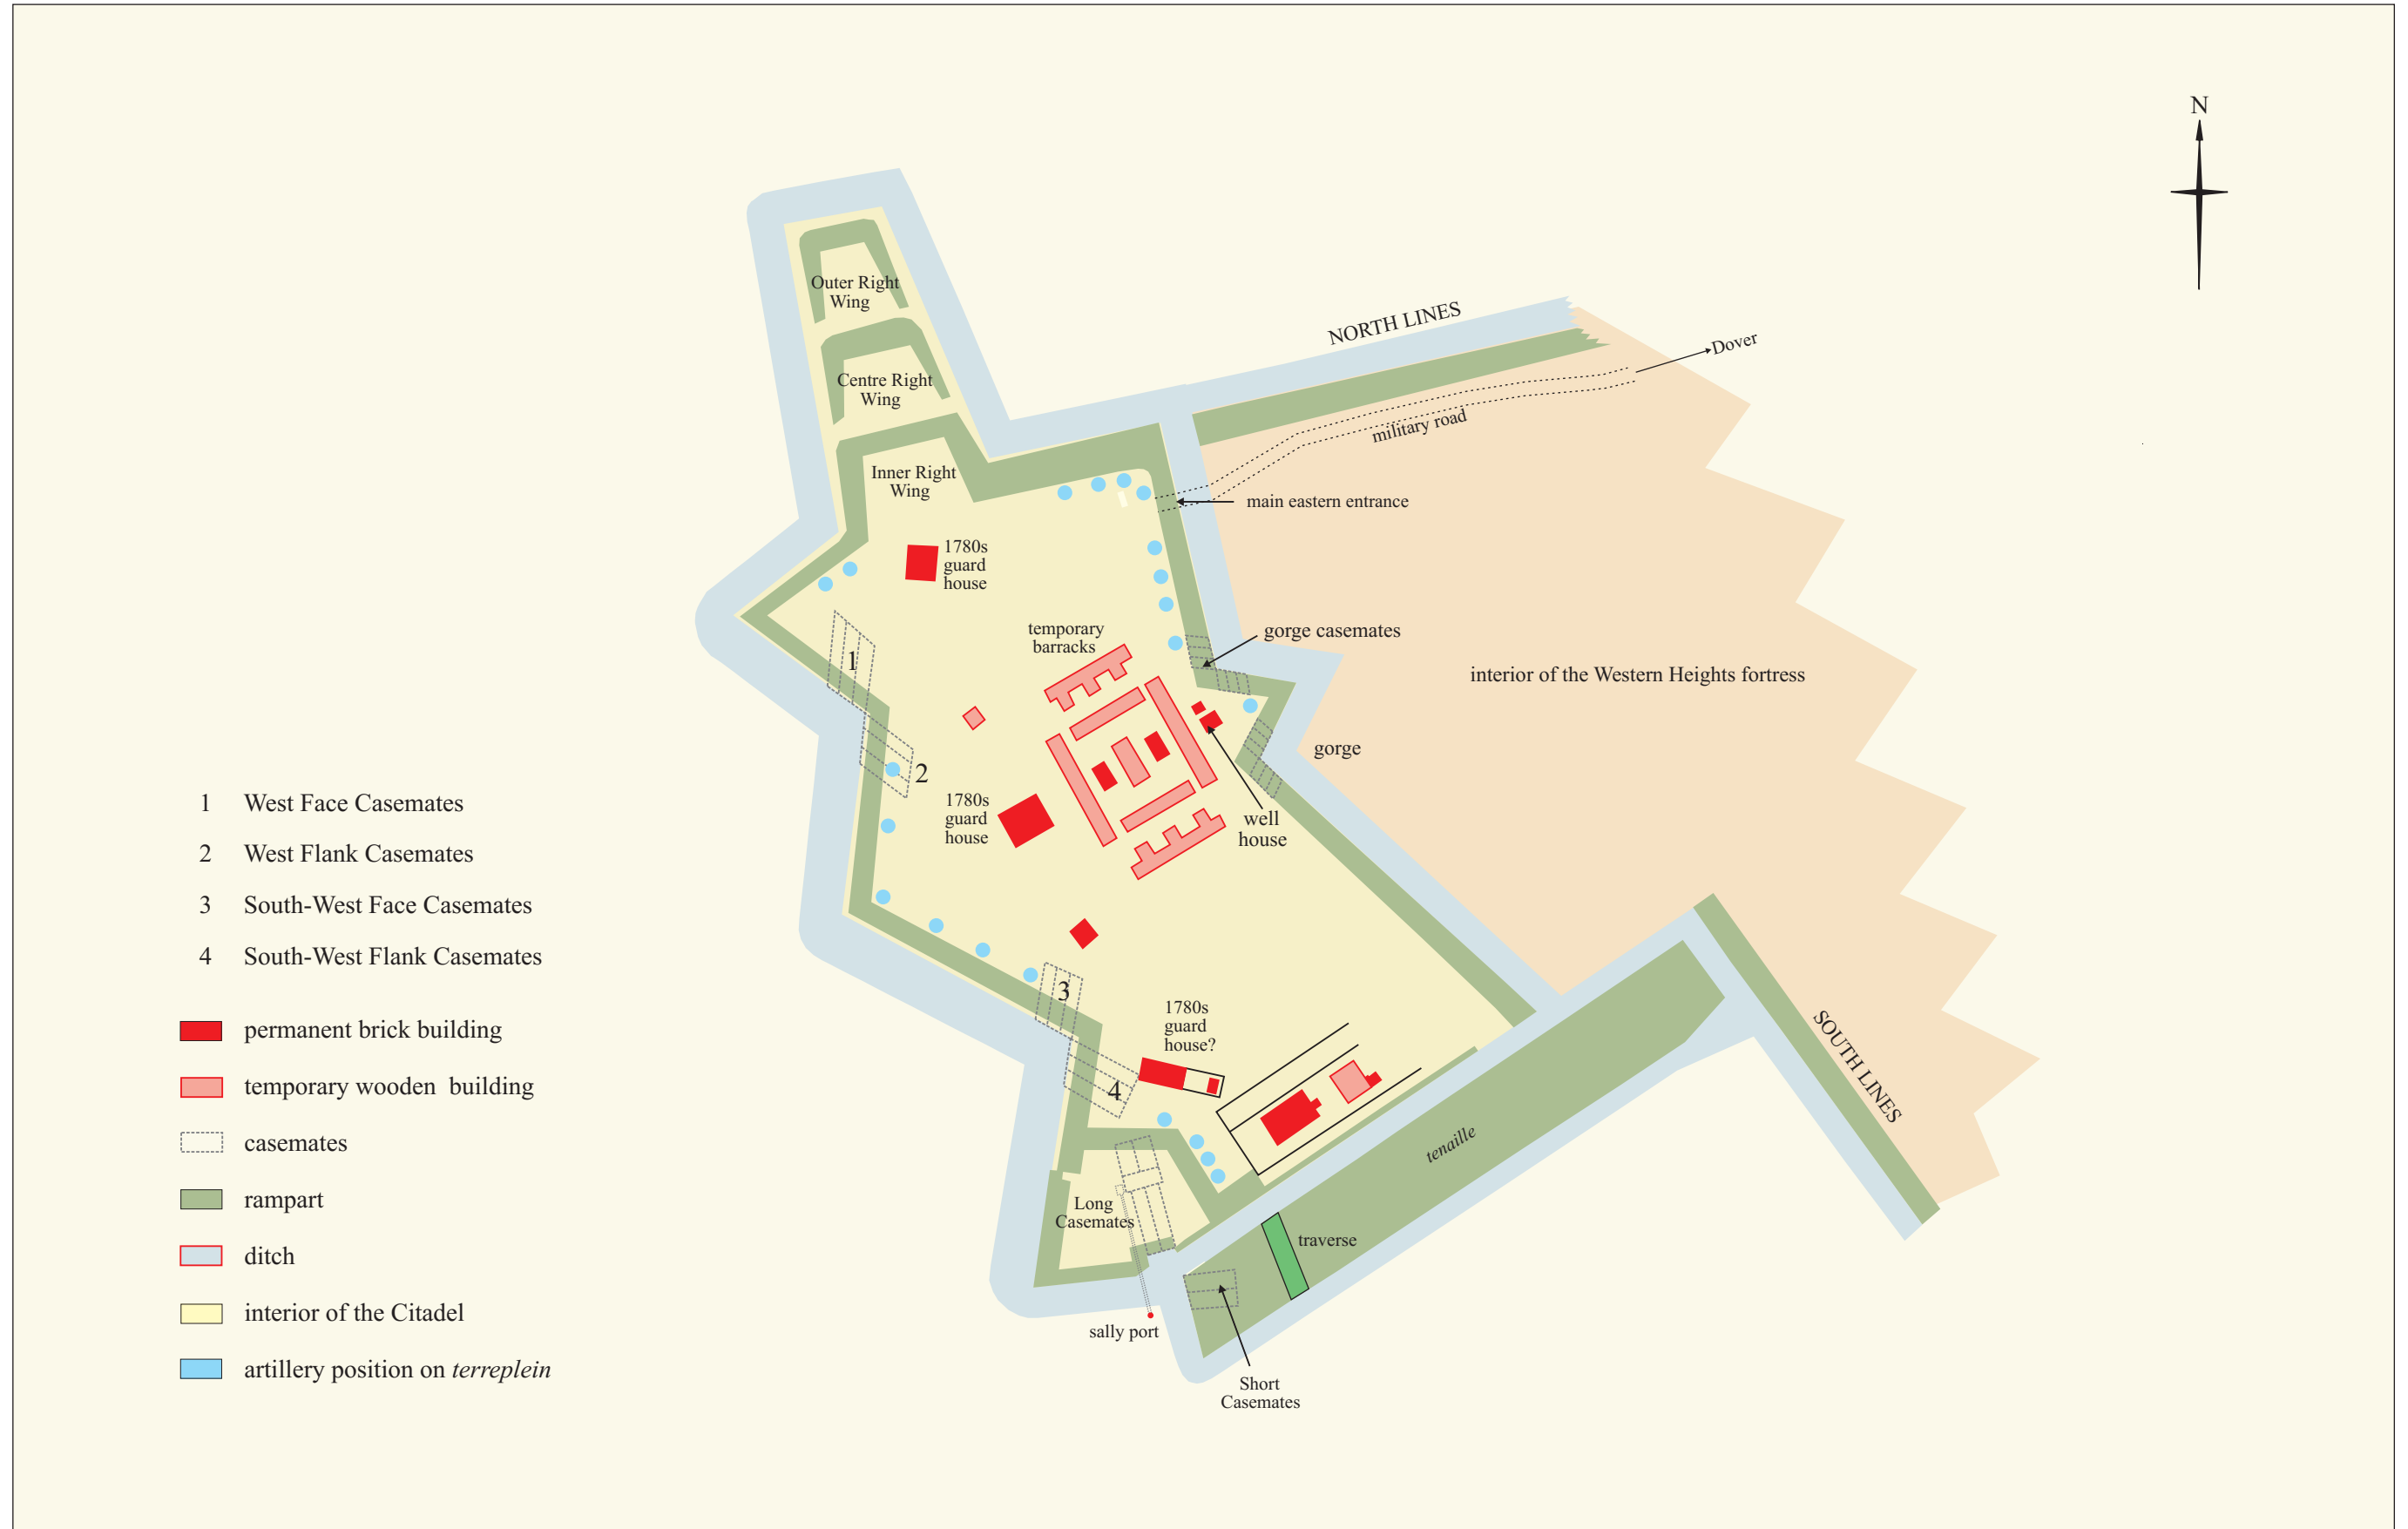
Figure 8 Plan showing the Citadel in 1815 (after PRO: MR/1/1346)

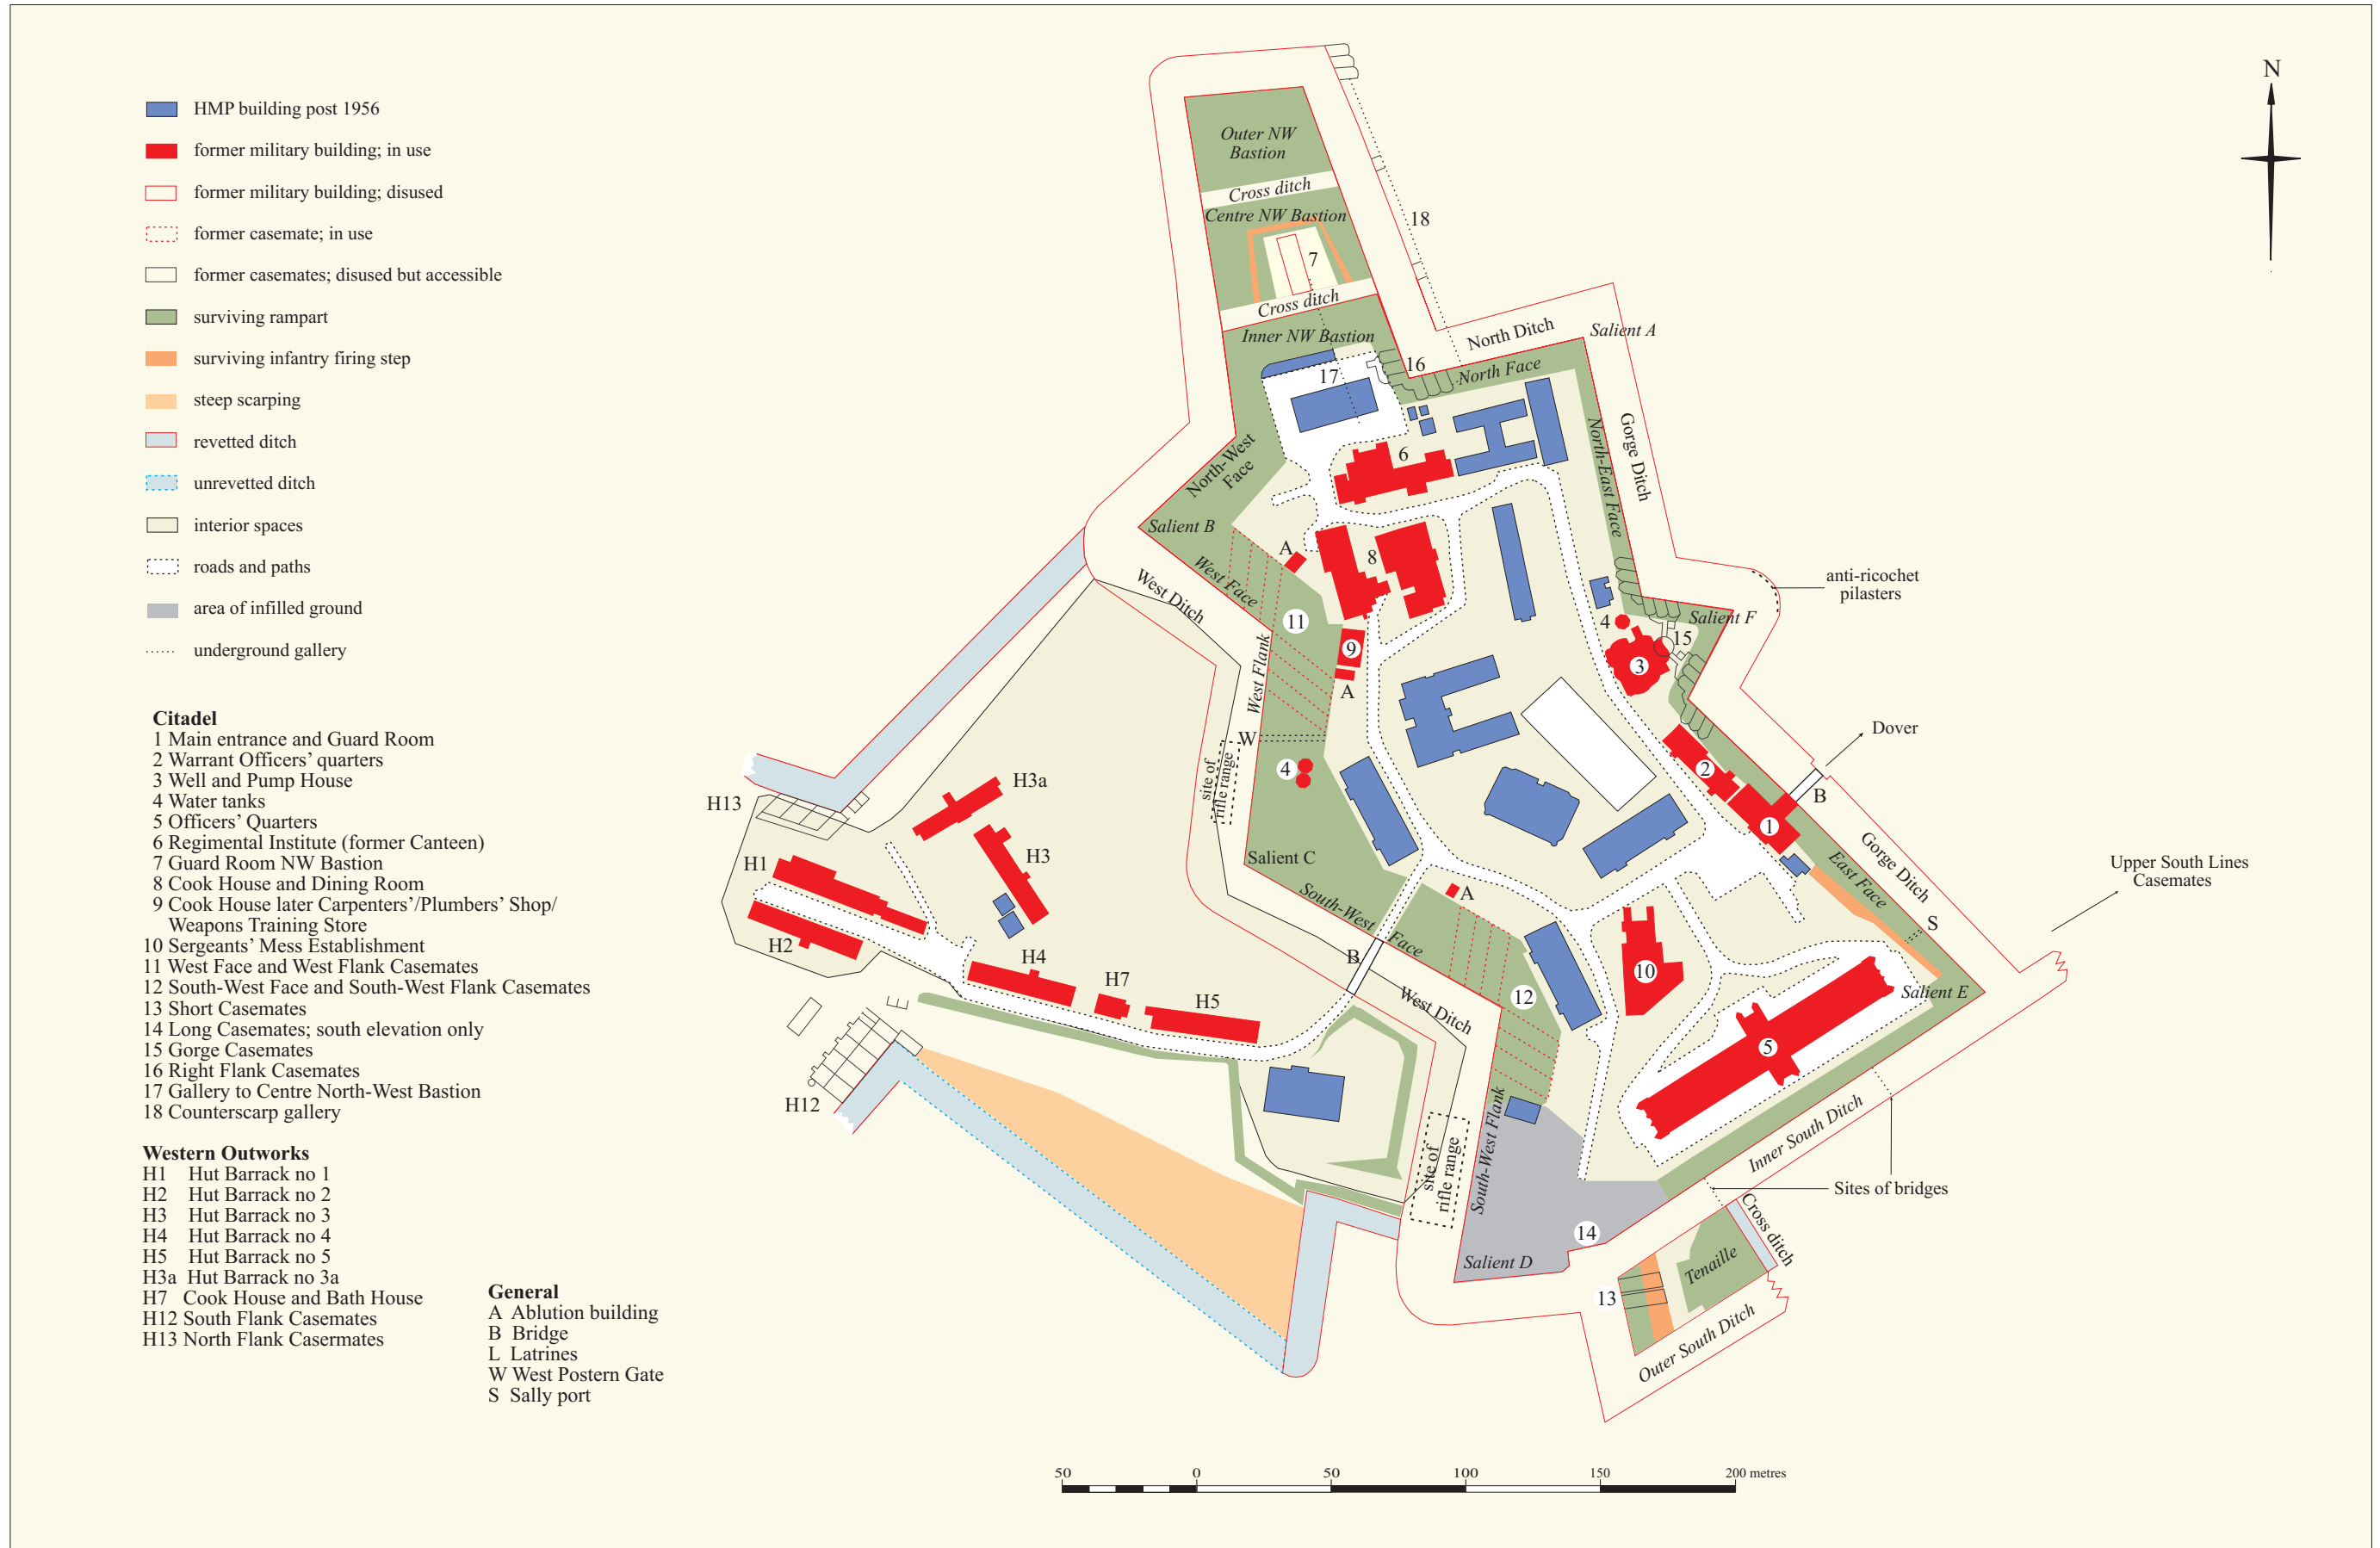
Figure 15 Plan showing the Citadel c1998 (text in italics indicates the nomenclature of the fortress used from the later 19th century onwards)

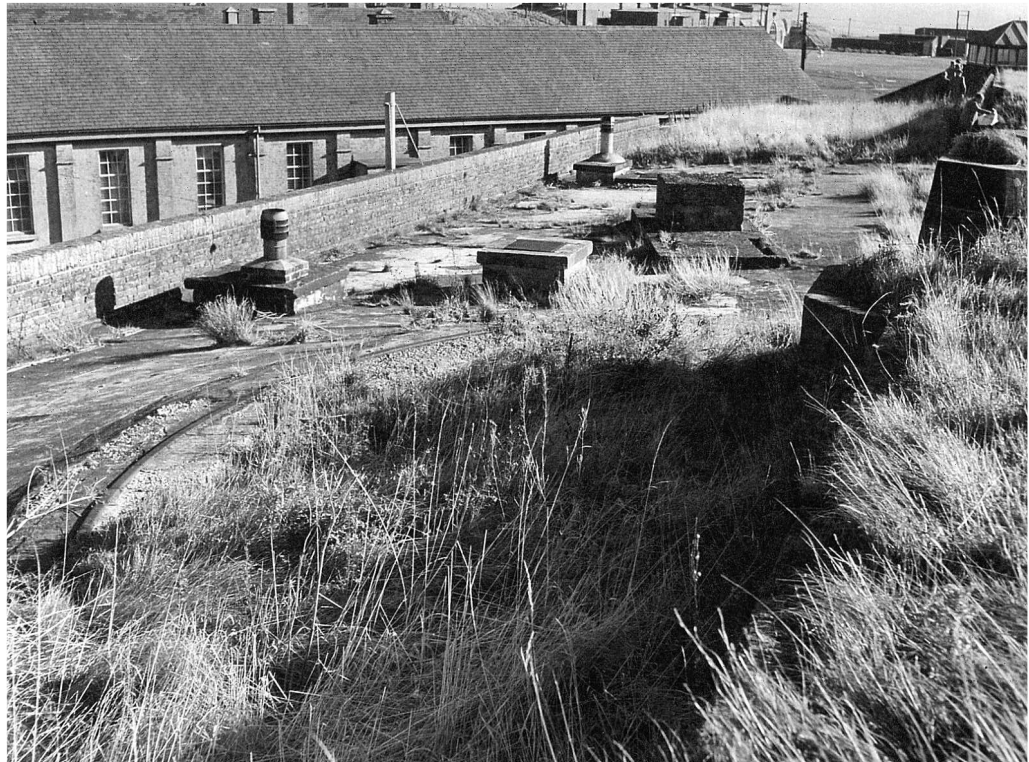
Figure 16
The terreplein of the West Face, in 1959, showing (at lower left) the racer from a late 19th-century traversing gun platform and (at top right) details of embrasures in the parapet. All of this detail is now lost or concealed (A5513/34 © Dover Museum)

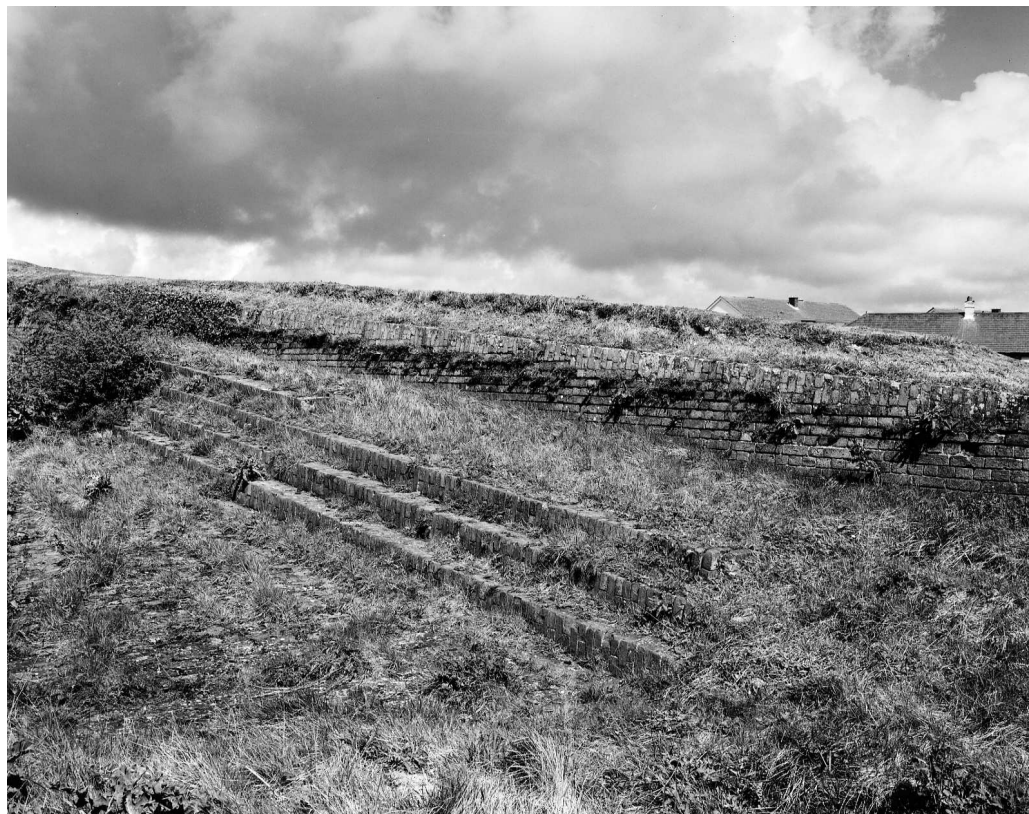
Figure 17
*Overgrown infantry
banquette and steps on
the East Face, or south
end of the gorge
rampart (NMR:
BB032736 © Crown
copyright 1998)*

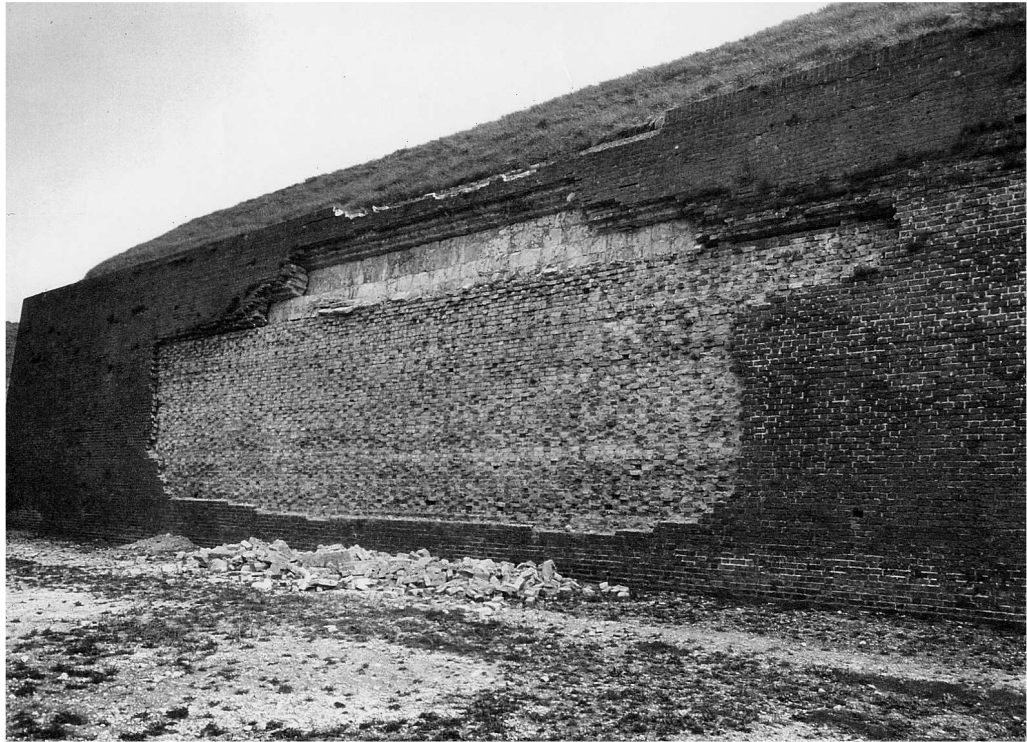
Figure 18
North end of the western scarp revetment of the NW Bastion, in 1959, showing defective brickwork cut out prior to repair. Note the heightening marked by a junction between brickwork and chalk ashlar, probably representing the Napoleonic and 1860s construction phases respectively (A6207/4 © Dover Museum)

The scarp and counterscarp revetments of the main ditch are virtually complete, built in stock brick, steeply battered and usually strengthened at the salient angles with large dressed stone quoins. The revetments have been repaired to a very good standard at various times, not least by HMPS, judging by damage recorded on photographs taken in 1959 (Fig 18). The general bond pattern is that of Flemish bond to between $\frac{1}{2}$ and $\frac{3}{4}$ height, with English above but in a couple of locations the bond is all English or Flemish.

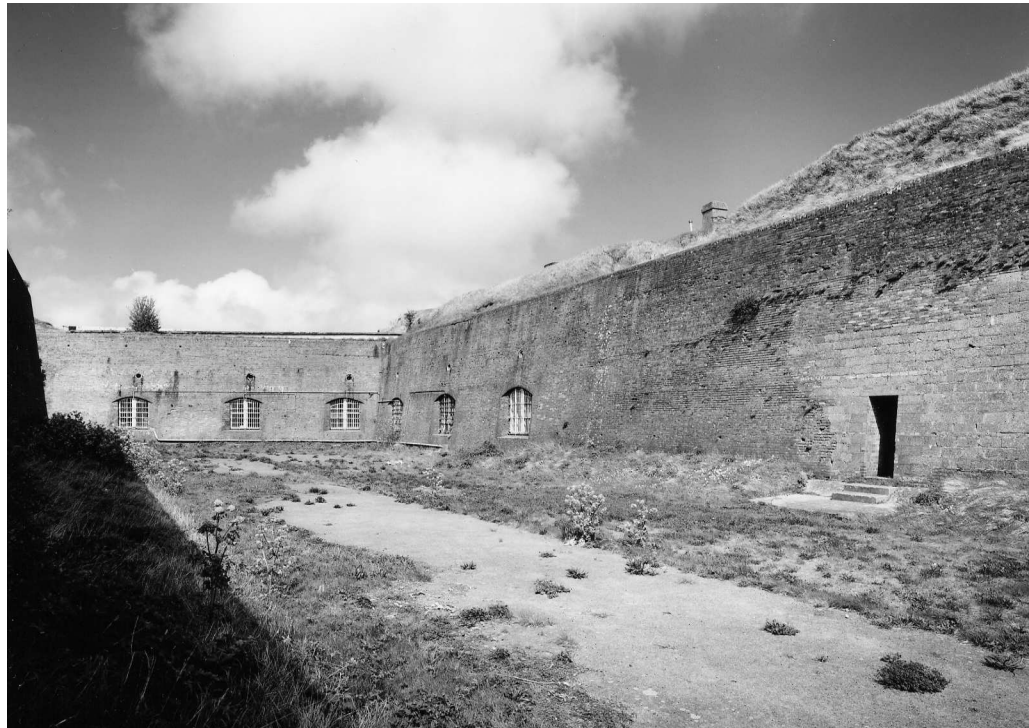
Figure 19
The West Ditch, looking north, showing the West Postern (at right) and the windows of the casemates of the West Face and West Flank (NMR: BB032743 © Crown copyright 1998)

North of Salient C, a concrete floor in the ditch is from another miniature rifle range. The scarp revetment incorporates the West Postern, a small square-headed doorway constructed in a concrete repair to the revetment and approached up three steps defined by low flanking walls (Fig 19). Inside the doorway, a small section of an earlier semi-circular brick vault is visible, from a gallery that led under the rampart to the interior of the fort. Both entrance and gallery were probably inserted in the 1850s/60s and they are depicted on the 1871 Citadel plan, although the present form is modern (PRO: WO/78/2755/12). Originally, it was a sally port to the ditch and a stairway ascending the counterscarp into the Western Outworks; although the stair has gone, the scar of its two relieving arches remain. In the 20th century it provided a route to the rifle ranges.

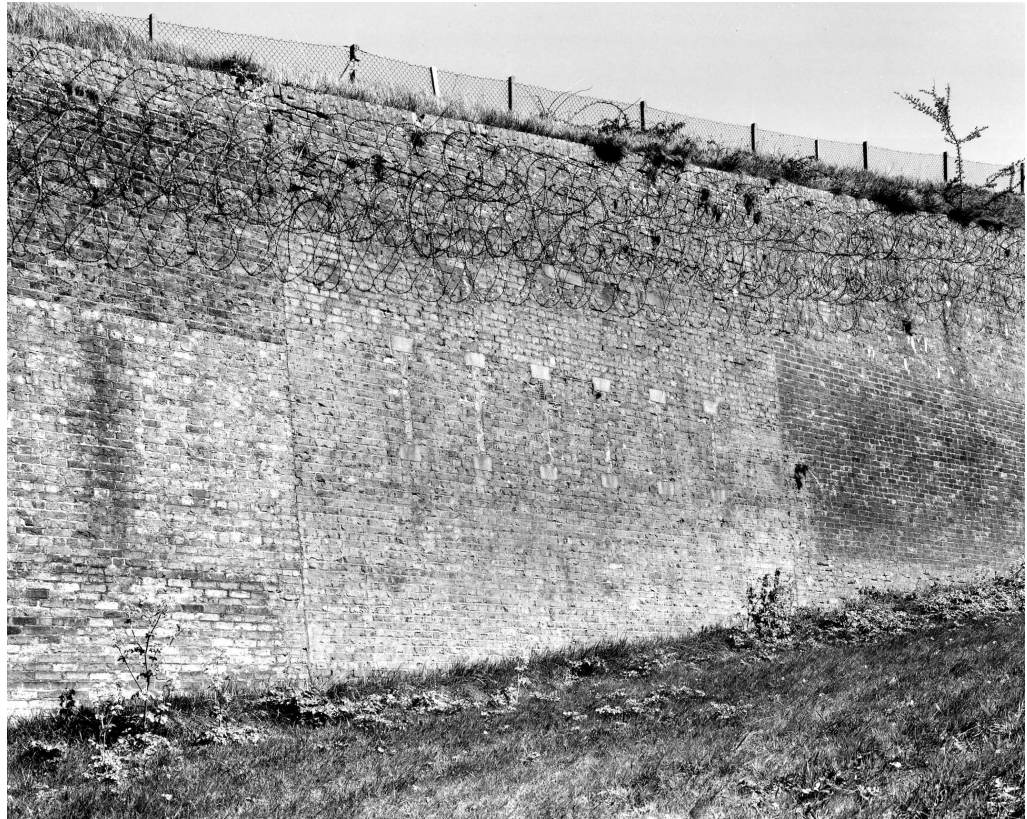
The revetments have large areas of patched repairs, most by HMPS. On the east, the counterscarp has two sections inserted into the Napoleonic brickwork, with very clear

Figure 20
Inserted walling in the counterscarp revetment of the NW Bastion with, just visible, blocked loopholes (NMR: BB032730 © Crown copyright 1998)

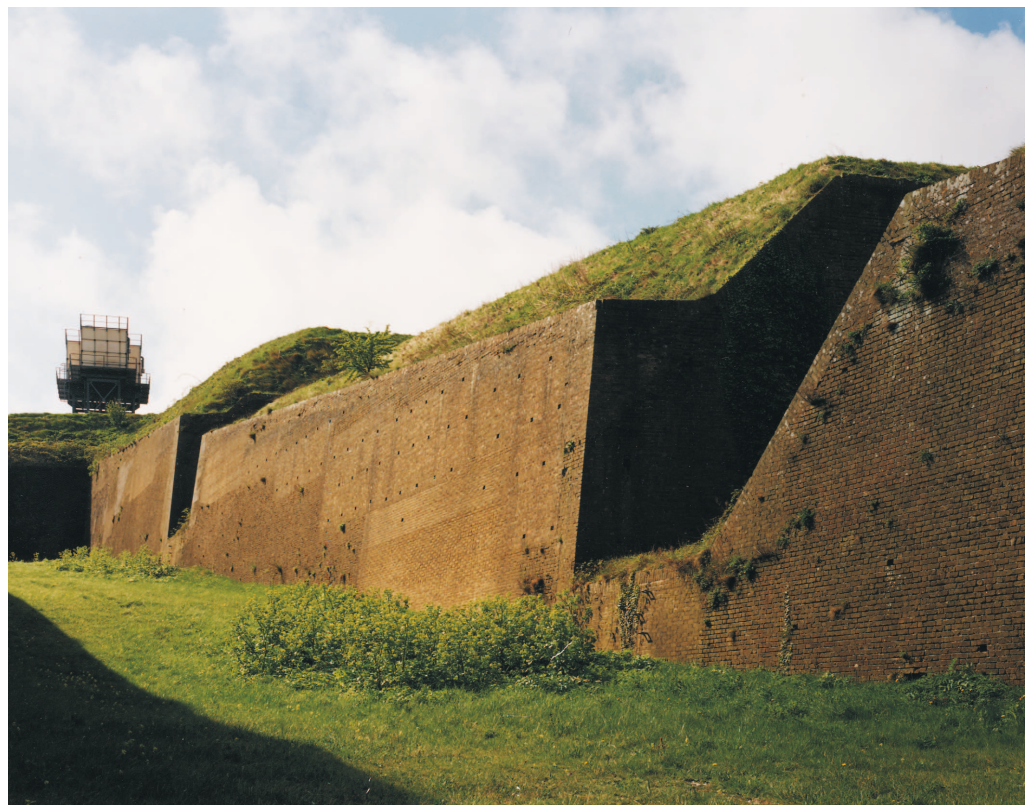
Figure 21
The eastern scarp revetment of the NW Bastion, showing the cross ditches and clear patching of the brickwork (NMR: BB03729 © Crown copyright 1998)

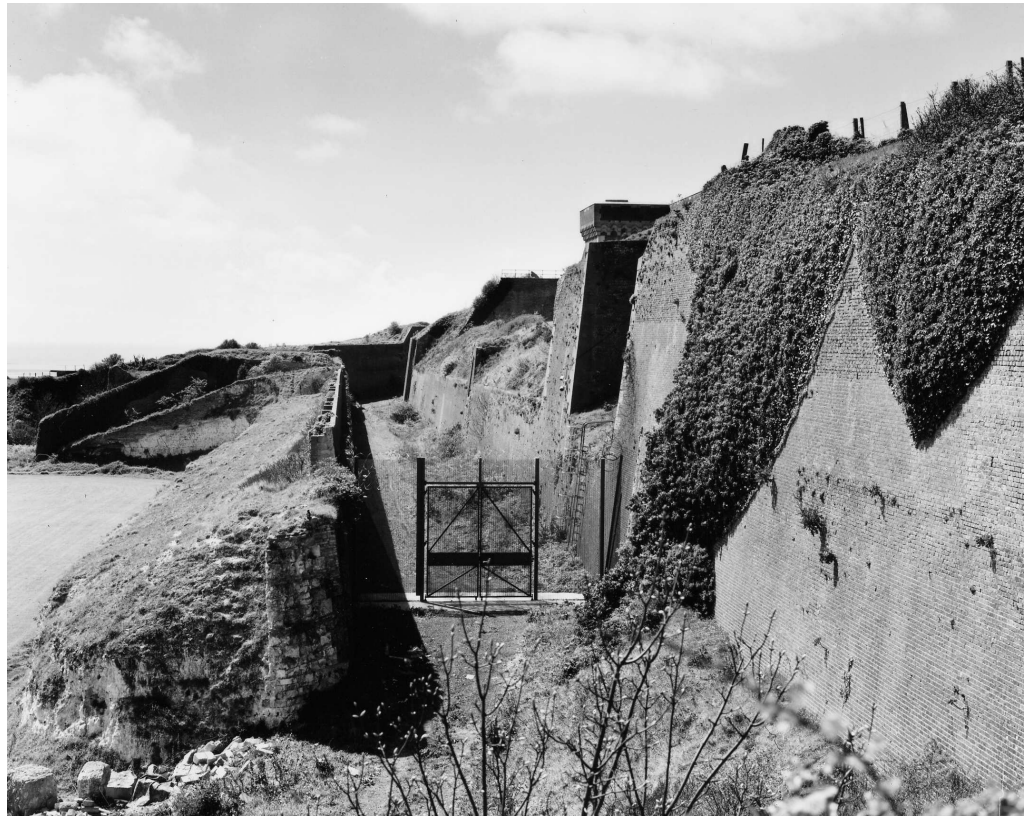
The *tenaille* was a long rectangular ‘island’, between twin ditches, on which were concentrated defences to protect the entire south face of the Citadel. The ditches were badly damaged during construction of South Front Battery in the last years of the 19th century; the outer ditch was removed for three-quarters of the original length and the *tenaille* cut away to leave a new sloping profile on the south (Fig 23). Most of the inner ditch survives although its counterscarp revetment is generally reduced to half of the original height of 3.35m (11ft); at the south-western end it has been rebuilt by HMPS with concrete blockwork. The scarp revetment is complete and, in the ditch bottom and running along its base, there is another ditch averaging 4.8m (15ft 9in) wide and 1.0m (3ft 3in) deep, ending just before the Long Casemates.

The damage to the *tenaille* has left a neat section at the north-east end, exposing both chalk bedrock and construction details of the counterscarp revetment of the inner ditch. The revetment comprises an inner layer of chalk ashlar, some 2.0m (6ft 7in) thick,

Figure 23
The south face of the Citadel, from the east. The inner ditch of the tenaille, now guarded by a modern gate, survives, while to the left, the tenaille itself has been cut away leaving a 45° slope; the outer ditch has gone (NMR: BB032737 © Crown copyright 1998)

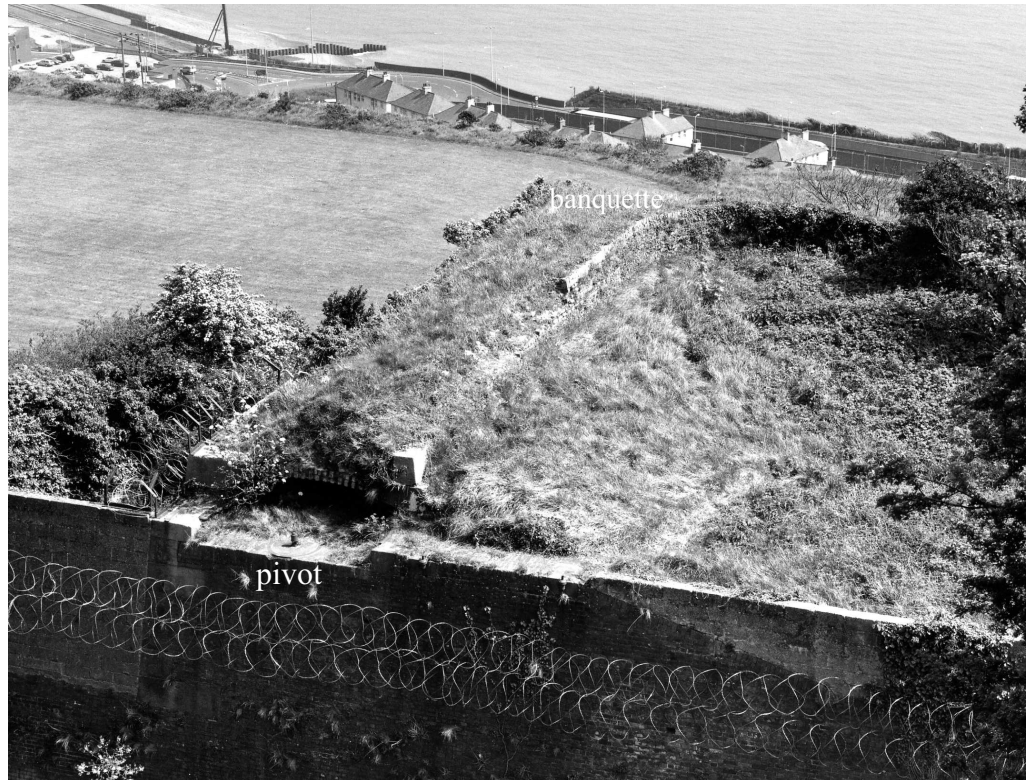
Figure 24
Part of the demi-bastion at the west end of the tenaille. Note the infantry banquette (centre) and pivot for a swing bridge (lower left) (NMR: BB043986 © Crown copyright 1998)

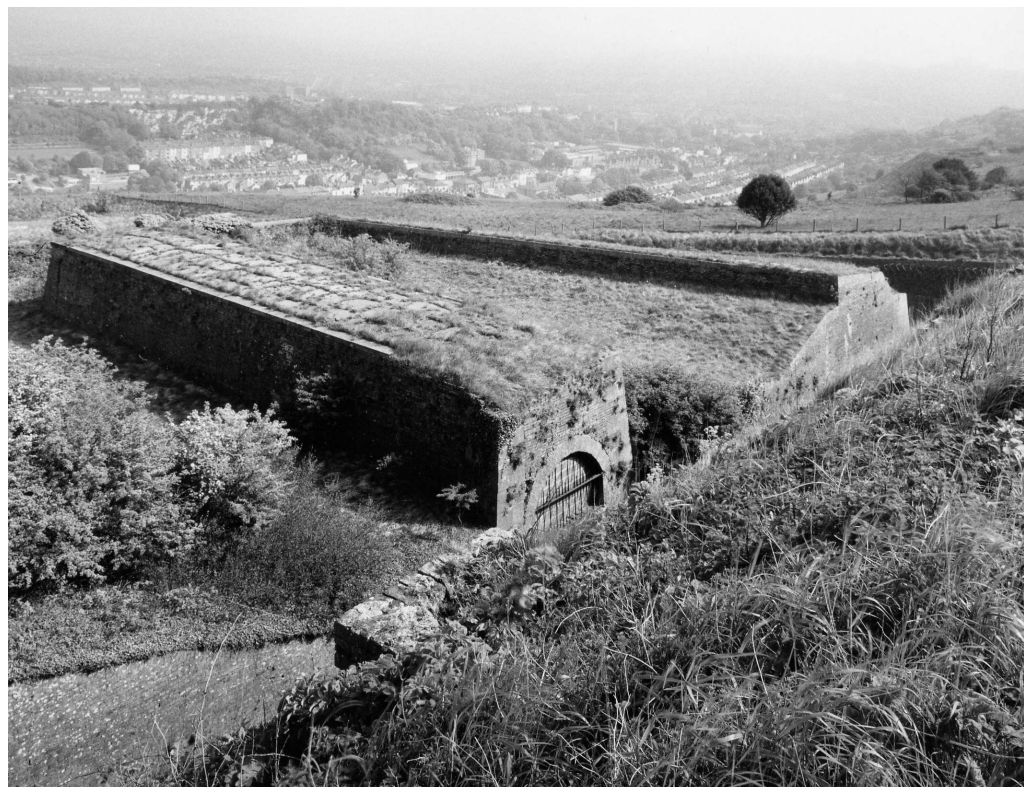
Figure 27
The long rectangular Guard Room on the Centre North-West Bastion, with the infantry banquette beyond, from the south-west. The only window to the Guard Room is just visible (lower centre) (NMR: AA043948 © Crown copyright 1998)

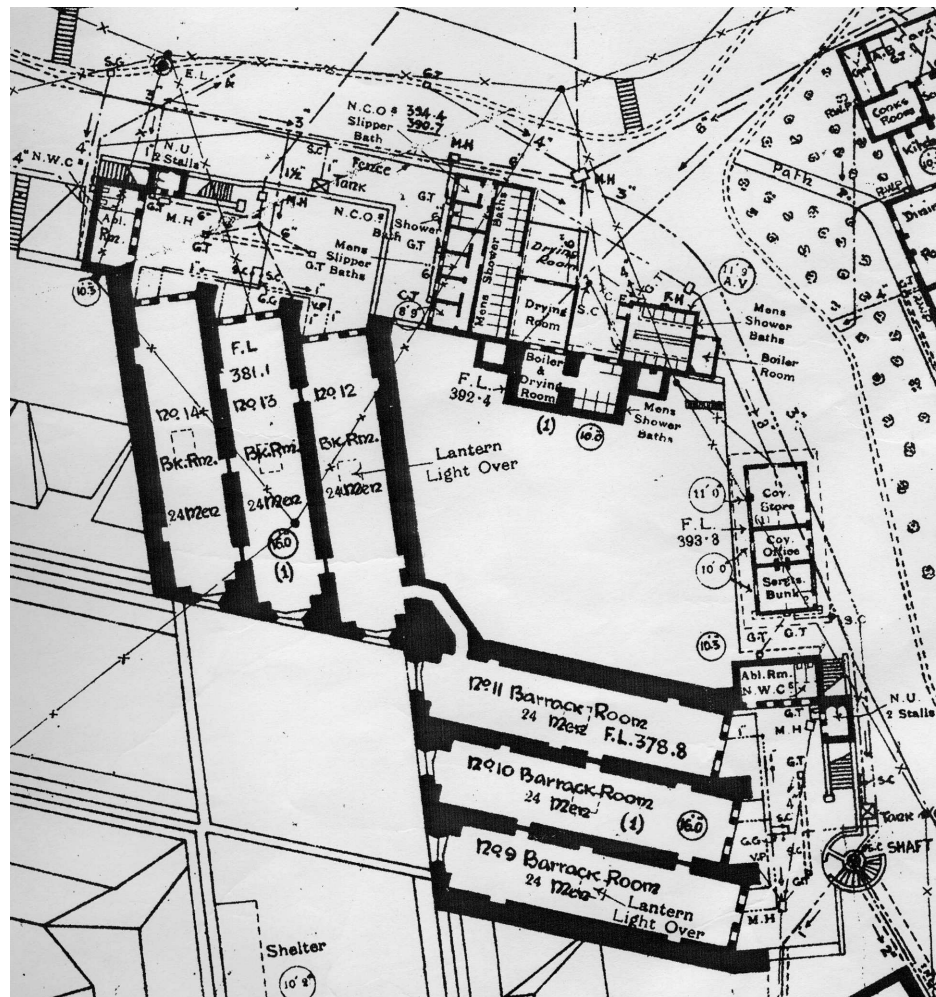
Figure 31
Extract of a general plan of
the Citadel, showing the
South-West Flank and
South-West Face
Casemates, at 1:500 scale,
printed in 1930 with
annotations to 1947
(402582 © HMPS)

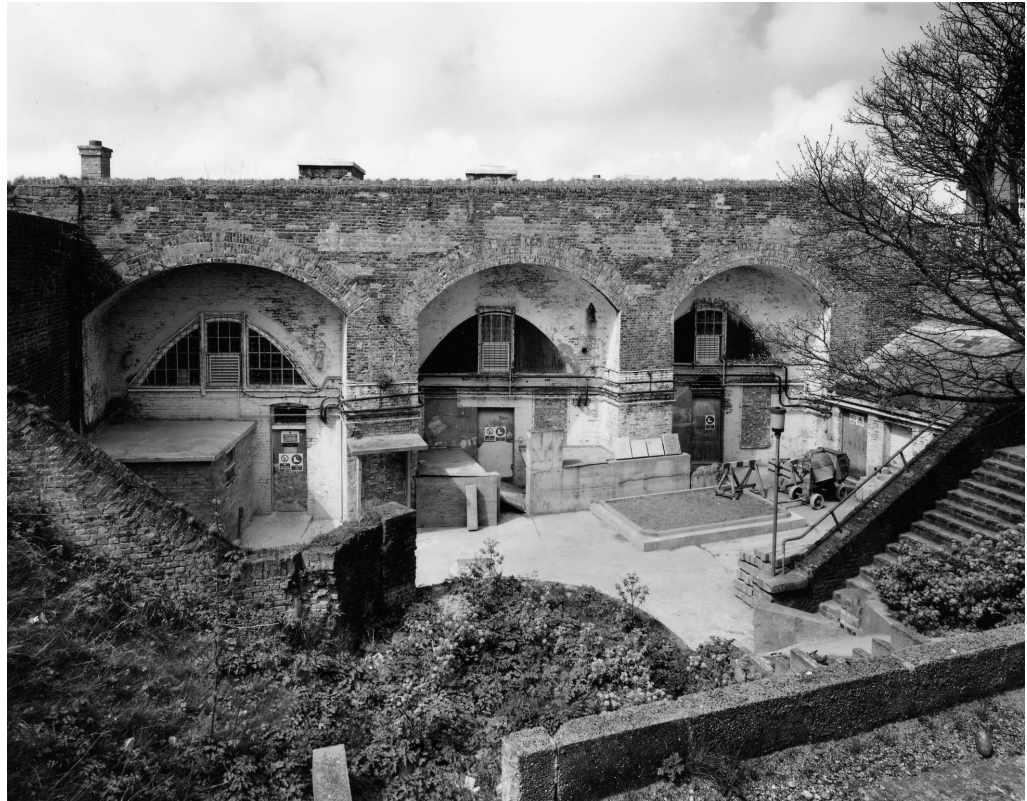
Figure 32
The rear elevation of the South-West Flank Casemates, from the south-east. Note the recessed façade of each casemate and the parabolic vaults. The sunken area incorporates an ablutions building with lean-to roof (right) (NMR: BB032719 © Crown copyright 1998)

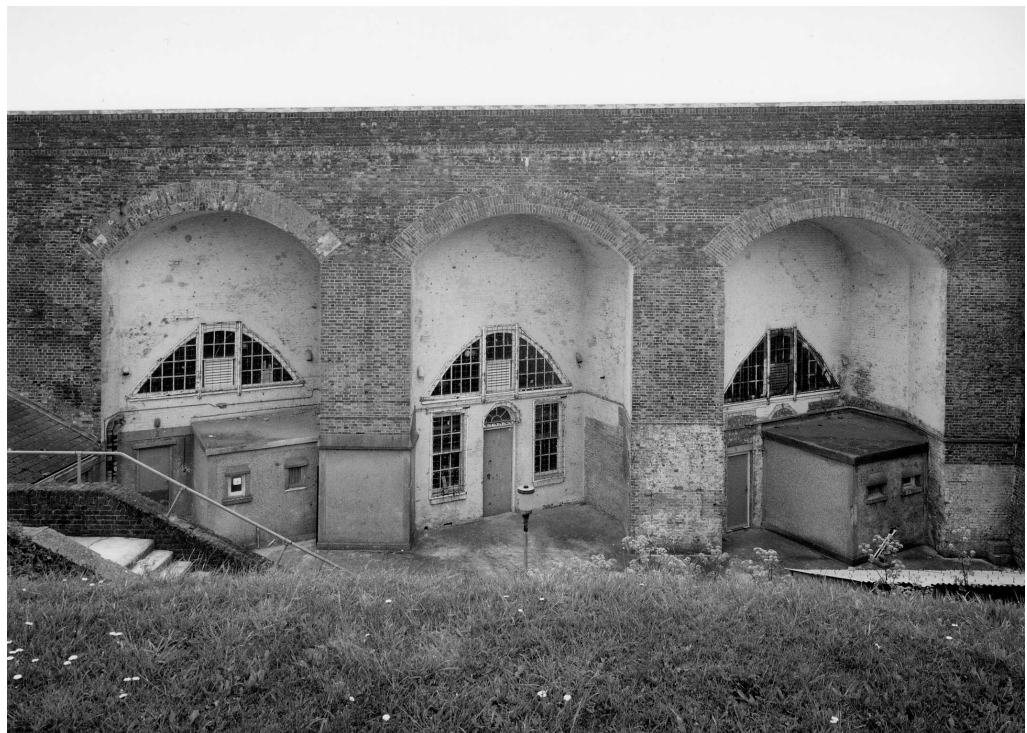
Figure 33
The rear elevation of the West Face Casemates. The central casemate retains much of its original appearance with central fan-lit entrance and flanking windows. Above the entrance another window rises to the crown of the parabolic vault (NMR: AA043936 © Crown copyright 1998)

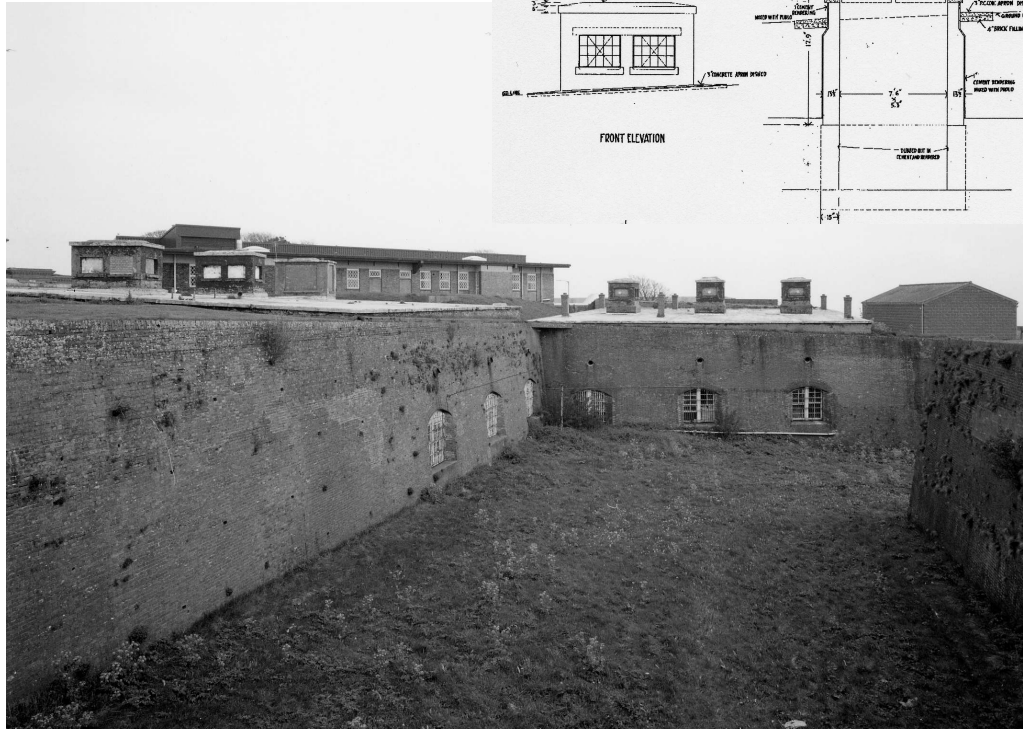
Figure 34
The South-West Face Casemates and the South-West Flank casemates, from the NW, showing the windows at ditch level (inserted into the former embrasures) and the lantern lights placed on the roof around 1913. The drawing shows the lanterns as proposed in 1913 (photo NMR: AA043990 © Crown copyright 1998, drawing 402652 © HMPS)

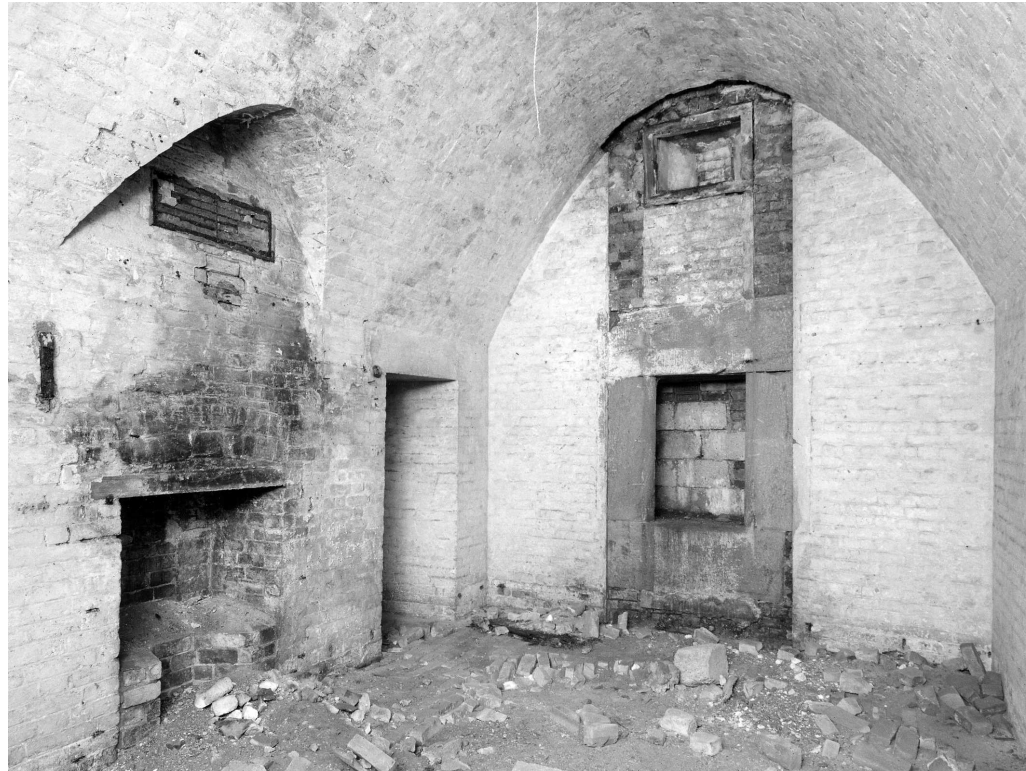
Figure 37
The Gorge Casemates; southern group, central casemate of the outer set, showing the blocked carronade embrasure and scar from the vertical sliding shutter in the ditch wall (at right), entrance (just left of centre) and fireplace (at left) (NMR: AA044007 © Crown copyright 1998)
