THE WESTERN HEIGHTS DOVER, KENT

Report No 2: The Citadel

SURVEY REPORT

LAND-FRONT FORTRESS AND BARRACKS 1779-1950

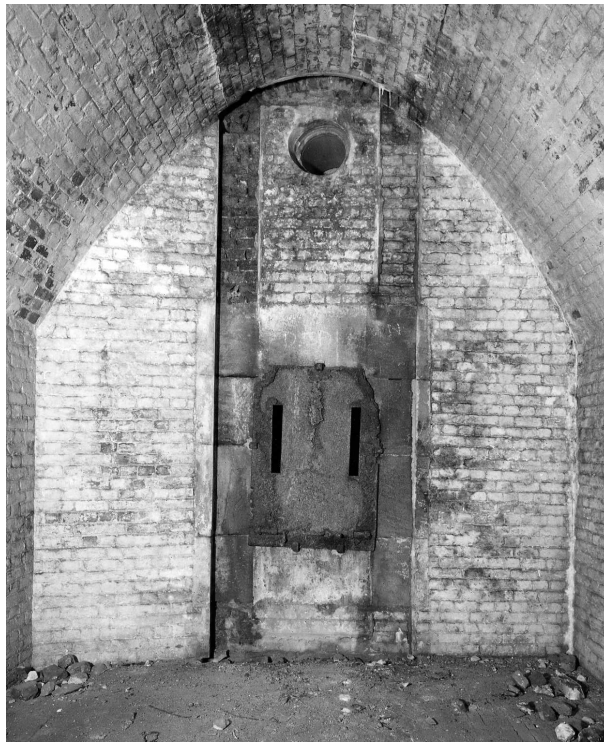
Figure 42
*Inner NW Bastion; a
gunroom in the Right
Flanking Casemates.
Detail of the ditch wall
showing the scars from
the original sliding
shutter and its
replacement, a small
fixed steel shutter
perforated with loops
for small arms fire
(NMR: AA043967 ©
Crown copyright 1998)*

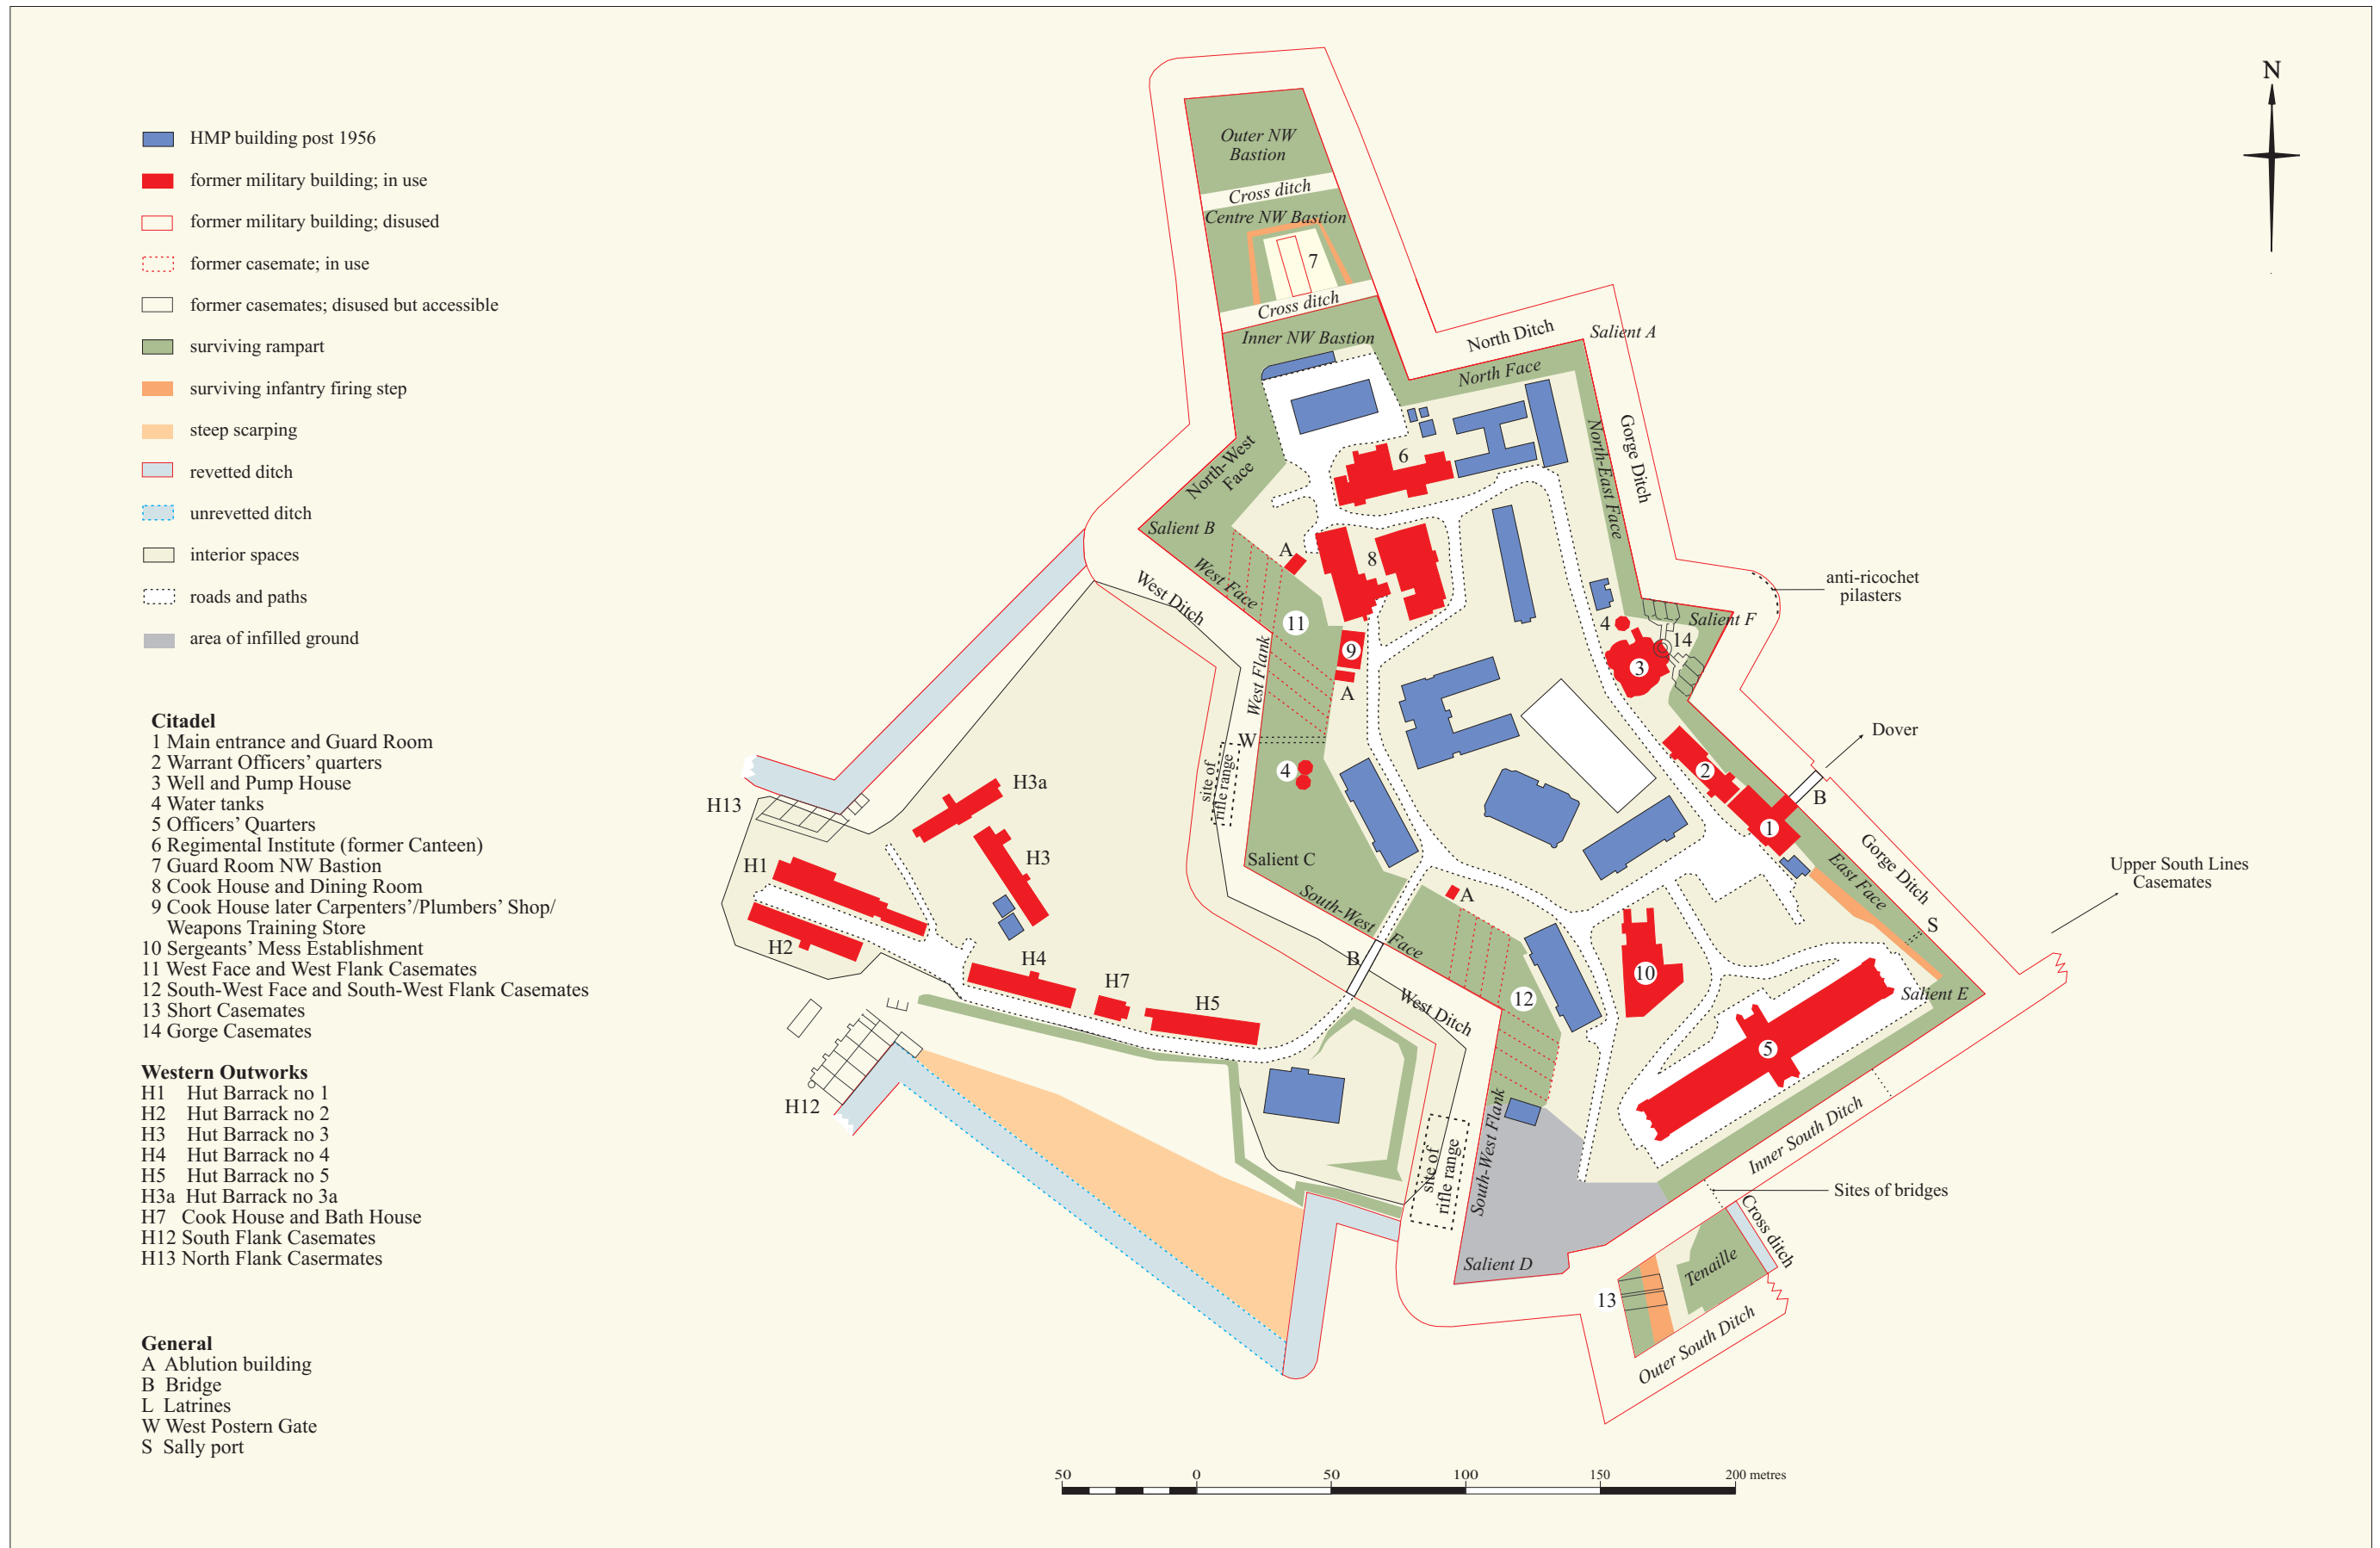
Figure 49 Plan showing the Citadel c1998, with all remaining buildings (text in italics indicates the nomenclature of the fortress used from the later 19th century onwards)

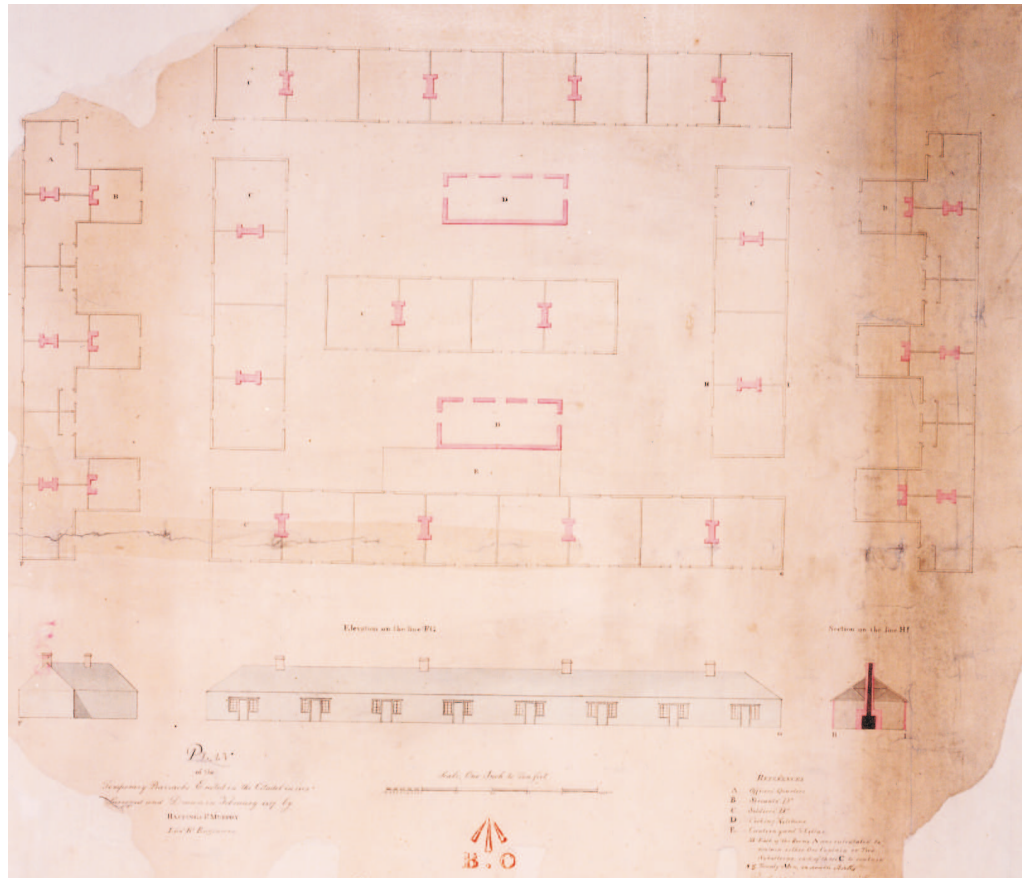
Figure 50
Plan of the Napoleonic Temporary Barracks in the Citadel, dated 1817. The large reectangular arrangement comprised the soldiers barracks and cooking kitchens, with separate officers' blocks on the east and west sides (north is at the top)(extract of MPH/1/506 © The Public Record Office)

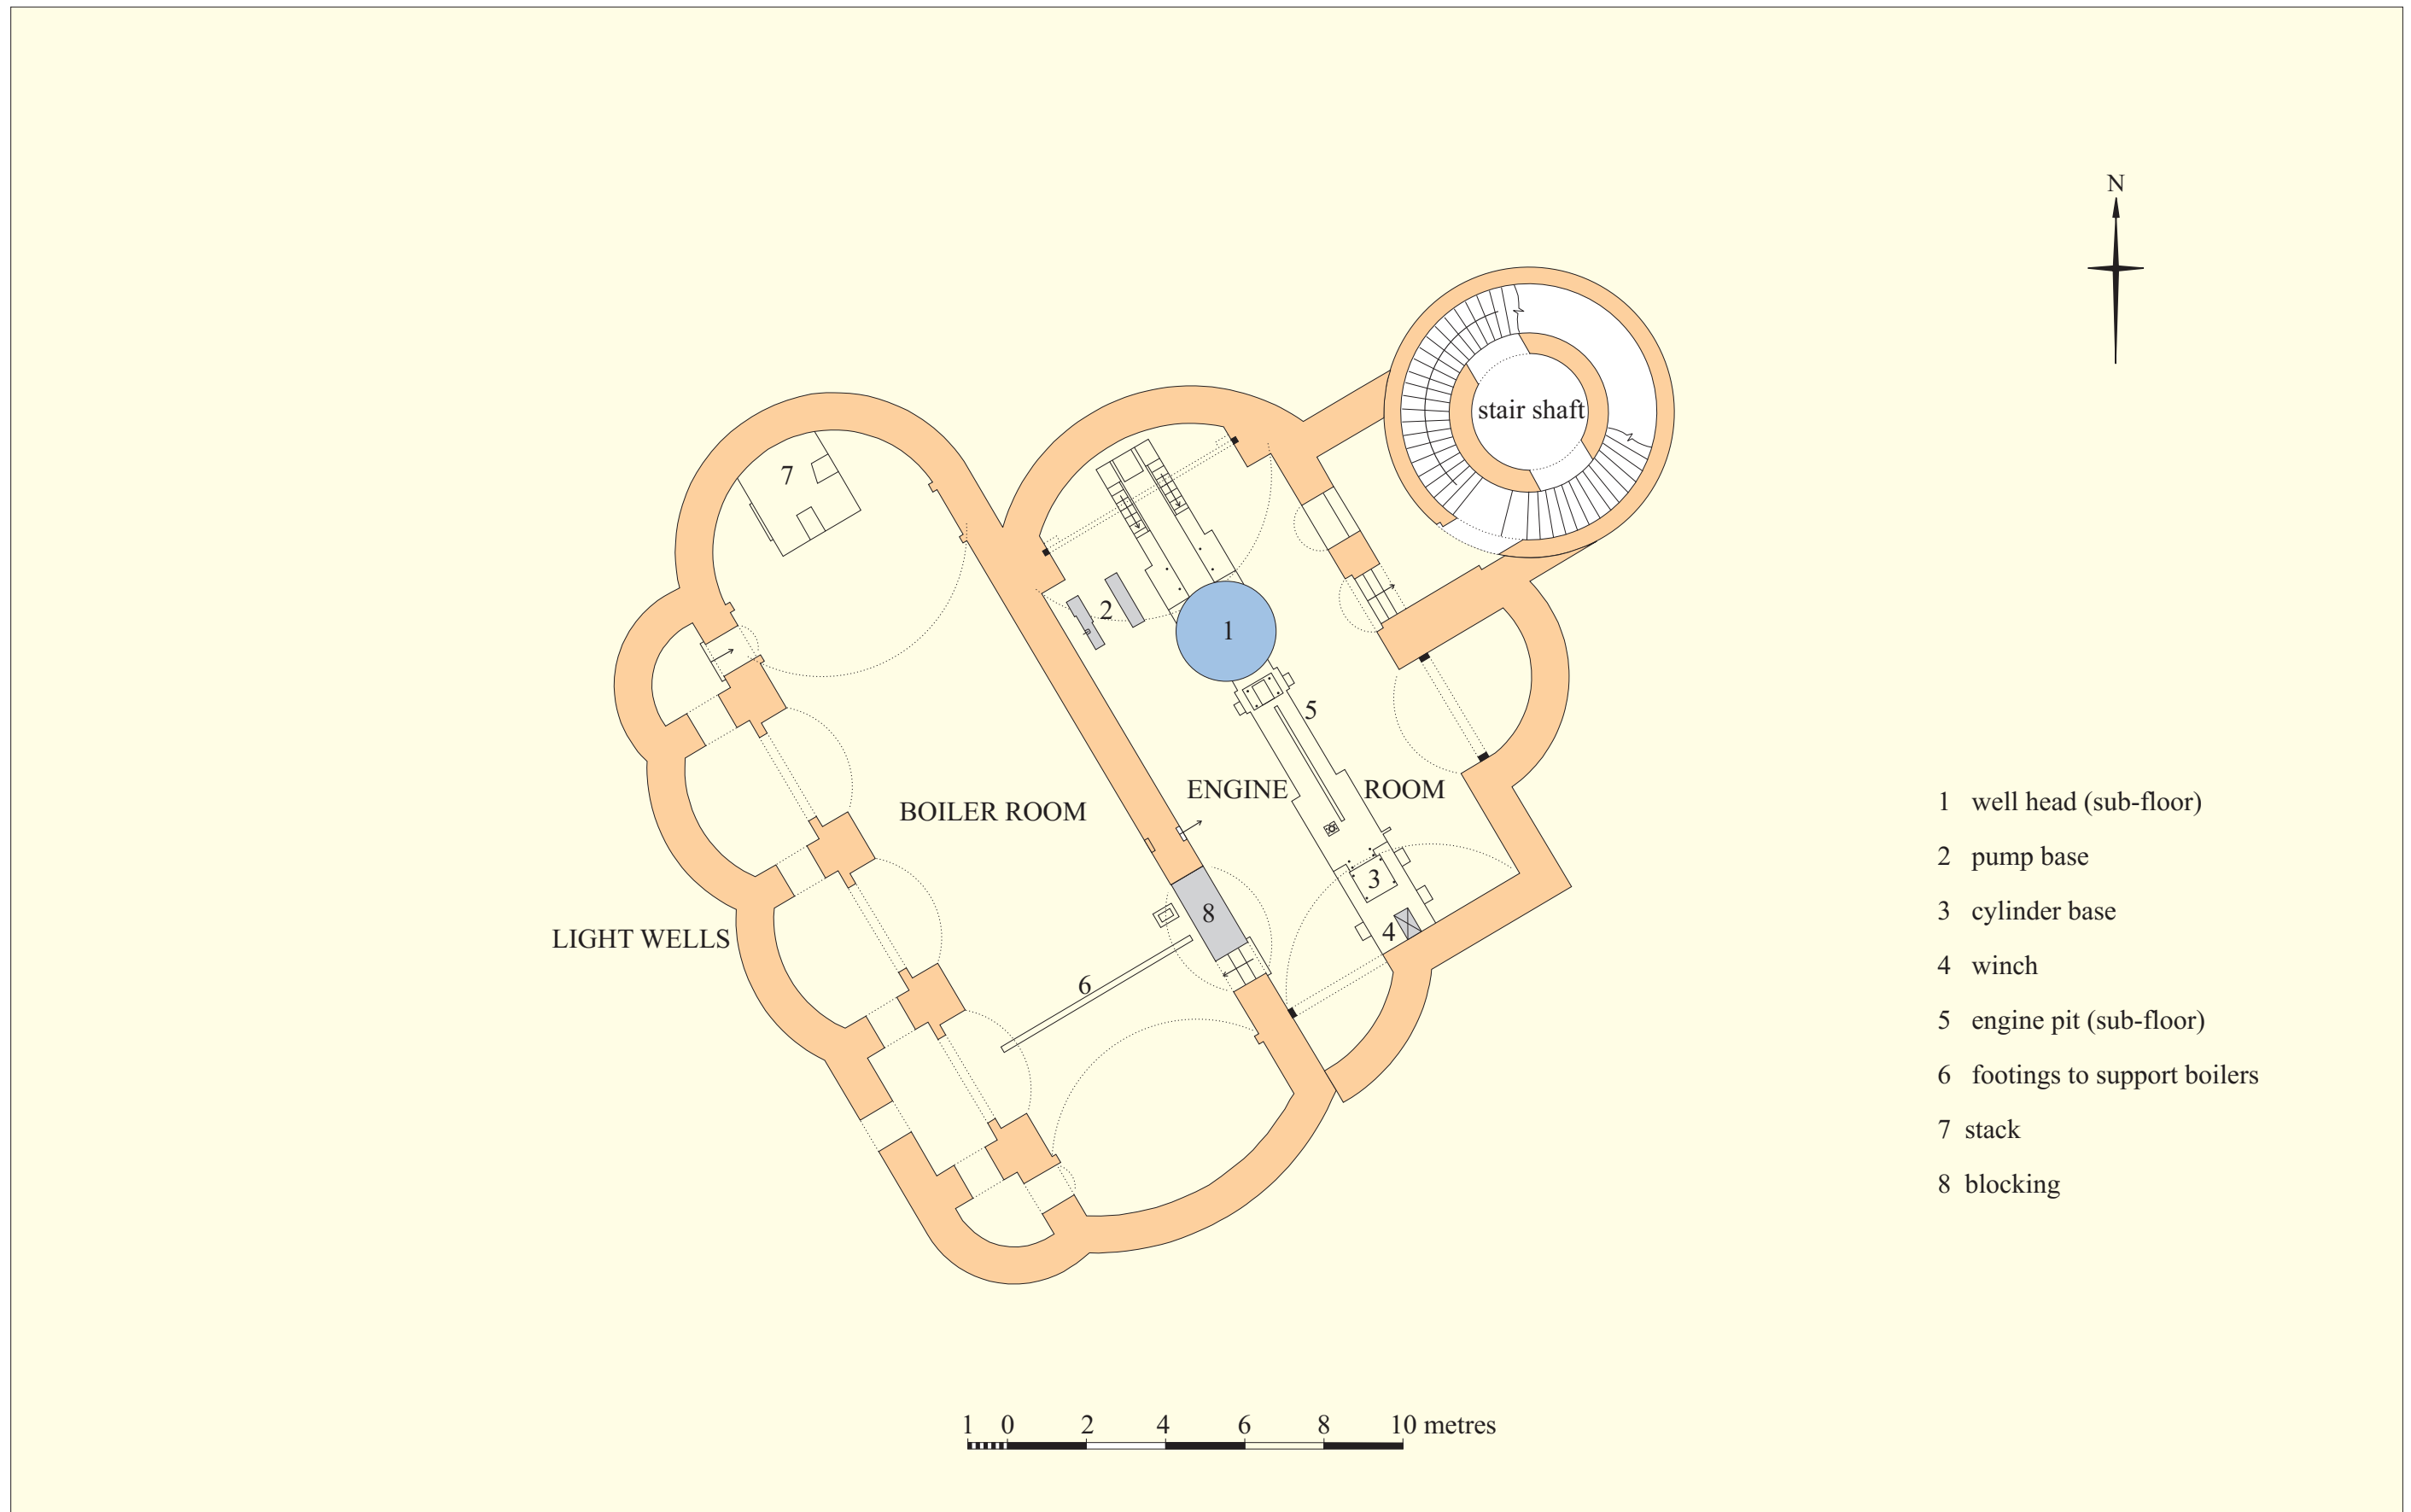
Figure 56 Plan showing the 1860s Well and Pump House

Two masonry bases in the north-west corner are for either a Steam Booster Pump or a Centrifugal Booster Pump, both indicated on the 1930 plan. The plan shows that they were used for circulating water between the two underground storage tanks to the west. The base for the steam booster pump is identifiable by a cut-out in its west side for a small fly-wheel. A cylindrical tank mounted on scrolled brackets on the wall above these bases may also be part of the pumps. The small size of the bases suggests that this plant may date from the end of the 19th century or later, when compact engines were widely available.

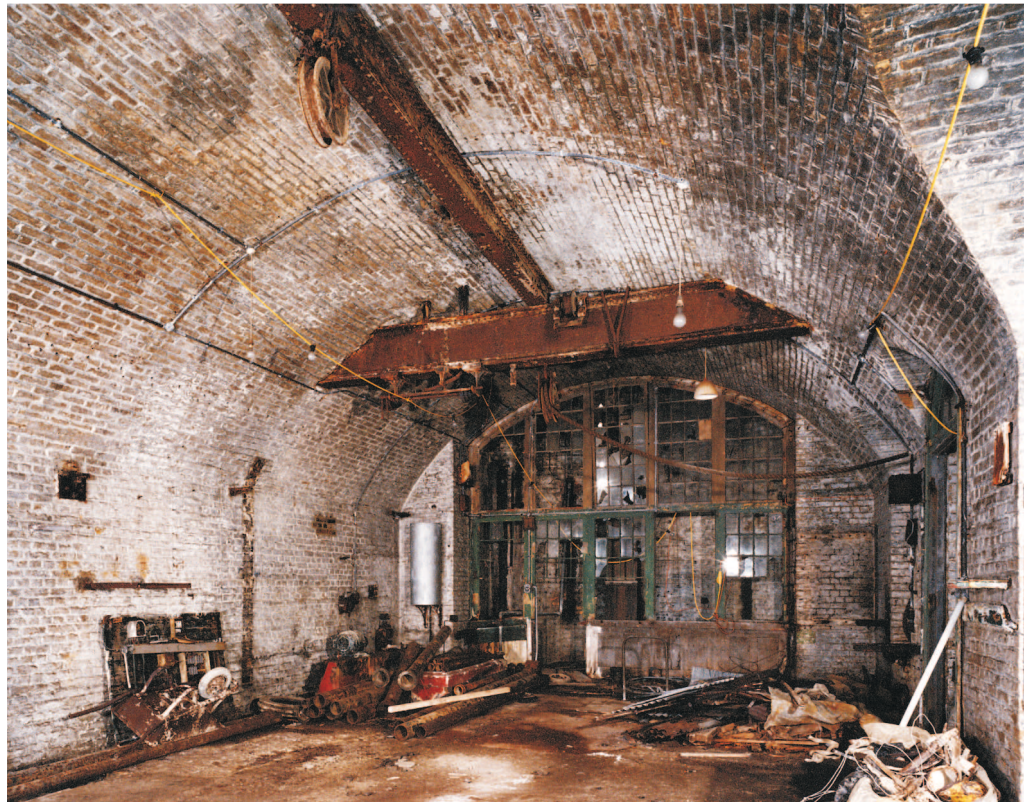
Figure 57
The Engine Room, showing the lifting beam and light well partition (NMR: AA044020 © Crown copyright 1998)

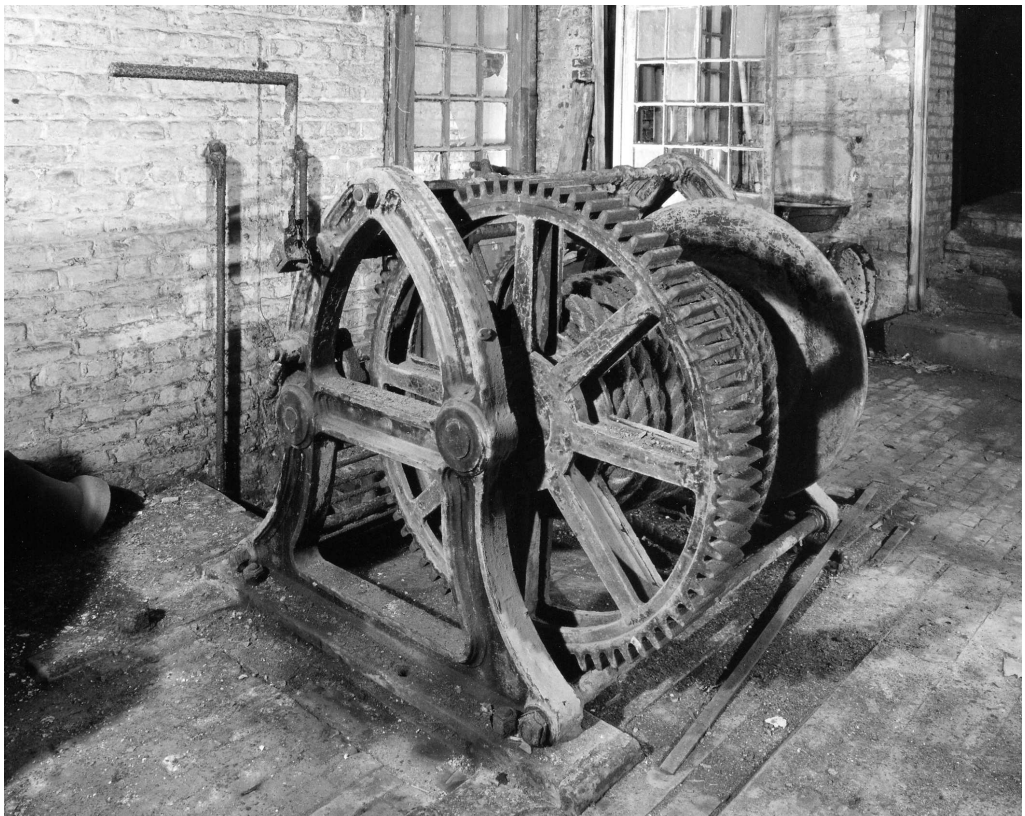
Figure 58
Hand-operated winch in the Engine Room (AA044013 © Crown copyright 1998)

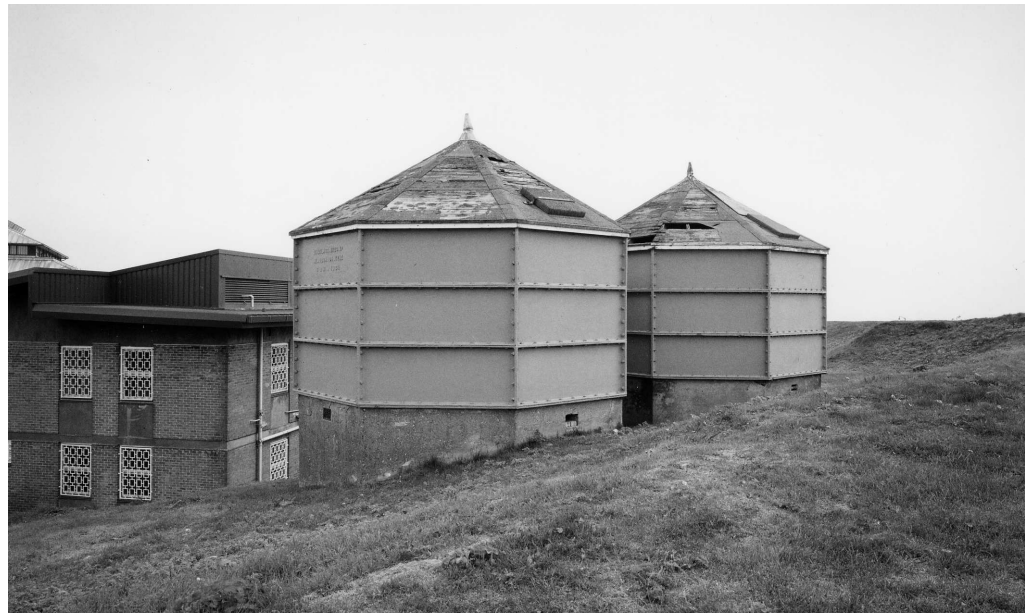
Figure 59
Twin water tanks set into the western rampart of the Citadel, erected in 1861 (nearest) and 1901 respectively (NMR: AA043942 © Crown copyright 1998)

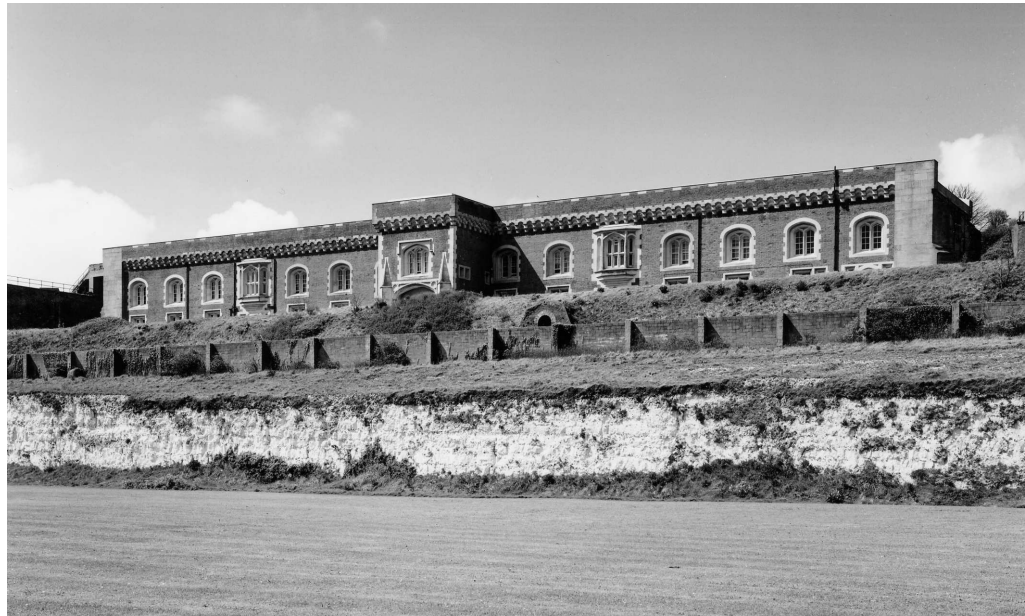
Figure 60
The Officers' Quarters,
south elevation (NMR:
BB032722 © Crown
copyright 1998)

brick as its principal facing material. The brickwork is laid in English bond, with limestone dressings (mostly concealed by stucco repairs), including door and window surrounds, the moulded top course of the plinth, and the corbelled eaves, from which the stone-coped brick parapet rises. The heavily fortified and buttressed ends of the building, however, which are comparable in detailing to the contemporary *caponiers* at Drop Redoubt and Detached Bastion, have more durable gritstone masonry and are divided into three by pointed buttresses incorporating shouldered set-backs (Brown *et al* 2001, Pattison 2001). Similar pointed buttresses flank the entrances in the north and south porches, which have flush stone quoins to the corners.

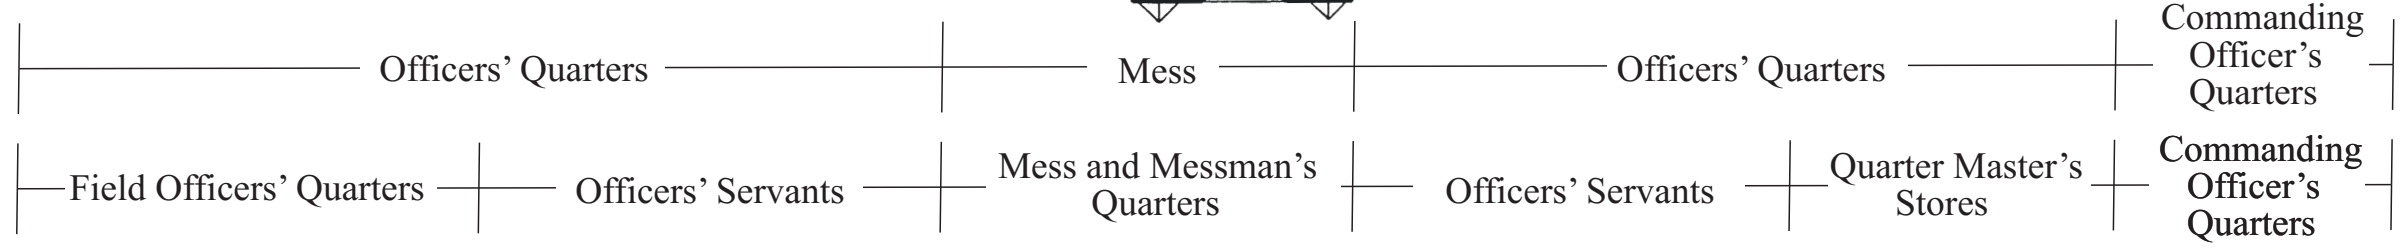
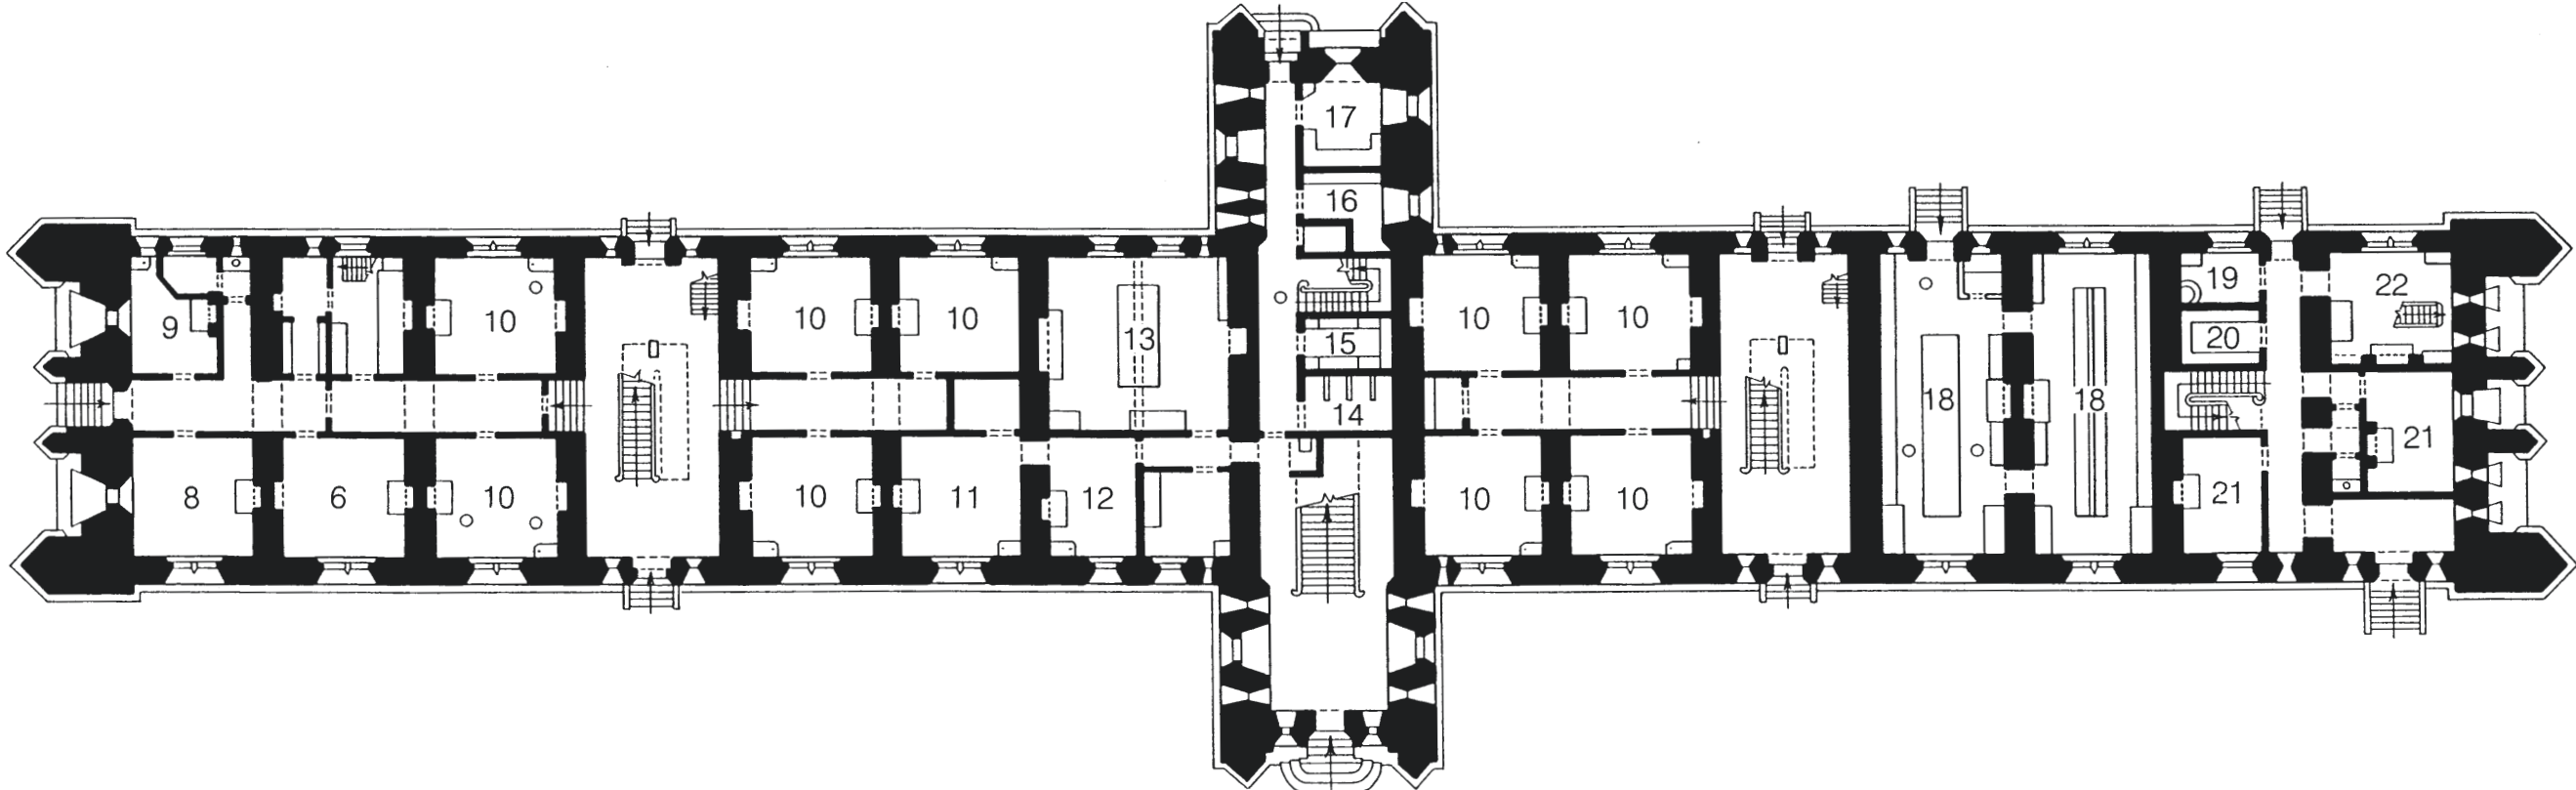
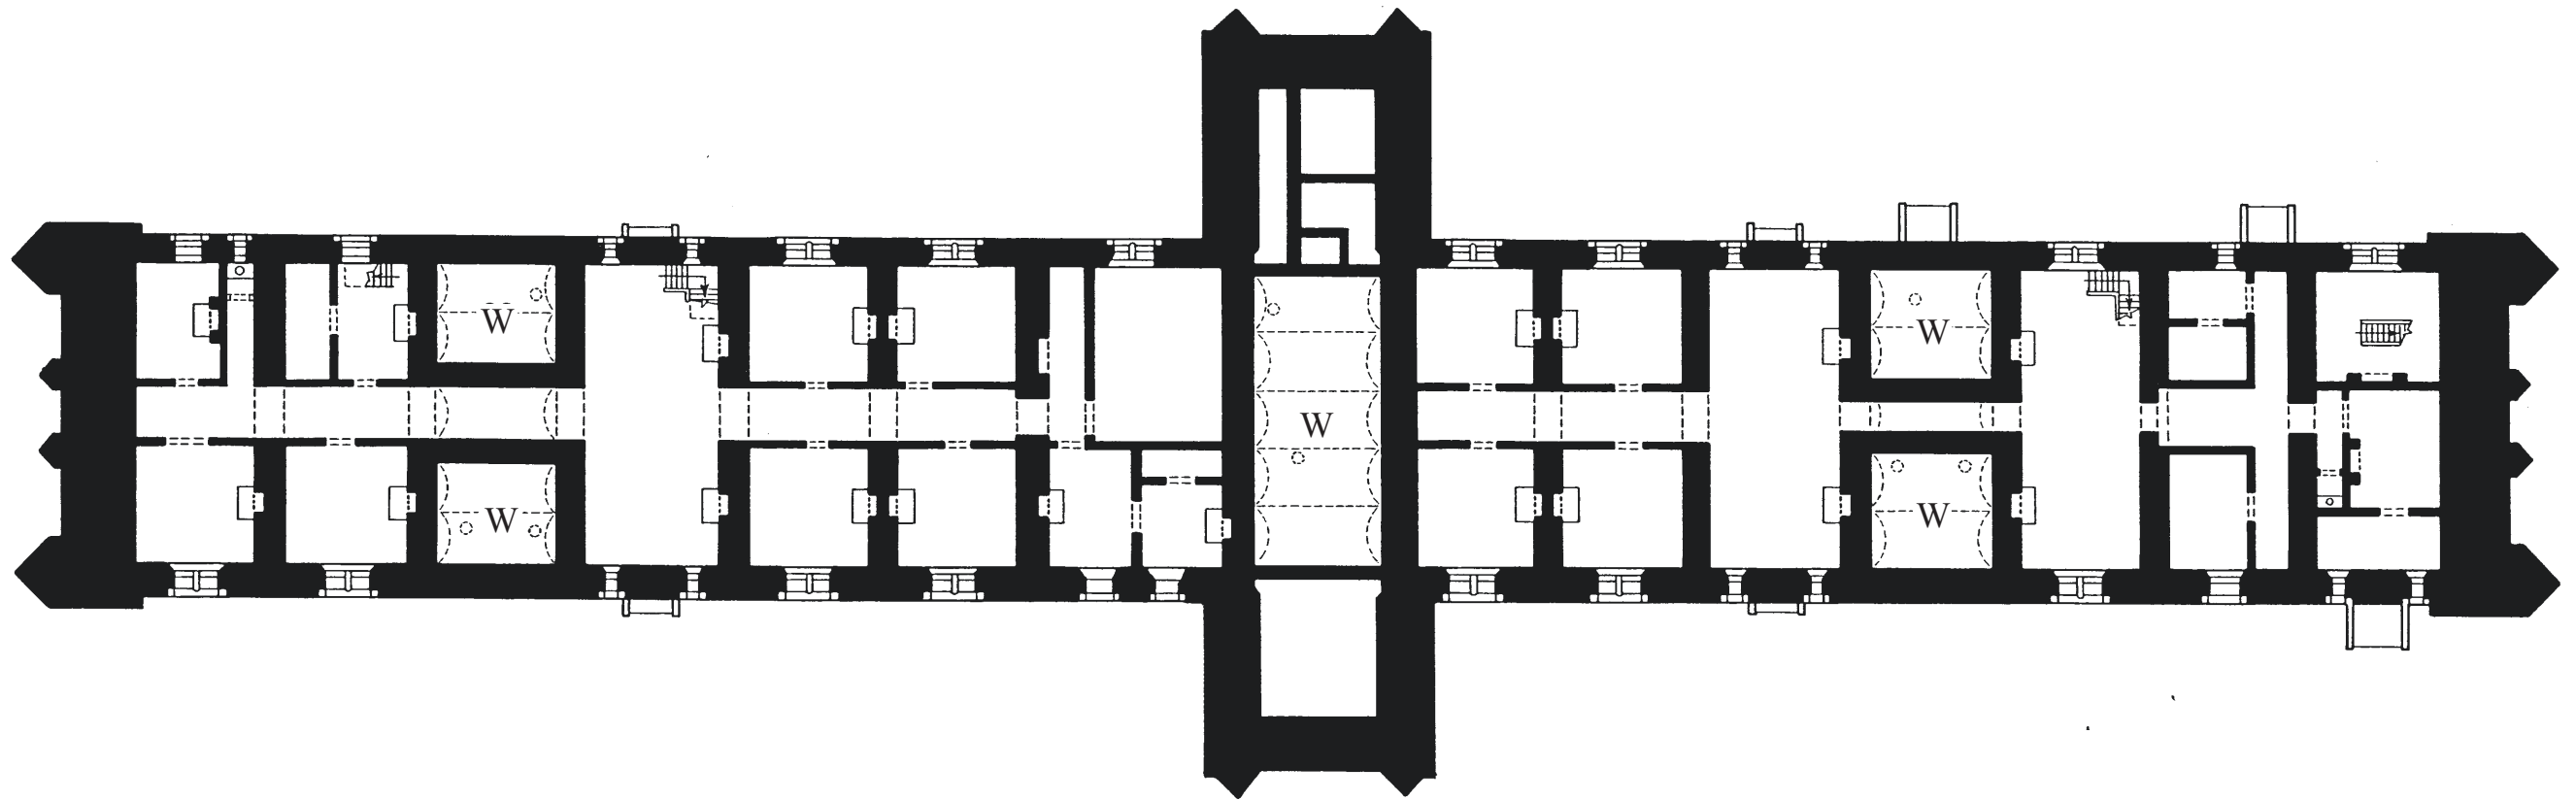
Figure 65 The Officers' Quarters; ground (lower drawing) and first floor(upper drawing) plans (after HMPS: 402584)

vault, either one or two per vault (Fig 64). On the ground floor these are positioned so as to allow their use with minimum disruption, all but two being placed within service rooms, store-rooms or circulation areas. They may have served as inspection hatches, but could perhaps also have been used to draw water from the tanks under siege conditions. Water was supplied from the Pump House (HMPS: 402604).

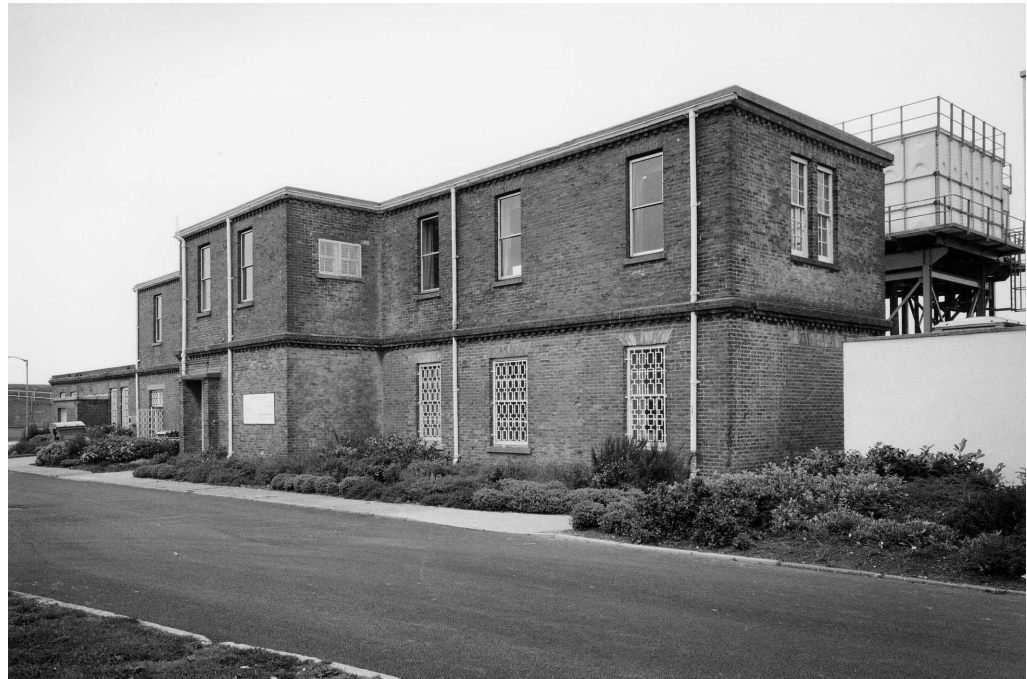
Figure 68
*The former Canteen
and Regimental Institute
building in the Citadel,
from the east (NMR:
AA043938 © Crown
copyright 1998)*

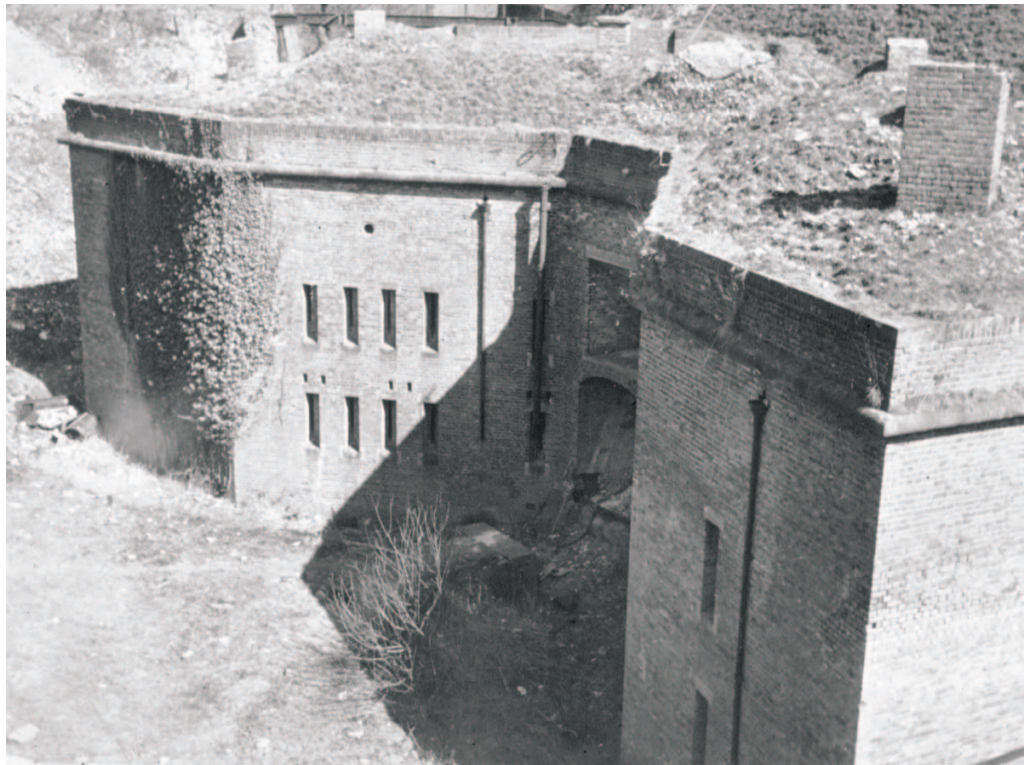
Figure 72
*The Double Caponier of
the Western Outworks,
from the SW c1959 (©
Dover Museum, ref
D07891)*

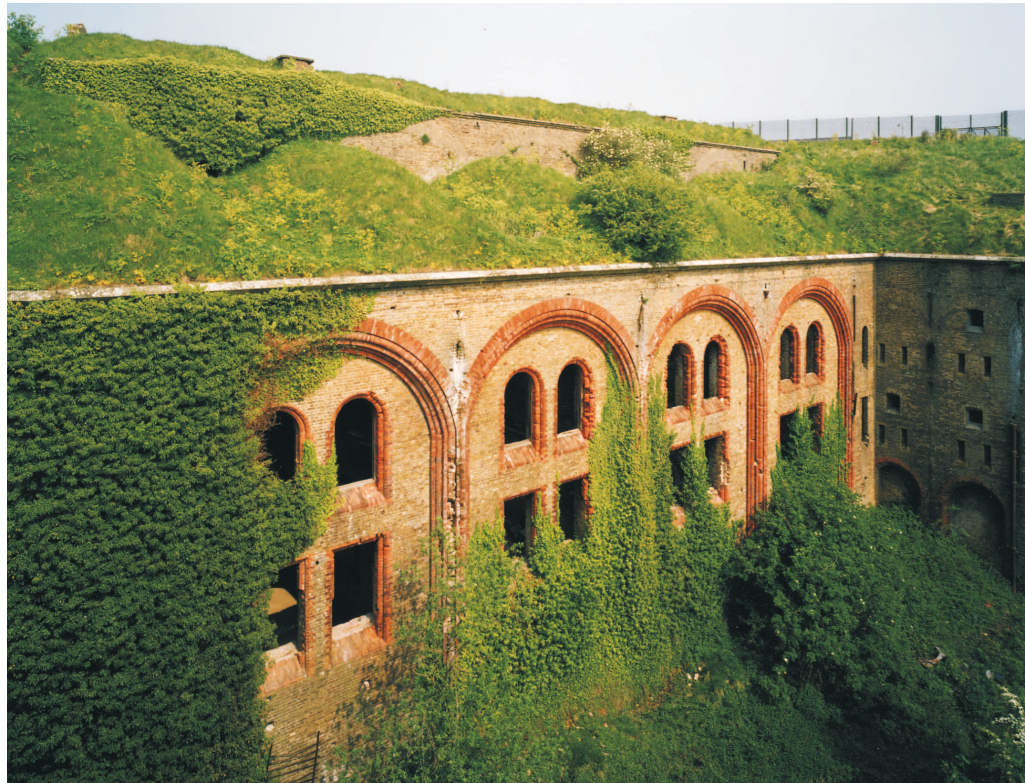
Figure 74
The South Flank Casemates of the Western Outwork, from the south. Above the capping course of the main elevation, earthworks protect a series of casemated gun positions, the front wall of which is just visible (NMR: BB032747 © Crown copyright 1998)

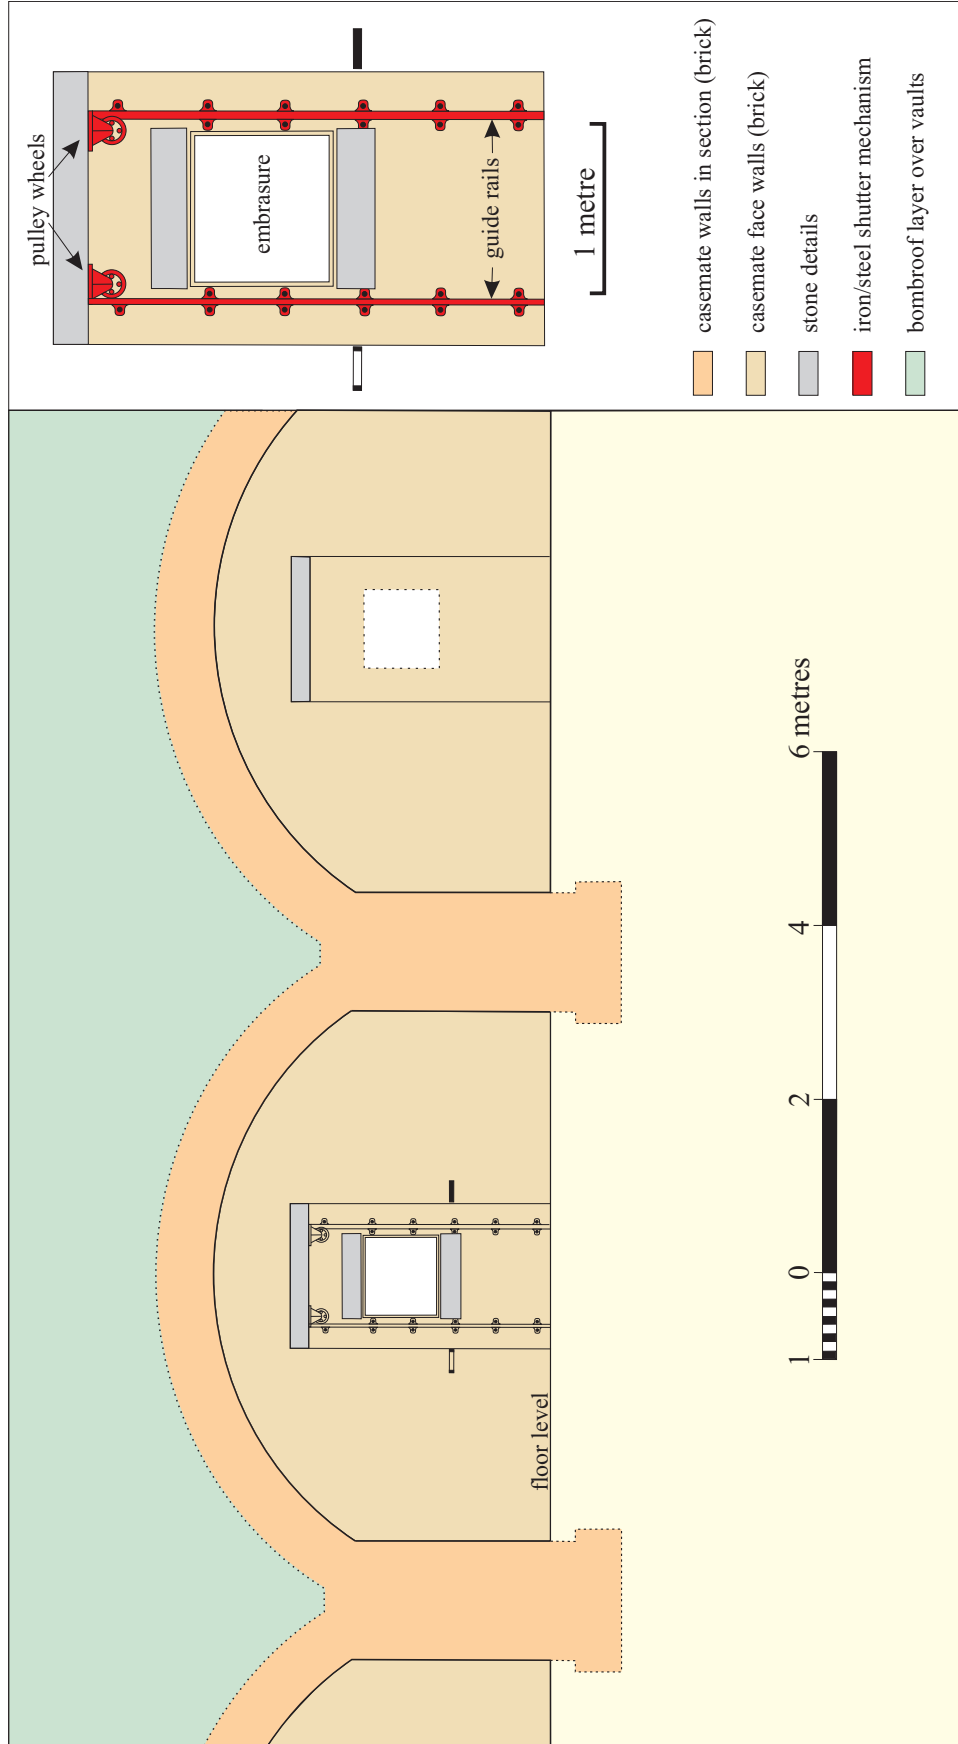
Figure 81
South Flank Casemates: elevation of the face wall of No 3 Haxo casemate, showing the wrought iron shutter over the carronade embrasure, with detail

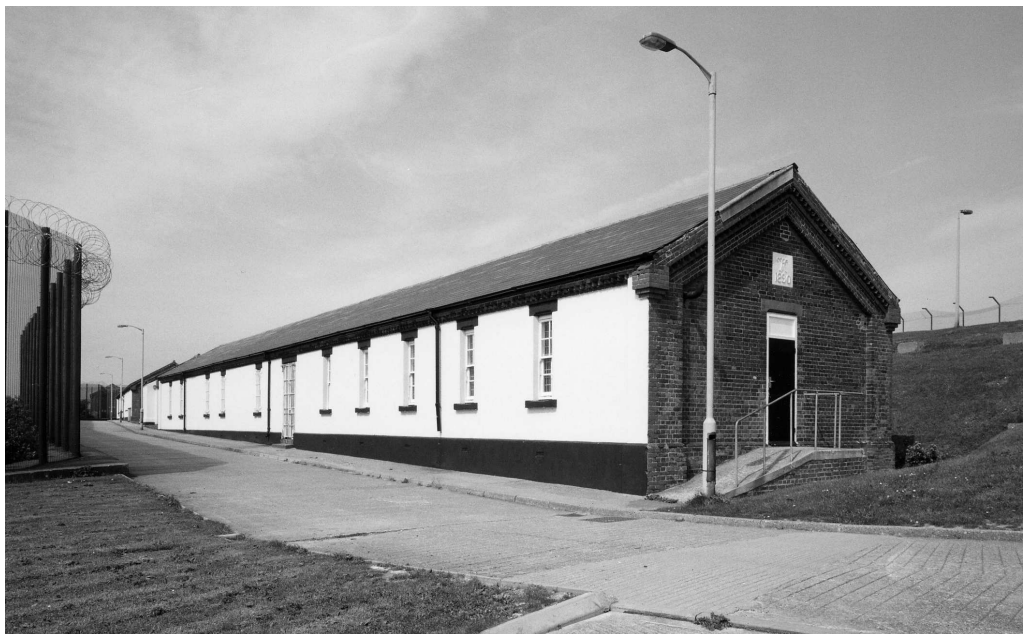
Figure 85
Barrack Hut No 5, in the Western Outworks, from the SE (NMR: AA043991 © Crown copyright 1998)

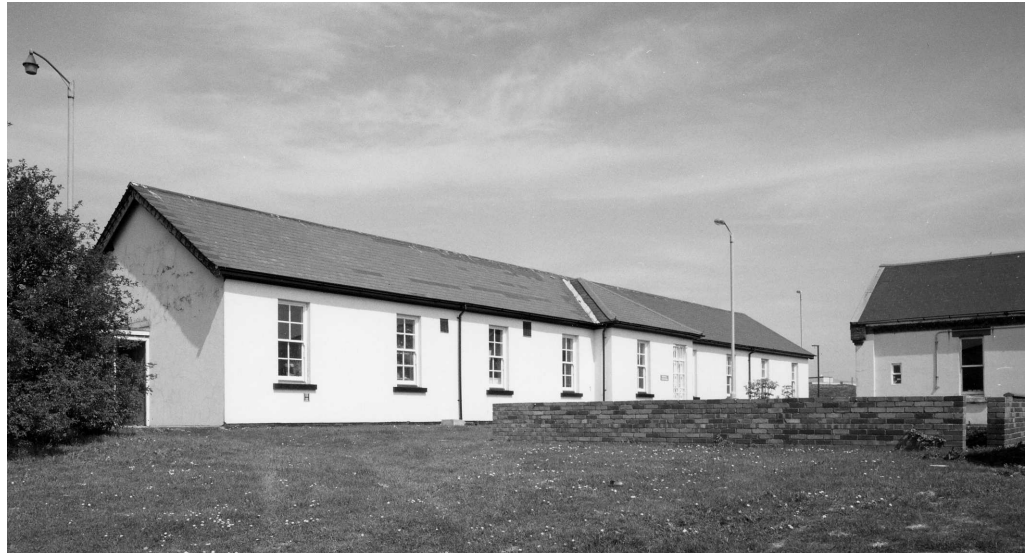
Figure 87
*Barrack Hut No 3a, in
the Western Outworks,
from the SE (NMR:
AA043993 © Crown
copyright 1998)*
