RICHMONT CASTLE, EAST HARPTREE AN ANALYTICAL EARTHWORK SURVEY

Richmont Castle, East Harptree, An Analytical Earthwork Survey

NGR: ST 5615 5574

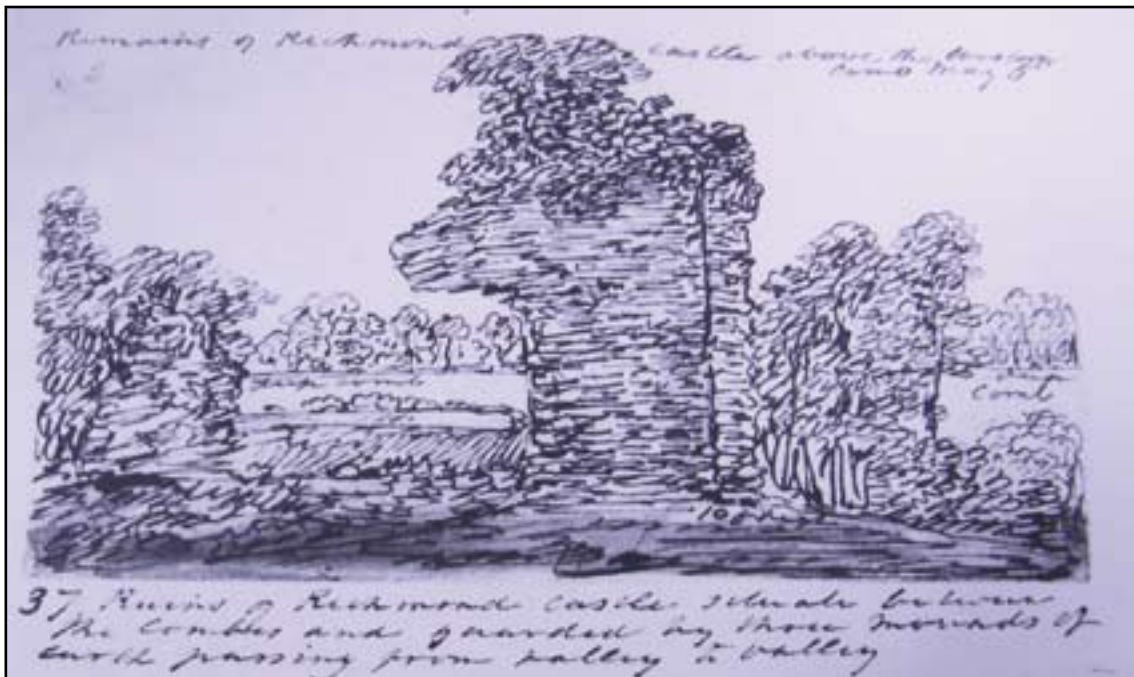
Figure 2. Skinner's sketch of the donjon at Richmond. The caption reads 'Ruins of Richmond Castle situate between the combes and guarded by three mounds of earth passing from valley to valley'

burnt the gates and secured the castle. The subsequent history of the castle is unknown but it probably remained the residence of the de Harptree family (later known as de Gourney) for much of the later medieval period. By the mid 16th century it was clearly a ruin since Leland records that 'many olde foundations were used towards a new house at Eastwood' by Sir John Newton (Toulmin Smith 1964, 85; Chandler 1993, 427). In the late 18th century a local antiquary, the Revd J Collinson, recorded that the vestiges of what he called a dungeon [donjon?] and circular building were still visible (Collinson 1793, 589). Later, the Revd John Skinner visited the site and although there appears to be no commentary he sketched the *donjon* (Fig 2).

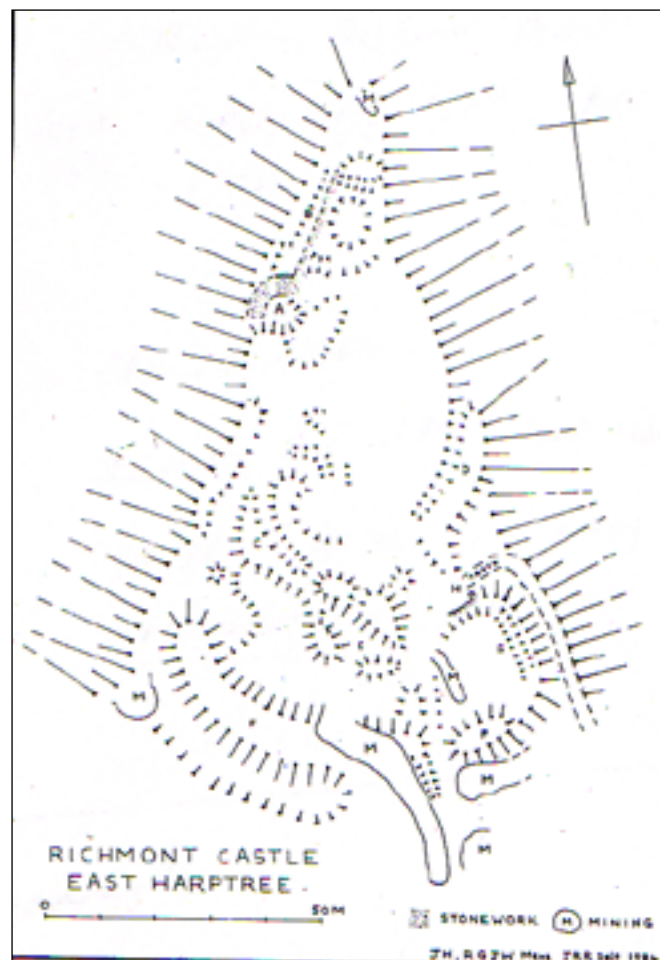
Figure 3. Russell's earthwork survey of Richmond Castle

Little archaeological investigation has been undertaken at Richmond Castle apart from an earthwork survey that was carried out in 1983. The survey identified the outline of the castle, the remains of the tower, and the inner and outer bailey. The castle entrance was thought to be on the east side where a modern track ascends from the valley to the castle. A fragment of sandstone roof tile and a sherd of pottery of unknown date were recovered. Traces of the mining activity were also planned. In the valley on the western side of the castle a dam was noted but not surveyed. The dam was interpreted as being either contemporary with the castle or equally likely, dating to the lead mining on the site (Russell 1984, 61-62; Fig 3).

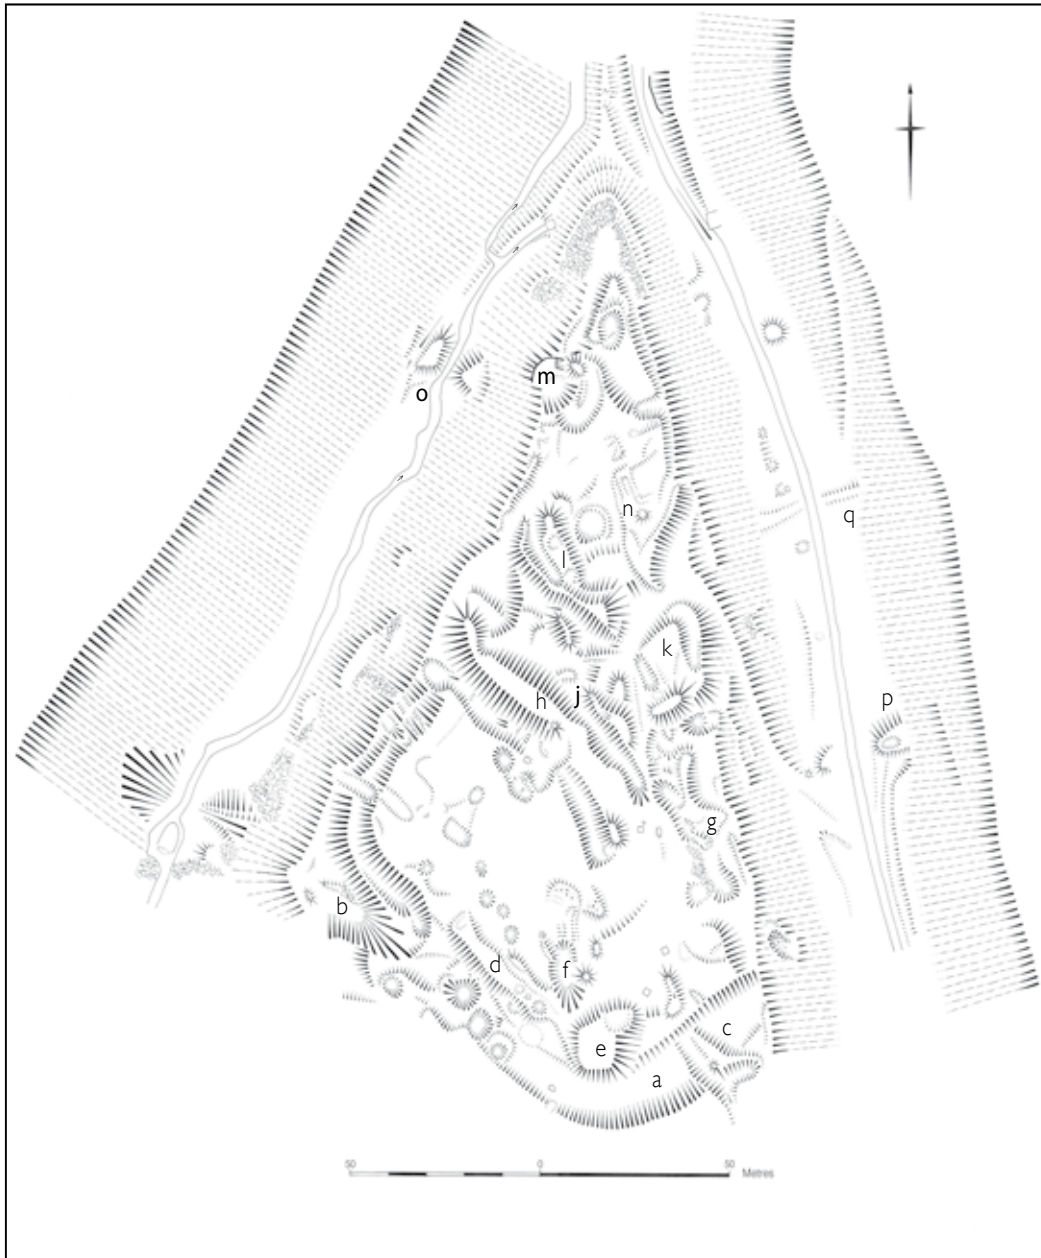
Figure 4. Plan of the earthworks at Richmond Castle
1:1000 survey plan (reduced)

The southern end of the surveyed area is defined by a broad ditch (a) that cuts off the end of the spur. Overall the ditch has a basal width of up to 8m and is 1.3m deep on its internal, northern face. It extends from the eastern edge of the spur for 38m before turning at right-angles for a further 52m towards the western spur edge. At this western point mining activity obscures its course; however, a curving double terrace probably marks the castle's outer ward.

Cutting into much of the ditch are several circular pits, some of which are embanked, which measure between 5-10m diameter and 0.2-1.2m deep. There are also two linear rakes; the most prominent is on the western side where there is a deep cutting measuring up to 16m wide and c3.1m deep (b). In addition, the rock-face here is exposed in a linear fashion along its northern side, which was either caused by weathering or, more likely, another phase of mineral extraction. The western side of the outer castle perimeter is also punctured by several rakes that extend down the scarp for at least 14m. Overlying the south-eastern side of the ditch is a double scarp which marks another area of mineral extraction that descends towards the edge of the spur (c). At this point there is also another deep easterly cutting measuring 2.2m deep and 5m wide.

There is little evidence of an internal bank along the northern side of the ditch apart from a small section along the south-west side (d), and possibly on the western side. On the south-west side, the bank has a flat top and measures 30m long and 5m wide. It stands no more than 0.4m high. In several places it has been cut by mining scoops. Further north-west its course is unclear; however, along the western side is a slight scarp which is the same width as the bank in the south and may therefore be its course in this area.

Abutting the ditch in the southern corner is a rectilinear platform with a projection on its north-east side (e). The platform measures 15 x 10m and stands 0.5m high. Its purpose is not entirely clear; however, given its position on the castle's perimeter wall it may well mark the site of a former outer gate-house.

Between the ditch and a prominent bank to the north, in the outer enclosure, there are several pits and small rakes. These include a deep elongated rake (f) to the north of the proposed gatehouse. The rake measures c18 x 10m and is up to 1.7m deep. On its northern and eastern sides are spoil heaps. Another deep rake is on the eastern side (g); here an amorphous cutting, representing at least two phases of mining,

can be seen. Elsewhere on this relatively flat open area, there are several smaller square or circular pits and scoops, possibly mining test pits.

The northern side of this mining episode is marked by a fragmentary bank and external ditch (h) which marks the castle's inner bailey wall; it stands 2.2m high and is up to 5m wide at the top. Its form has been partly obscured by later mining activity; however, three elements can be identified, each at much the same height although the width varies slightly. The external ditch is also fragmentary and has been cut into by the later mining. The longest section of the ditch is in the west and measures 35m in length and up to 5m wide at the base and up to 1.5m deep. The most pronounced cutting through the bank is a rake that extends 32m through the centre of the bailey wall (j). It is up to 5m wide at the base and up to 2m deep. The southern end is slightly lower than the northern end, and probably marks the course of the bailey wall ditch at this point. To the east of this rake there are further cuttings within the bailey ditch. On the northern side of the bank is a level rectangular platform (k), possibly a building platform, which measures c15 x 10m.

To the north of this bank and ditch lies another bank which has again been cut into (l). It measures 32m long and c2.5m high with a basal width of 10m diminishing to 2m at the top. The eastern side of the bank has been largely destroyed, leaving a slight bank which forms a terrace on the eastern escarpment. Further north, and as far as the scarp edge, is the castle's inner bailey. It is defined on the scarp-edge by a break in slope marking the course of a curtain wall. On the western side is a terraced platform with walling in the north-western segment. It measures 12m diameter and 0.8m deep (m). This feature was the site of a tower or *donjon*. The rubble core of curtain walling can also be seen on the northern side of the tower extending for c13m. On the north-eastern side of the tower there is a sub-circular depression with a bank on its northern and eastern sides. This was probably another tower or building. On the eastern side of the keep is a rectilinear feature (n), probably a building, measuring 8x4m with a rectangular depression on its eastern side. Despite the lack of evidence of walling on the eastern side, the break in slope here, where stonework has been robbed out, represents its course.

Along the western valley floor is a substantial dam (o), which has been breached in the centre. The dam measures 2.2m high and has a basal width of 16m which decreases to 8m at the top. The southern face is steeper than that to the north. To the north of the dam the stream flows along a concrete trough as far as a concrete platform which has a grill on the southern side. An over-flow leat, with a lip 0.2m above the base of the trough, lies on the western side, thus ensuring a consistent flow of water to the grill. This trough and over-flow leat were presumably the work of the Bristol Water Company and were constructed at much the same time that the conduit was constructed along the eastern combe. The dam has previously been interpreted as dating either to the medieval or post-medieval period (Russell 1984, 61-2); however, it is more likely to be medieval since there is no evidence of any industrial processing of lead or calamine along the valley bottom which may have required the dam.

Along the eastern valley floor there are two banks. The southern example (p) is the most prominent and is cut by the modern track. It stands up to 0.8m high and 10m wide at the base with a pit in the eastern section. To the north is the second, smaller bank (q), which again has been cut by the modern track. Although the earthwork is considerably lower than the western dam (o), these banks may also have been dams; however, a source of water is less clear than in the western combe since water has been culverted underground by the Bristol Water Company, and this interpretation must therefore remain tentative.

Two tracks have been terraced into the scarp on either side of the eastern valley. The one on the eastern scarp lies to the north of the northern bank (q) and ascends the slope towards East Harptree; the second track lies beside the southern bank (p) and ascends the slope to the interior of the castle between the two curtain walls. This track has previously been interpreted as dating to the medieval period (Russell 1984); however, it is too narrow and well-engineered to be considered as the main access to the castle. It is more likely to post-date the castle and is probably contemporary with the industrial activity.

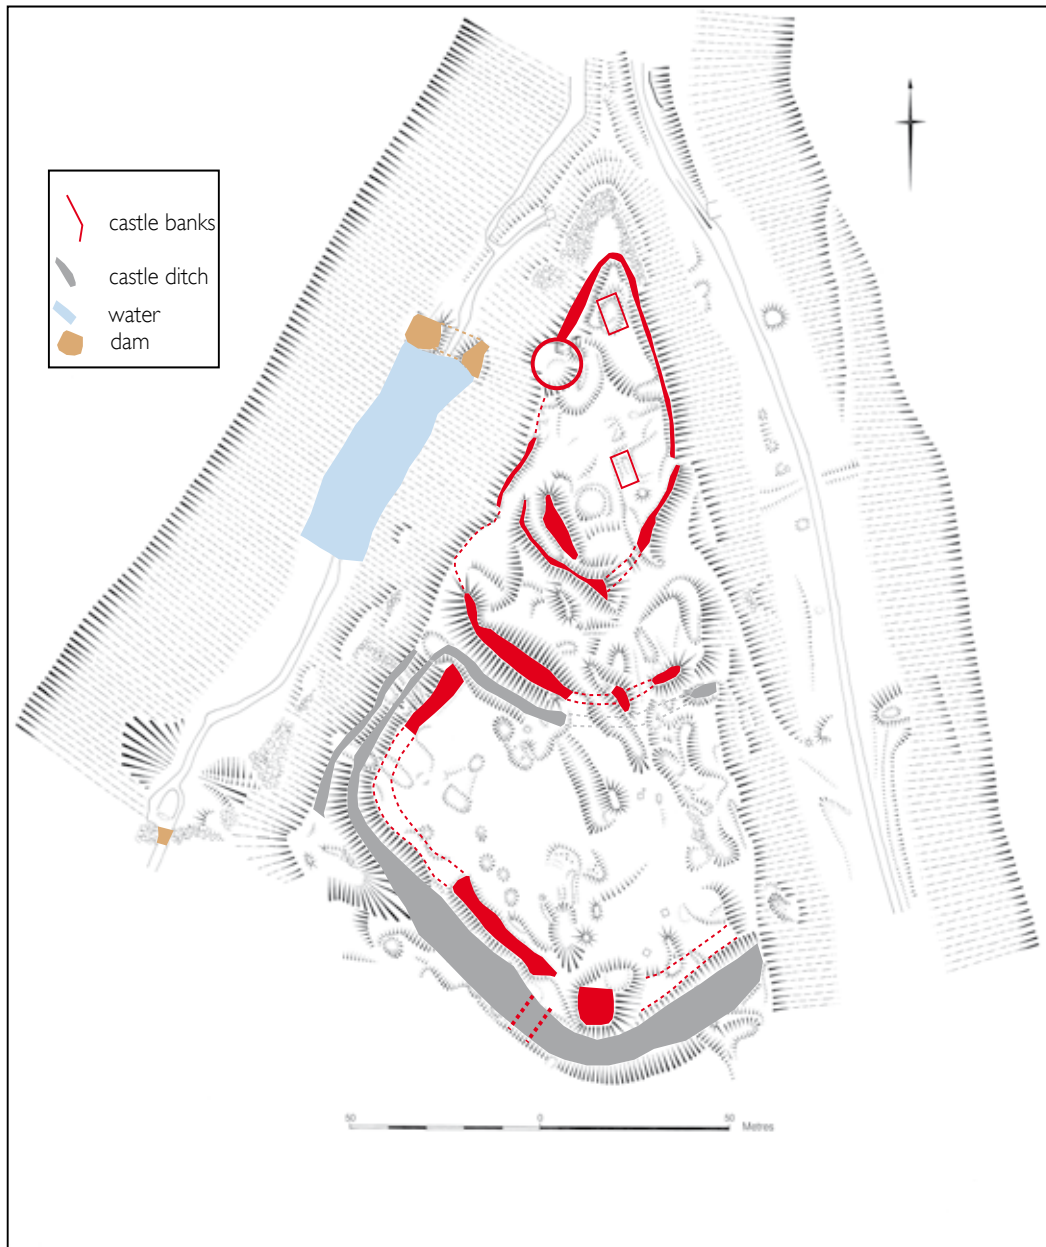
Figure 5. Interpretation plan of Richmond Castle

Morphologically the castle is of at least two phases (Fig 5). The southern, outer boundary ditch is more angular and much broader than the other two enclosure banks and it is also noticeable that it is set slightly askew; the corresponding bank is also much lower and degraded than the inner two. This suggests that the bank was either completely dismantled or, more likely, that it was never a substantial structure in the first place and was probably surmounted by a timber palisade. This outer bank and ditch, enclosing as it does the greater area of the promontory, is probably the earliest feature but its dating is unclear. Comparing it with examples elsewhere it could be seen as an Iron Age promontory enclosure of the sort that is widespread across the south and south-west of the country (eg Lamb 1980). Examples include the curving enclosure on the Corallian ridge above Lacock (Wilts) where Romano-British pottery has also been recovered (NMR: ST 96 NW 5), or Bincknoll on the chalk escarpment in the same county (NMR: SU 17 NW 2). Indeed, there are striking similarities between Richmond and Bincknoll: both have been severely quarried thus masking their earlier form, but more significantly the earthworks at Bincknoll suggest several phases culminating in the later medieval motte-and-bailey phase. Although Field suggests that the earliest phase may be prehistoric he also argues that it could be of late Anglo-Saxon date (Field in prep). Another possible interpretation is that it is a cross-ridge dyke which cuts off the promontory similar to, for example, Cothelstone Hill on the Quantock Hills (Riley 2006, 48).

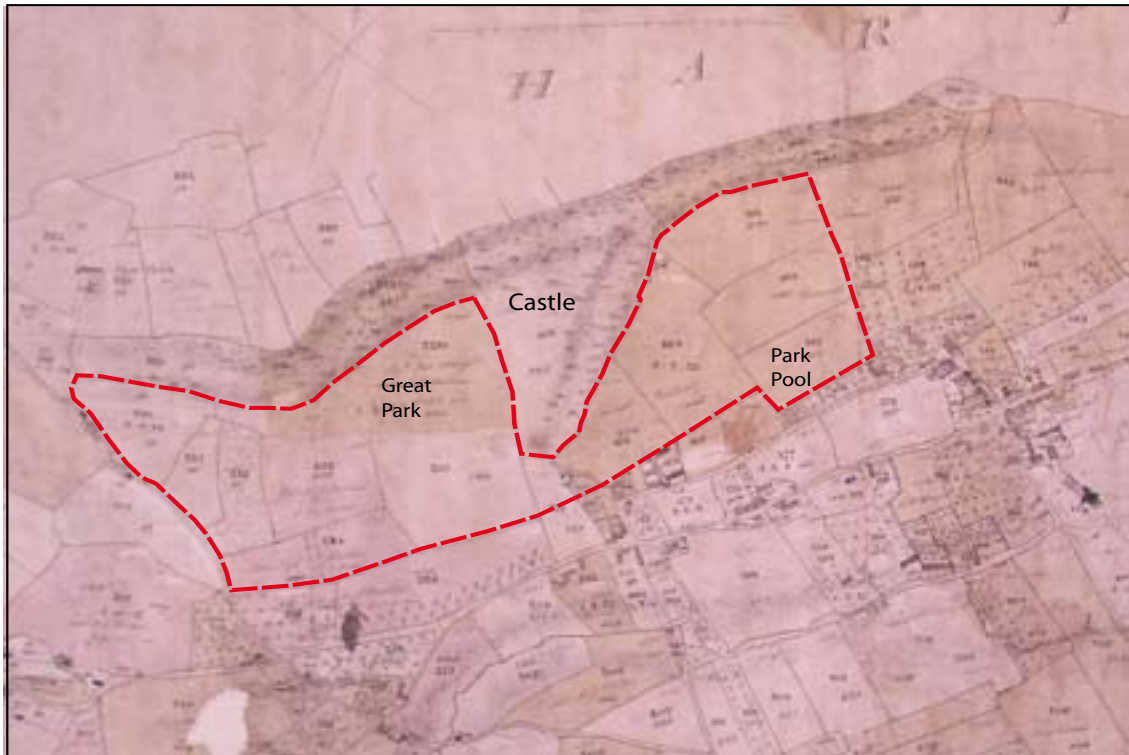
Figure 7. Possible area of the park at Richmond
