CAMBRIDGESHIRE EARTHWORK SURVEYS III

A.E. Brown and C.C. Taylor

This paper is a continuation of the two previous ones, whereby plans of extant earthworks in the county are published with brief descriptions. All but three of the plans in the present paper have been produced by students attending courses organized by Leicester University Adult Education Department. The moats at Duxford were surveyed by pupils of Duxford Church of England Primary School, under the direction of one of the authors and with the help and co-operation of Mr. P.K. Chivers, Headmaster, and Miss F. Dale, organizer of the school archaeological club. The site at Landbeach was surveyed by students attending a course run by London University Extra-Mural Department.

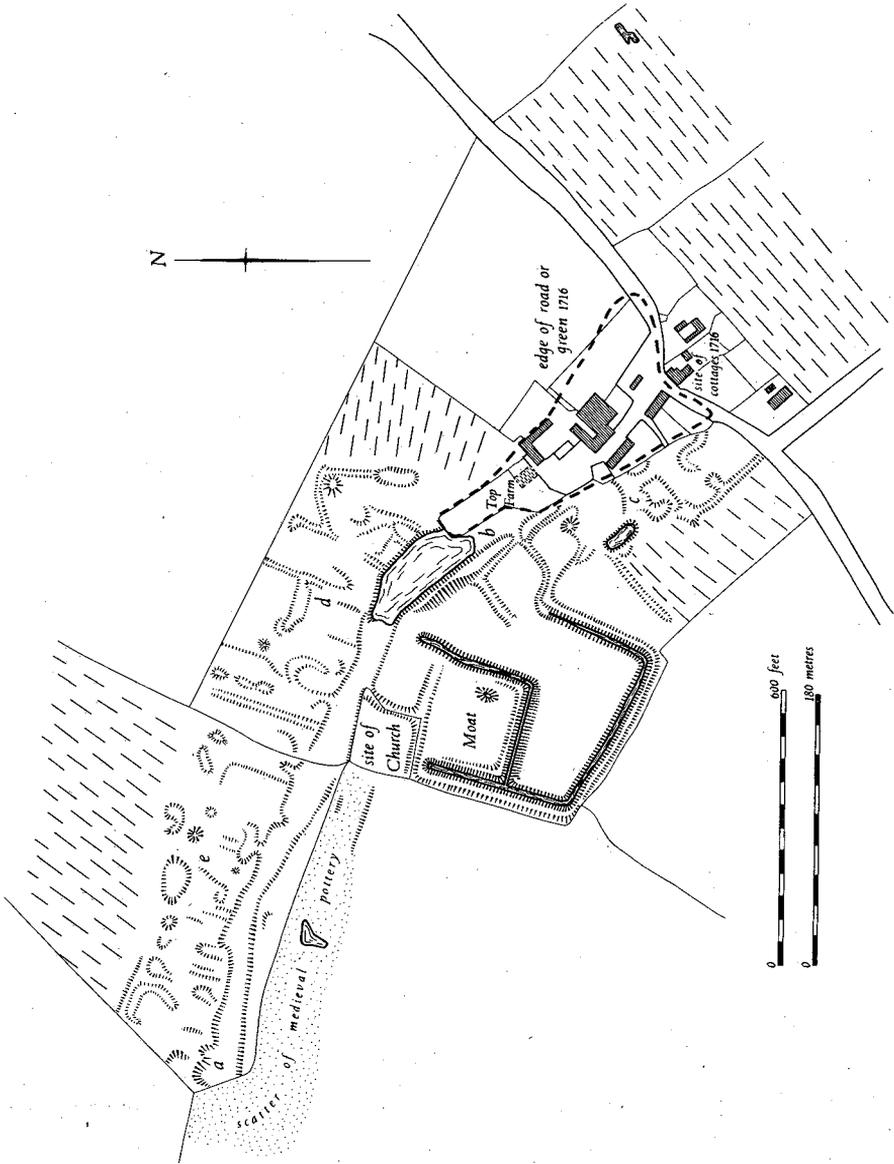
Fig. 1. Coppingford, deserted medieval village.

DESERTED VILLAGE OF COPPINGFORD (TL 165801) (Fig. 1) lies in the parish of Upton, 3 km. south of Sawtry. It is situated on the top of a broad flat clay ridge at about 50 m. above OD. The village is first mentioned in Domesday Book where it is recorded as being held by Earl Hugh with sixteen villeins and two borders. A church and a priest are also listed there¹.

The most prominent feature of the surviving earthworks is a somewhat battered but unusually wide hollow-way which extends across the site from N.W.-S.E. ('a'-'b' on

Fig. 1). At its S. E. end it is now occupied by a large pond and beyond to the S. E. no trace of it survives as the area is covered by modern farm buildings. However, on the 1716 map not only is the S. E. part of the hollow-way marked as a track but its continuation is shown curving further S. E. and opening out to form a wide triangular 'green' at the S. E. end of which were the two cottages. Top Farm already stood at the N. W. end of this green in 1716 and thus partly blocked the road into it from the N. W. The present road already ran along the S. E. side of the green in 1716. This hollow-way and green were the main street of the medieval village alongside which houses presumably once stood. The very fragmentary remains of these buildings still survive in three places. S. E. of the existing farm buildings ('c' on Fig. 1) are a few mutilated low scarps and banks with, beyond a shallow ditch which presumably marked the limits of the village here, the N. E. ends of a block of ridge-and-furrow. These remains, which lay in Harrison's Close in 1716, are apparently the sites of former houses and closes lining the S. W. side of the green.

Further north ('d' on Fig. 1) and on the north side of the hollow-way is another area of very disturbed earthworks which may also be the sites of houses and closes. To the west ('e' on Fig. 1) also north of the hollow-way, are other fragmentary earthworks of a similar character, with ridge-and-furrow beyond. This area was called Town Close in 1716. The land on the south side of the hollow-way at the west end of the site is now under permanent arable. Here for the whole length of the hollow-way and beyond is a wide area covered with considerable quantities of medieval pottery. Most of it is of 13th and 14th-century date, and though there is nothing that is definitely earlier than the late 12th century, there are small amounts of late medieval and post-medieval pottery.

In the centre of the site, and now the best-preserved part of it, is a double-moated enclosure. This has been much altered in antiquity, but it appears to have once consisted of a small rectangular enclosure bounded by a continuous wet ditch, with an outer L-shaped enclosure on its south and east sides, also bounded by a wet ditch on the south, west and parts of the east sides. There is no trace of any ditch on the north side of this outer enclosure, its boundary here being the edge of the main hollow-way. The general appearance of this moated site and the existence of a sharply defined outer bank along the west, south and east sides of the outer enclosure give the impression that it is not only considerably changed since its original medieval use, but that some of these changes might be connected with an attempt to turn the site into some form of post-medieval garden, perhaps of late 16th or 17th-century date. However this cannot be proved. In the N. W. corner of the moated site is a small rectangular area bounded by a shallow ditch on the east and south and by the hollow-way on the north. This is traditionally the site of the parish church of Coppingford. This church, dedicated to All Hallows, was certainly destroyed before 1707⁸.

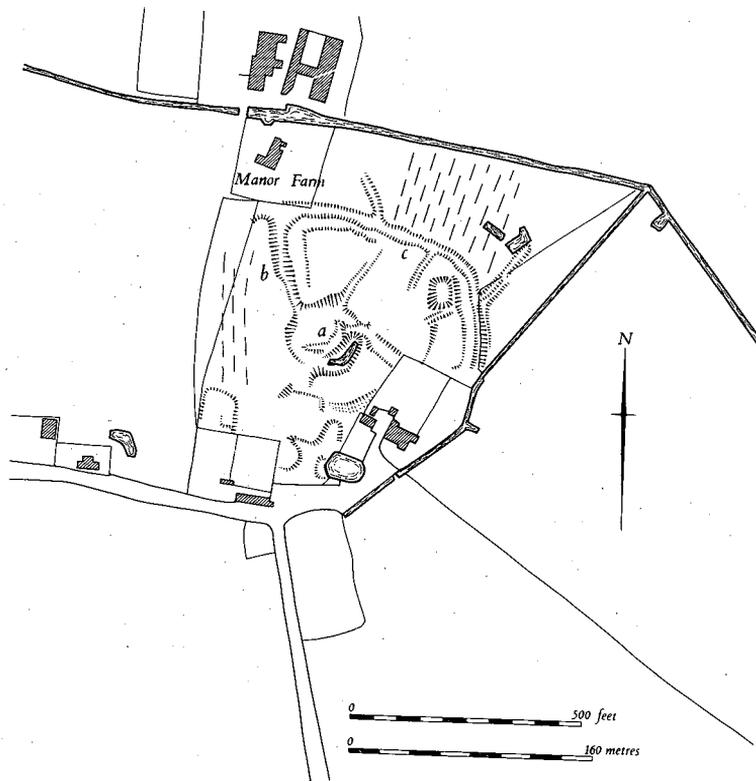
Fig. 2. Woodwalton Castle.

WOODWALTON CASTLE (TL 211827) (Fig. 2) lies almost 2 km. N. of Woodwalton village and 600 m. north of the isolated parish church, on clay at 7 m. above OD. It is situated on the northern tip of a promontory which projects north into Woodwalton Fen. The site though tactically strong appears to have no strategic importance. However this view may be unjustified, for Monks Lodge, an artificial fenland canal dug or recut soon after 1147 by the first monks of Sawtry but possibly Roman in origin, terminates a little to the west of the castle⁹. Though this lode was certainly used by Sawtry Abbey 1.5 km. to the west, it could have also been of use to the inhabitants of Woodwalton and the surrounding villages. Thus the castle's position protecting the fen edge of the lode may be significant.

The main feature of the site is the motte itself, but this has been so badly damaged and altered that only a fragment remains. It appears to have once consisted of either a conical mound or a ring work on the hilltop, surrounded by a deep wide ditch. Now only the S. E. part of the motte survives ('a' on Fig. 2) as an irregular curved bank 1.5 m. high. Below it to the S. E. is one fragment of the original ditch which is 2 m. deep, but which has probably been made deeper than it once was by later quarrying. To the west and north a low curving scarp only 0.5 m. high is probably the outer side of the motte ditch there. From the N. W. corner of the motte a broad shallow ditch, now partly filled in, ('b' on Fig. 2) extends down the hill. At its north end it joins a well-marked ditch 0.5 m. deep which runs around the base of the hill on the north, N. E.,

east and S. E. sides ('c' on Fig. 2). This ditch has been much altered by later drains, and it is no longer possible to trace it around the south and west sides of the hill, if indeed it ever existed there. It may be all that remains of the boundary of an outer enclosure or bailey, though it is possible that it is a later feature unconnected with the motte. Between the motte and the ditch on the north are a number of small shallow ditches, low scarps and a rectangular pond 0.5 m. deep. No purpose or date can be assigned to these. There are further indeterminate earthworks south of the motte and a rectangular platform 0.25 m. high to the S. W. The latter is probably only part of an abandoned garden of a house which once stood to the south. Slight traces of ridge-and-furrow lie to the north of the site, and on the west side of the hill below the motte.

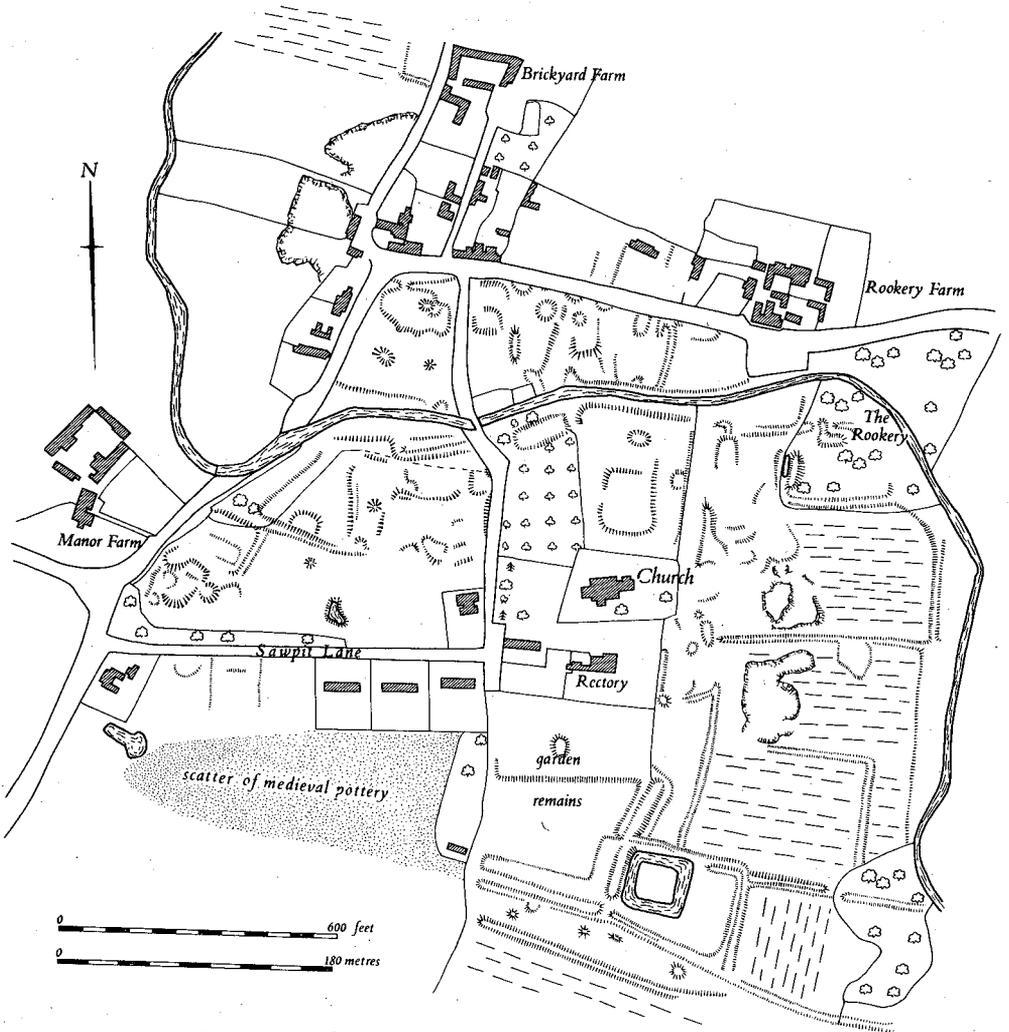
Fig. 3. Hamerton: settlement remains.

SETTLEMENT REMAINS, HAMERTON (centred T L 135796) (Fig. 3), formerly part of the village, lie in and around Hamerton, in the valley of the Alconbury Brook on clay between 20 m. and 35 m. above OD. The first indication of the size of Hamerton is in 1086, when Domesday Book lists it as a fifteen-hide manor with a recorded population of twenty-eight¹². In 1327, 27 people paid the Lay Subsidy Tax², but thereafter there is no record of the size of the village until the late 17th century. Then in 1674, 26 people are listed in the Hearth Tax Returns for Hamerton⁴.

The earthworks in and around the village are extensive, but form little coherent pattern. In the centre of Hamerton, along both sides of the Alconbury Brook, is a continuous spread of low banks, scarps and ditches, none of which have any clear overall form though the remains of one or two former closes can be identified. It is possible that all these earthworks are the sites of former houses and gardens which once lined the brook and that subsequently the village moved both north and south on to the higher ground. If this is so, then there are parallels for this type of movement in the area. At Luddington, to the N. W., in Northants., the process is documented as occurring in the 19th century¹³. However if this happened at Hamerton it certainly took place many centuries ago. One argument against this idea, is the extensive spread of medieval pottery, mainly of the 13th and 14th centuries which, together with much stone rubble, was discovered during the survey in the arable land south of Sawpit Lane, on the S. W. side of the village. This indicates a dense occupation here in the medieval period. The material recovered from Hamerton adds to the evidence from elsewhere in indicating the complexities of change and movement in medieval villages which, at the moment, we know little about.

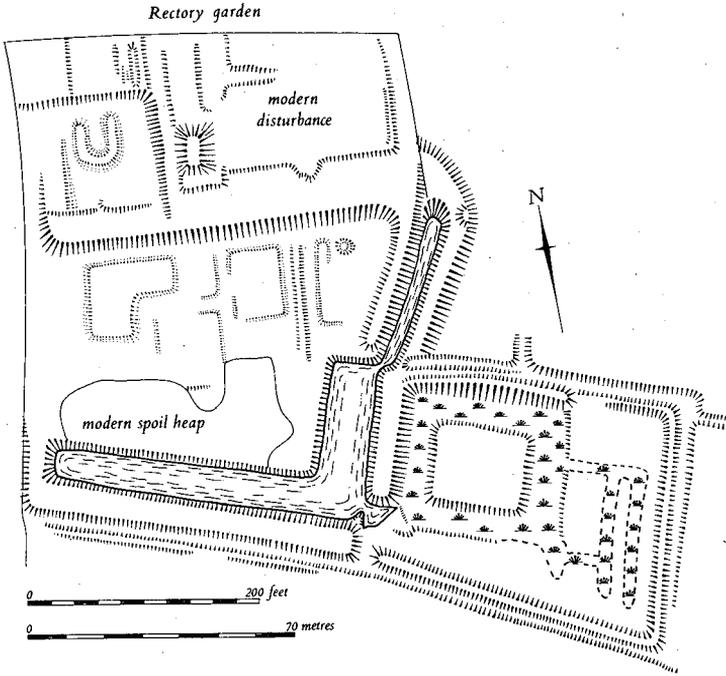
Fig. 4. Hamerton: garden remains.

GARDEN REMAINS, HAMERTON (TL 137795) (Fig. 4) lie immediately S. of the church and rectory on a gentle southern slope, on clay at 30 m. above OD. The remains, though previously described as a moated site, are those of an abandoned garden, probably of late 16th or 17th-century date, though no details of its history are known. It was presumably laid out behind the old manor house which stood on the site of the present rectory, perhaps by the Bedell family who held the manor of Hamerton between 1565 and 1643. In the latter year the manor was divided between the two daughters of the last of the Bedells. One of these daughters sold her interest to her sister Elizabeth who had married Sir Francis Compton. He sold the manor house in

The earliest plan of the area is a map of 1838 (in the Huntingdon Record Office) which is probably a copy of the now lost Enclosure Map. This shows a large farm and outbuildings on the site of the rectory, with the field to the south, which now contains the large mound, called Mount Close. The S. E. part of the site lay in a very large field then known as Ram Close. The earthworks can be divided into two distinct parts, each of which presumably represents a separate section of the original gardens. Immediately south of the rectory is a broad rectangular area bounded on the south by a straight scarp 0.5 m. high. This area is much disturbed by later activity but the slight outlines of what may be the edge of walks or flowerbeds survive, especially at the west end, in the form of low scarps nowhere more than a few centimetres high. In the centre is a large rectangular mound almost 2 m. high which appears to be composed of brick and stone rubble. The bricks are of 17th-century type.

Below the scarp is another flat area. The southern part has been covered with spoil removed from the pond to the south, but on the remaining open section is again a series of rectangular features edged by scarps less than 10 cm. high. These also may be the remains of flowerbeds and walks. To the south again, bounding this section of garden, is a long rectangular pond or canal, with a wide flat-topped terrace walk on its south side. The pond extends north at its east end to bound part of the east side of the garden and terminates abruptly. From its N. E. corner a narrow ditch with a low bank on each side runs N. E.

The second section of the garden lies to the S. E. of the above. It consists of a trapezoidal area bounded by a low bank and external ditch. The west part is occupied by a low, flat, square island only 0.25 m. high surrounded by a wide shallow ditch, now marshy but presumably once filled with water. From the east and S. E. sides of this ditch run a series of other marshy depressions of generally rectangular form. This whole area is perhaps some form of elaborate water garden.

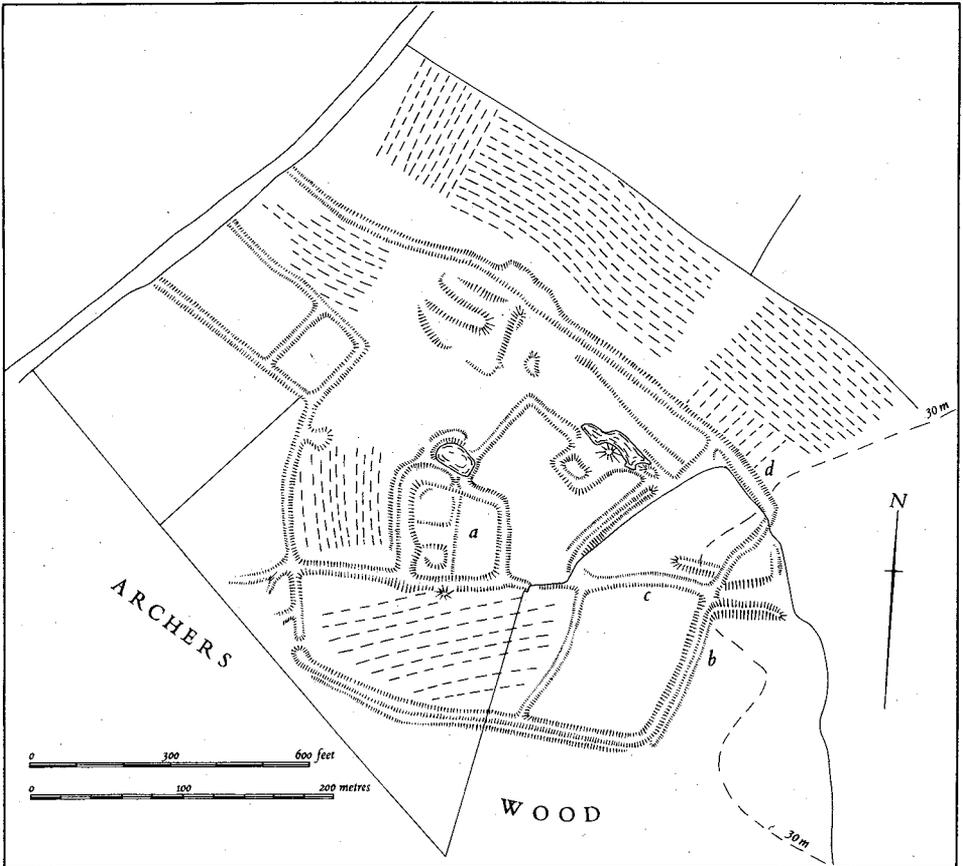
Fig. 5. Sawtry: Archer's Wood moated site.

MOATED SITE, ARCHER'S WOOD, SAWTRY (TL 175183) (Fig. 5). This site lies within and north of Archer's Wood, towards the southern end of Sawtry parish, on level clayland at 30 m. above OD. Details of its history and of a small excavation on the main moat have already been published in these proceedings¹⁵, and little can be added to what has been written there apart from a description of the earthworks themselves. The present plan indicates that the enclosures associated with the main

moat ('a' on Fig. 5) are far more complex than has hitherto been appreciated and that some have ridge-and-furrow within them. In addition it is clear, from field evidence alone, that not all these enclosures are of the same date. For example the ditch which forms the east side of the main outer enclosure ('b' on Fig. 5) is later than the internal ditch to the west of it ('c' on Fig. 5) which once extended further east and has been cut by the main enclosure ditch. Further, the main enclosure ditch on the N. E. side ('d' on Fig. 5) has cut across pre-existing ridge-and-furrow.

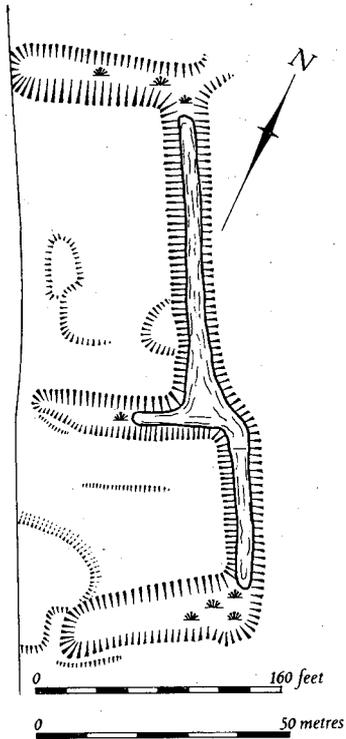
Fig. 6. Duxford: moat (Lacey's Manor).

MOATED SITE, DUXFORD (TL 481464) (Fig. 6) is situated at the N. end of Duxford village, just east of the east end of St. John's Street and close to the R. Cam, on river gravel at 24 m. above OD. Little is known of its detailed history, but something of its historical setting can be inferred. Duxford village is a good example of what has been termed a polyfocal settlement¹⁶. That is, it made up of at least three separate focal points, which have grown together to form one nucleated village. All these centres are still clearly visible in the present village. There is the present St. Peter's Street which has the parish church at its east end, and St. John's Street which has the now redundant church of St. John in its centre; between the two parallel streets is a third focus centred on a small rectangular green which was clearly once much larger. These foci are probably to be identified with three of the four separate large manors recorded under Duxford in Domesday Book, the fourth entry there being perhaps a separate settlement north of the village, now deserted, though its site was, until recent destruction, marked by another small moat. Each of the three foci which make up the present village has a moated site near its east end, though that of the central one is now reduced to two ponds S. E. of Temple Farm and even on the enclosure map of 1822 (in Cambridgeshire Record Office) was shown only as a three-sided moated enclosure much altered by that date. The three moats may be seen as the sites of the manor houses of the three parts of the village. The moat being described here is thus the site of the manor house of the north, or St. John's Street, part, the manor of which was held by the Lacey family in the 13th and 14th centuries¹⁷. Nothing is known of the later history of this moat. The earliest depiction of it is not until the 19th century when it is shown on the enclosure map as a sub-rectangular island, orientated north-south and completely surrounded by a water-filled ditch. The map also shows the ditch on the east side extending south beyond the island for a short distance and marks an entrance across the ditch or moat in the centre of the west side. This plan is at variance with the OS version of the site, apparently made in 1952 just before a housing estate was laid across the western part. The OS plan¹⁸ shows the same main rectangular enclosure, but also indicates that the ditch to the south turned west at its south end. The plan also marks an entrance in the centre of the northern side but none on the west. Only half of this moated site now remains and so the problem of the entrances on the north and west cannot be resolved. However, the surviving earthworks do suggest that the moat once consisted of two conjoined rectangular enclosures, bounded on all sides by a wide wet ditch. The surviving ditch is about 1 m. deep and still partly wet. The section of the interior that still remains is flat and featureless except for some slight scarps which appear to be of relatively recent origin.

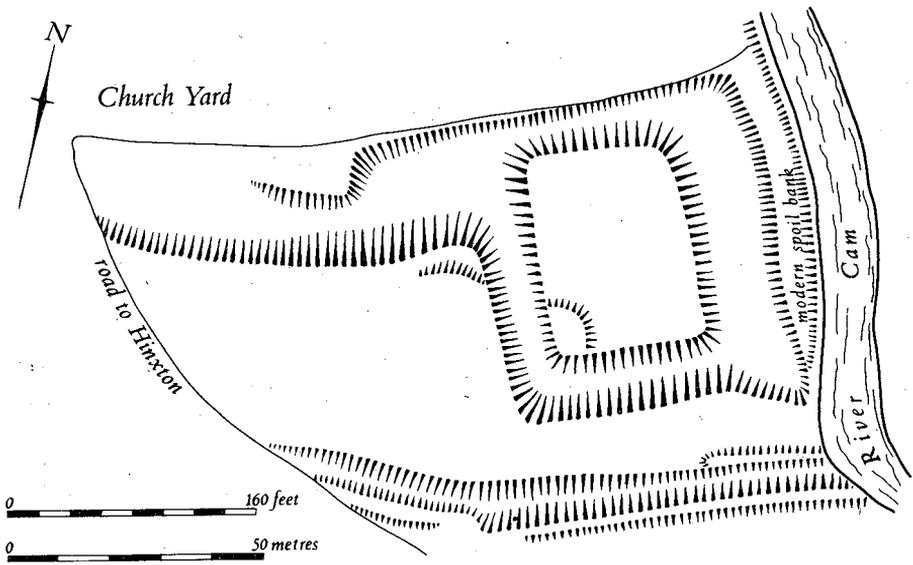
Fig. 7. Duxford: moat (St. Peter's church).

MOATED SITE, DUXFORD (TL 482459) (Fig. 7) lies in the S. E. corner of the village, immediately S. E. of St. Peter's Church, at the east end of St. Peter's Street. It is situated adjacent to the R. Cam on gravel and alluvium at 24 m. above OD. Its general historical setting has already been discussed above, and there is no doubt that the site is that of the medieval manor house of the southern focus of Duxford village. As far as can be ascertained, this was the manor held by Hardwin de Scalers in 1086, which eventually passed to the Le Groyz family in the 12th century and remained with them until at least the late 13th century¹⁷. The moat described here was therefore almost certainly constructed by a member of the this latter family.

The site is first shown on the Enclosure Map of Duxford of 1822 with almost exactly the same overall plan that it has today, though with all the ditches and the long ditch to the south apparently filled with water. It consists of a rectangular flat-topped island with no interior features beyond a slight mound 0.25 m. high in the S. W. corner. This is entirely surrounded by a wide ditch, now dry, up to 1 m. deep. In the N. W. corner the ditch widens and runs west and is cut up to 2 m. deep into the rising ground. It then fades out and a low scarp continues its southern side as far as the modern road. On the southern side of the site is a broad V-shaped ditch, also now dry, up to 2 m. deep with a low outer bank on the south. At its east end this ditch is cut by the present course of the R. Cam. However, the river here is not on its original course which, to judge from the parish boundary between Duxford and Hinxton lay 250 m. to the west. The present river, actually the inlet channel for Duxford Mill, may not have existed in medieval times.

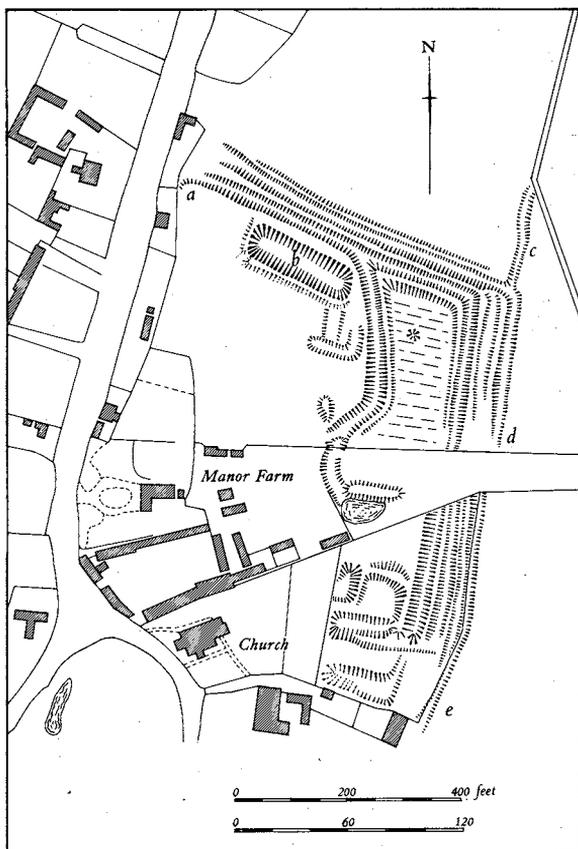
Fig. 8. Landbeach: manorial earthworks.

MANORIAL EARTHWORKS, LANDBEACH (TL 477655) (Fig. 8). These earthworks lie at the north end of the existing village, in permanent pasture, on gravel at 7 m. above OD. The present Manor Farm and the church are situated immediately to the west. The remains are only partly depicted on OS maps and they are described as a 'moat'. In addition the Ordnance Survey marks 'Site of Manor House' immediately east of the church, though on what evidence this is based is not known. The existing Manor Farm seems to be on the site of the medieval manor of Chamberlains, which was acquired in the 14th century by Corpus Christi College¹⁹. The survey published here suggests that the remains are not a moat at all but the outer part of the medieval manorial farmstead.

The main feature of the site is a set of multiple ditches which survive on the north and east of the area. These consist of two main ditches, up to 1.5 m. deep, separated by a low bank and with a slight outer bank on the north side. The ditches have been destroyed in the centre of the east side by a later farm track and the west end of the north side has recently been filled in. There is no trace of a south side to the enclosure, north of the Rectory, nor of the west side. However the fact that part of a corner of the inner ditch survives in the N. W. ('a' on Fig. 8) suggests that the enclosing ditches may have extended along the west side. The purpose of these enclosing ditches is not entirely clear. The best explanation is that, in a generally low-lying area close to the fens, they were necessary for drainage.

Farm. The most obvious is the large rectangular pond, now dry, 2 m. deep ('b' on Fig. 8), close to and parallel with the north side of the main enclosure. Further to the S. E. of this pond is a broad ditch which is connected to the inner ditch of the main enclosure to the north and which runs due south in a markedly sinuous curve. The southern end is largely destroyed but it appears to terminate at a modern pond within the existing farmyard.

Between this ditch and the east side of the outer enclosure is a block of well-marked ridge-and-furrow. It consists of fourteen ridges less than 0.25 m. high and only 30 m.-36 m. long. This is not only extremely short for medieval ridge-and-furrow, but placed as it is within a manorial enclosure it is an unusual feature. In the southern part of the site, immediately east of the church, is a series of other indeterminate earthworks which are difficult to interpret. They appear to be the sites of former buildings, but their general appearance suggests that they are perhaps of no great antiquity.

One other feature of the earthworks is perhaps quite unrelated to the manorial remains. This is a narrow ditch which passes along the east side of the enclosure and runs north beyond it ('c', 'd' and 'e' on Fig. 8). This ditch can be traced for a mile to the north where it meets the Car Dyke, an artificial canal of Roman date. The purpose of this ditch is not entirely clear. As it now exists it is no more than a drain, and where it passes along the east side of the manorial enclosure it appears to be no more than another, third ditch to that enclosure. The possibility that it was for drainage is further strengthened by the way it meets the N. E. corner of the manorial enclosure where it runs into the outer ditch on the east side as well as bending round it. On the ground, at least, it seems to be little more than a way of removing surplus water from parts of the enclosure ditch.
