HSBC, 8 Market Square, Stafford: An Archaeological Excavation 2000

Birmingham University Field Archaeology Unit **Project No. 743** August 2000

> by Richard Cuttler

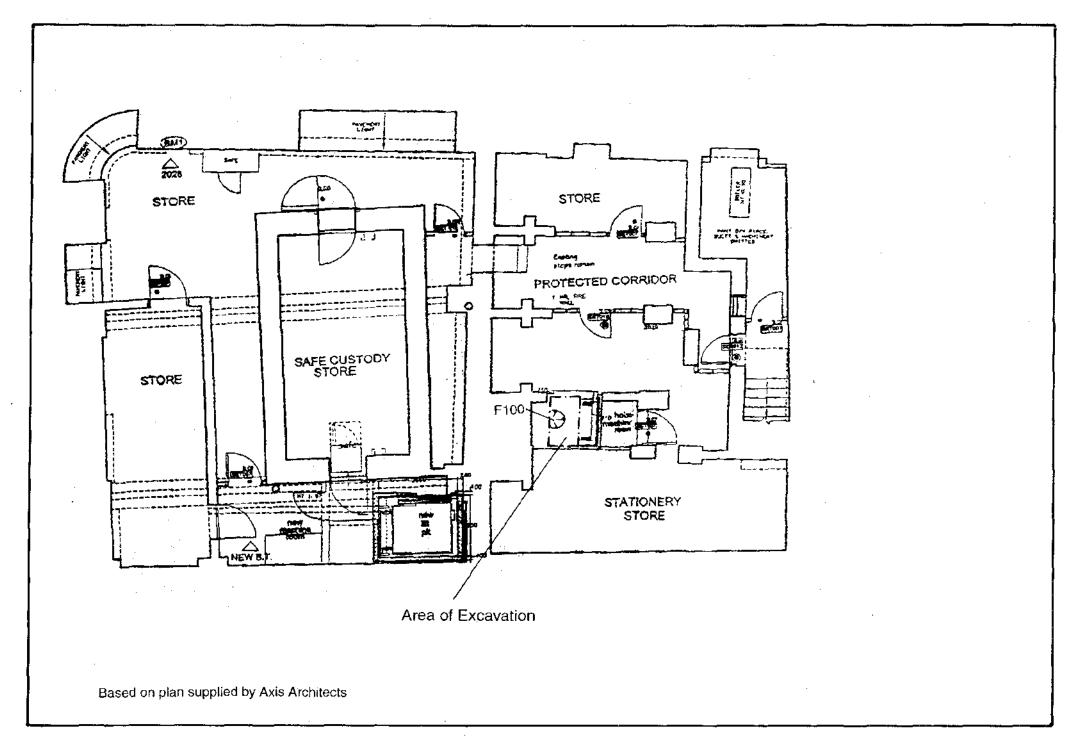
Fig.3

- Fig. 1 Location of site, Ordnance Survey map, 1:50,000.
- Fig. 2 Location of site, Ordnance Survey map, 1:1000
- Fig. 3 Area of excavation.
- Fig. 4 Section, 1:20

Groundworks at the site consisted of the excavation of a single trench, approximately 2.00m long and 1.4m wide, within the basement of the property. Any significant archaeological deposits were to be excavated by hand and recorded on *pro-forma* record cards supplemented by scale plans, section drawings and photographs, where appropriate. Where no archaeological deposits were identified, the stratigraphy was to be recorded and photographed. These records comprise the site archive, which, at the time of writing, is stored at Birmingham University Field Archaeology Unit.

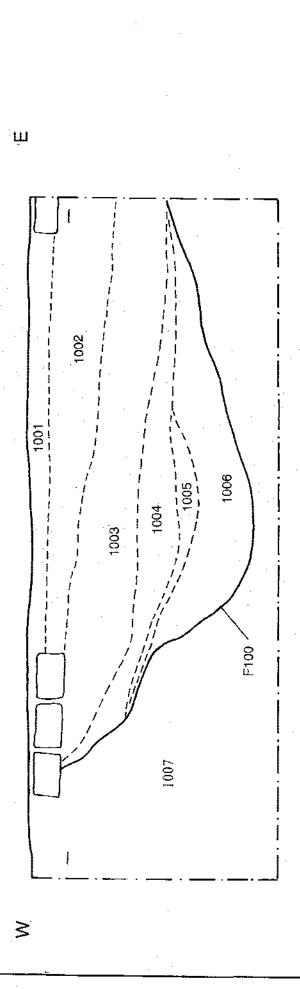
The trench was excavated to a depth of 0.6m below the level of the basement (totaling and depth of 2.6m below the level of the present ground surface). The lowest deposit encountered was a natural, orange sandy gravel (1007). A shallow, rounded depression (F100), approximately 0.28m in depth and 0.95m in width overlay this deposit. Feature F100 was interpreted as a natural undulation within the sand and gravel. Successive layers of orange sand and gravel with iron panning (1002 – 1006) overlay Feature F100. The basement floor was finally sealed by a layer of concrete (1001) approximately 0.08m in depth (Fig. 4)

No finds were recovered during the excavation and all deposits below the concrete basement floor (1002 to 1007) consisted of undisturbed natural.
