Incol Pressworks, Church Lane,
Bickenhill, Solihull:

An Archaeological Evaluation
2006

**Project No. 1527
November 2006**

By Mark Charles

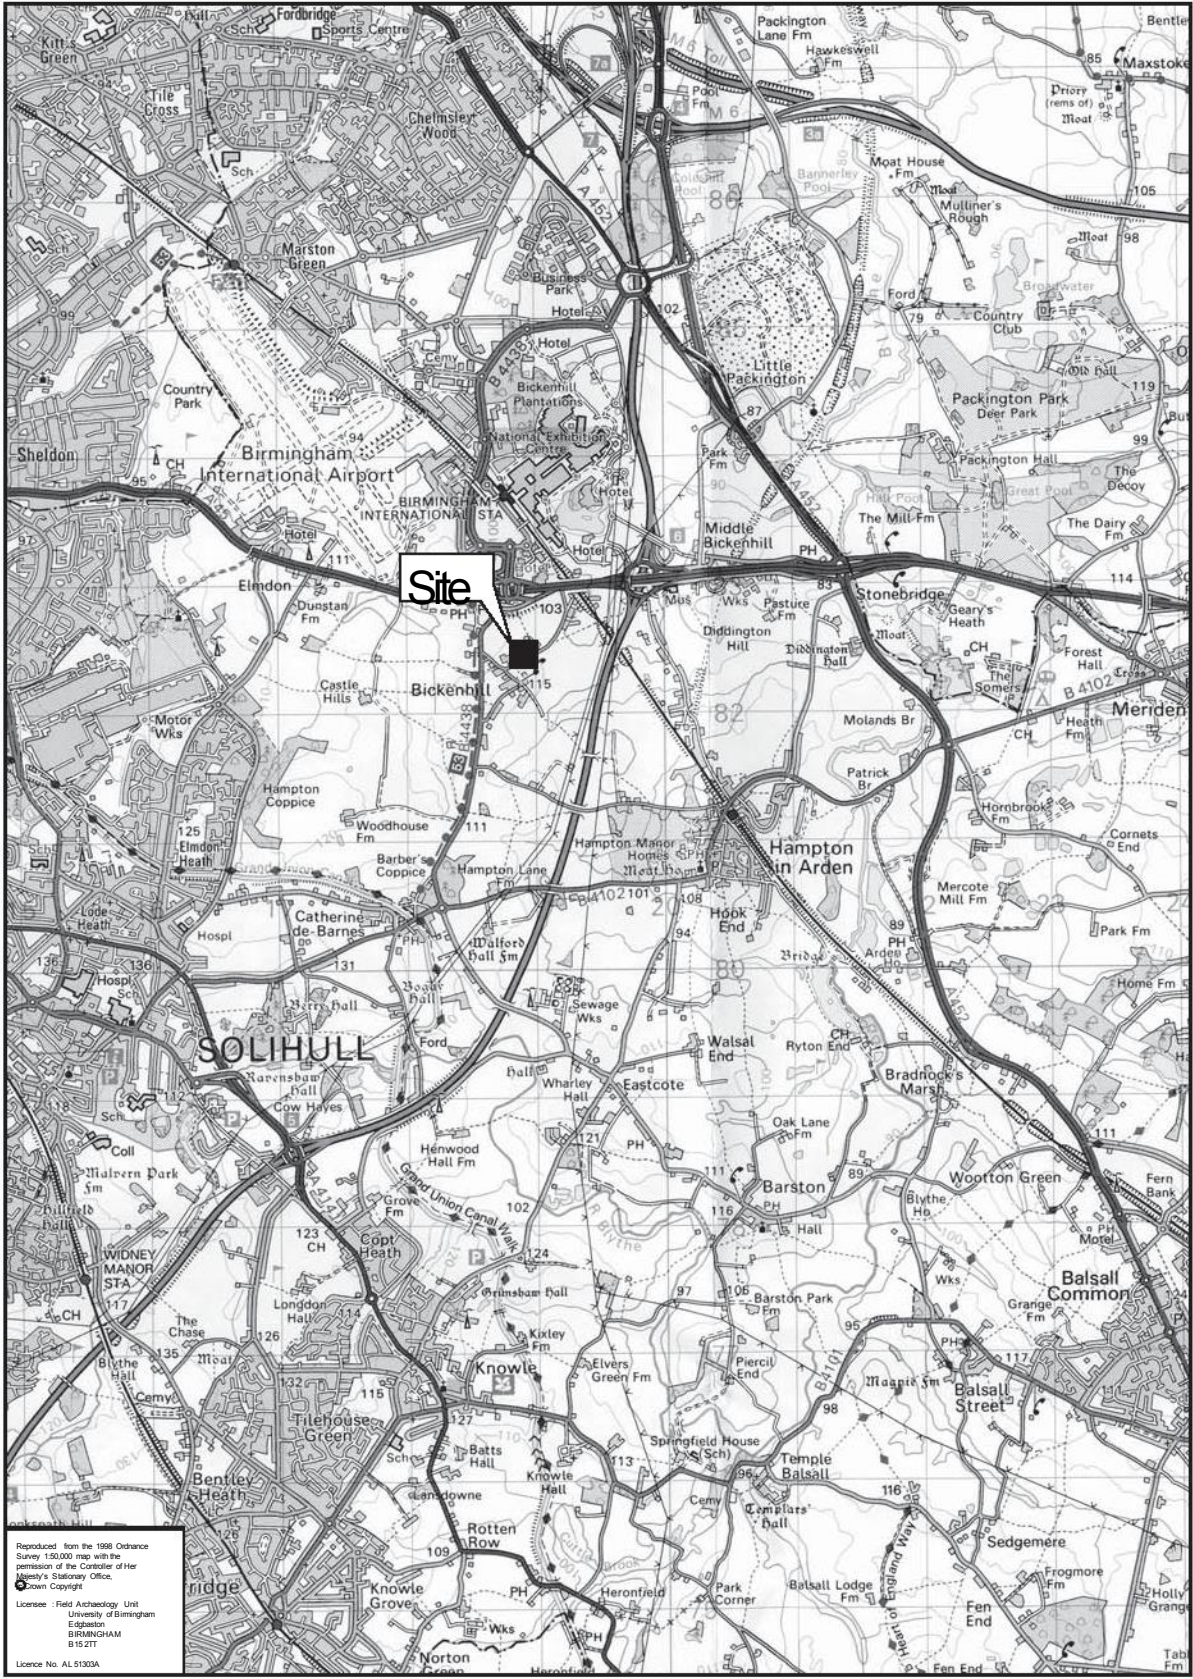
Fig.1

The site is located at Incol Pressworks, Church Lane, Bickenhill, Solihull, north-east of St. Peters Church (SMR SI 144) and is centred on NGR SP 18845 82481 (Fig. 1, hereinafter referred to as the site).

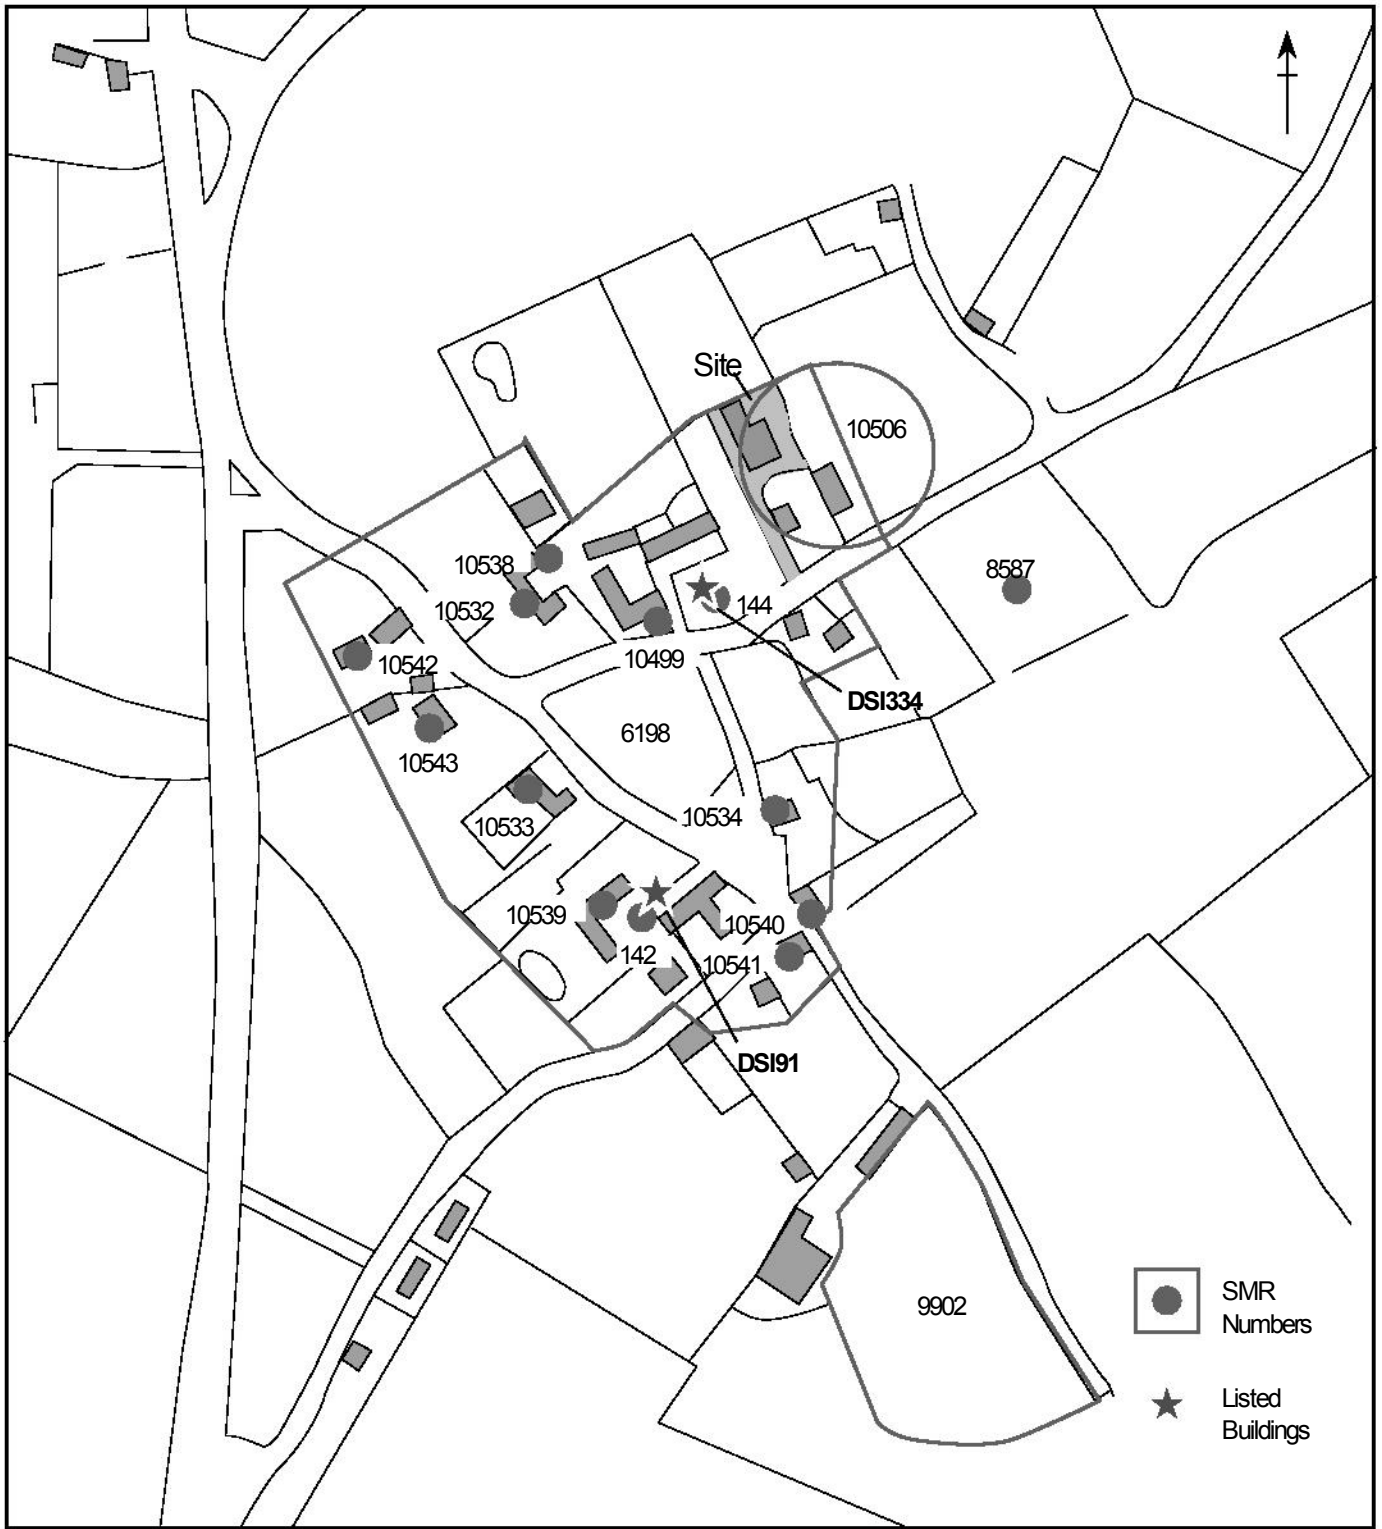
Fig.2

The area in and around the historic medieval core of Bickenhill has a relatively high concentration of archaeological sites (Fig. 2 and Appendix 2). Evidence for settlement may date back to the mid to late Anglo-Saxon period. The Domesday survey suggests four or possibly five settlements within the area that were later incorporated into the parish, one named as Bichehelle (Bica's Hill) and another (Alia) Bichehelle (SMR MSI6198). The village of Bickenhill was originally part of the manor of Church Bickenhill, one of several such manors in the parish.

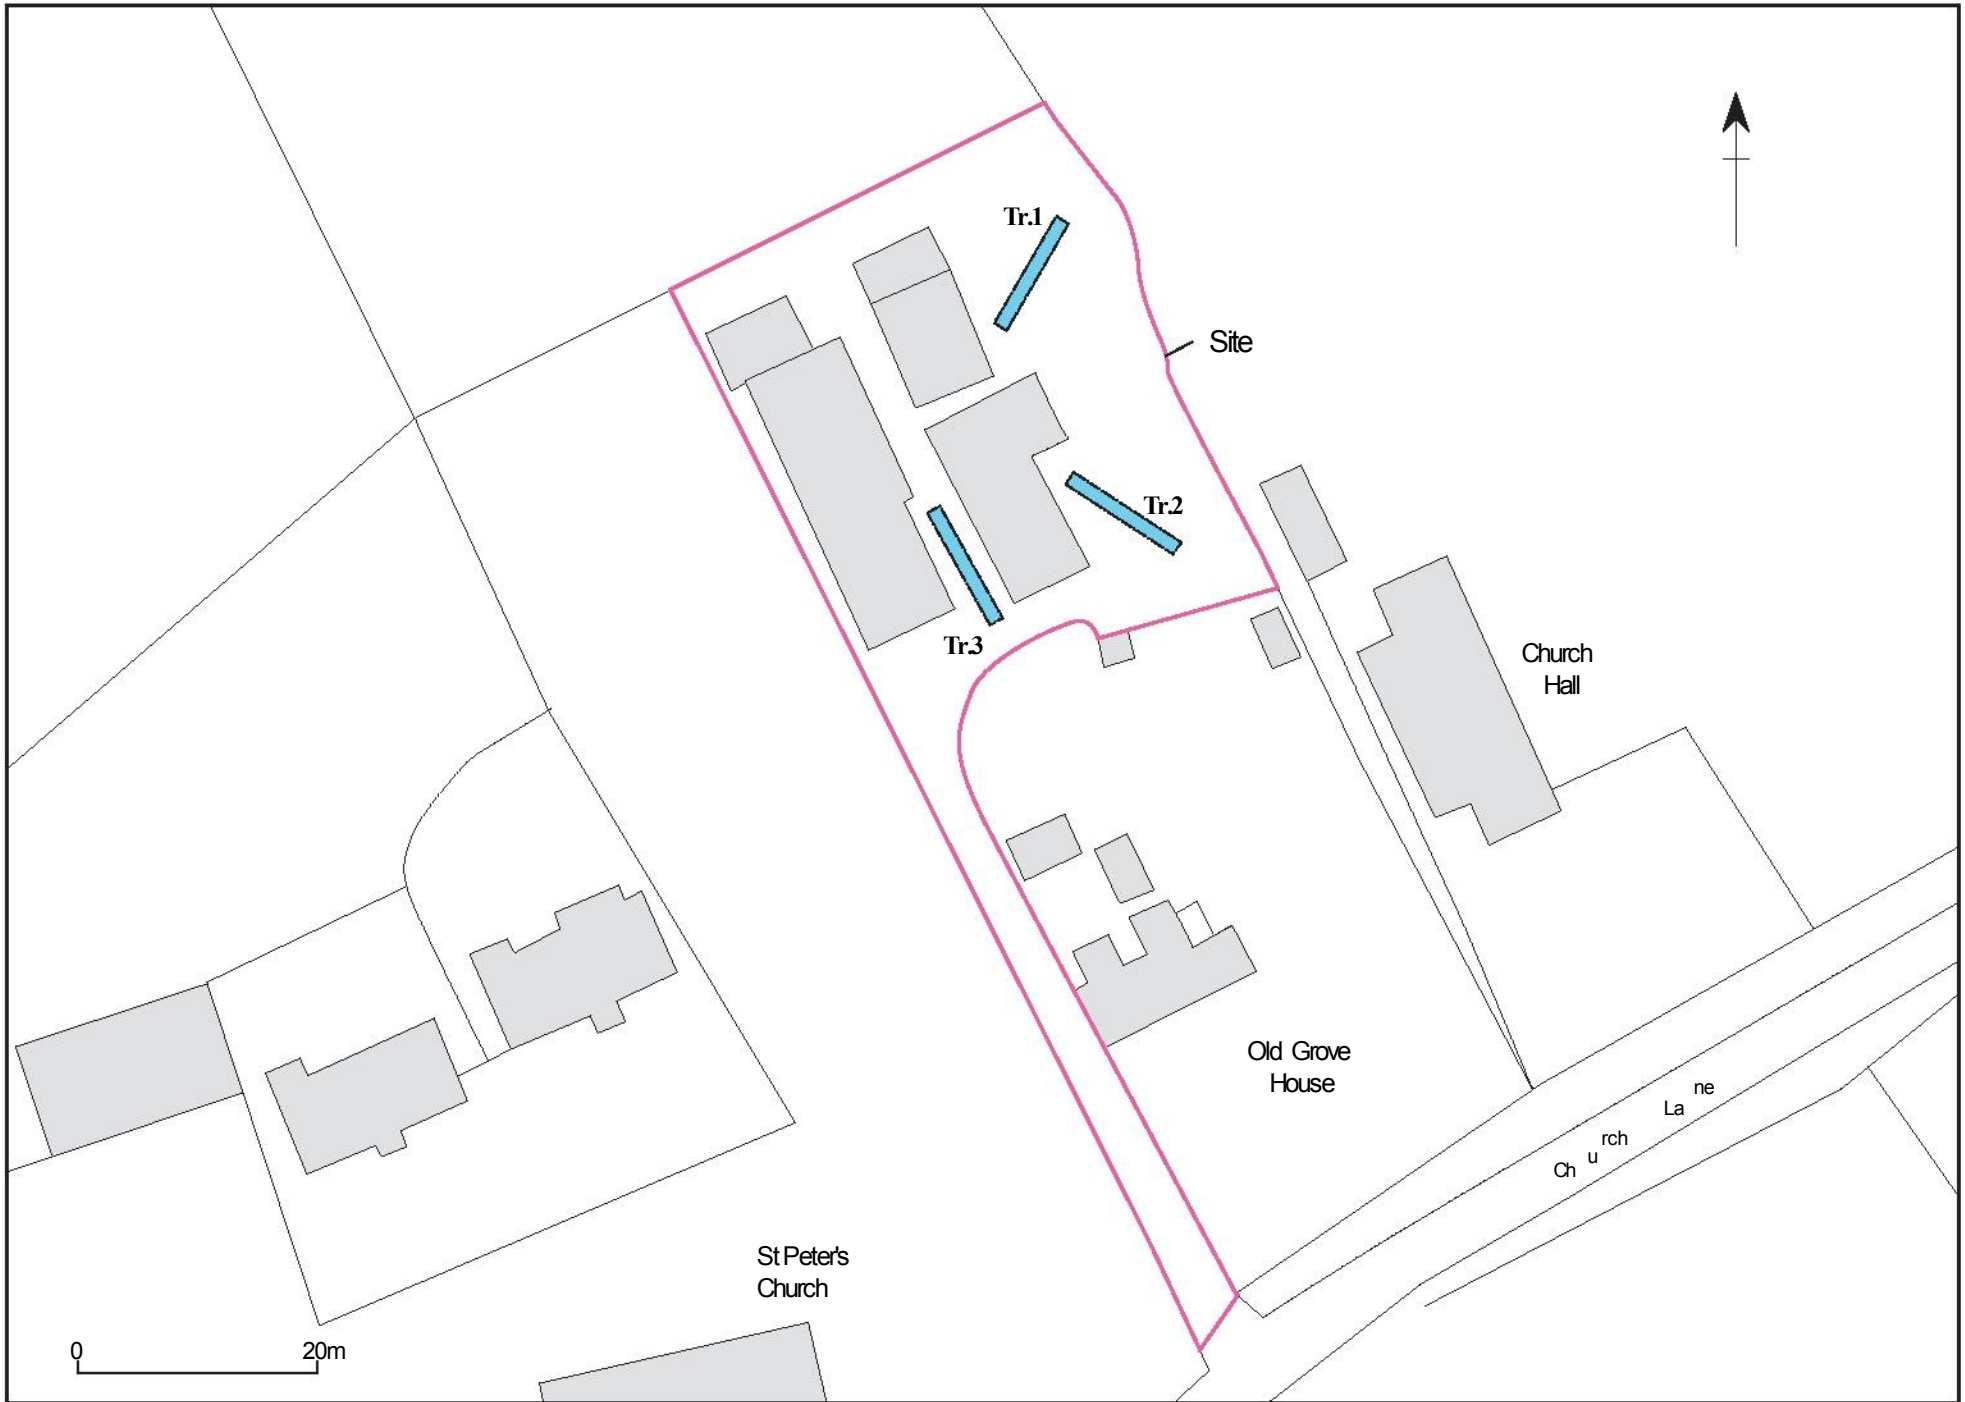
Fig.3

The site covers an area of approximately 1.5 hectares. A total of 3 trenches were excavated across the site totalling 48m² which provided a 3.5% sample of the total area (Fig. 3).

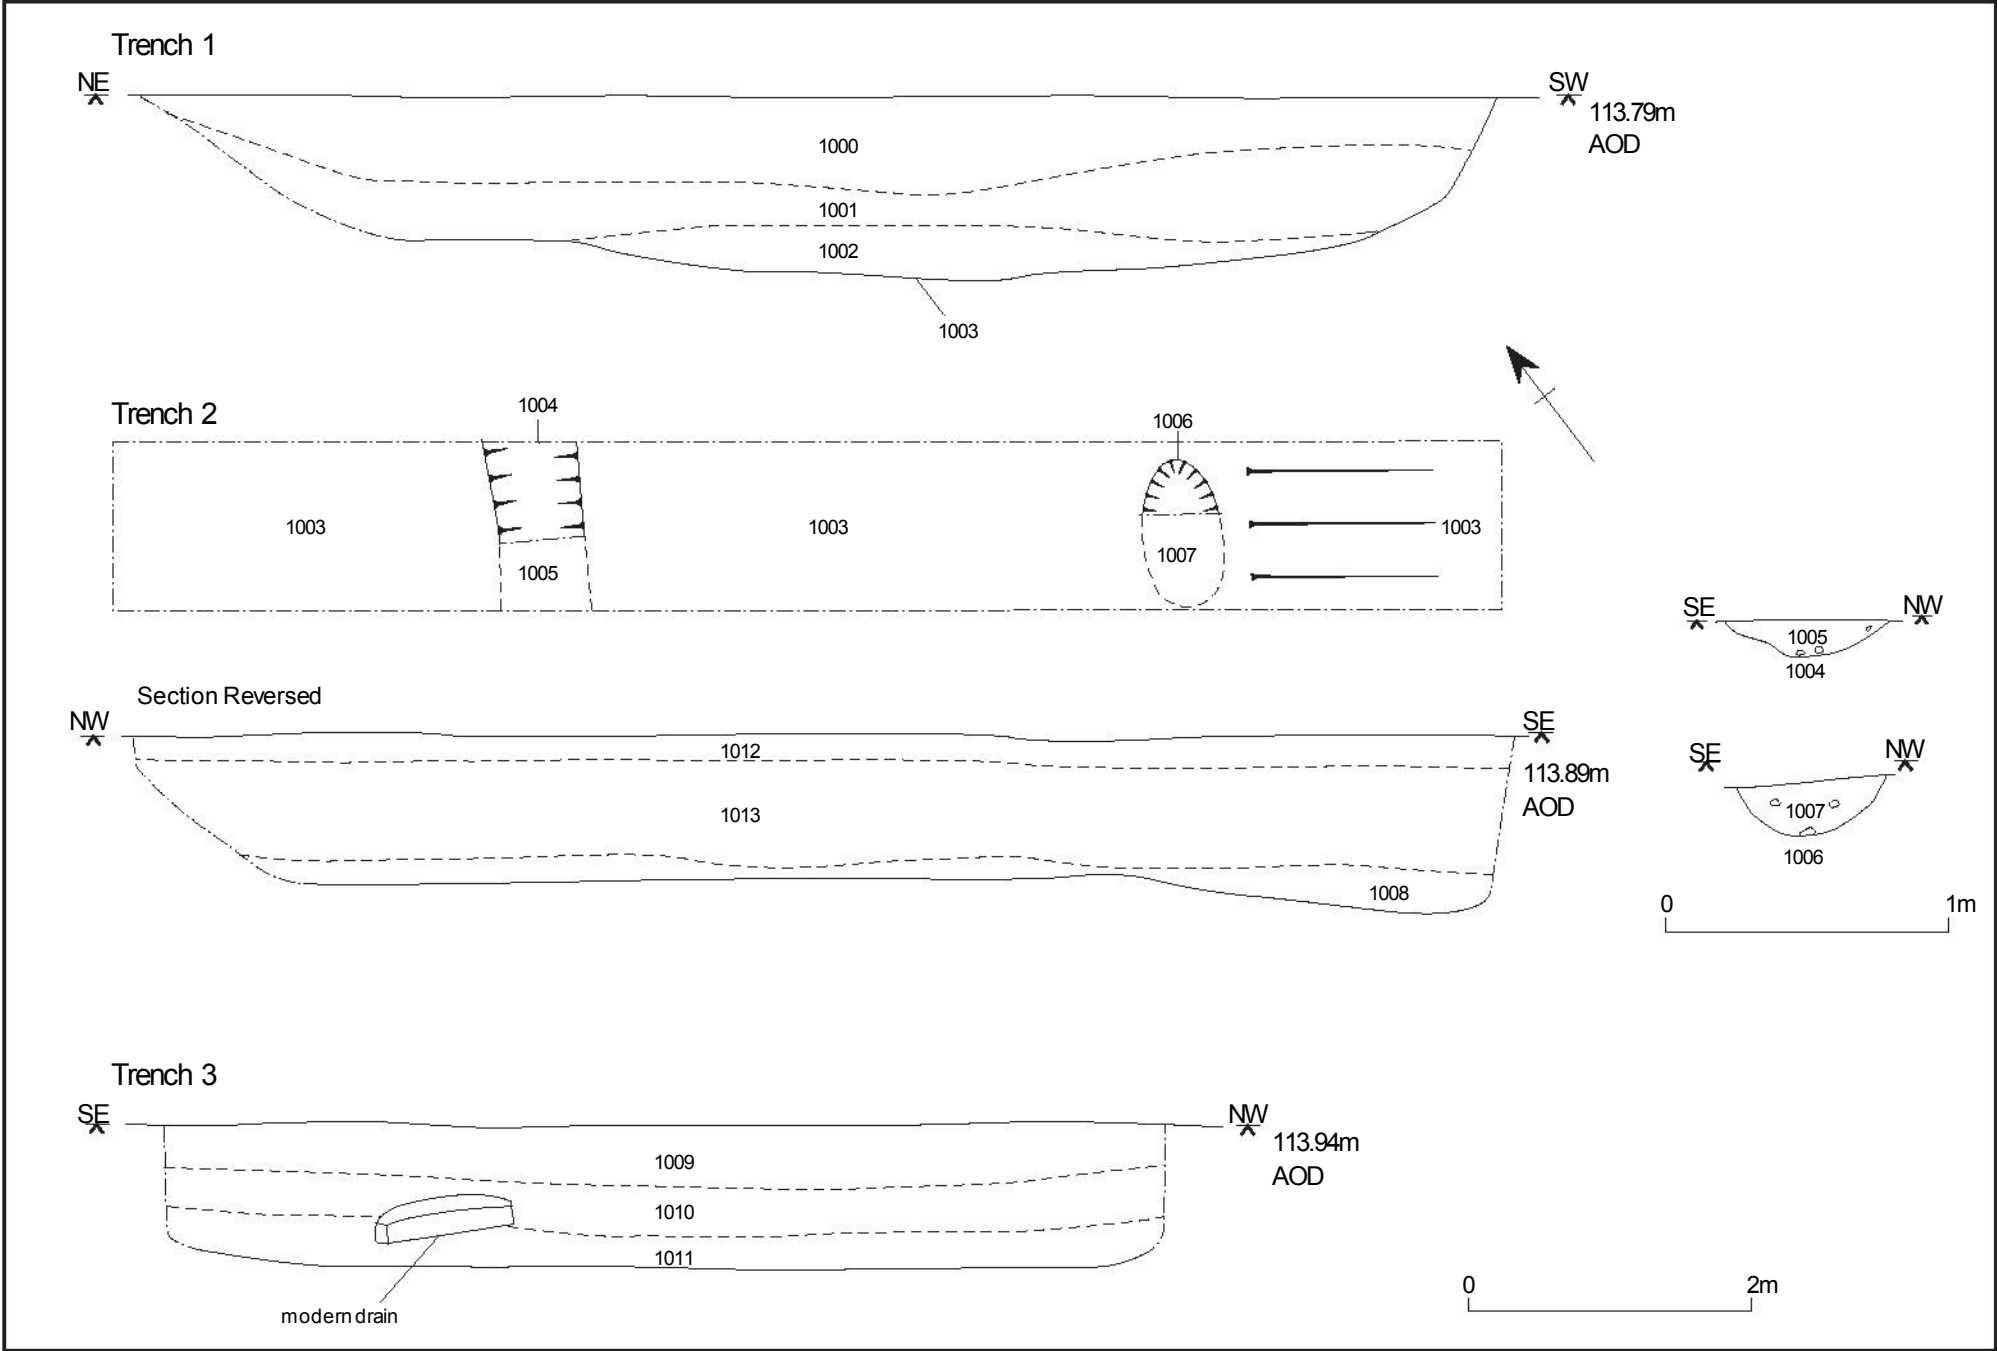
Fig.4

Three trenches were excavated. Archaeological features were found in one trench, Trench 2 (Fig. 4, Plate 2), located to the south-east of the site, where two features, a pit, 1006 (Plate 4) and a gully, 1004 (Plate 5), aligned south-west to north-east, were cut into the natural clay. No finds were recovered and therefore these features remain undated.

In the north and west parts of the site the natural clay subsoil was sealed by an undated grey sandy clay subsoil (1002 and 1011, Trenches 1 and 3; Fig. 4), 0.30- 0.40m deep. The natural subsoil in the south-east part of the site was overlain by a dark grey silty sandy clay containing brick rubble (1008, Trench 2; Fig. 4), of probable post-medieval date. These layers were sealed by topsoil and modern rubble overburden.

Trench stratigraphy: Natural orange-red boulder-clay (1003) was revealed 1.00- 1.30m below modern ground level (113.79m AOD). This was sealed by up to 0.40m depth of grey sandy clay subsoil (1002), which, in turn, was overlain by up to 0.20- 0.70m of root disturbed, dark brown-grey topsoil (1001). These layers were sealed by 0.30- 0.70m of (1000). No features were observed or recorded.

Trench stratigraphy: Natural orange-red boulder-clay (1003) was revealed 1.00-1.30m below modern ground level (113.89m AOD), sloping down to the south-east. The trench revealed two features cut into the natural boulder-clay (see table below, Plates 4 and 5). Natural 1003 was sealed by 0.20-0.30m depth of dark grey silty sandy clay containing brick rubble (1008), possibly a levelling layer, which, in turn, was overlain by 0.70m of root disturbed brown-grey topsoil (1013). These layers were sealed by 0.20m depth concrete and tarmac overburden (1012).

Feature No.	Description	Max dimensions (m)	
		Width	Depth
1004	Gully. Aligned NE-SW with a 'bowl'- shaped profile. Exposed length 1.80m. Filled by brown sandy clay (1005). No finds.	0.60	0.12
1006	Pit with a 'bowl'- shaped profile. Whole feature exposed. Filled by grey-brown sandy clay (1007). No finds.	0.60	0.22

Trench stratigraphy: Natural orange-red boulder-clay (1003) was revealed 1.00m below modern ground level (113.94m AOD). This was sealed by 0.30m depth of grey sandy clay subsoil (1011), with pebble inclusions, which, in turn, was overlain by 0.50m of dark grey-brown topsoil (1010). These layers were sealed by 0.20m depth concrete and tarmac overburden (1012). No features were observed or recorded.

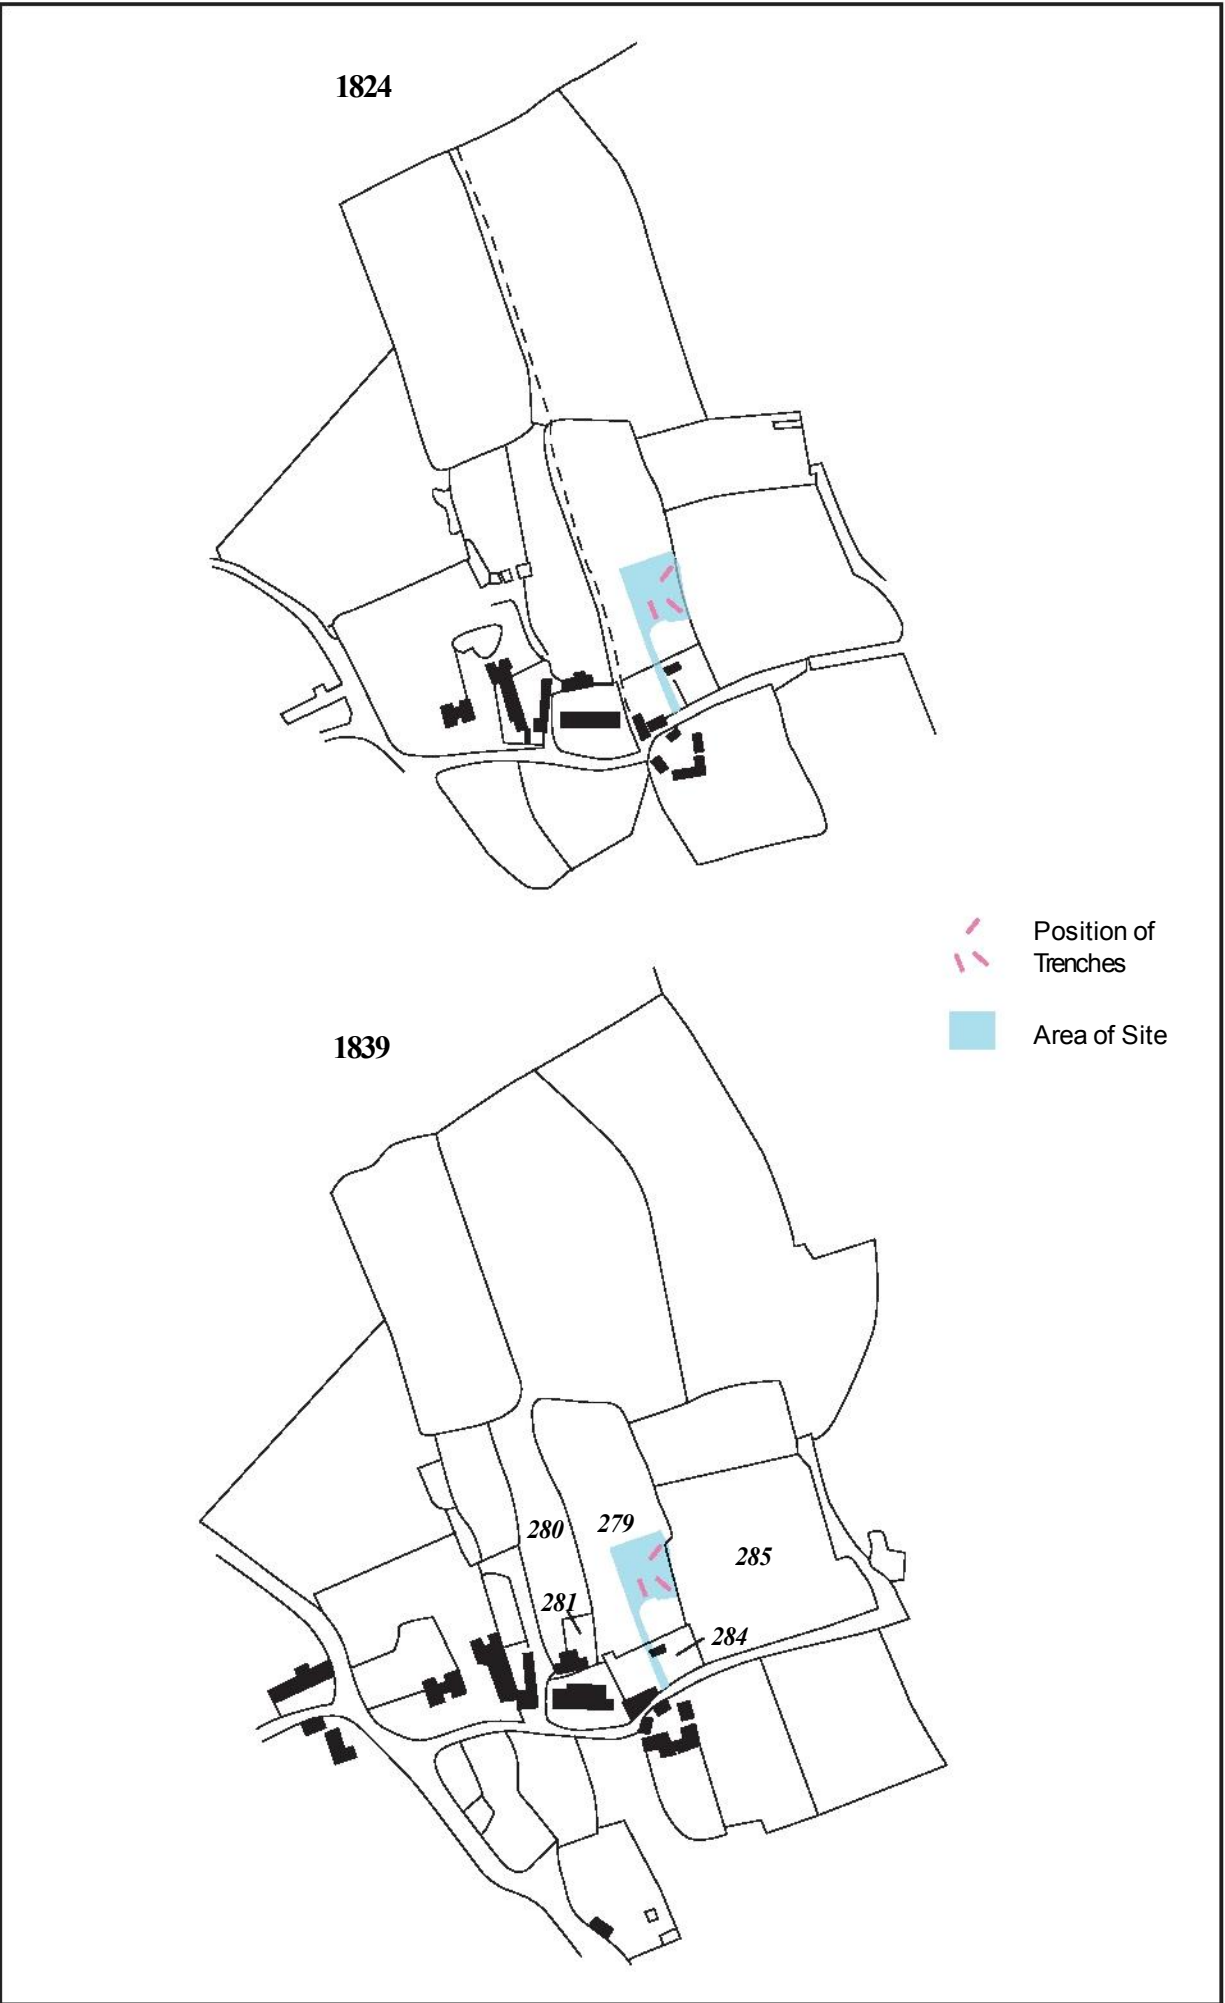
Fig.5

There have been no known significant archaeological finds on the site. The first relevant cartographic evidence is the 1824 enclosure map (Fig. 5). This illustrates that the site was located at the southern end of an enclosed field with a 'footroad' or path running north to south along the western edge of the field. At this time the field was known as 'John Holmes old inclosure' suggesting that the field had been enclosed since at least the 18th century.

An 1839 tithe apportionment map (Fig. 5) shows very little change since 1824, except that the field, at this time is known as the 'croft', was owned by James Middleton and was retained for pasture, measuring 2 acres, 1 rod and 8 perches.

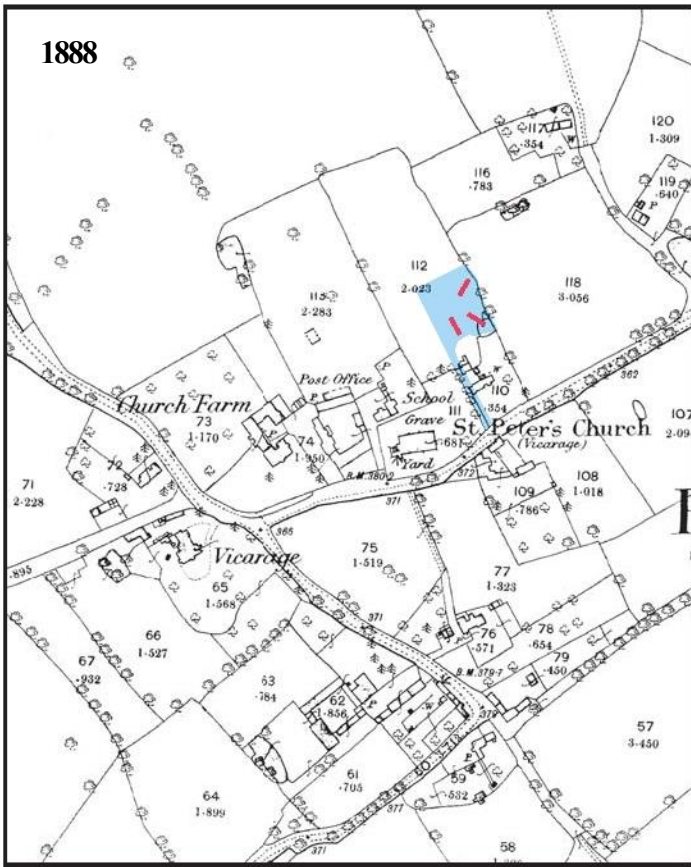
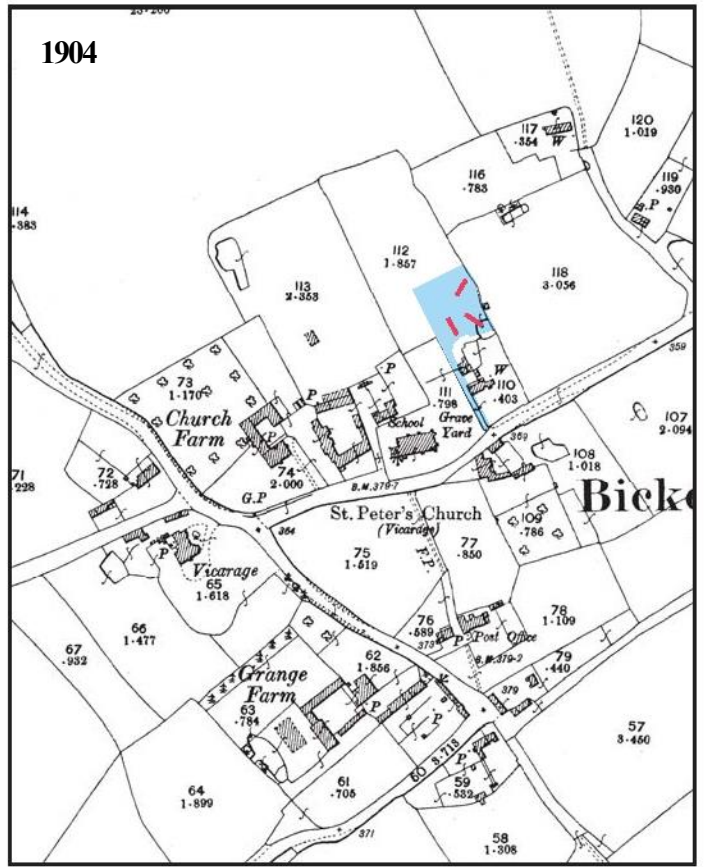
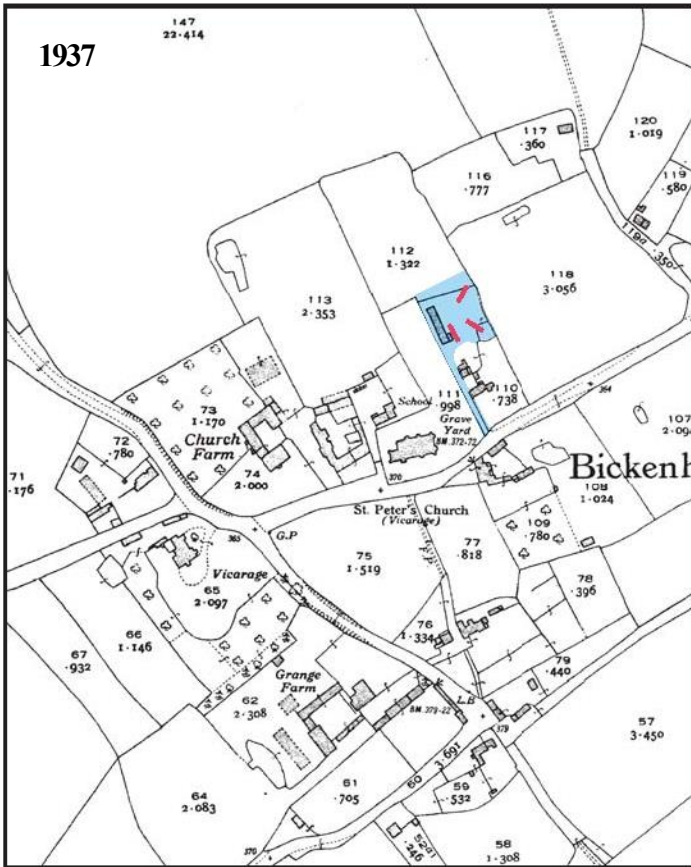
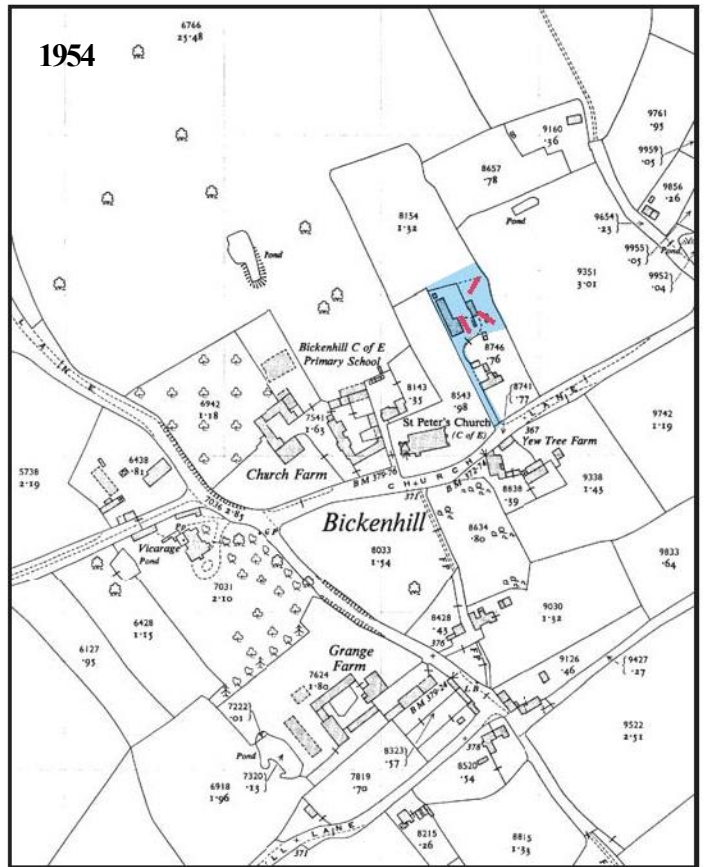
Fig6

The later Ordnance Survey maps (Fig. 6) confirm that the site was retained for agricultural use until at least 1904. By 1937 the graveyard to the west has been extended and the original field has effectively been halved by the change in land use including construction of buildings probably associated with the pressworks.

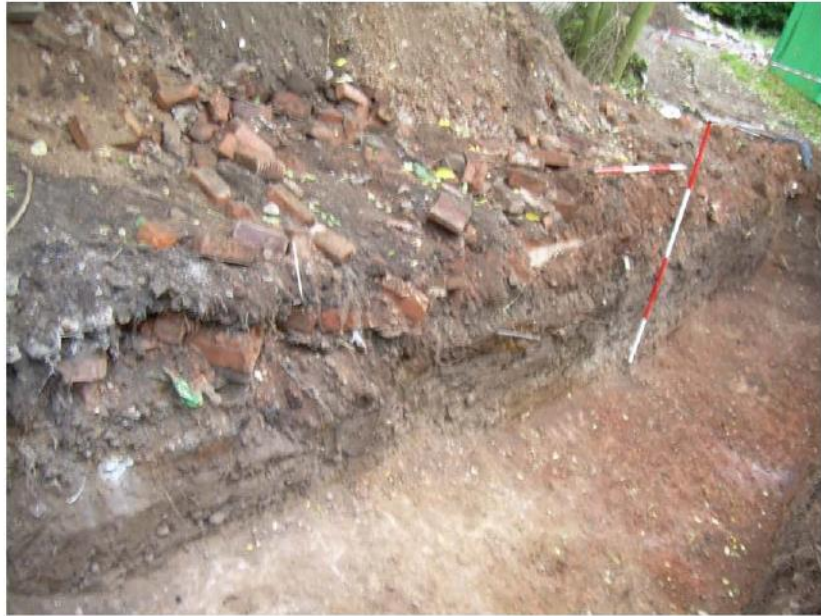
Plate 1

Trench 1 (Fig. 4) (Plate 1) 10m in length x 1.6m in width

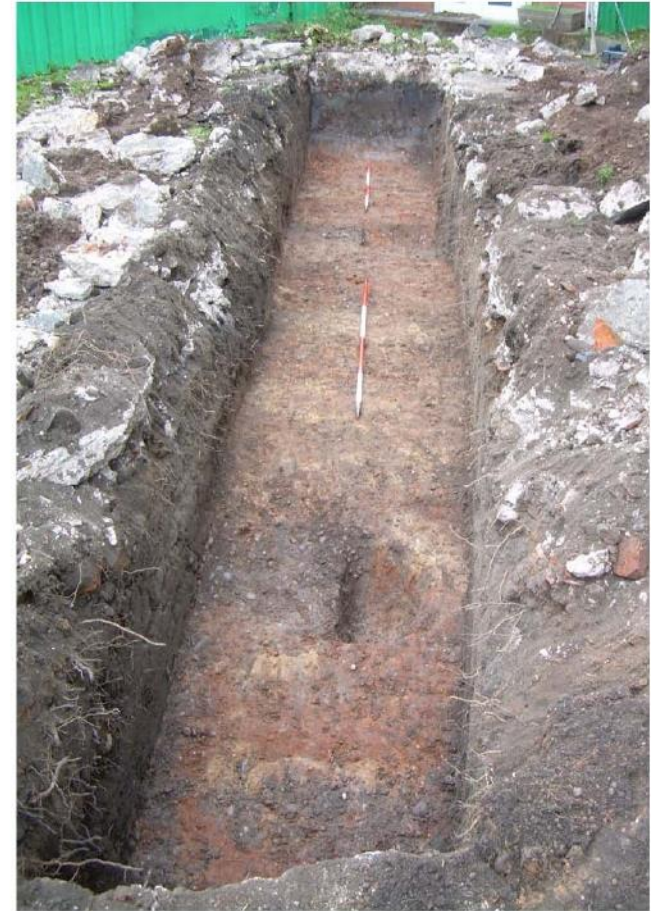
Plate 2

Trench 2 (Fig. 4) (Plate 2) 10m in length x 1.6m in width

The trial- trenching recorded archaeological features in one of the three trenches excavated. In Trench 2, in the south-east part of the site, a pit and gully of an unknown date cut the natural boulder clay. Although the features are undated it is possible that they could relate to medieval or post-medieval settlement activity, in view of their location. The depth of subsoil and topsoil in all the trial- trenches is consistent with the site being maintained for agricultural purposes, evident from the 18th and 19th cartographic evidence, prior to the erection of works buildings in the 20th century.

The archaeological features recorded during the evaluation will not be affected by the proposed development as they are in an area proposed for car parking. Deep groundworks are unlikely to be undertaken in this area. As the features are sealed by at least 1m of overburden they are likely to be unaffected by shallow ground works for the car park unless the groundworks exceed a depth of 0.90m below the current ground surface, in this area of the site. As the trial-trenches did not reveal any archaeological features in the area of the proposed office building there would appear to be no need for further mitigation. However, the final decision on mitigation rests with Warwickshire Museum.

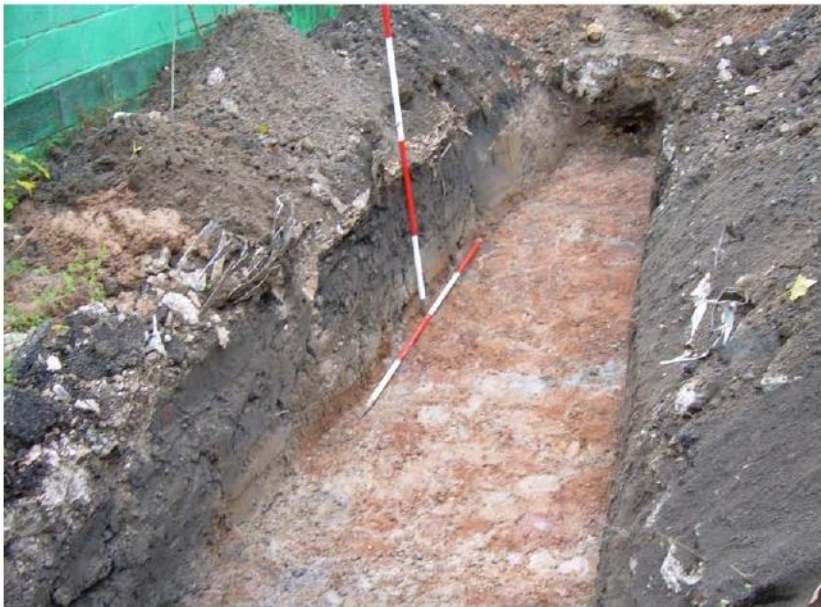
Plate 3

Trench 3 (Fig. 4) (Plate 3) 10m in length x 1.6m in width
