NORTHERN ARCHAEOLOGICAL ASSOCIATES
AELFLEDA TERRACE, WHITBY, NORTH YORKSHIRE

Negative Watching Brief Report

Development: Re-routing of water main **Planning application reference:** N/A

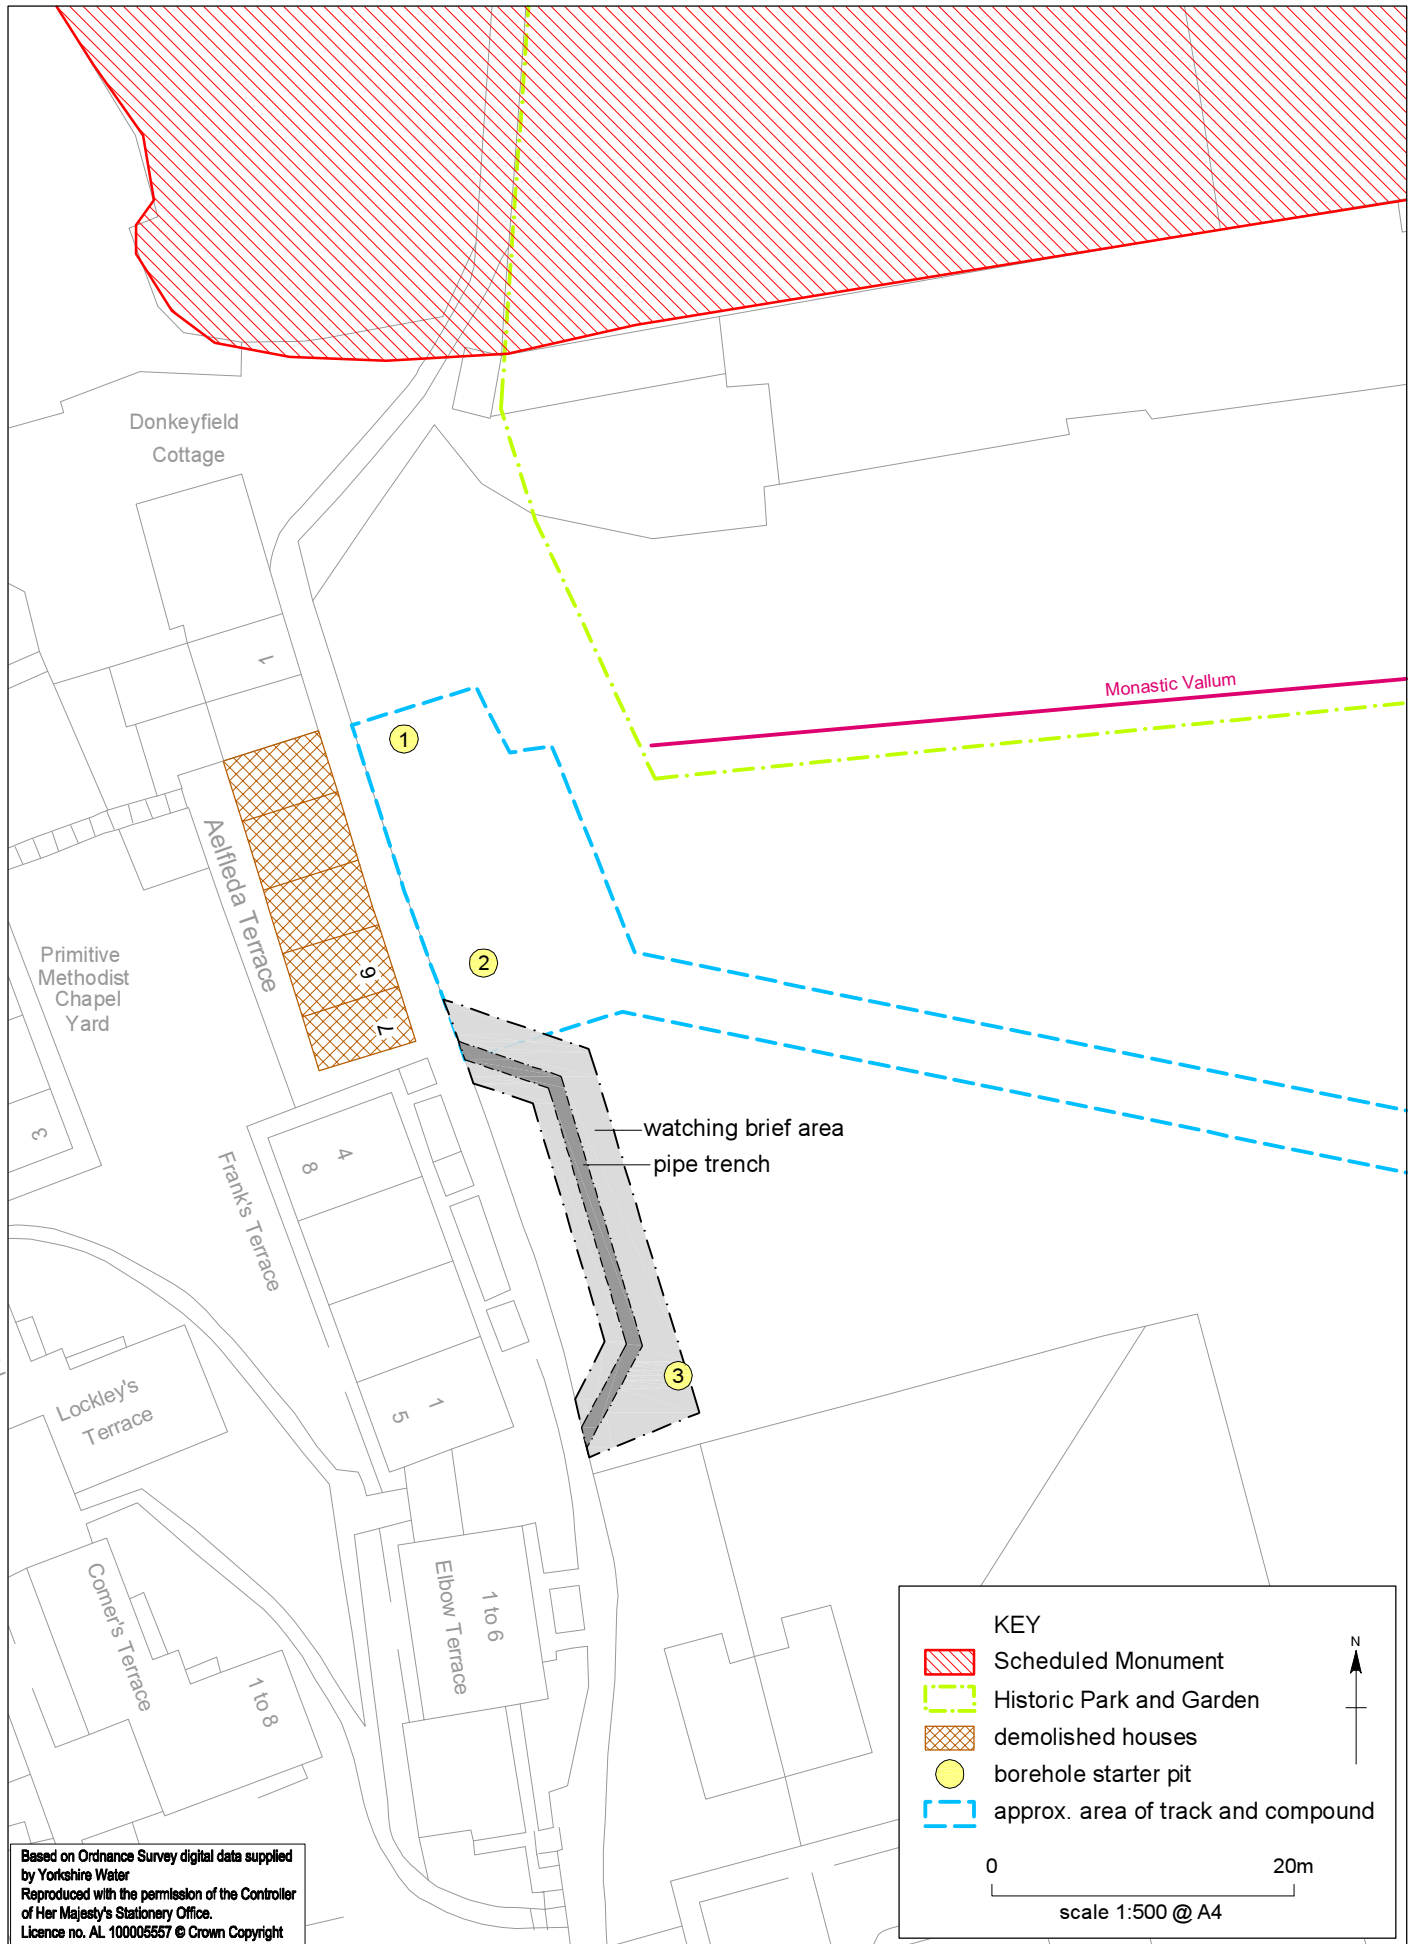
Figure 2

Aelfleda Terrace, Whitby: watching brief area

Archaeological monitoring was conducted during the excavation of a pipeline trench, to a depth of approximately 2m below ground level (Figure 2; Plate 1). No archaeological features were identified, although the cut for a revetment wall facing Aelfleda Terrace to the south was noted.

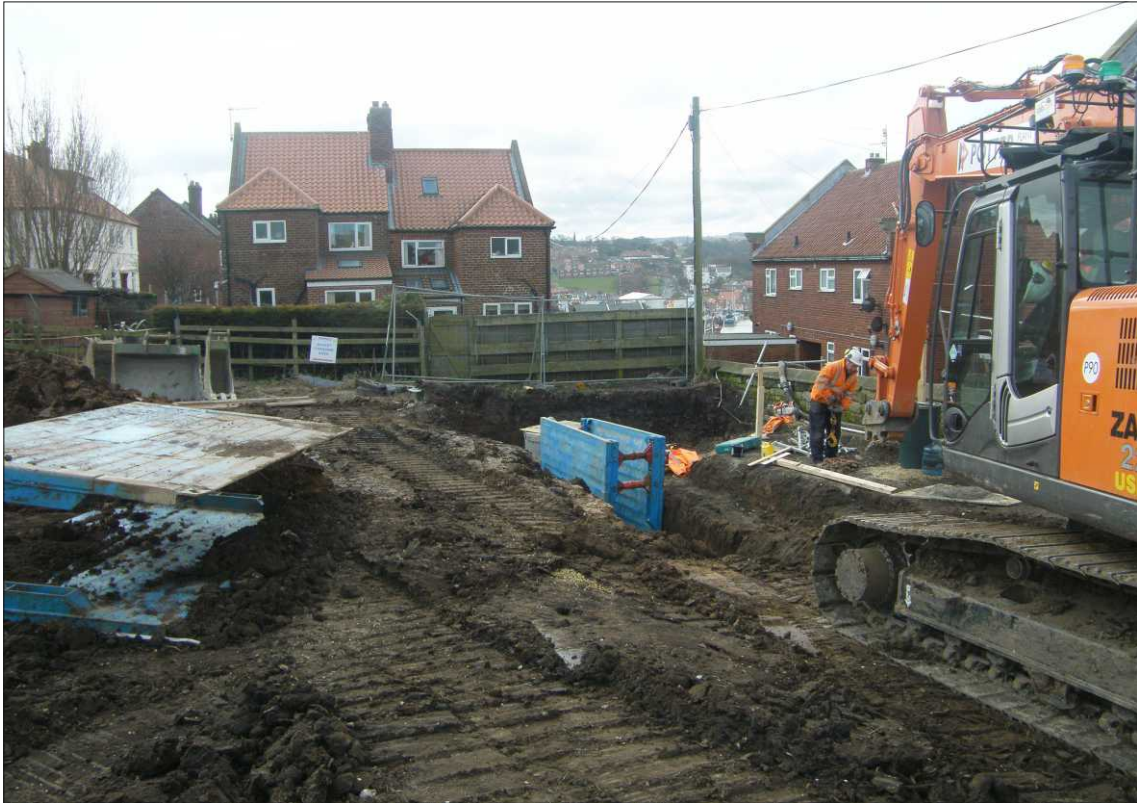
Plate 1

Aelfleda Terrace, Whitby: general view of works

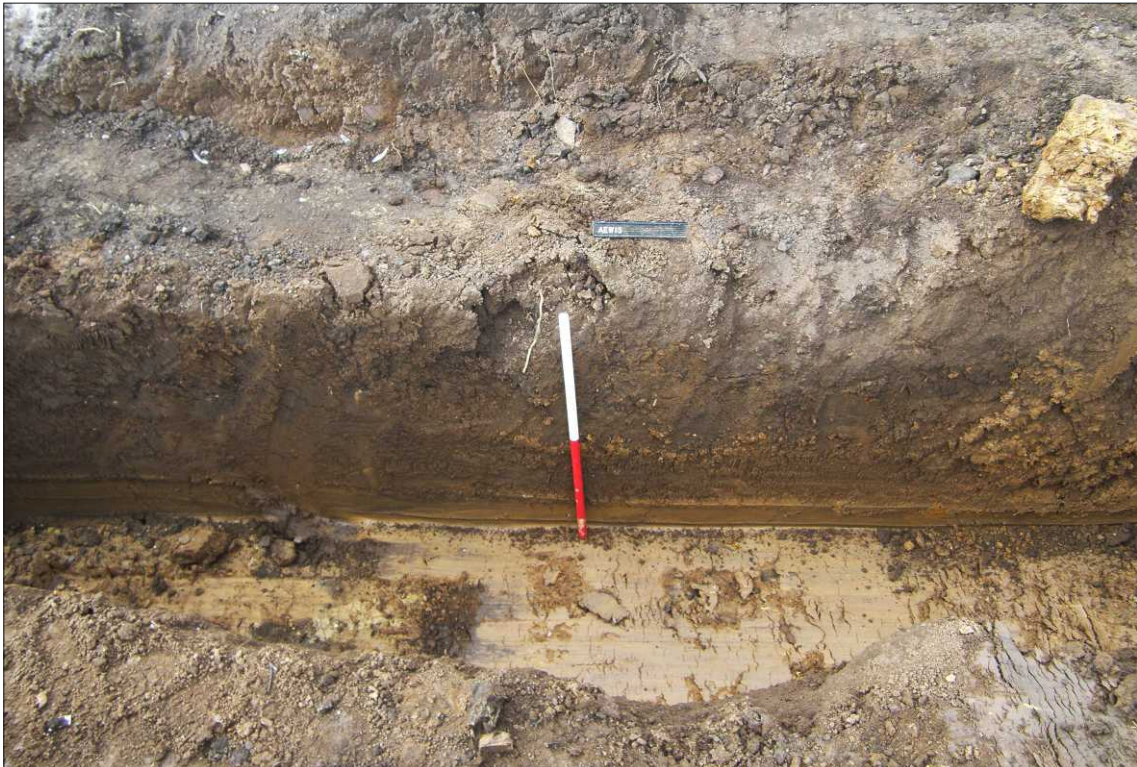
Plate 2

The natural boulder clay was located approximately 1.3m below ground level (Plate 2), and consisted of light grey mottled mid-yellow and reddish brown sandy clay. This was overlain by between 0.8m and 1.2m of colluvial subsoil, a firm mid grey brown slightly clayey silt-sand. Sealing this was between 0.4m and 0.6m of loose, dark brown grey silty sand topsoil.

Aelfleda Terrace, Whitby: section of trench showing deposits
