## ARCHÆOLOGICAL NOTES.

## RESTORED CROSS-SHAFT AT BRADBOURNE.

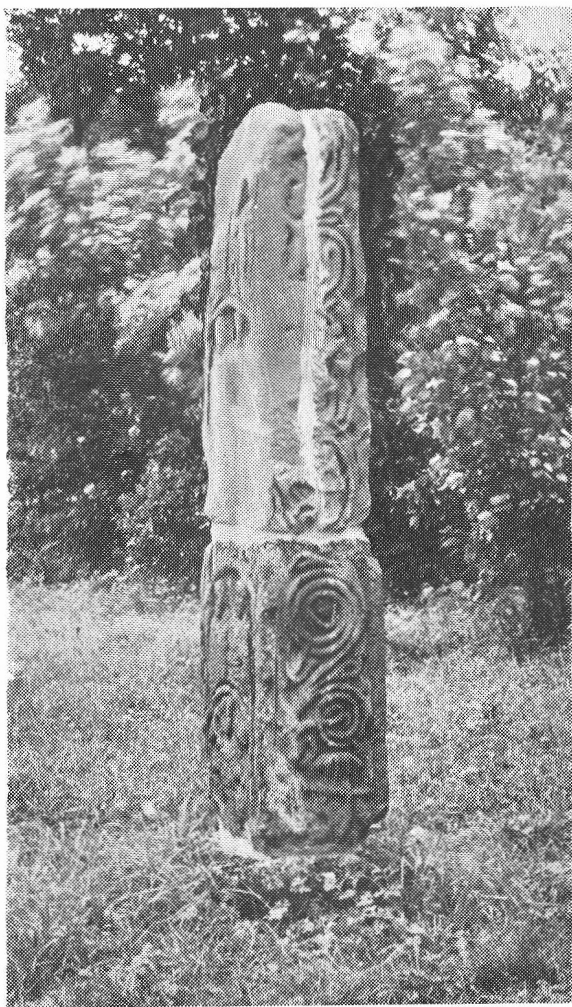
RESTORED CROSS-SHAFT AT BRADBOURNE

The illustration is of a restored cross-shaft at Bradbourne and is one that has been pieced together from three fragments. The lower part has long been in the churchyard but the upper part, which had been split longitudinally, had served as a stile in the churchyard wall until rescued some 60 years ago and placed in the church. From a tentative restoration Bishop G. F. Browne and Sir Henry Dryden first suggested that all three fragments were part of the same cross. Mr. T. E. Routh in his *Corpus of Pre-conquest Carved Stones in Derbyshire, D.A.J.*, LVIII, in which he describes the fragments and classes the lower part as Anglian eighth century, however, was then inclined to the view that they were parts of two distinct crosses, but later for reasons beyond the scope of this note became convinced that only one cross was involved. A study of the illustration showing the continuity of the beautiful vine scroll motive confirms this.

The restoration was done under the supervision of the Rev. R. F. Borough, vicar, by Messrs. Tyler and Coates, of Ashbourne, with the approval of the Council for the Care of Churches and the Chancellor of Derby Diocese. The Society of Antiquaries defrayed the cost.
