**Archaeological monitoring at the Church of
St Michael and All Angels, Winwick, Northamptonshire,
March 2018**

Winwick Parish Church

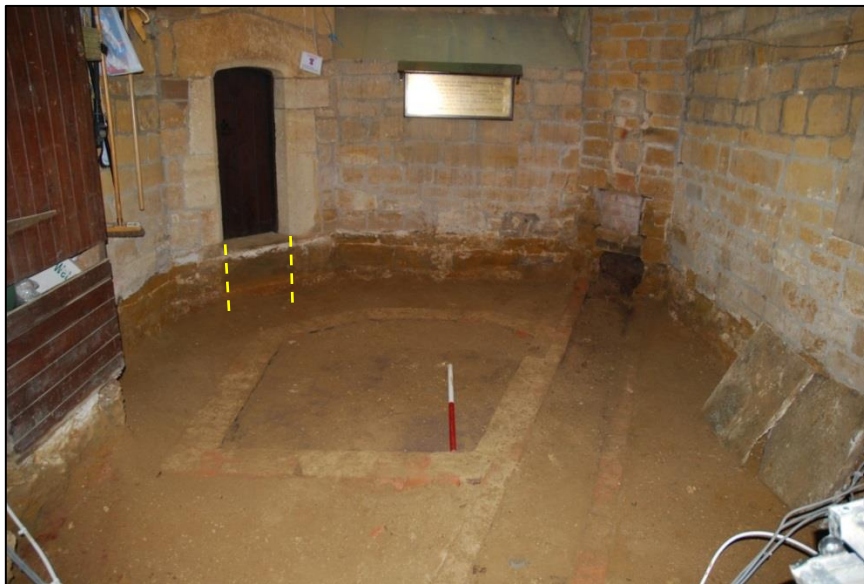
The floor reduction showed that in the south-western corner of the tower the doorway at the foot of the spiral stair to the ringing floor and bell-frame once related to a floor at the same level as the new one now is. A step had been put into it when the tower floor had clearly been raised, probably during the 19th-century (Fig 3)

Fig 3: The west tower reduced and features exposed, looking west; scale 1m. Note the spiral stair doorway and the levels there at left, and the blocked fireplace at far right.
