Land at Cotford St Luke, Bishop's Lydeard, Somerset

Archaeological Desk-Based Assessment

NHS Property Services Limited

Bristol: October 2016

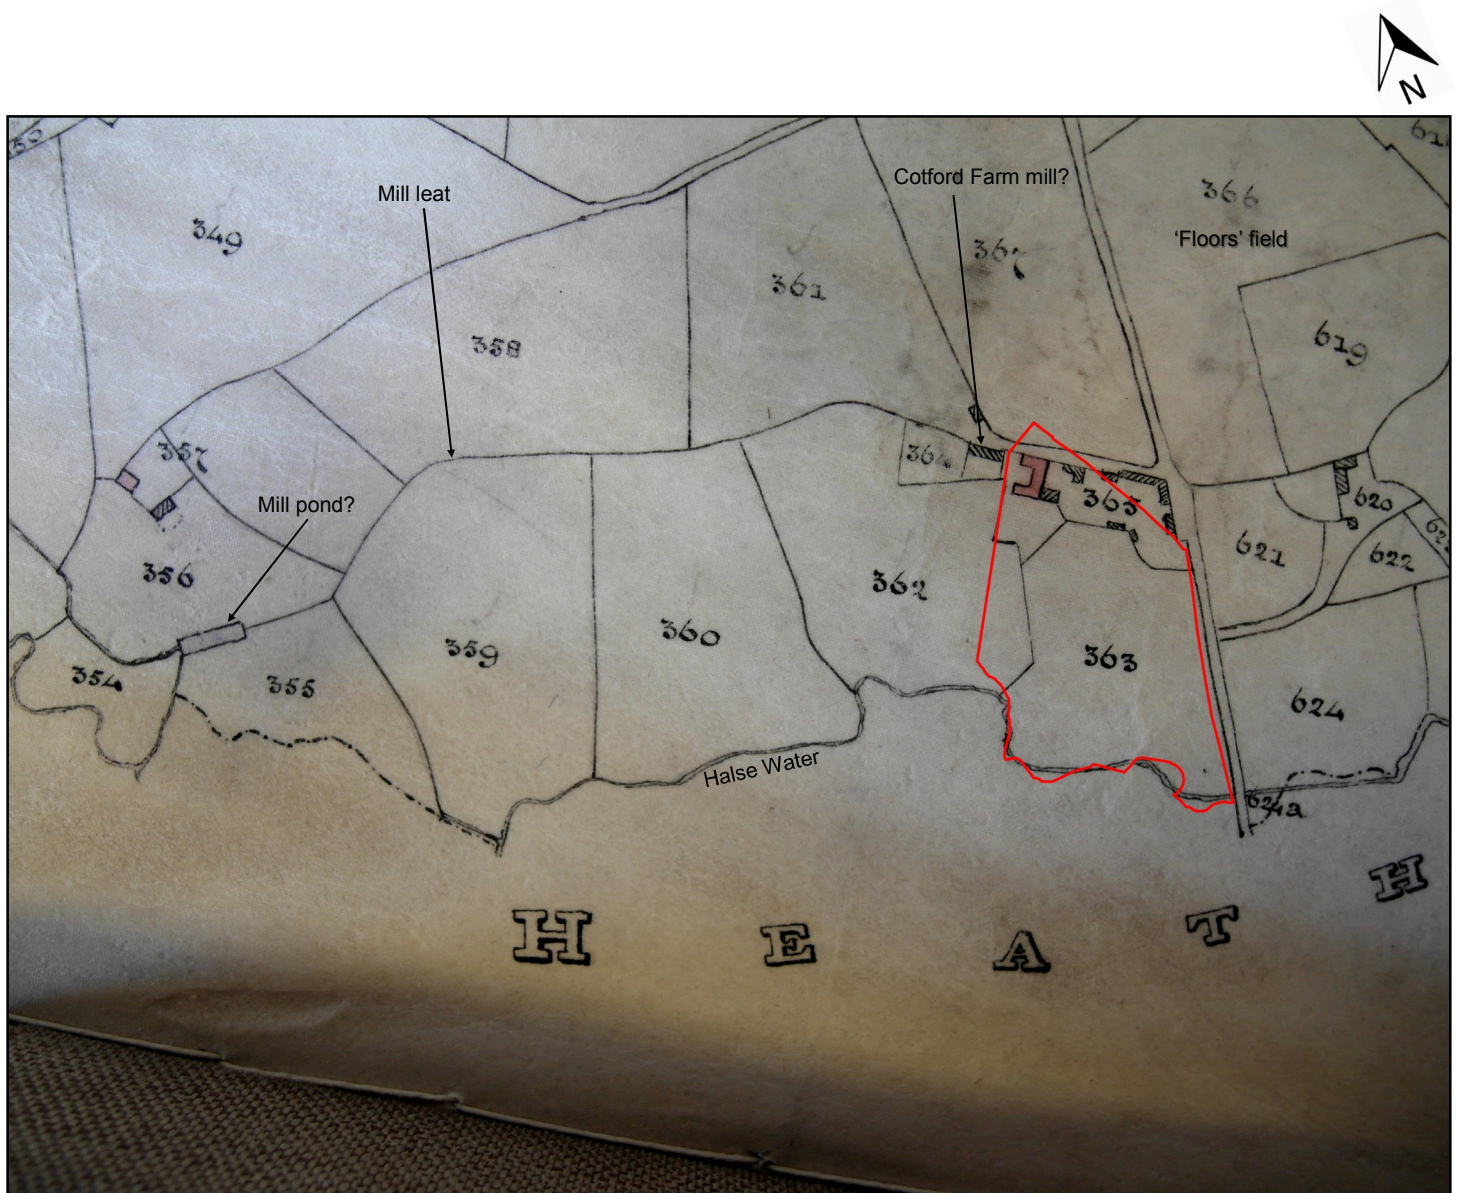
Figure 5

Extract from OS First Edition 6" map, Somerset Sheet 70NW. Surveyed and published 1887. Boundary of study area outlined in red. Not to scale. Source: National Library of Scotland

The First Edition of the OS 6" map was, very unusually, surveyed and published in the same year, 1887. It is presented here as **Figure 5** (Somerset Sheet 70 NW). This, and its contemporary counterpart, the 25" map (Somerset Sheet 70.5) is the last map to depict Cotford Farm in existence since, as we have already noted, the estate was sold in or around 1890. The main changes

appear to be that Little Cotford had by this time completely vanished, to the extent that without the testimony of the tithe map, its existence might not even be suspected from the OS alone. Again as already noted, the field boundary pattern in this area has also been heavily modified, with the removal of many hedgelines and consolidation into larger fields – although the 'Floors' field survives from the time of the tithe survey. The funnel-shaped access route to the site of Little Cotford has been another casualty of these changes.

To the south of the farm, what appears to be a dead straight watercourse heads south-south-west to a confluence with the Halse Water, at exactly the same point as shown on the tithe map. Presuming that the mill was actually in existence at the earlier date, it must have had a tailrace, but on the tithe map there is only an odd, dog-legged boundary between fields 362 and 363, which would not provide the most efficient flow of water, but there may be other reasons for that layout, now unrecoverable. The OS shows that between the two maps, a tailrace that was either completely new or heavily modified had been established, with a far more efficient dead straight run to the stream.

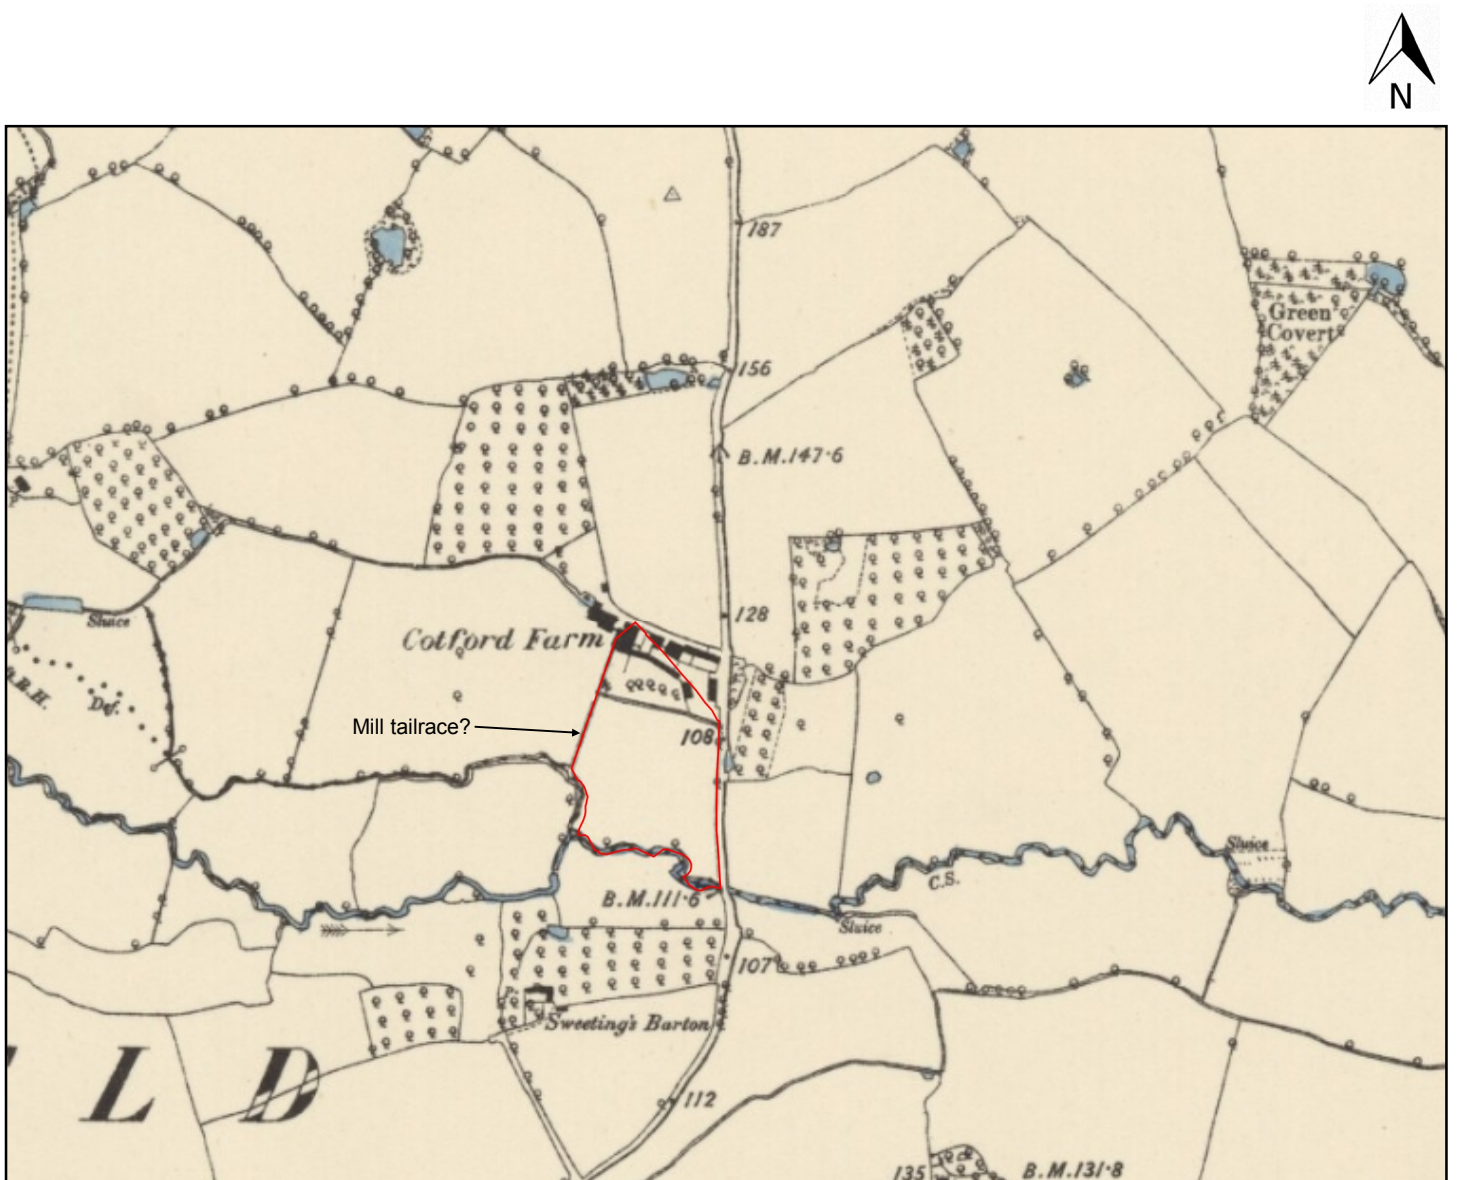
Figure 6

Extract from OS Second Edition 6" map, Somerset Sheet 70NW. Revised 1902-03, published 1905. Boundary of study area outlined in red. Not to scale. Source: National Library of Scotland

The publication of the OS Second Edition map (in 1905), marks an almost complete departure from the entirely rural landscape that had gone before, and the imposition of the hospital complex, its ancillary services such as roads and outbuildings, and notably, its landscaped grounds and gardens to its south, east and west, has caused massive disruption to the existing pattern which will be self-evident from the map itself (**Figure 6**). Cotford Farm itself has of course gone, but at least a part of its site remained undisturbed as indeed it does to this day, albeit truncated by the new access road running north-westwards from the western side of the road to Lydeard. In fact the outline of the greater part of the original farmyard enclosure can still be clearly discerned, with the new access road running diagonally through its northern half, south-east/north-west, and with its western side formed by the putative tailrace from the former Cotford Farm mill. What seems clearly to be a new building has appeared on its former site, south of the new road, and with its orientation paying scant regard to the surviving antecedent boundaries. If we had to rely on historic aerial photography alone, the nature of this building might have been somewhat problematic (**Figure 9**); luckily however, historic large-scale mapping makes it clear that it was in fact a glasshouse. Like most of the other buildings in the immediate area, this is likely to have been established as an integral element of the hospital development, perhaps with a view to providing the inmates with fresh fruit and vegetables throughout the year, even in the winter – as such it may well have been worked as a direct adjunct to Asylum Farm, with the dual intention of acting as a form of 'therapy' for patients.

The structure persisted on this site until at least 1969, but had gone 20 years later (Old Maps); its site lies firmly within the boundary of the proposed development.

On the eastern side of that latter road, Asylum Farm is new, constructed in the western part of the old 'Floors' field, and to its south, although unidentified, lies a new a group of buildings which remain today and are known as South Villas. The reservoir, pump house, and the two gate lodges to the site, are all new, as are the Isolation Hospital to the north, the chapel to the north-west, and the sewage works to the south-west; *all* of these elements owe their existence *solely* to the establishment of the hospital. To the south of the former Cotford Farm site, its mill tailrace (if such it actually was), formerly running south to the Halse Water, has vanished, and does not appear even to betray itself on modern lidar imagery (**Figure 8**).

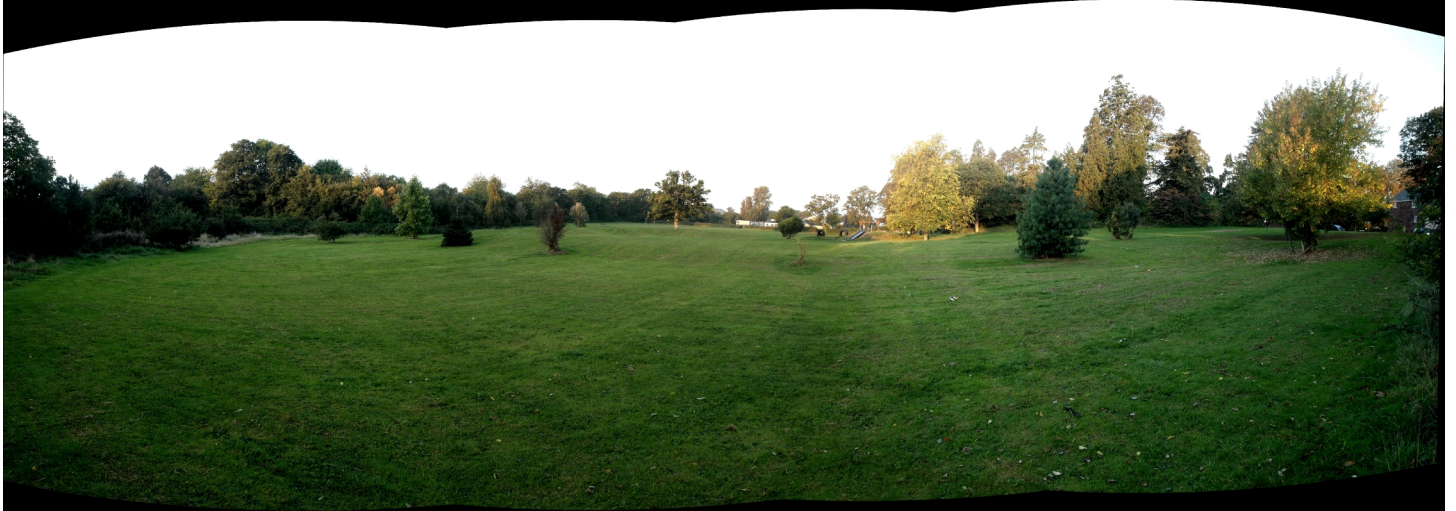
1. Composite panoramic view of the northern part of the site. The view pans round from north-west on the right-hand side of the frame, to south-west on the left. Taken from close to the site's northern boundary, from OS NGR ST 17104 27045. The embanked curvilinear area in the centre of the frame is modern, and related to the use of part of this area as a recreation and amenity space.

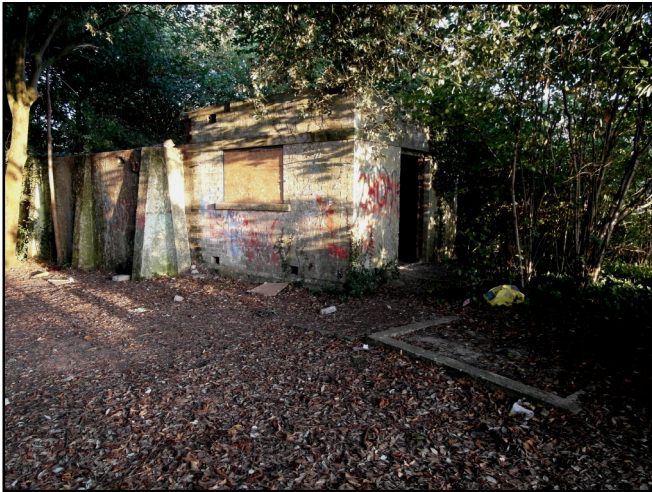
2. The group of structures at the north-eastern side of the site identified as 'tanks' on modern OS mapping. View to north-west.

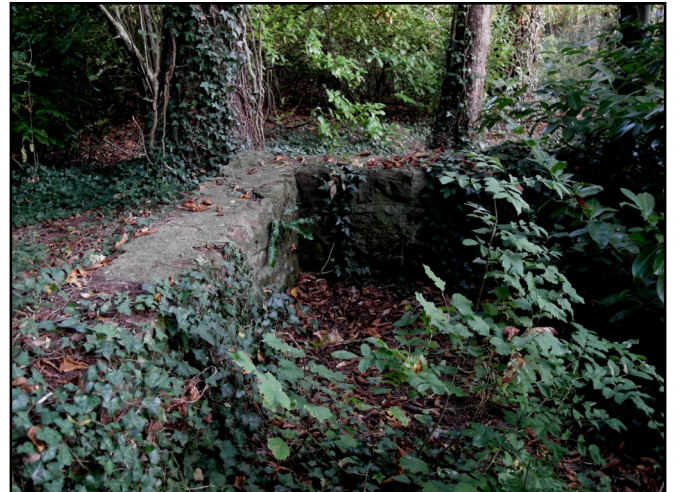
3. View of the north-west corner of the masonry structure in woodland and undergrowth on the western side of the Lydeard road, and immediately to the north of Cotford Bridge. It is marked on OS maps from the end of the 1920s, but its function when in use is, at present, entirely unknown. It lies within the site boundary, at its extreme south-eastern corner.

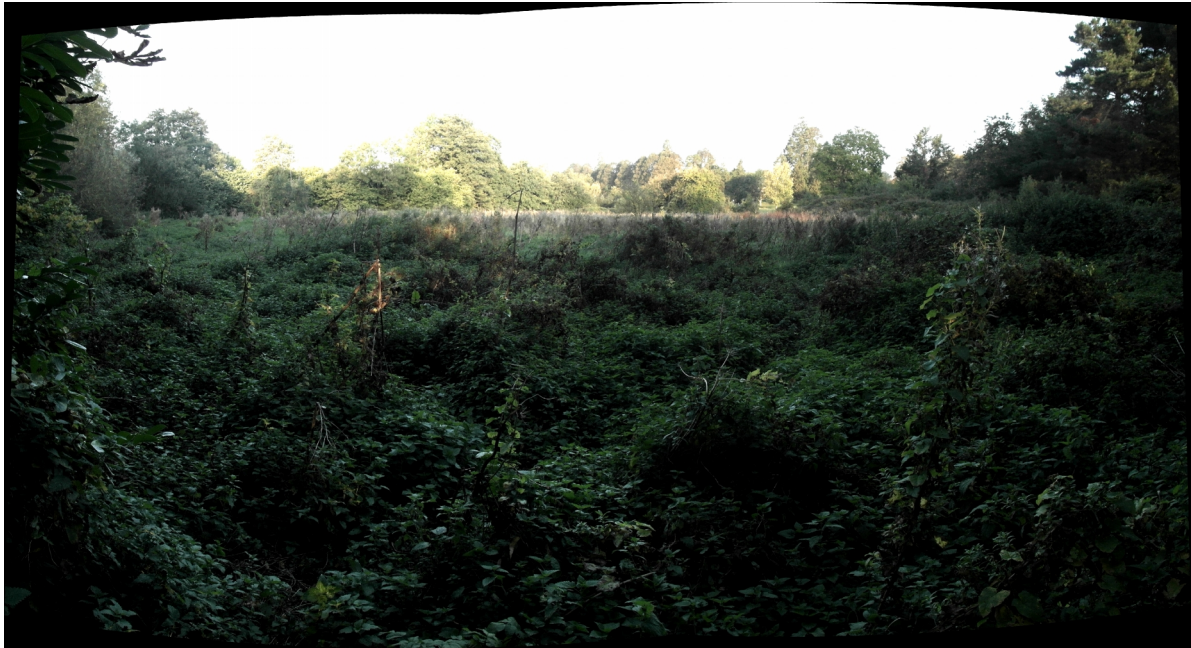
4. Composite panorama taken from close to the south-eastern corner of the site, looking across the southernmost of the two enclosures which divide the site into northern and southern halves. Note the heavily overgrown state of this area, although this is slightly variable across it. The view pans round from the west on the left hand side of the frame, to north-east on the right hand side.
