Research and Development. The National Aircraft Factory Branch Line.

Members of the Archive Team (Colin Richardson and Peter Skinner) recently noticed that the platform attached to the Steve Frieze Removals and Storage business had been tidied up and become more visible. The platform was, of course, once in use for the branch railway line which served the National Aircraft Factory and its successors from 1918 to about 1924.

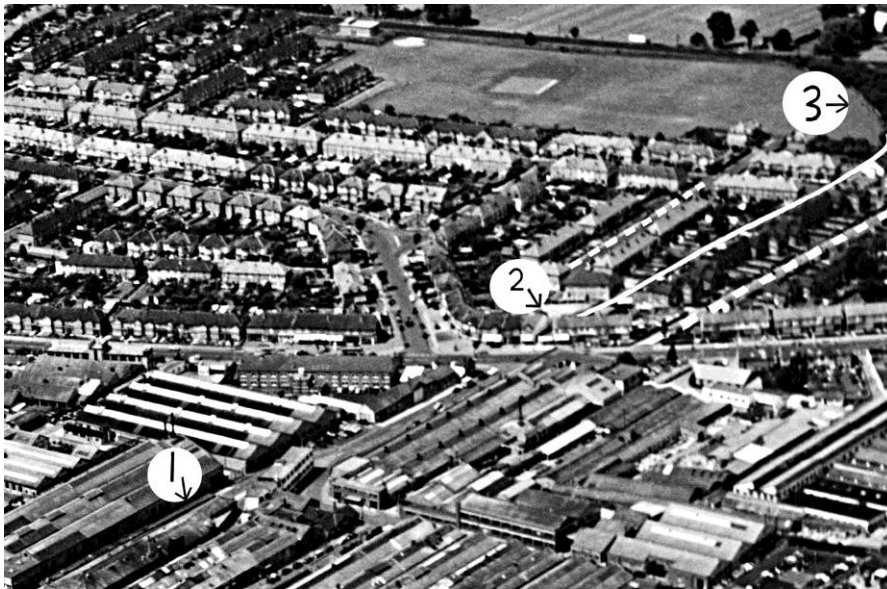
The 1960 aerial photograph below is often referred to in this article. A London A – Z street map could be useful in conjunction with the aerial view. The numbers refer to the aerial photograph. Also in this picture are a dotted white line indicating Headley Avenue, more or less between ‘2’ and ‘3’, to its right a single white line representing the railway ‘track bed’ and to its right another dotted white line indicating Merebank Lane.

Aerial view from 1960 looking approx. north. Stafford Road runs across the picture from left to right, just below ‘2’. The numbers refer to the text above. (Handford/Tom Samson).

It was decided to check if there were any other reminders of the route taken by the branch line from the factory platform ‘1’, to Stafford Road and then across Stafford Road ‘2’ and then via the curve round to join the West Croydon to Epsom railway line ‘3’, with a recreation ground shown to its left.

Position '2' on the 1960 photograph above shows a side wall and roof apex of a business at rather a strange angle, with a gap to the next business on the right. A stall with canopy occupies the gap at ground level. This is where the branch line crossed Stafford Road.

(A London A – Z or local street map will be handy for local Members. For others, a continuous white line has been placed on the picture from behind the Stafford Road crossing point by '2' to the railway banking '3' showing the branch line route.).

The curved banking is clearly visible in the labelled photograph at '3'. There has been little change between 1960 and today (July 2011). The banking can be accessed from the adjacent recreation ground. Trains from the Waddon direction bound for the National Aircraft Factory would pass the branch line intersection and after the points had been set, reverse onto the branch line and onwards to the Factory. When a train left the Factory bound for Waddon, it would halt just past the intersection and then reverse towards a line cross-over to regain the correct track. Good co-ordination was needed by the railway staff involved regarding the operation of any train using the branch line.

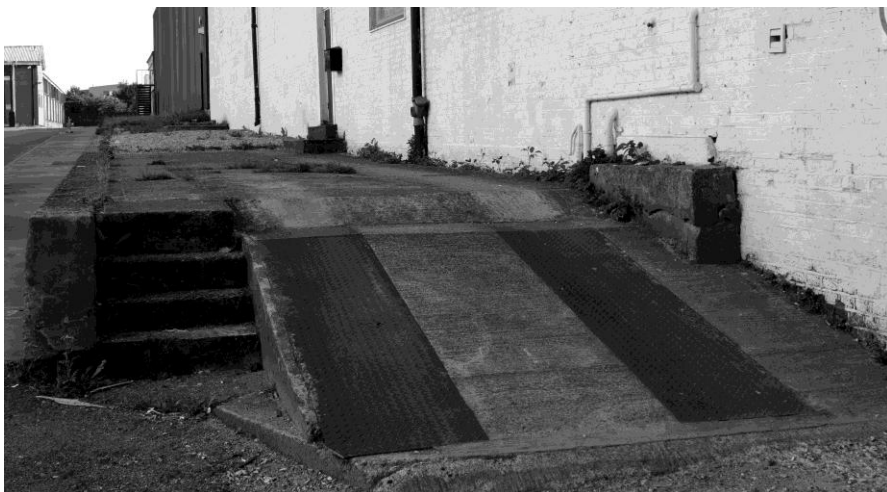
The Steve Frieze Platform. ‘1’.

This is the north end of the platform adjoining the Steve Frieze Removals and Storage business in Princes Way. The line continued roughly southwards across Queensway and on to the west side of Croydon Airport's 'C' hangar. (Peter Skinner, June 2011.).

The platform is a significant relic of the factory branch line, still remaining in 2011 in Princes Way. This part of the line continued south across Queensway to alongside the west side of the NAF hangar (known to CAS as ‘C’ hangar).

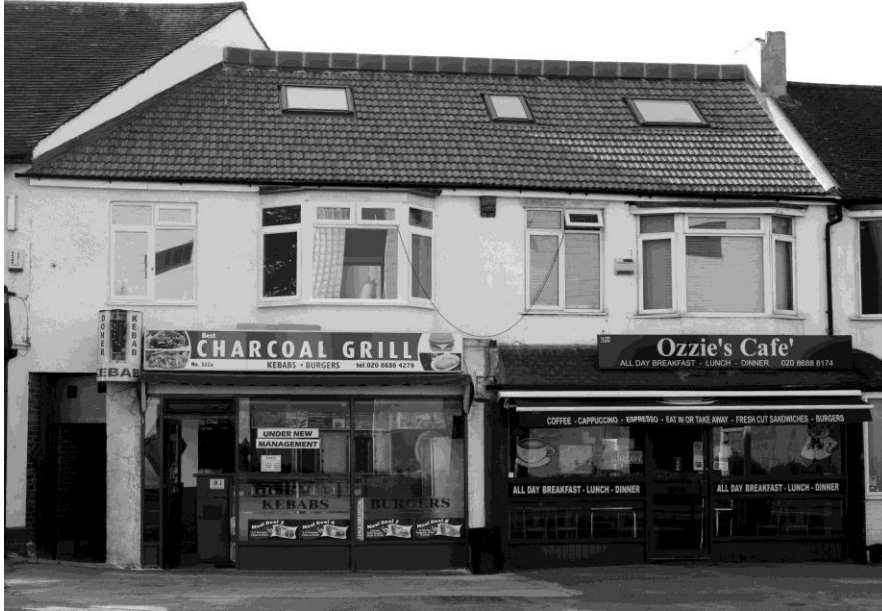
Crossing Stafford Road. '2'.

The far left of the picture clearly shows the wall and apex of a business at a strange angle relative to the 'new' businesses, 'Charcoal Grill' and 'Ozzie's Café', on its right. The narrow passageway occupies part of the space where the branch line passed after crossing Stafford Road. (Peter Skinner, June 2011.).

In June, 2011, some building modifications are evident. Two businesses now fill the gap, with the upper storey of one forming a bridge over a narrow passageway.

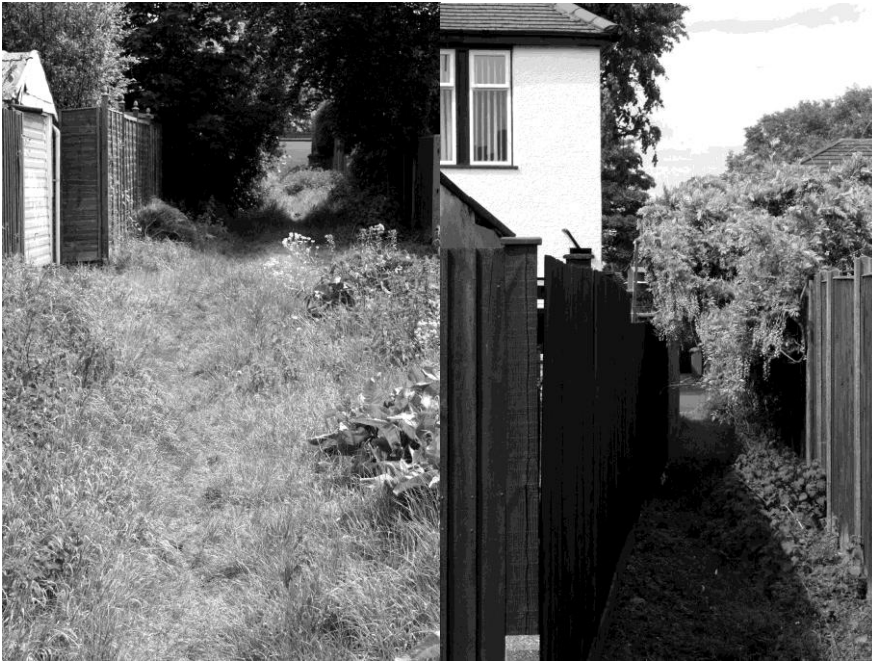
The 'track bed' looking south towards 'Charcoal Grill' and Stafford Road. (Peter Skinner, June 2011).

The 'track bed' looking north towards the curved banking '3'. The house is in Godalming Avenue. (Peter Skinner, June 2011).

It came as a surprise to the CAS researchers when it was discovered that most of the 'track bed' between Stafford Road and the curved banking which joined the Croydon to Epsom railway line is still visible in 2011! Today the 'track bed', shown as a continuous white line, serves to access the rear of the gardens of houses between Headley Avenue (between '2' and '3', shown as a dotted line on the 1960 aerial view) and Merebank Lane (also shown as a dotted line on the aerial view). A few garages and sheds appear along the route but its narrowness and grass surface makes vehicular use and turning difficult. There are links via passages from both Headley Avenue and Merebank Lane. On maps the 'track bed' between the gardens runs close to the route of the Croydon district boundary. [e.g. Ref.1].
