DUDDO TOWER, FROM THE S.E.

DUDDO TOWER.

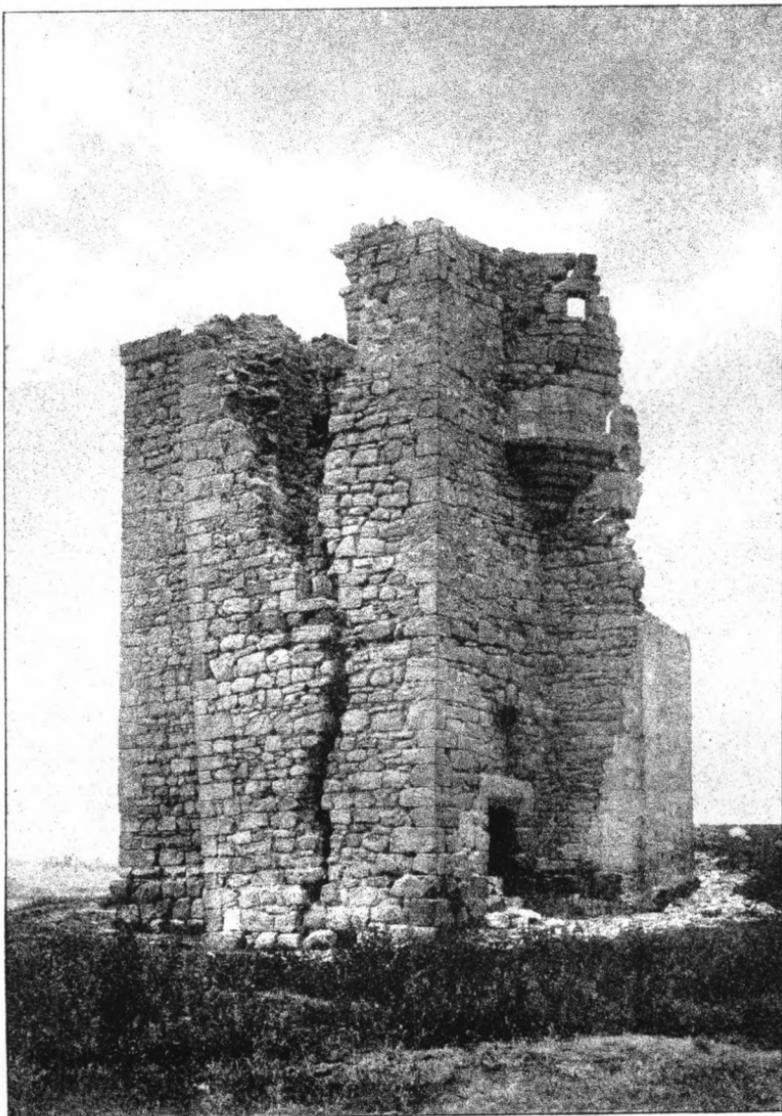
The northern portion of the tower has quite disappeared, but the plan seems to have been more or less of a square, measuring about 36 feet outside, with a rectangular stair-turret, 13 feet 7 inches broad, projected about 10 feet from the south wall, at a distance of 16 feet 6 inches from the south-west corner of the tower. The south wall of this turret is rent from top to bottom. On the east face of it, in the re-entering angle, is the entrance, a four-centred door of rude construction, with two bar-holes on the right. The recess under a rough arch over the door was no doubt for an armorial panel. A round angle turret is corbelled out above the entrance. This is entered off the main wheel-stair at the third floor level. The south wall of the tower to the west of the entrance turret contains two square-headed windows.

James IV. of Scotland rased and cast down a tower at Duddo when he invaded England in the autumn of 1496.¹ Only a piece of this tower was standing in 1541, and it had not been repaired before 1561, when half of it is stated to have been left with a barmkin round it. The present ruin, which is built of rubble, exhibits none of the characteristics of a tower of the fifteenth century. The angle turret is indeed an evident sign of late sixteenth-century construction. Like Doddington and Coupland, the existing tower was very probably built subsequent to the report of the Border Commissioners in 1584.
